# **DESTRUCTIVE EXAMINATION OF SHIPPING PACKAGE 9975- 02101**

SRNL-STI-2016-00209, Revision 0

## **DESTRUCTIVE EXAMINATION OF SHIPPING PACKAGE 9975-02101**

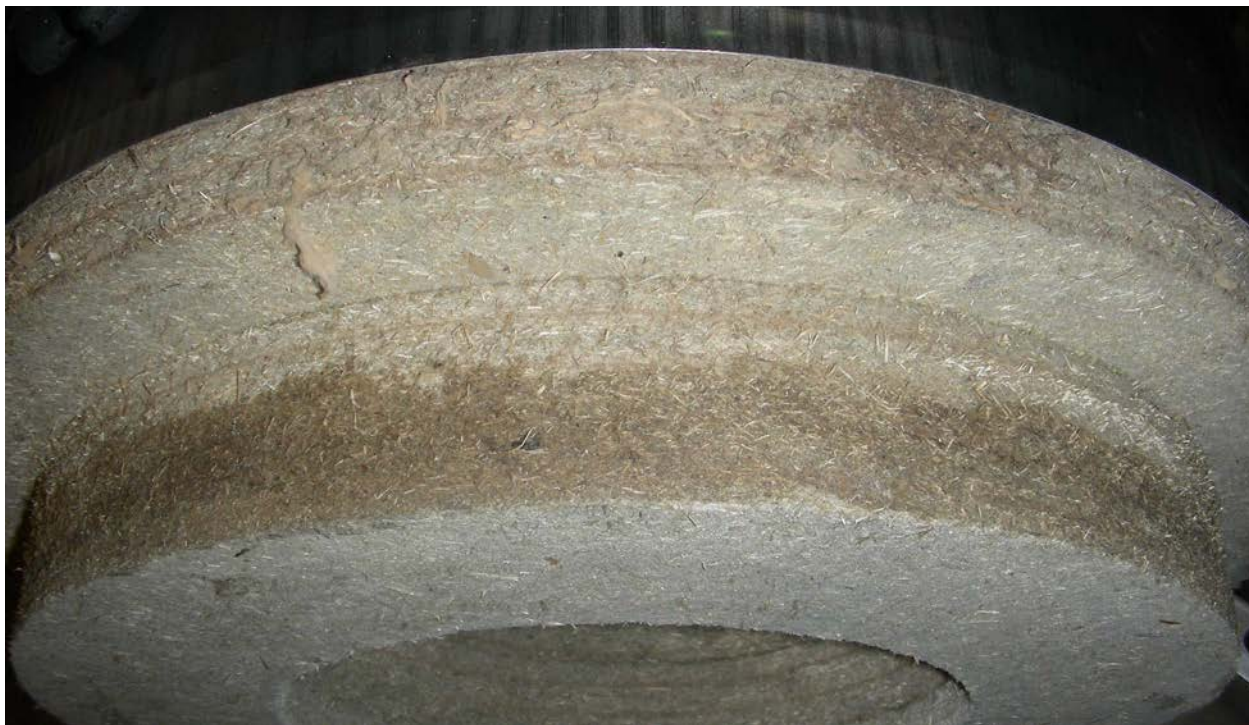
The field surveillance report included two observations on the fiberboard appearance, noting evidence of water stains on the upper subassembly and mold on  $\frac{1}{4}$  of the upper subassembly outer circumference. When first examined in SRNL, the stains were attributed to smeared glue, and the mold on the upper subassembly was also observed on adjacent regions of the drum and lower subassembly (Figures 1, 2). In addition, significant mold was observed around the bottom ~ 2 inches of the lower fiberboard subassembly and in several regions on the side (Figure 3). The bottom layers of the lower subassembly were saturated with water (darkened) and very soft. They tended to separate and split apart during handling. During the second examination in SRNL, the moisture content near the bottom was reduced, resulting in some cracking / splitting of the fiberboard (Figure 4).

Figure 1. Upper fiberboard subassembly with mold and dark regions attributed to smeared glue.

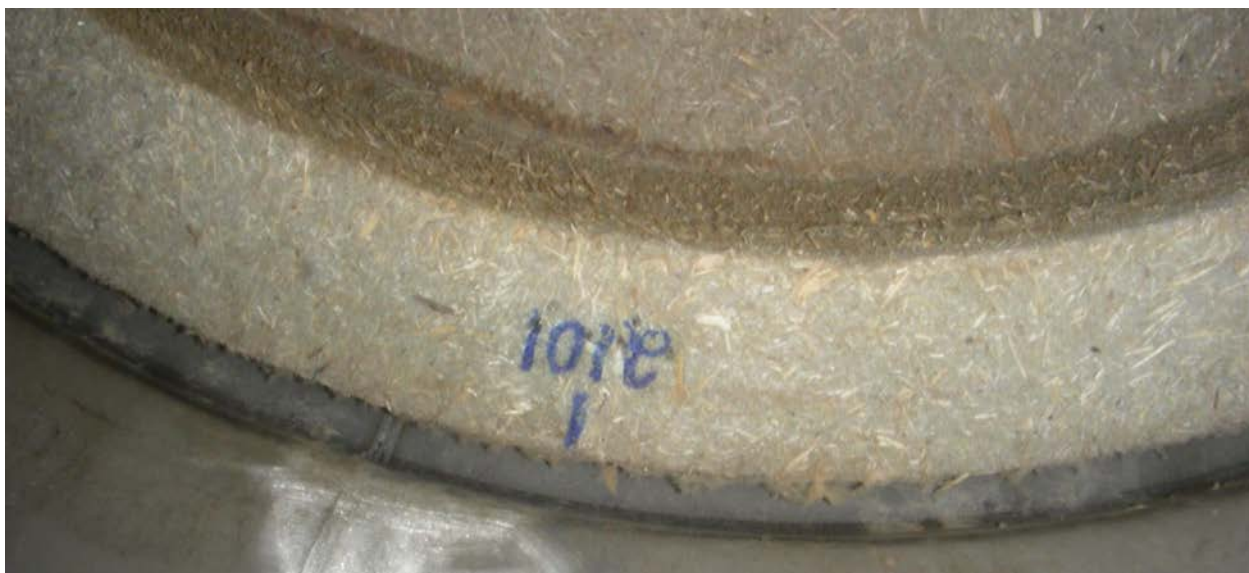
Figure 2. Mold between lower fiberboard subassembly and drum, coincident with the mold on the upper fiberboard subassembly.

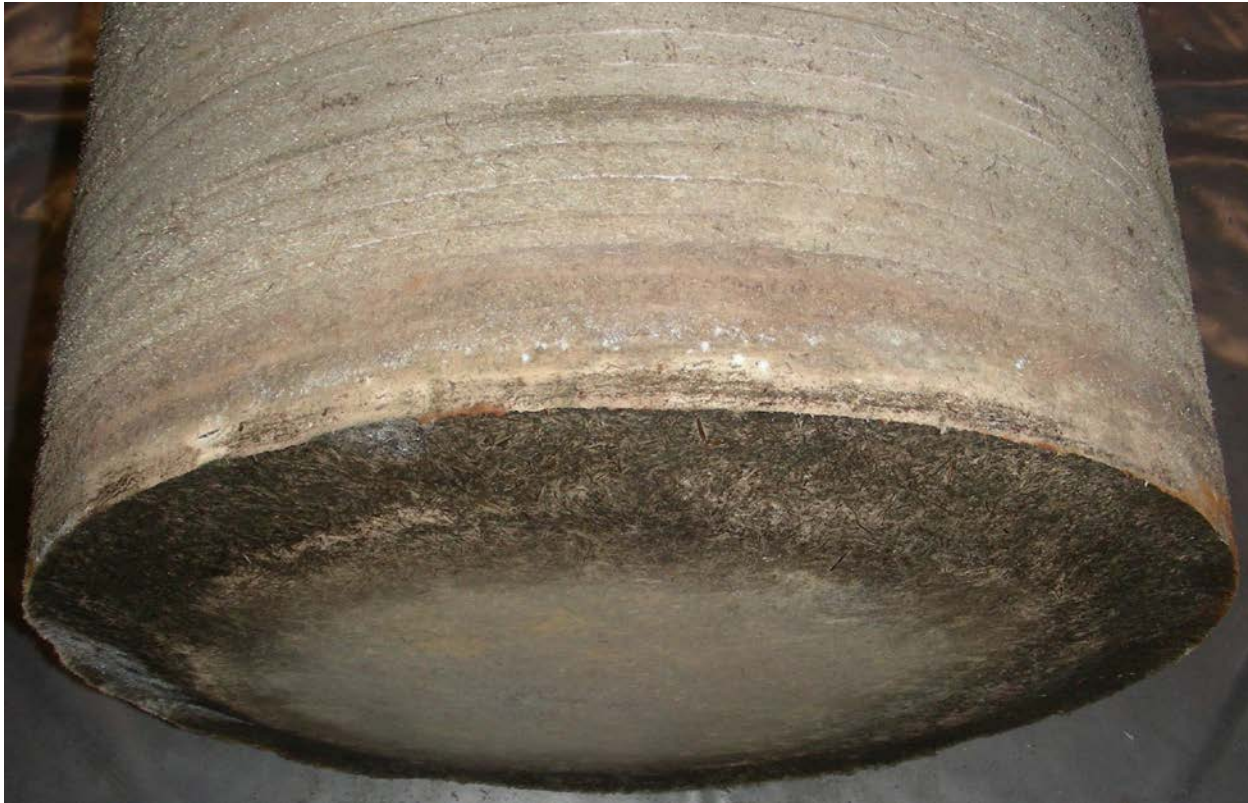
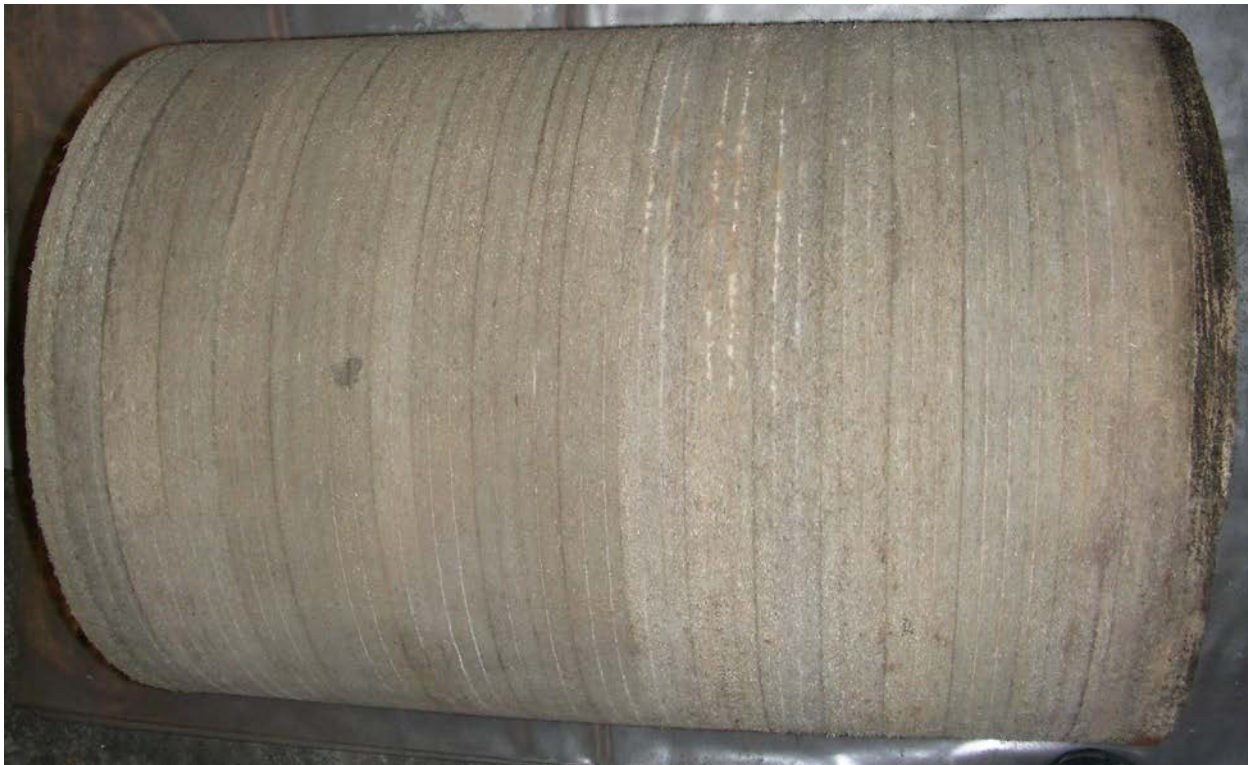
Figure 3. Lower fiberboard subassembly mold in the bottom saturated layers (a) and on the side (b).

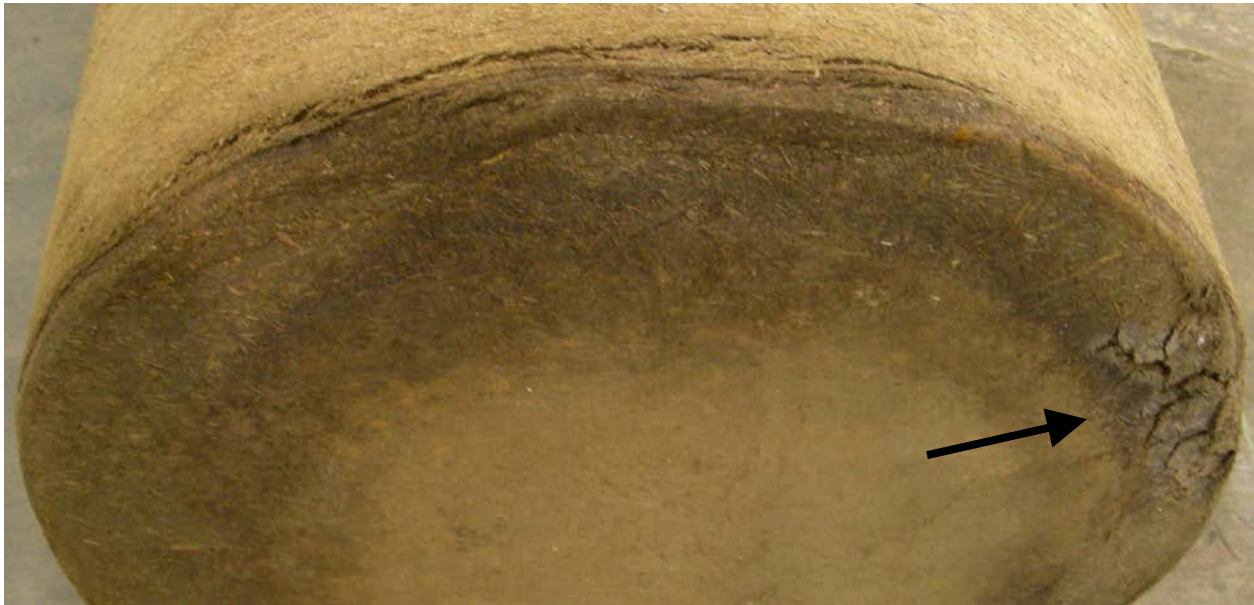
Figure 4. Cracking of the lower fiberboard subassembly following partial drying out.

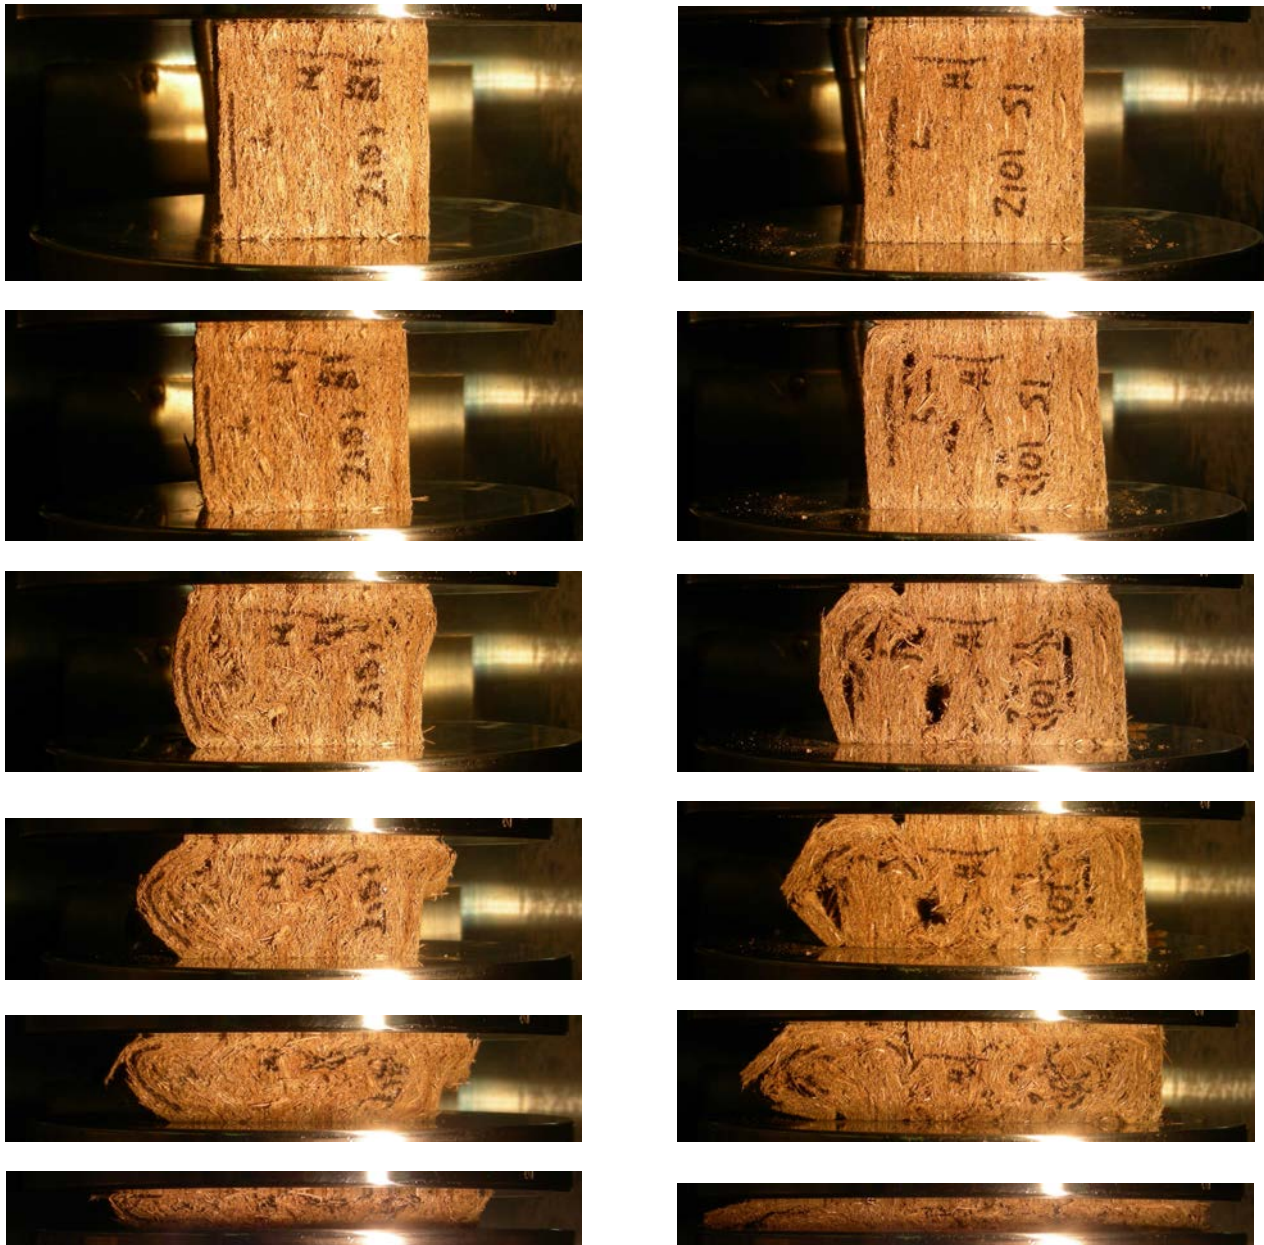
Figure 11. Photographs of fiberboard samples during compression testing, parallel orientation

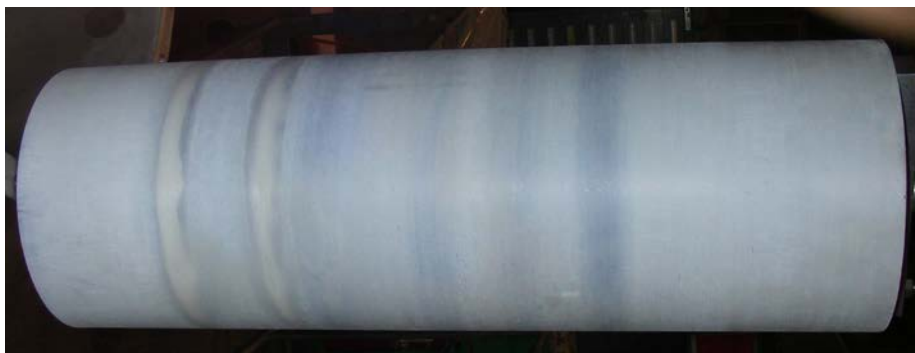
The entire surface of the lead shield was visually examined. It was found to be free from significant deformation and physical damage. The outer side surface is covered with white corrosion product, with varying thickness, as has been observed on other packages (Figure 14).

Figure 14. Lead shield with white corrosion product.

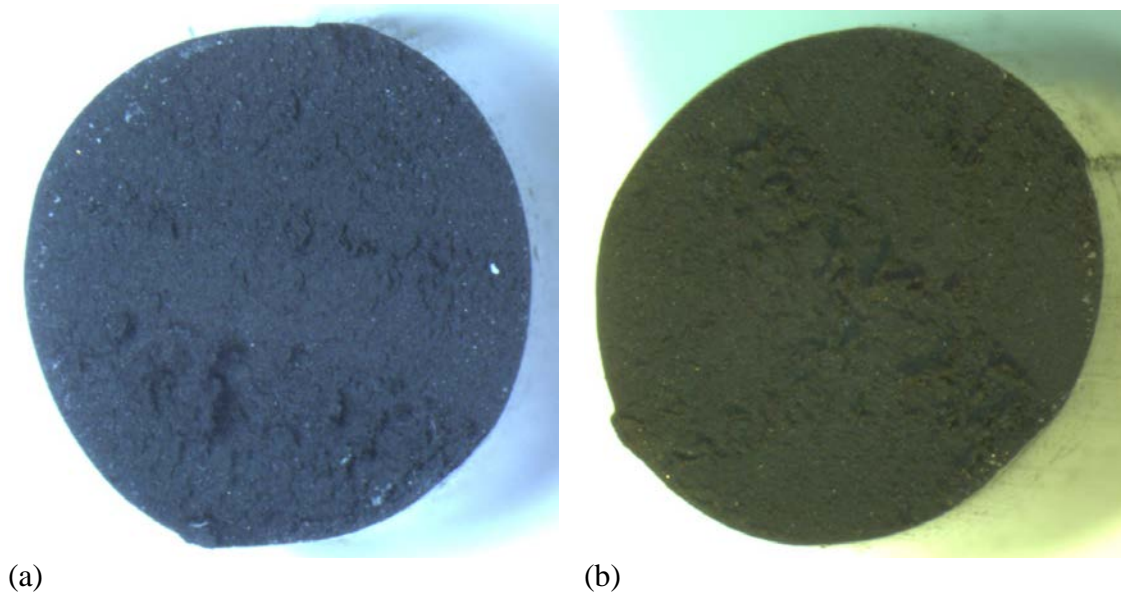
Figure 16. Optical cross section of the (a) PCV outer and (b) SCV outer O-rings. Photos taken by 723-A Met Lab.

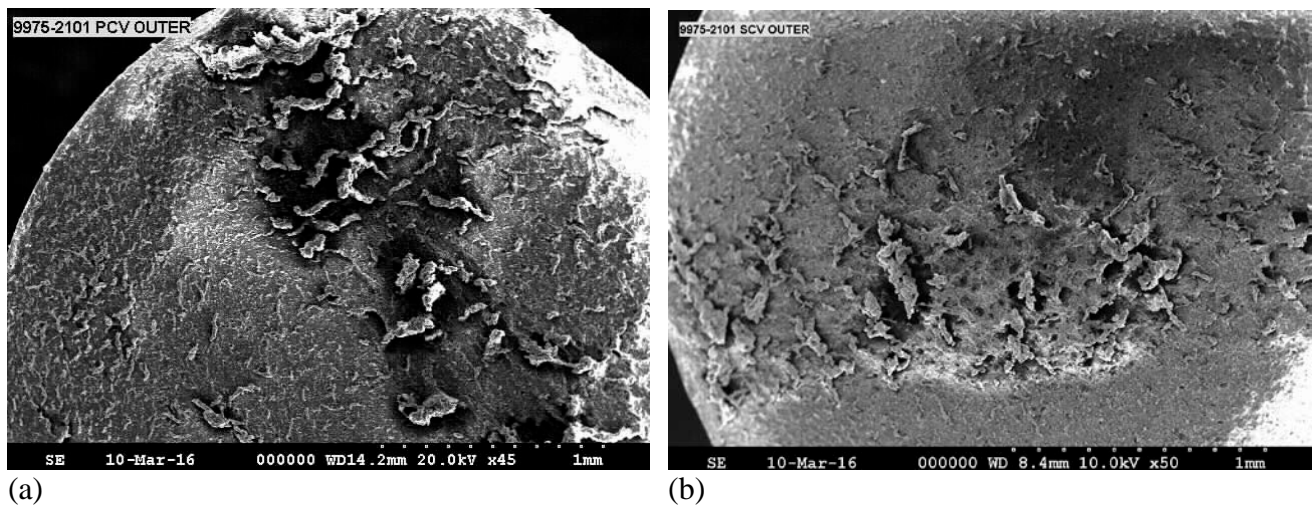
Figure 17. SEM cross section of the (a) PCV outer and (b) SCV outer O-rings. Photos taken by 723-A Met Lab.

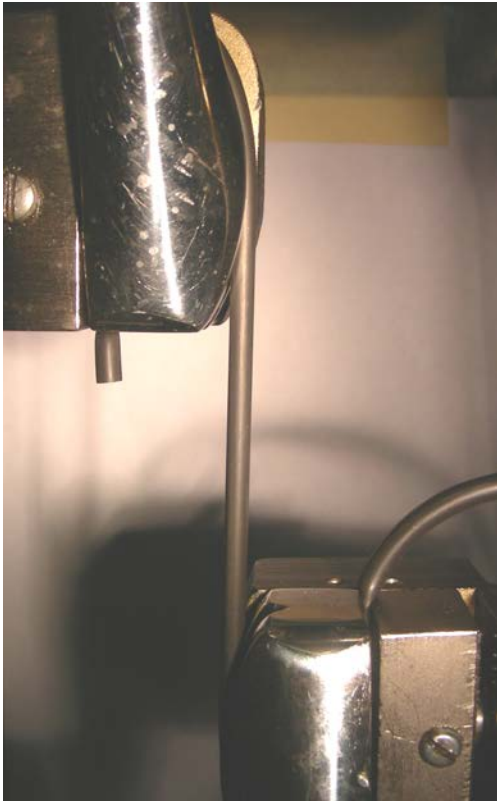
The PCV inner O-ring was tensile tested in accordance with ASTM D1414, using a cut (single strand) sample. The test was interrupted at 50% strain (Figure 18) to visually examine the O-ring for signs of cracking or other degradation. None were observed. The initial stress-strain curve for the PCV inner O-ring is shown in Figure 19, along with results of other tests with Viton GLT O-rings. In this first test, the O-ring failed after reaching 356% elongation. A re-test was performed with a different grip arrangement, and reached 285% elongation (Figure 20). The first test uses a yarn grip which would allow some stretch beyond the gage section, especially if the O-ring had any residual grease. To more accurately measure the elongation, the second test was performed with an alternate grip arrangement which does not allow such stretch. Since these alternate flat grips pose a greater risk of breaking within the grips (which would invalidate the test), the portion of O-ring within the grips was wrapped with tape for cushioning.

Figure 18. 9975-02101 PCV inner O-ring during tensile test, at 50% stretch.

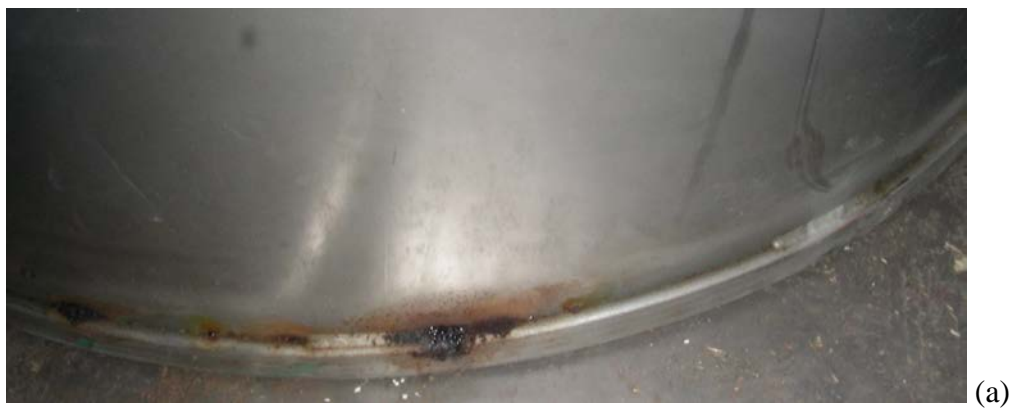
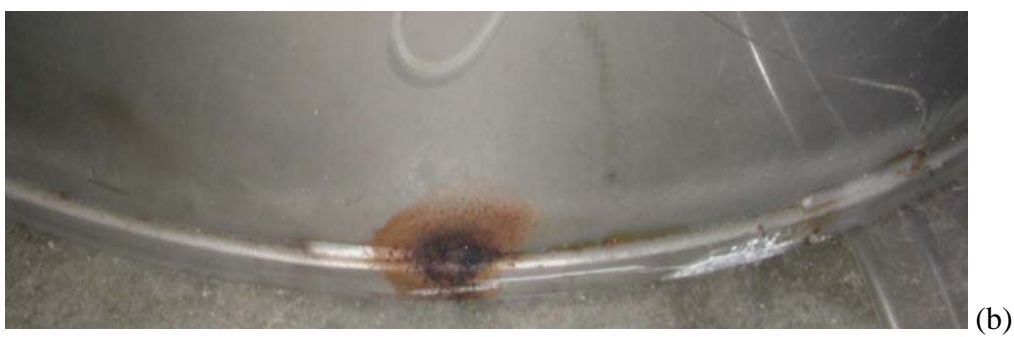
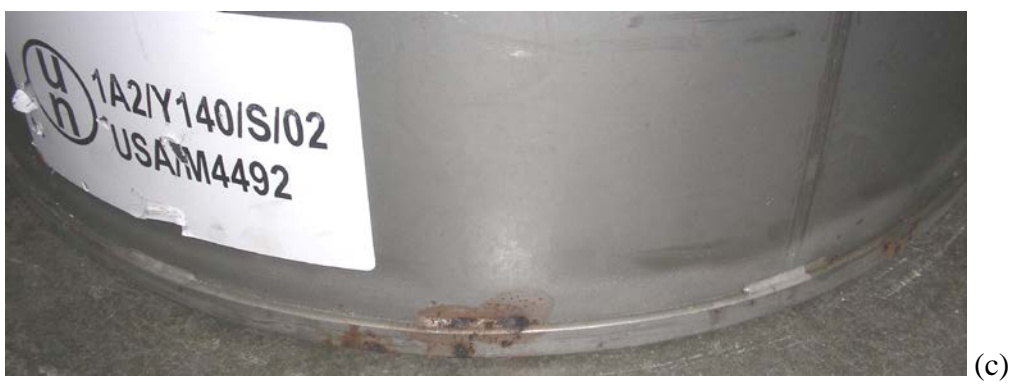
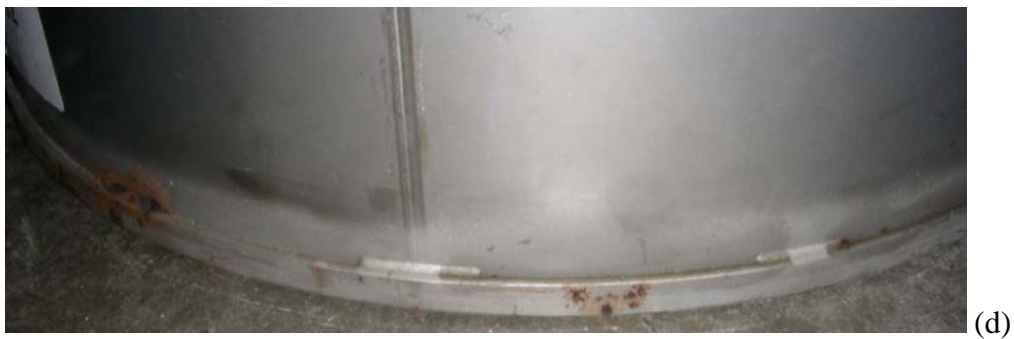
Corrosion was observed in four areas around the bottom edge of the drum exterior (Figure 21). Figure 22 shows corrosion on the inner drum surface just above the bottom crevice opposite three of these locations. The third of these locations is shown in Figure 23 after light cleaning. A small amount of water was placed in the drum, with the drum tipped slightly to concentrate the water at one of these corrosion locations. Water was later observed on the outside at that location, demonstrating a leak path through the bottom joint of the drum exists. It is anticipated that this leak path existed originally, and that the corrosion may have exacerbated that condition. Corrosion was also observed along the corner on the bottom of the drum (Figure 24). A section

When corrosion has been observed on the drum from other 9975 packages, it is typically heaviest along the bottom edge at the ends of the stitch welds. Two reasons contribute to this behavior. First, the residual stresses from these welds are prone to create larger gaps between the interlocking layers in the bottom edge. With the larger gaps, leakage through these local areas will increase and chlorides and other corrosive constituents that might leach from the fiberboard can preferentially concentrate at these locations. Second, the typical weld filler metal used on stainless steel is prone to contain elevated levels of ferritic microstructure, which can be more susceptible to corrosion. However, it is noted that corrosion has also been observed on the bottom surface of 9975 drums, and adjacent to the side seam weld [7, 12]. Neither of these locations is associated with a direct leak path or ferritic microstructure. Therefore, any change to the stitch weld configuration may reduce the severity of corrosion, but is not likely to eliminate it.

Figure 21. Four areas of corrosion on the drum exterior along the bottom edge.

Comment – Corrosion was noted along bottom edge of drum in several spots, and on the bottom surface.

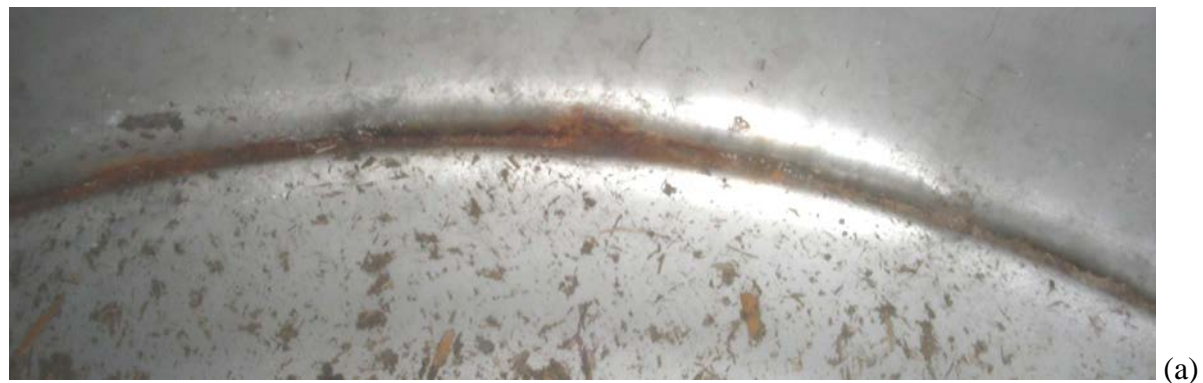
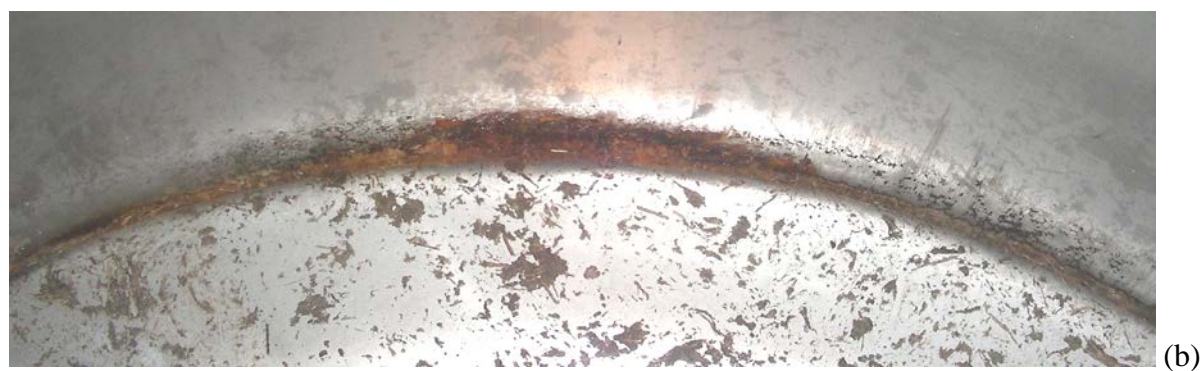
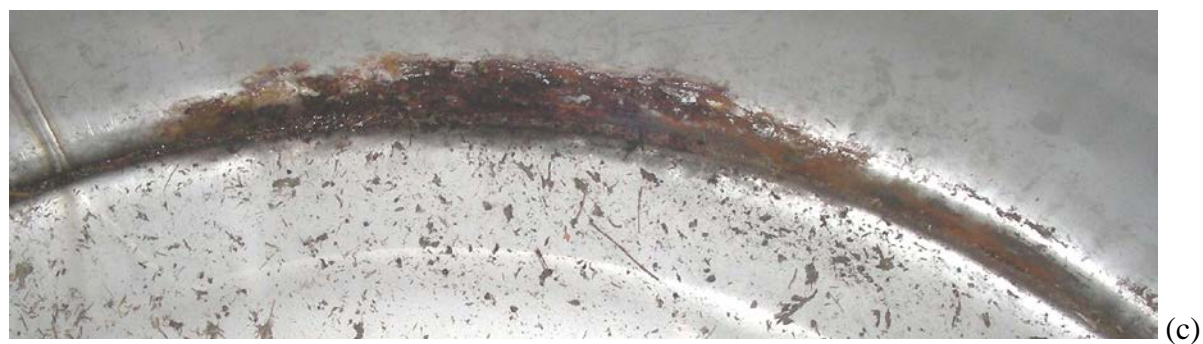
Figure 22. Corrosion (and fiberboard residue) on the drum interior opposite that shown in Figure 21 (a), (b) and (c).

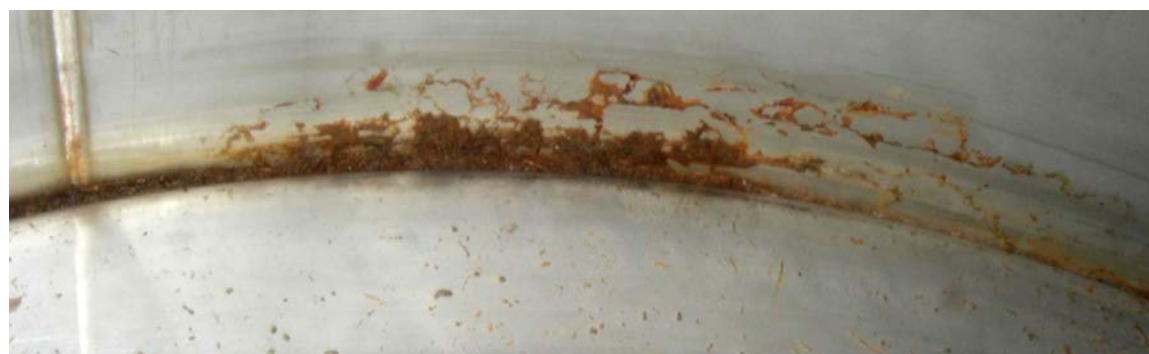
Figure 23. Corrosion on the drum interior opposite that shown in Figure 21 (c) after light cleaning.

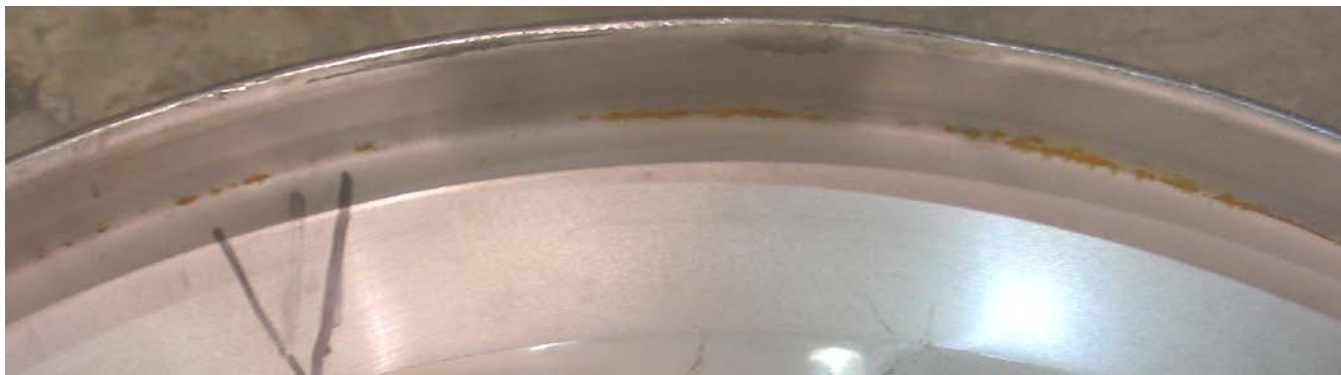
Figure 24. Corrosion on the bottom of the drum, along the outer corner.

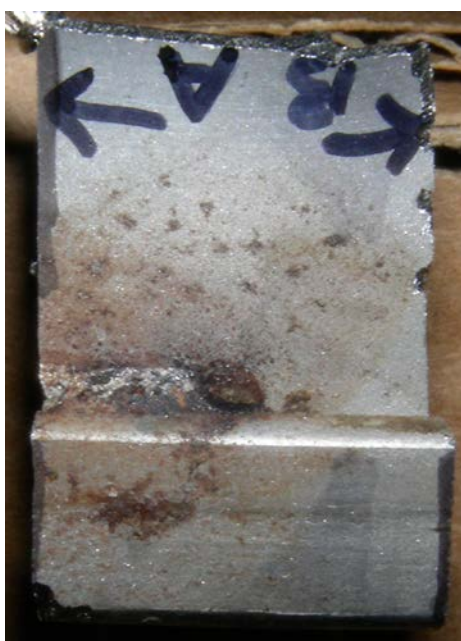
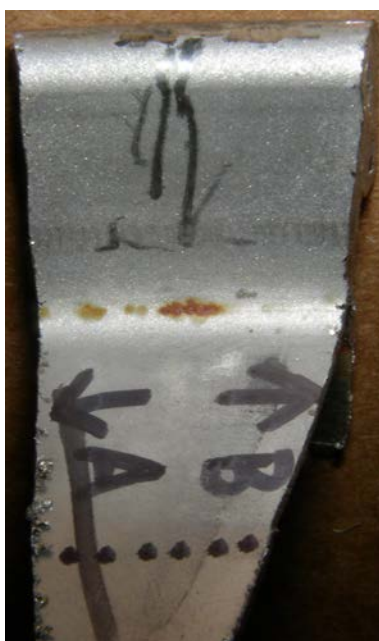
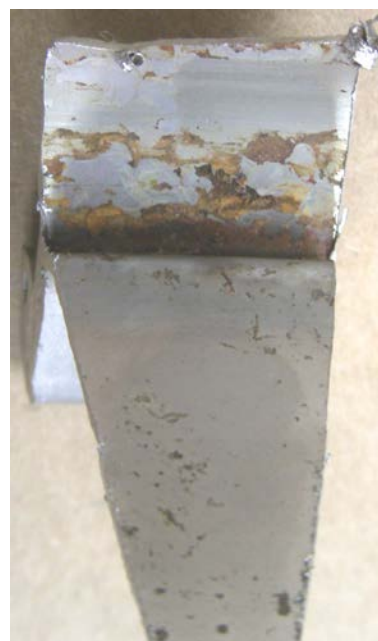
of the bottom edge was removed for metallographic examination that included the corrosion shown in Figure 21(c) and some of the corrosion on the drum bottom (Figure 25).

Figure 25. Section removed from drum containing corrosion shown in Figure 21 (c).

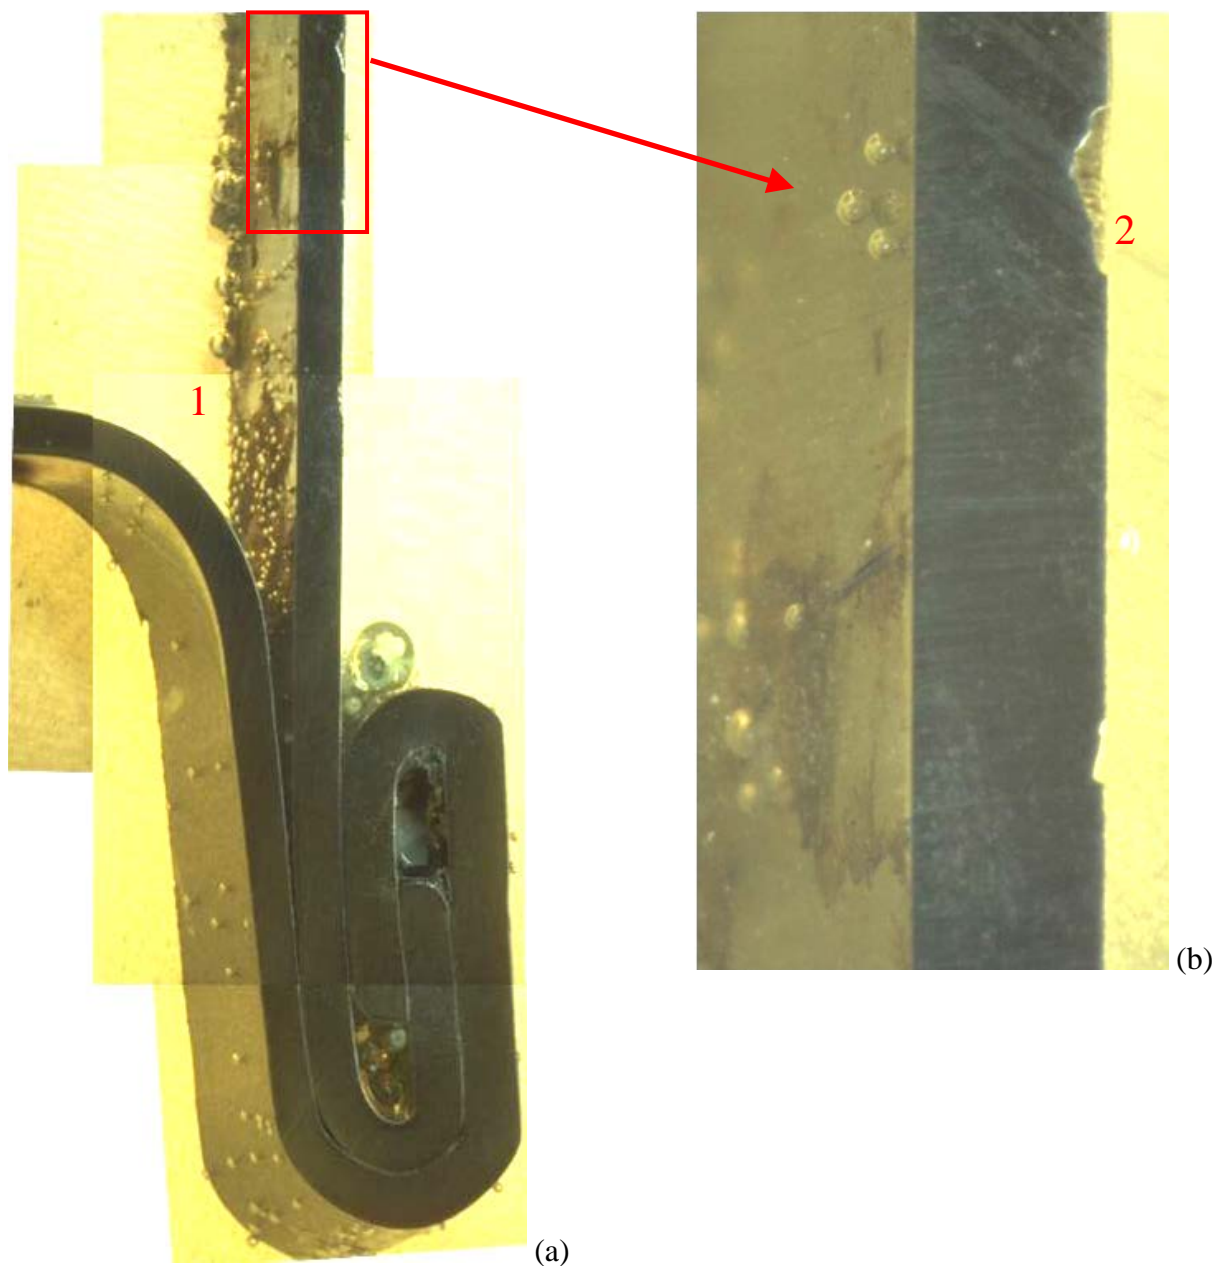
Figure 26 shows a cross section through the drum bottom flange less than ½ inch from one of the corroded locations, for reference. Limited corrosion was noted at this location slightly higher up on the drum exterior side. In comparison, Figure 27 shows a cross section through the primary area of attack, with general/pitting corrosion as well as cracking. The general/pitting corrosion is heaviest in the weld metal. Both corrosion and cracking are seen to extend through a single wall thickness in this cross section. However, it is judged that the overall integrity of the drum with regards to performing its safety function is still adequate. The impact of these observations is under evaluation.

Figure 26. Cross section through the “B” half of the drum metallographic sample. Corrosion / scale on the drum interior surface is noted (1). Minor corrosion on the drum exterior sidewall (2) is shown in (b). Photos taken by 723-A Met Lab.

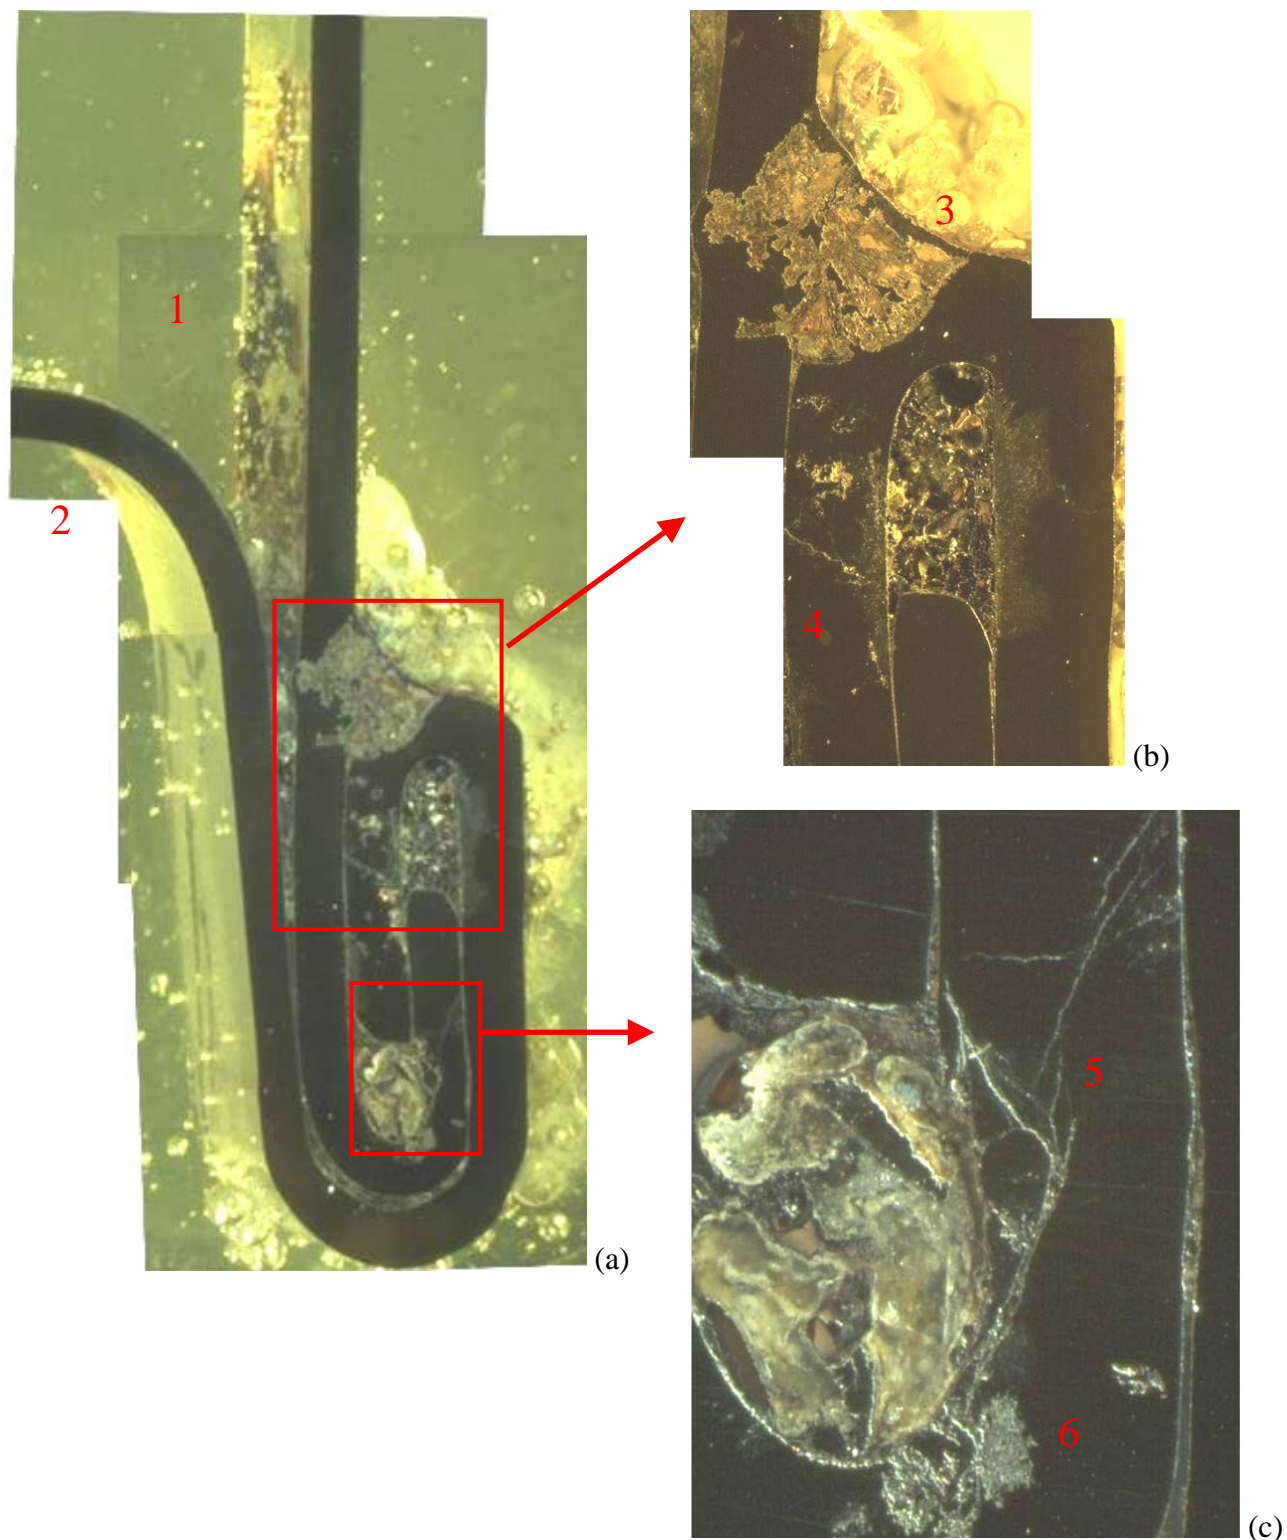
Figure 27. Cross section through the “A” half of the drum metallographic sample (a). Corrosion / scale on the drum interior (1) and exterior bottom (2) surfaces is noted. General/pitting corrosion (3, 6) and cracking (4, 5) are highlighted in (b) and (c), with penetration of the full wall thickness in some cases. Photos taken by 723-A Met Lab.
