Multifamily Housing Rehabilitation Process Improvements

Marshall L. Sweet, Abby Francisco, and
Sydney G. Roberts
Partnership for Home Innovation

March 2016

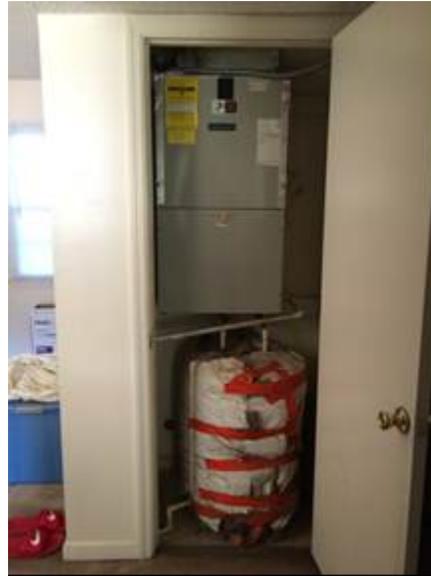
Each apartment has an air-handling unit and an electric water heater in a utility closet. The heat pump had an open return with a filter. Supply ducts branch off into a dropped soffit. The electric

water heater is positioned directly below the air handling unit. The HVAC filter rack was positioned at the base of the air handler, making it difficult to visually inspect and to change the filter.

Figure 5. Mechanical equipment inside utility closet pre-rehabilitation

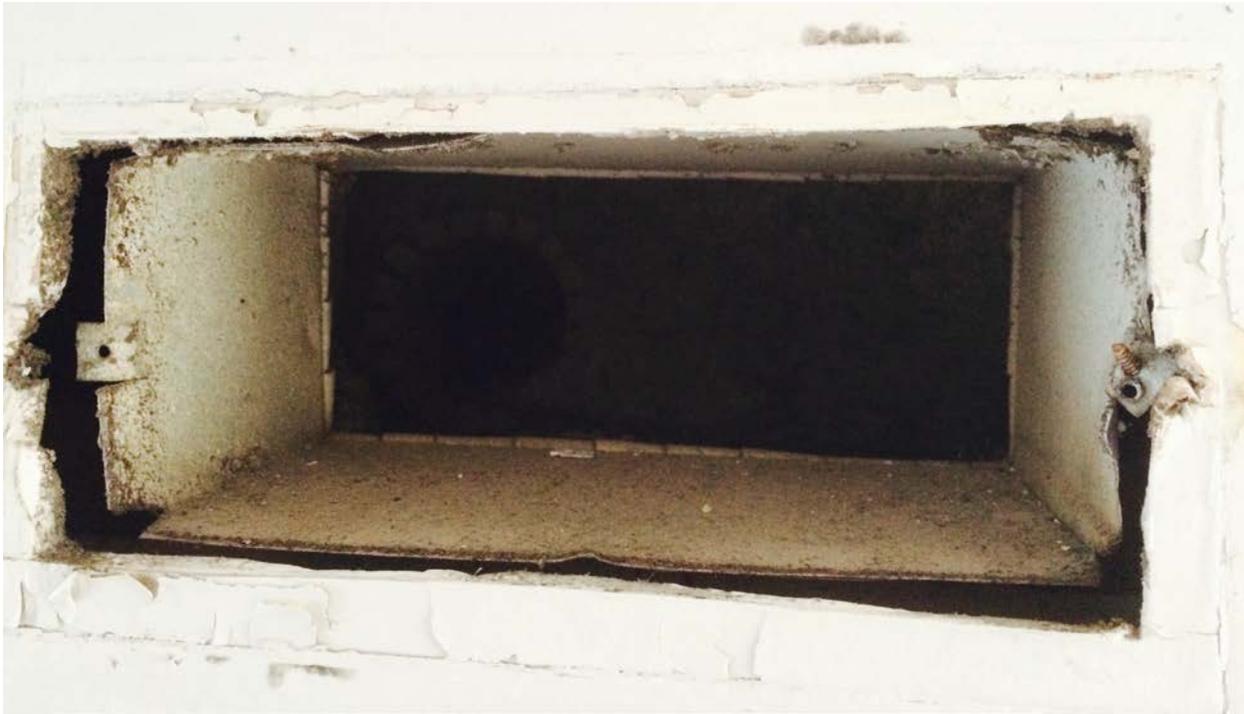
Enclosure and duct airtightness tests were conducted on the same sample of units pre- and post-rehabilitation at each site (Table 6). The ducts were in a plenum beneath the attic floor and insulation. There was no measured leakage to the outside. For the rehabilitation process, the ducts were inaccessible to perform duct-sealing measures at connections or along seams. The SOW did not include air sealing of the duct chase from the attic side or sealing the duct boots to the drywall. Inspection revealed significant opportunity for improvement and easy accessibility within the rehabilitation process for sealing the duct boots to the drywall (Figure 6). The replacement of the old air handling unit with a new one is assumed to be the source of the measured changes in total duct leakage. Total duct leakage increased at Warm Springs and Pigeon Bluff.

Figure 6. Duct boot not sealed to drywall

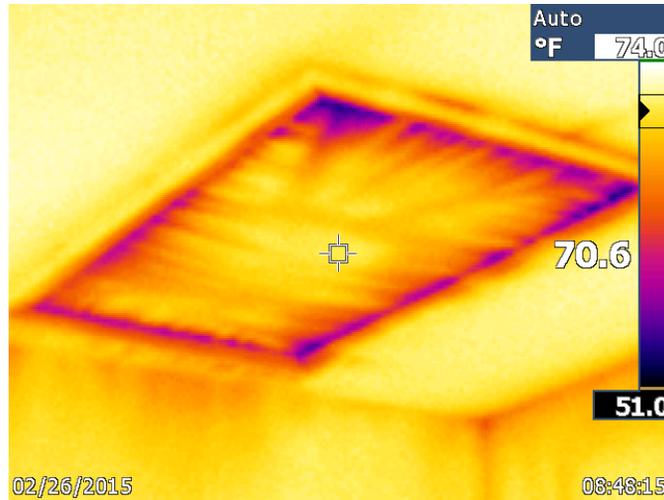
Within the SOW, the rehabilitation did not include enclosure air sealing, and none of the tradespeople made conscientious efforts to perform any air-sealing measures. However, replacing the windows and doors did reduce enclosure air leakage in most cases. Improved airtightness was included as a measure in the Beacon energy model and qualified the homes for utility rebates. During the test-out inspection at Hidden Creek, enclosure air leakage significantly increased at the first two units tested. The test-out inspection was halted so air-sealing measures could be performed to qualify the units for HEIP rebates. Although the average envelope leakage at each site decreased, the envelope leakage actually increased in several units. The increase is believed to have been caused from holes in the drywall behind the new kitchen cabinets. Figure 7 through Figure 9 show infrared images of air leakage through the enclosure while the building was depressurized. These images were taken in the winter, and the darker shading indicates cold surfaces where cold air from outside is being drawn in through leaks in the building enclosure.

Figure 7. Thermal image of attic hatch when the induced building pressure is -50 Pa

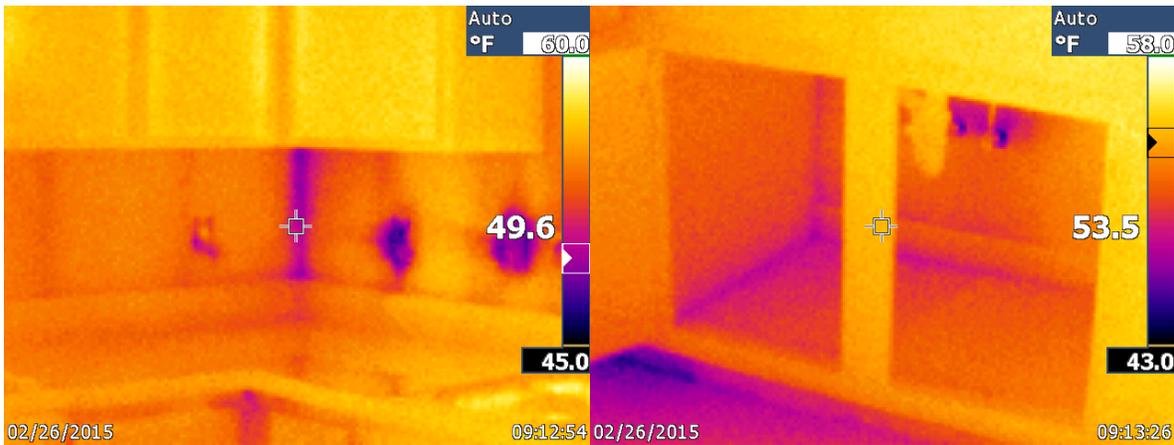
Figure 8. Penetrations in kitchen walls indicate the top plates were unsealed for light switches and outlets above kitchen counter (left); sink plumbing penetrations below counter (right)

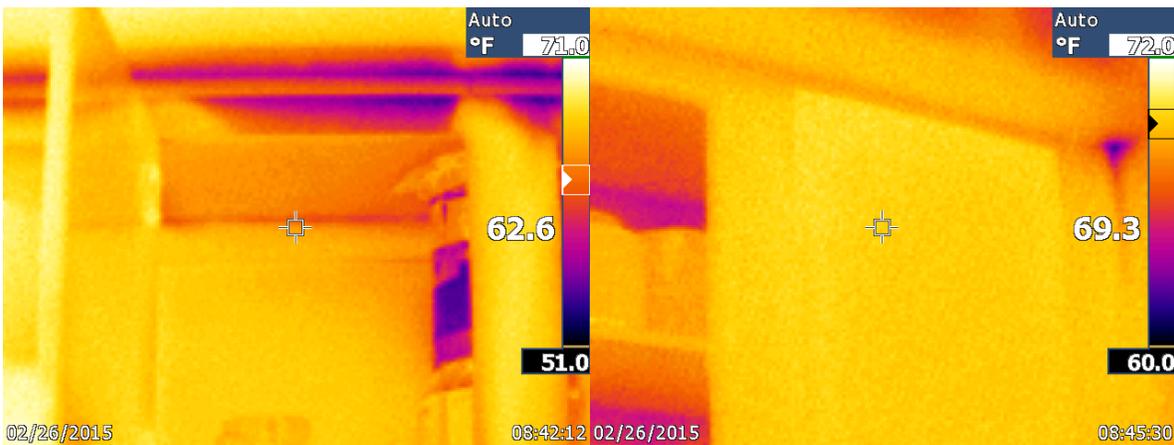
Figure 9. Thermal images of kitchen cabinets with doors open: above kitchen hood vent showing exhaust duct (left); open cabinet next to a closed cabinet (right)

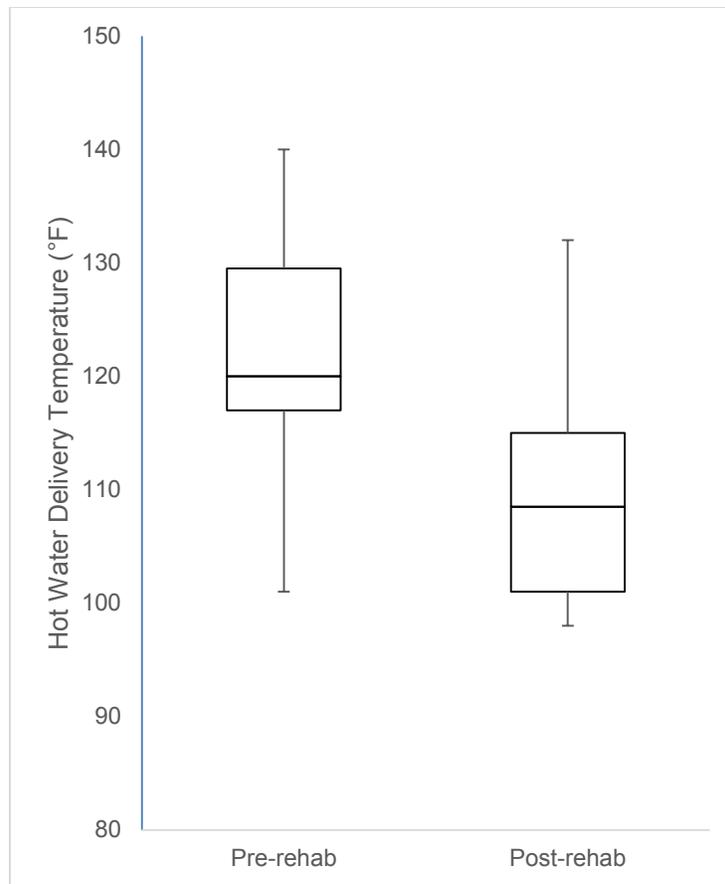
The pre-renovation water heaters varied in age, make, model, and condition because some were replaced during the previous 20 years. Every unit in the portfolio received a new Rheem Professional Classic Series 38-gallon electric resistance storage water heater to replace the existing electric resistance storage water heater. Hot water delivery temperatures were measured pre- and post-rehabilitation at the nearest (bathroom) faucet nearly an hour after any potential previous hot water draw could have occurred (occupants vacated their residences during testing, which took approximately an hour per unit). Thirty-eight units were tested pre-rehabilitation and 56 were tested post-rehabilitation (Figure 11). The median pre-rehabilitation temperature was 120°F, and the median post-renovation set point was 109°F. The post-rehab group is significantly lower than the pre-rehab group ($p < 0.00001$). Interestingly, the spread of the second and third quartiles is nearly identical between the two groups, 13°F pre-rehab and 14°F post-rehab. The total range of measured values was 34°F post-rehabilitation, ranging from 98 to 132°F, compared to the pre-rehab range of 101-140°F.

Figure 11. Distribution of water heater delivery temperatures pre- and post-rehabilitation

The variation in temperature in the pre-rehabilitation cohort might be explained by the fact that the residents have access to the water heaters and possibly could have changed the set points over years of use. Or, thermostat performance may degrade over time. However, researchers were surprised by the large range in post-rehabilitation delivery temperatures. Discussions with the plumbers and property managers indicated that the plumbers did not adjust the internal thermostat settings and the tenants were unlikely to make those adjustments. Adjusting the set point requires removing a cover plate and turning a screw with a flathead screwdriver. This indicates that the primary driver for hot water set point temperatures of electric resistance storage water heaters is the default setting from the manufacturer, which appears to be inconsistent. Temperature set point of electric resistance storage water heaters will have a large impact on energy consumption. The U.S. DOE estimates that for every 10°F reduction in temperature, a resident may save 3%-5% on their water heating costs⁹. Further, storage water heaters with water temperatures below the median post-rehab water temperature are “ideal” for growth of *Legionella pneumophila* bacteria according to the Occupational Safety and Health Administration, and many of the senior residents are at high risk of contracting Legionnaires’ disease¹⁰. On the high end, temperatures above 140°F can result in scalding. In most cases, it is best to maintain water heater tank temperatures between 122-125°F.
