EXAMINATION OF SHIPPING PACKAGES 9975-01641, 9975-01692, 9975-03373, 9975-02101 AND 9975-02713

W. L. Daugherty

January 2016

SRNL-STI-2016-00014, Revision 0

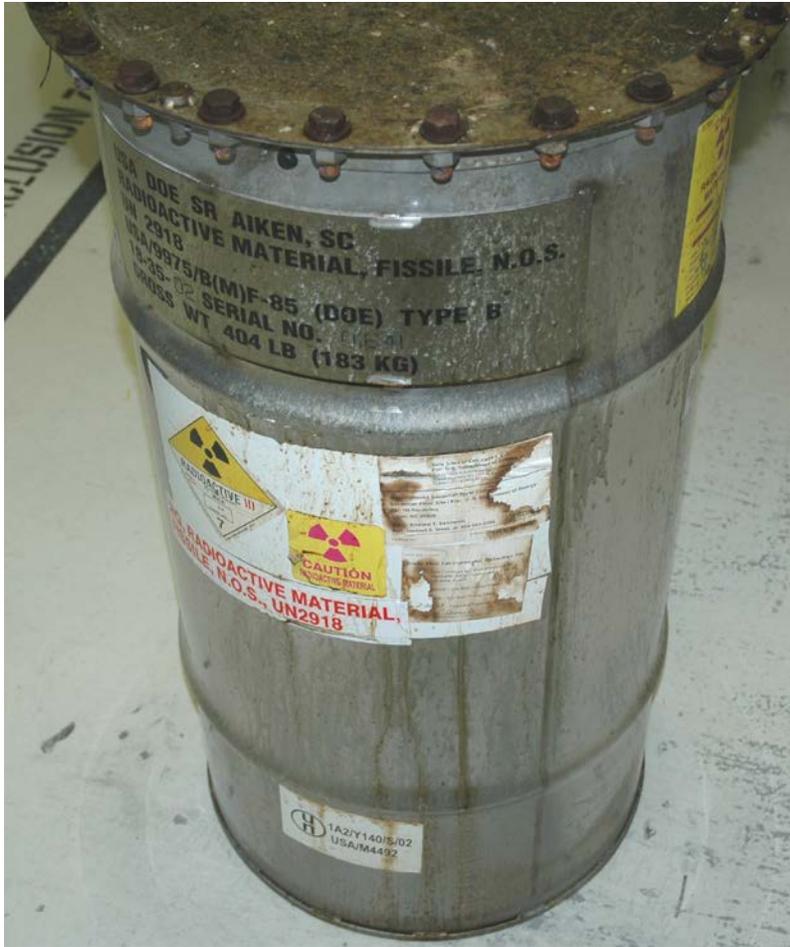
Package 9975-01641 was received in KAC in April 2003 with a 3.1 watt internal heat load. It experienced significant water exposure to the drum exterior, as evidenced by stains/debris on the drum and lid (Figures 1, 2). Some water entered the drum, as evidenced by stains on the drum flange and air shield (Figure 3) and on the drum side interior (Figure 4). Local regions of mold were observed on the side and the bottom of the lower fiberboard assembly (Figures 5, 6). Water stains were observed on one side of the upper fiberboard assembly (Figure 7), but no mold was present.

Figure 1. Stains on 9975-01641 drum side. Photo taken 9/11/13 by NMM personnel.

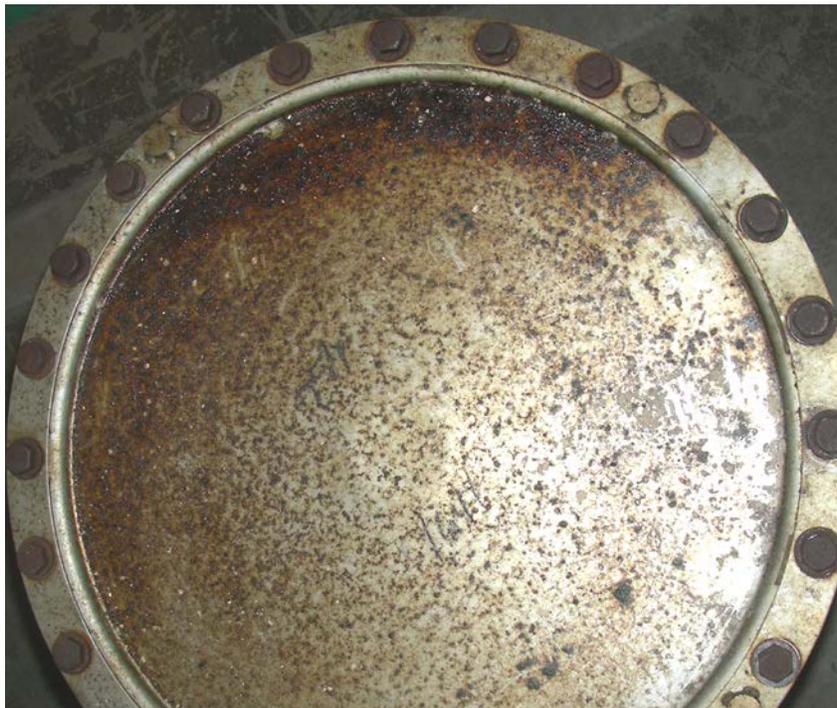
Figure 2. Stains and debris on lid of 9975-01641

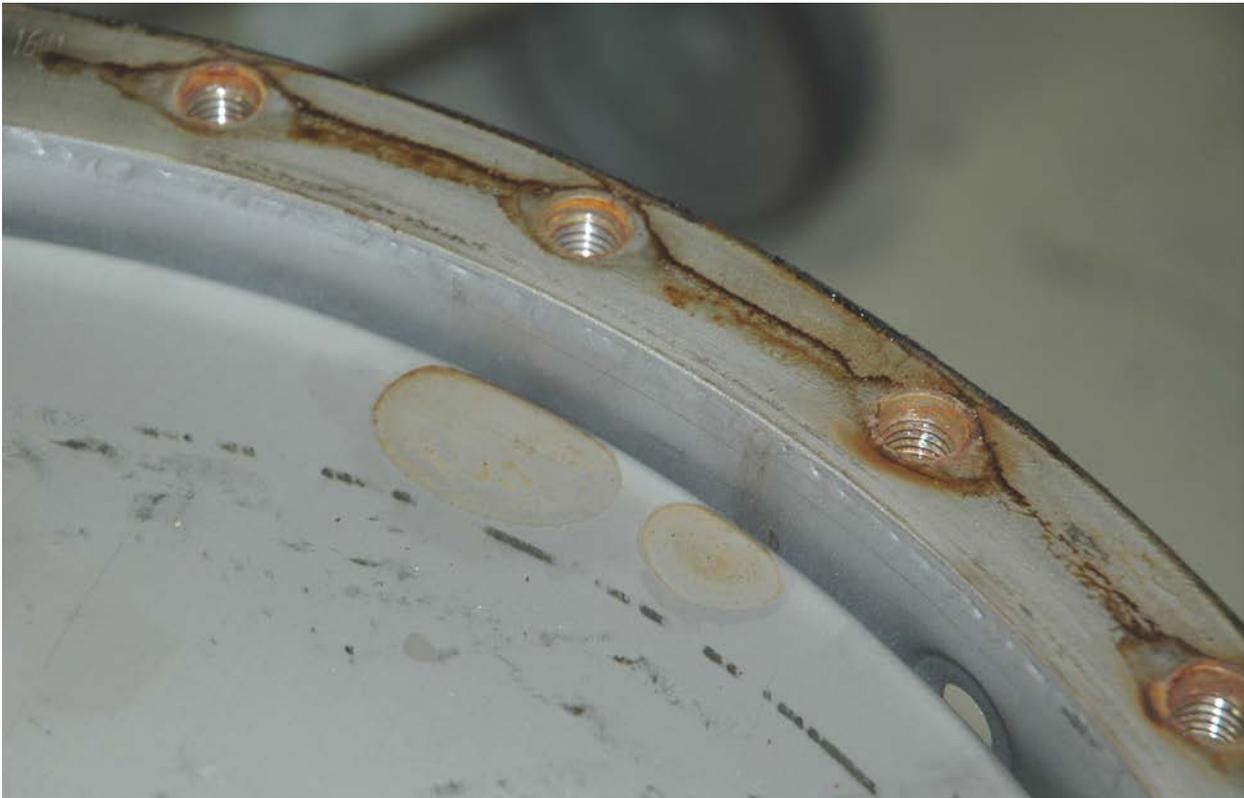
Figure 3. Stains on 9975-01641 drum flange and air shield. Photo taken 9/11/13 by NMM personnel.

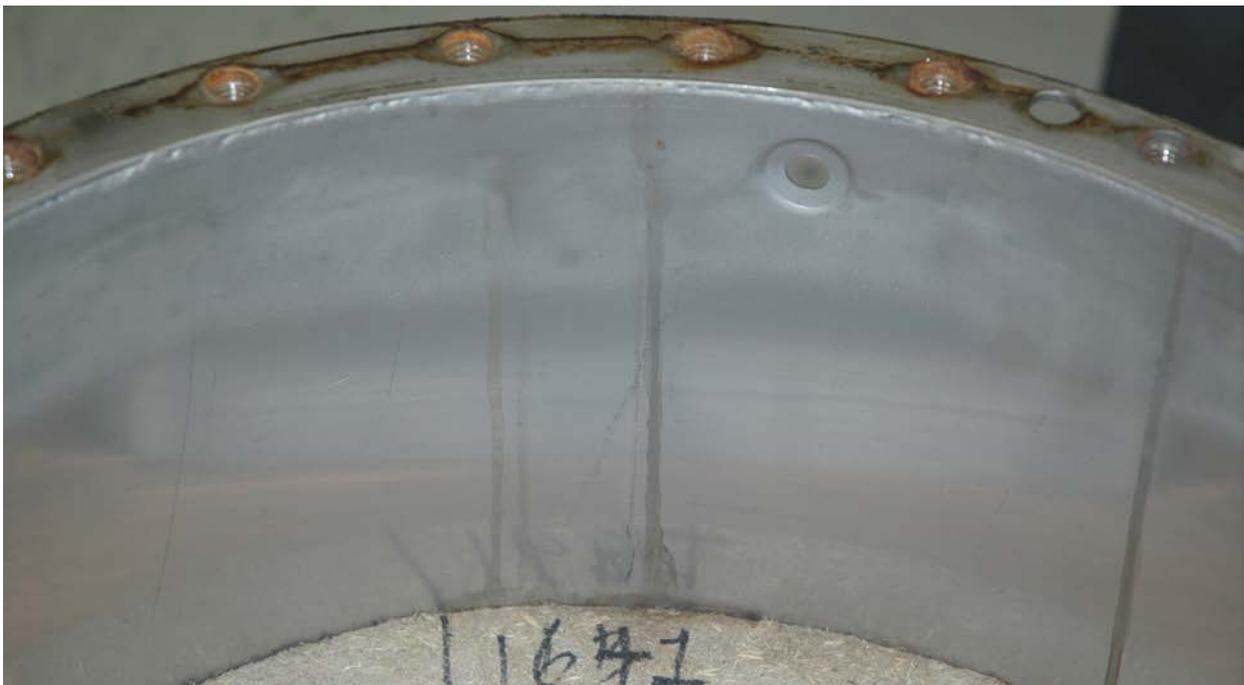
Figure 4. 9975-01641 drum interior stains from water running down side. Photo taken 9/11/13 by NMM personnel.

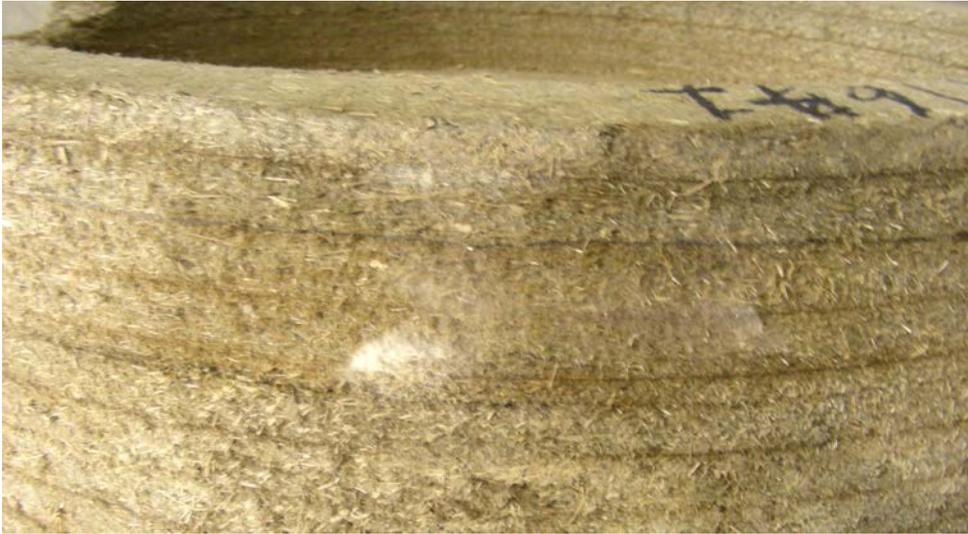
Figure 5. Mold on side of 9975-01641 lower fiberboard assembly

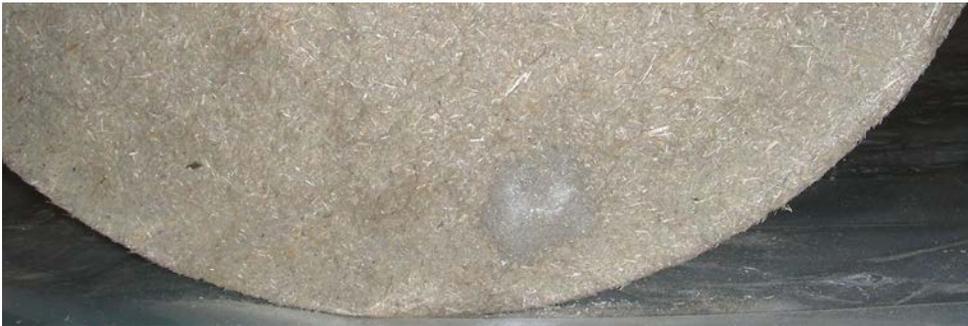
Figure 6. Mold on bottom of 9975-01641 lower fiberboard assembly

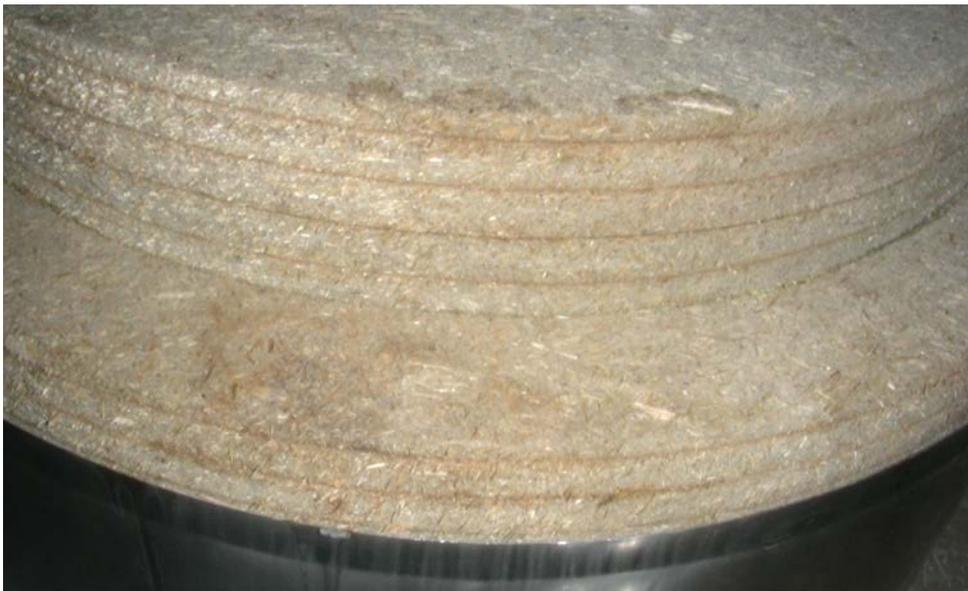
Figure 7. Stains on 9975-01641 upper fiberboard assembly

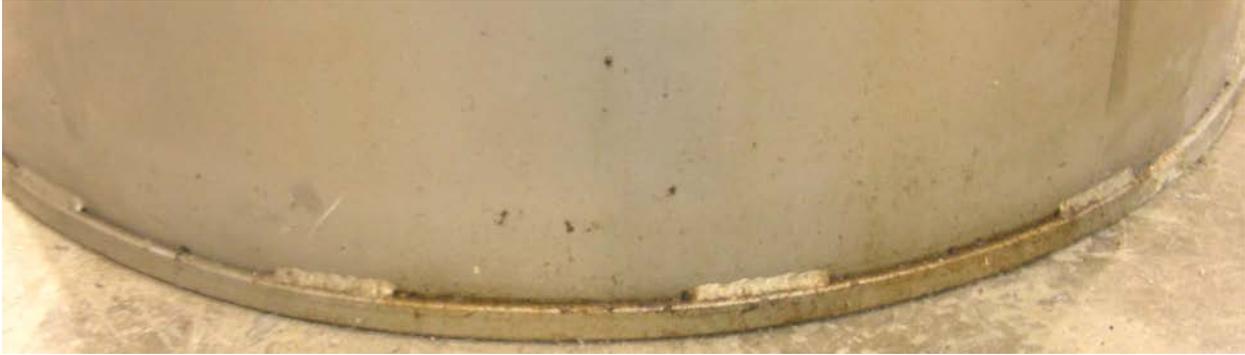
Several small spots were noted on the drum side near the bottom and along the bottom lip (Figure 8). These could indicate corrosion of the drum, or could be debris that was carried to this position.

Figure 8. Stains, debris and/or corrosion on 9975-01641 drum exterior

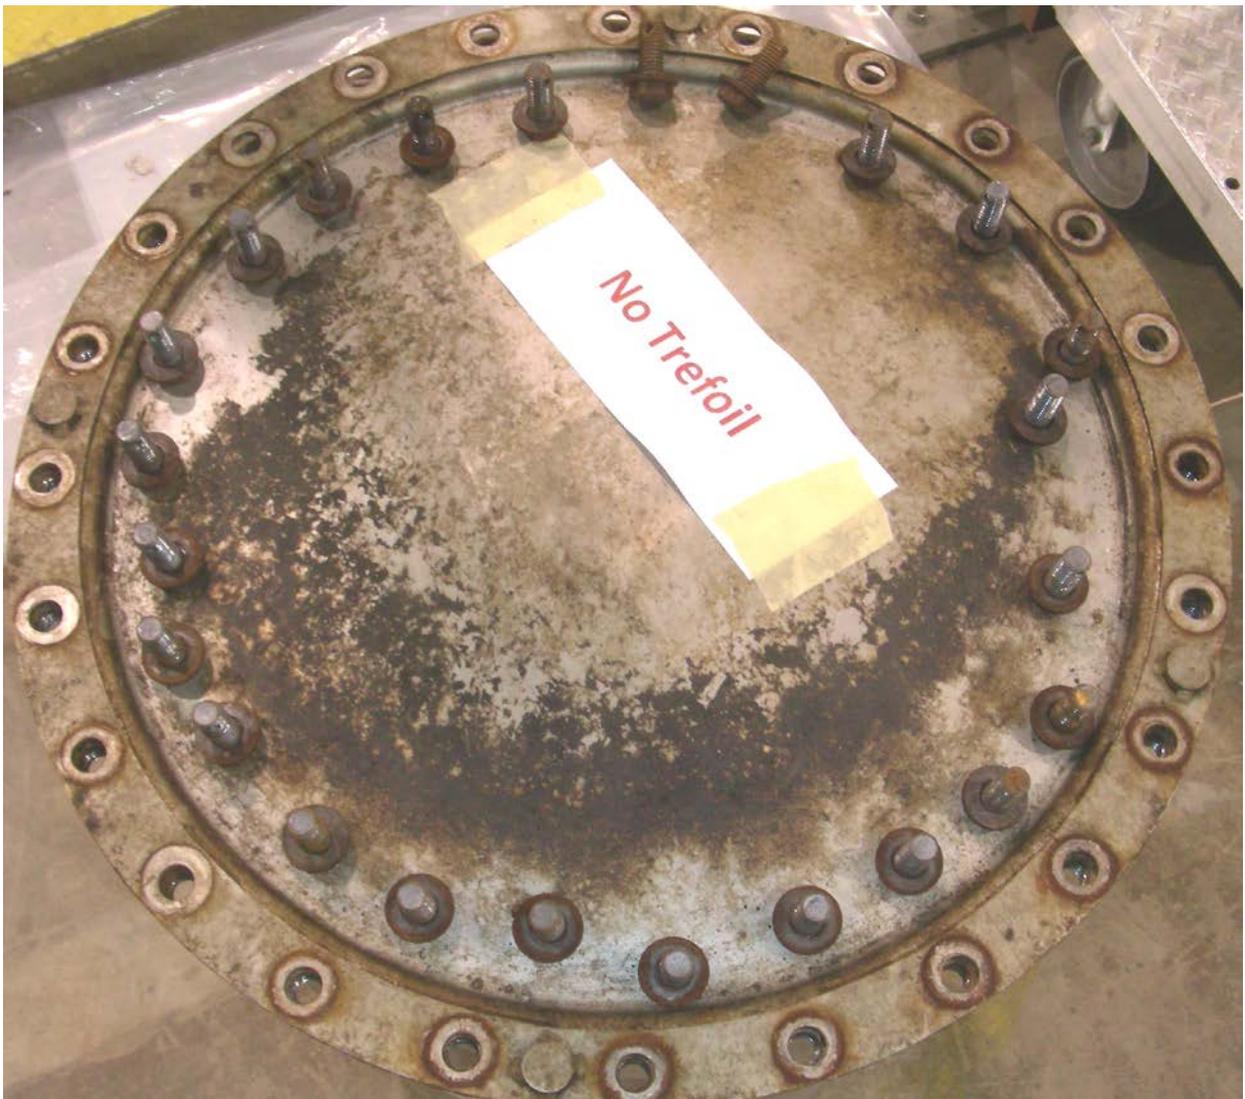
Package 9975-01692 was received in KAC in April 2003 with a 1.5 watt internal heat load. It experienced significant water exposure to the drum exterior, as evidenced by stains/debris on the drum and lid (Figures 9, 10). Significant water entered the drum, as evidenced by stains on the drum flange and standing water on the air shield (Figure 11), and heavy mold on the fiberboard assemblies (Figures 12 – 15). Numerous white flakes were observed on the upper fiberboard ID surface and on top of the shield (Figures 13, 16). This is assumed to be lead carbonate from the shield, but is more than is typically observed.

Figure 9. 9975-01692 drum lid with stains and debris

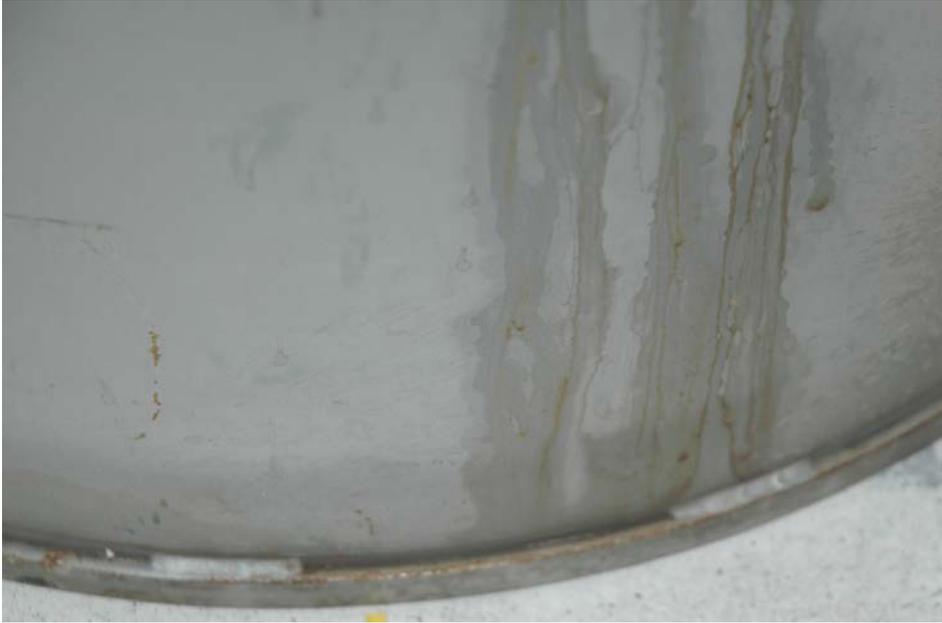
Figure 10. Stains on side of 9975-01692 drum. Photo taken 9/11/13 by NMM personnel.

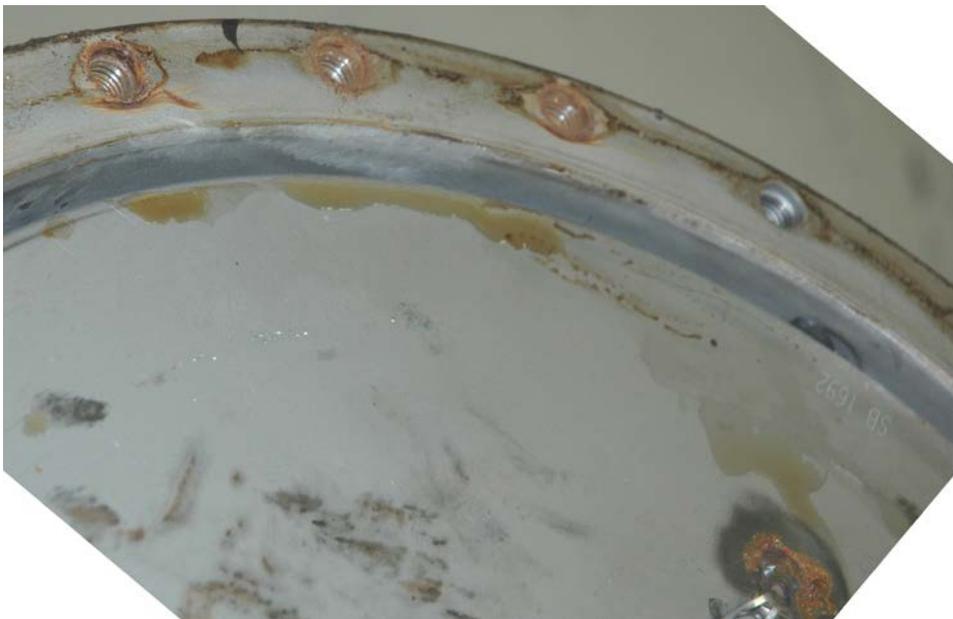
Figure 11. Rust stains on 9975-01692 drum flange and air shield, and water on air shield. Photo taken 9/11/13 by NMM personnel.

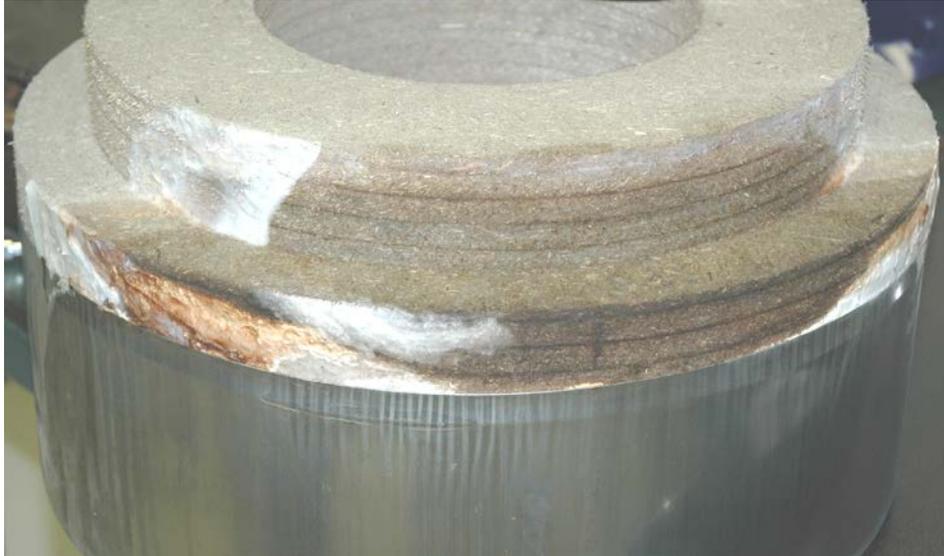
Figure 12. 9975-01692 upper fiberboard assembly showing wetted area and mold. Photo taken 9/11/13 by NMM personnel.

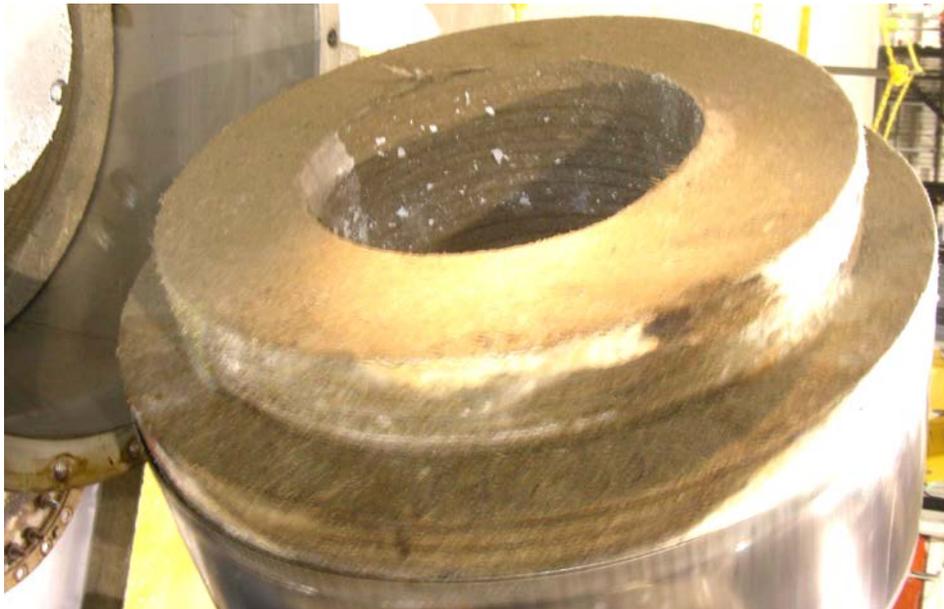
Figure 13. 9975-01692 upper fiberboard assembly with mold and lead carbonate flakes

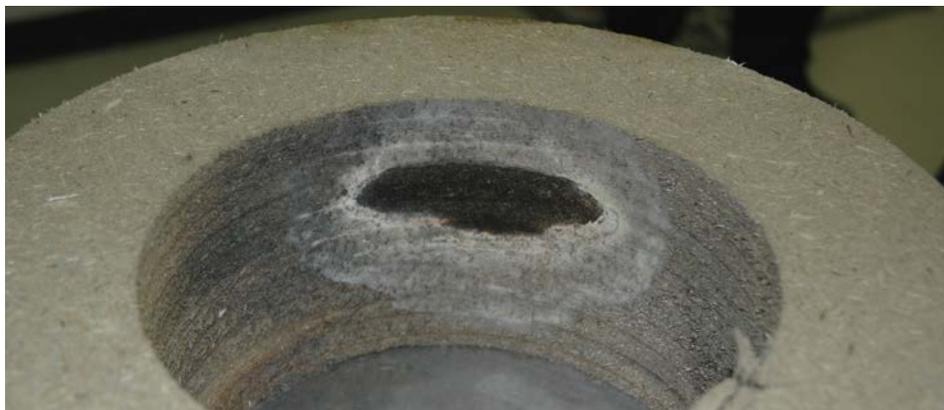
Figure 14. Mold on 9975-01692 upper fiberboard assembly ID surface. Photo taken 9/11/13 by NMM personnel.

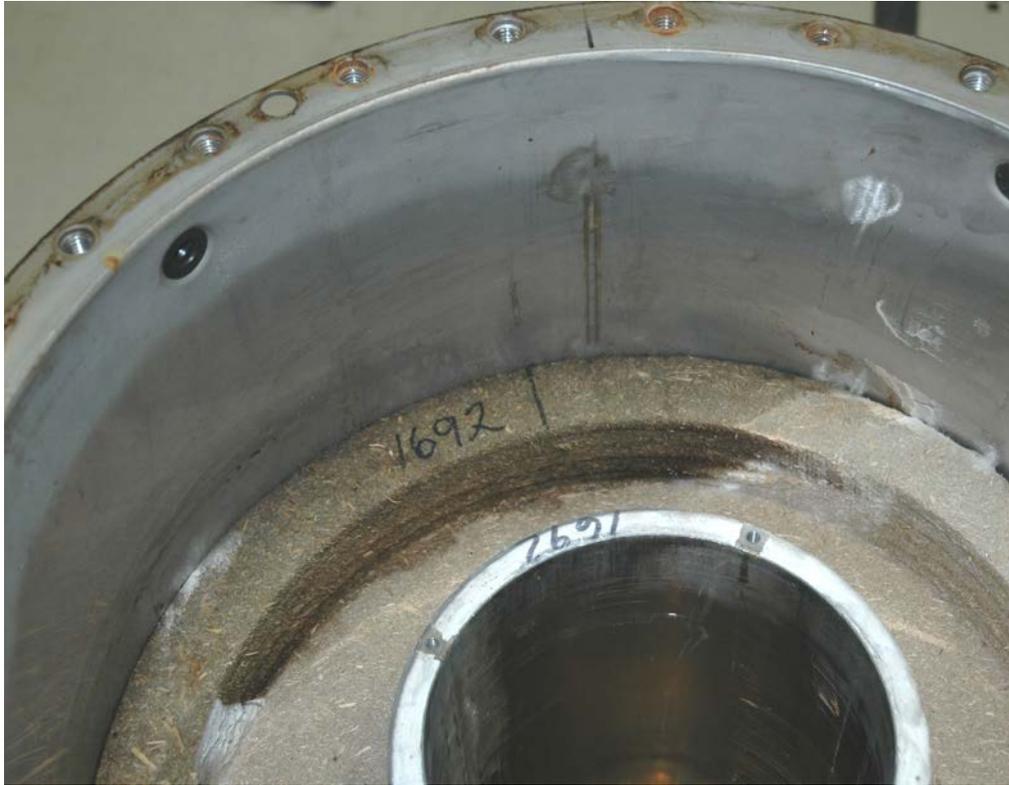
Figure 15. Top of 9975-01692 lower fiberboard assembly showing wetted area and mold. Photo taken 9/11/13 by NMM personnel.

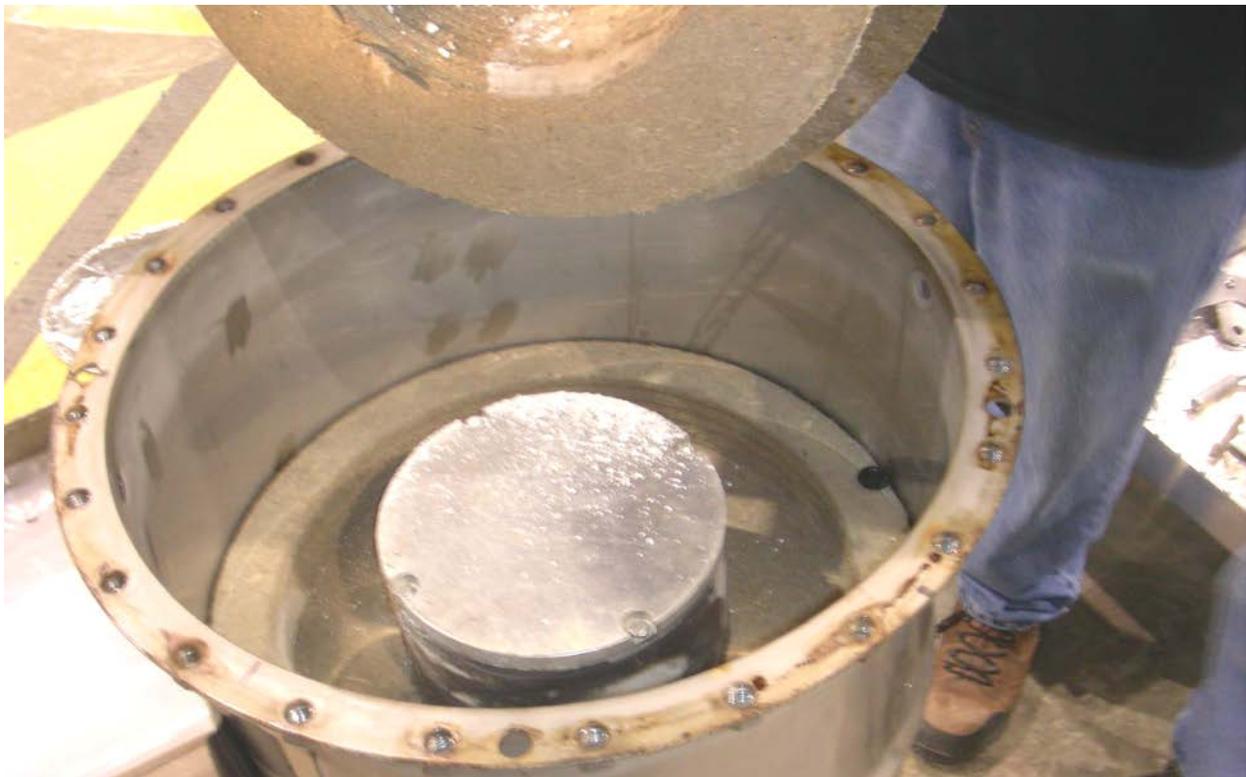
Figure 16. Lead carbonate flakes on 9975-01692 shield lid

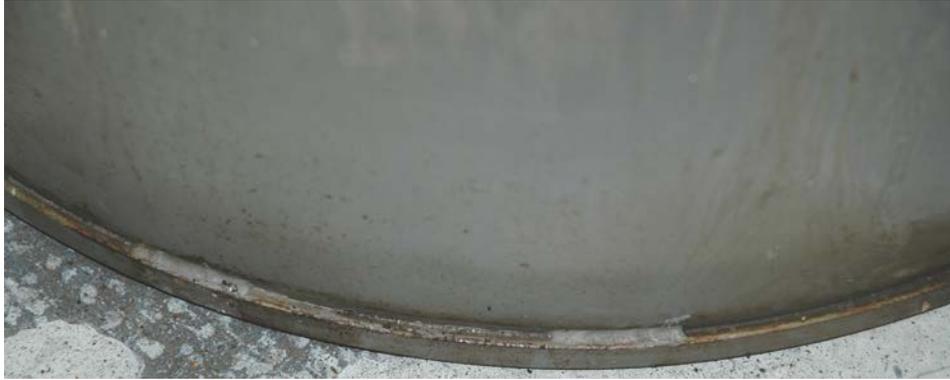
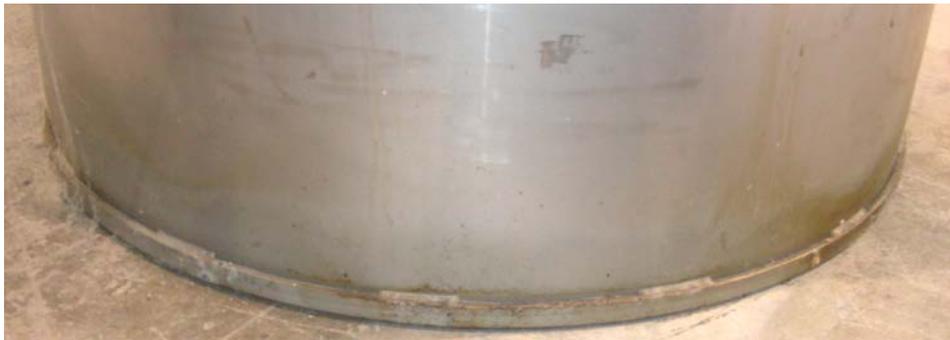
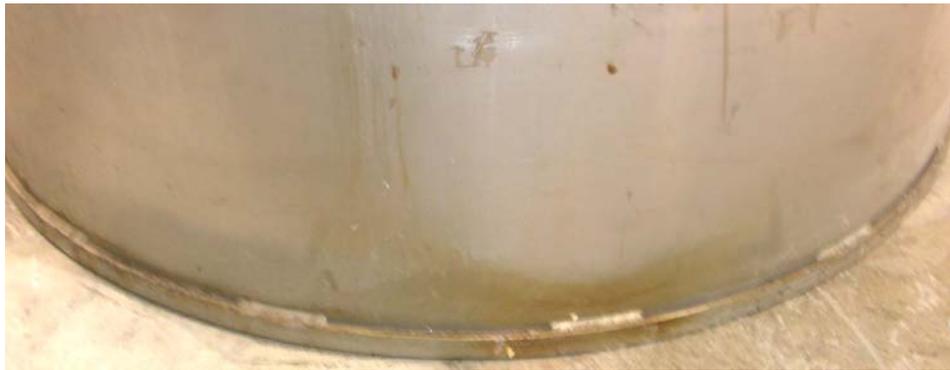
Light staining and/or corrosion were noted on the drum exterior along the bottom lip (Figure 17) and on the drum bottom. With minimal staining on the drum sides in these areas, it is likely that at least some of this staining / corrosion resulted from water inside the drum seeping out through the bottom lip.

Figure 17. Light staining or possible corrosion on 9975-01692 drum exterior.

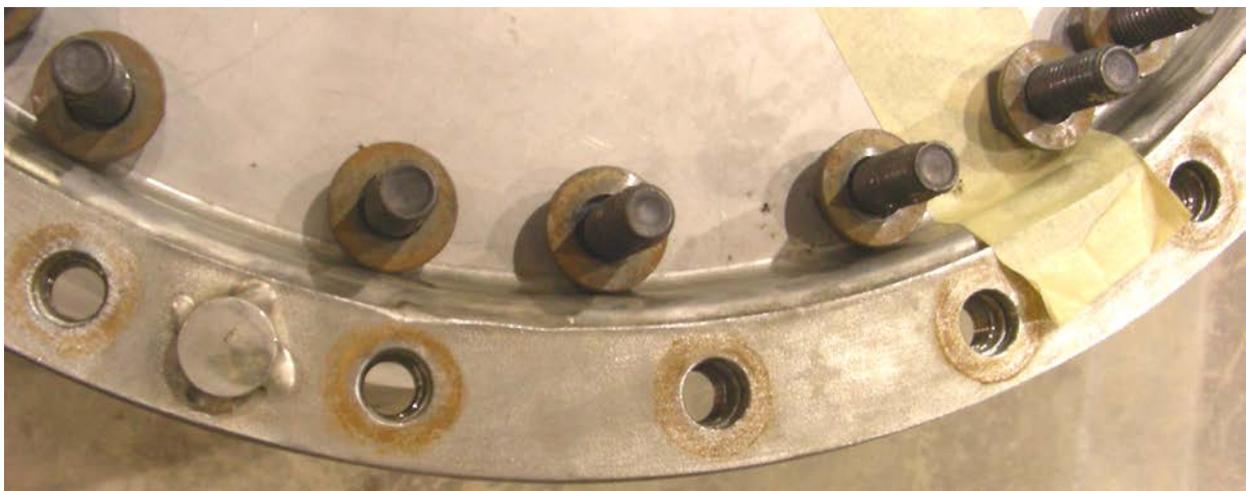
Figure 18. Rust stains on 9975-03373 lid (under bolts/washers)

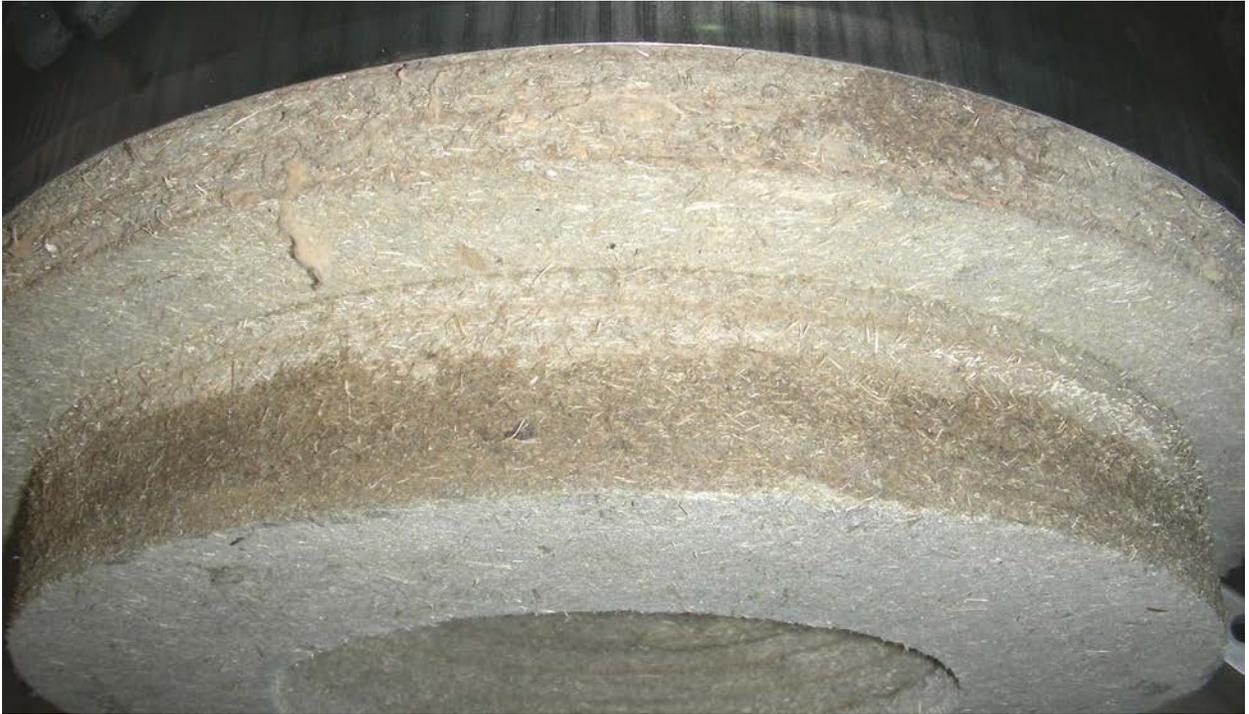
This package was sent to SRNL for additional examination, which occurred on August 20, 2015. In addition to the upper fiberboard assembly mold and stains (Figure 19), the lower fiberboard assembly was moldy and the bottom layers were saturated (Figures 20 – 22). Stains were observed on top of the air shield (Figure 23).

Figure 19. Mold on 9975-02101 upper fiberboard assembly

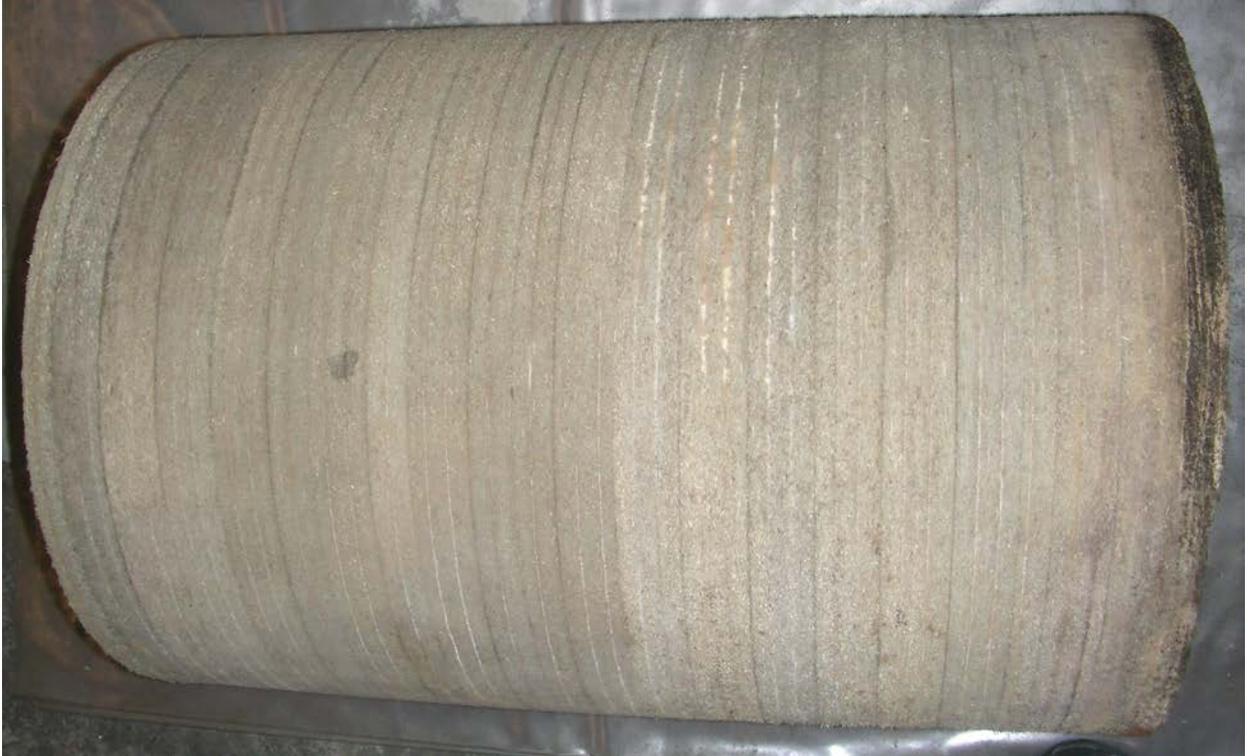
Figure 20. Mold on side of 9975-02101 lower fiberboard assembly

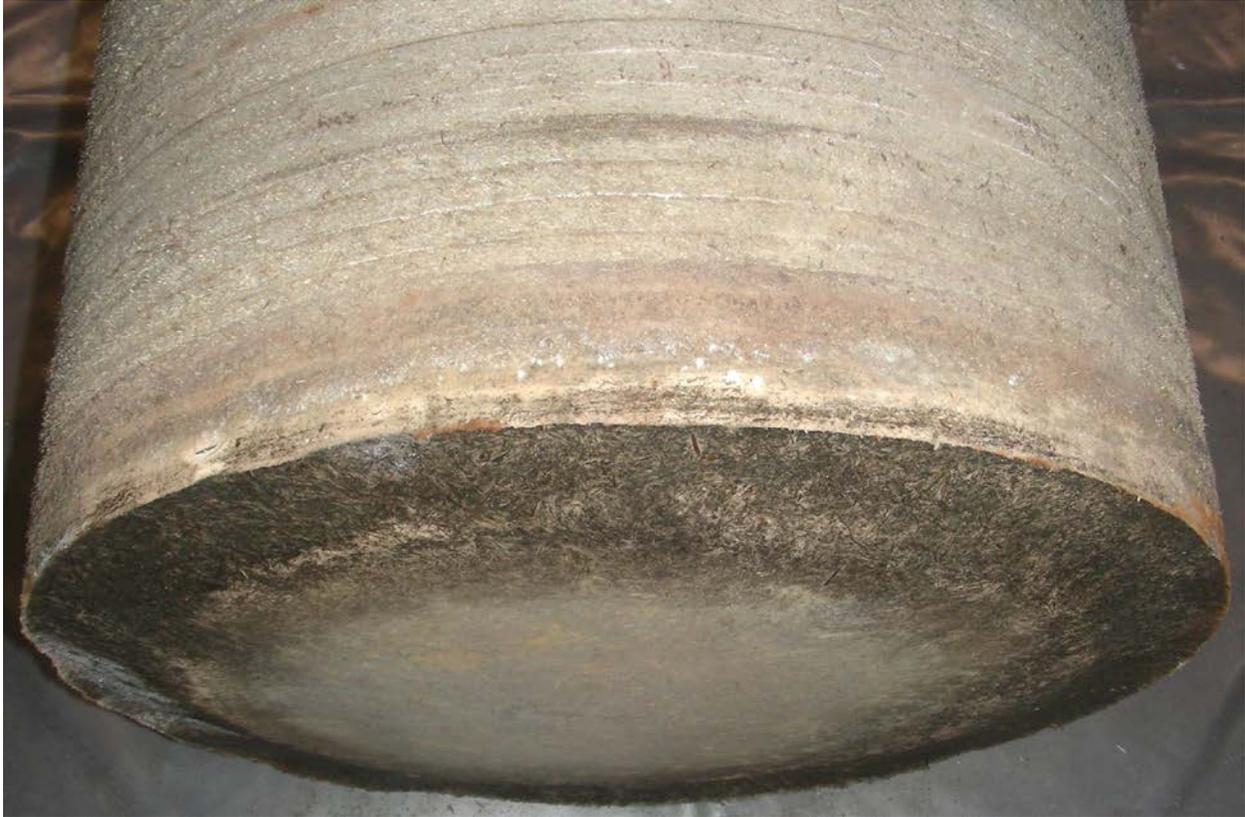
Figure 21. Mold on side and bottom of 9975-02101 lower fiberboard assembly

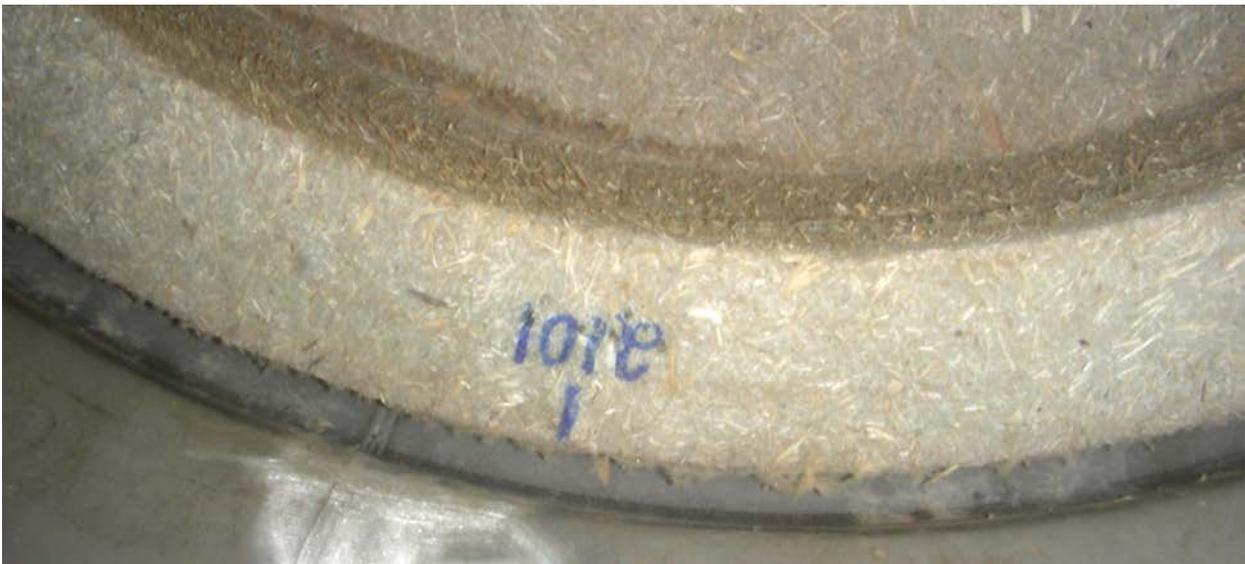
Figure 22. Mold between 9975-02101 lower fiberboard assembly and drum

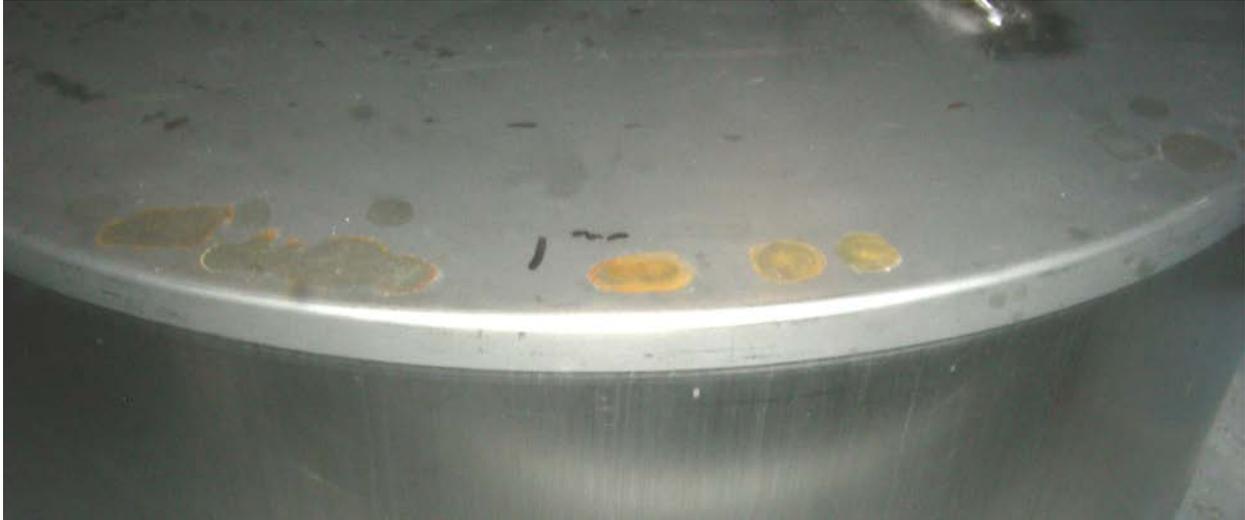
Figure 23. 9975-02101 air shield with water/rust stains

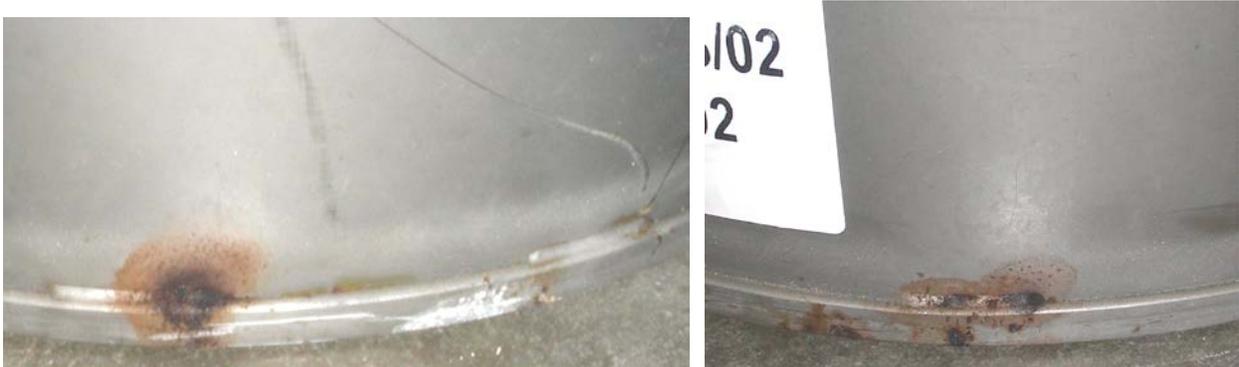
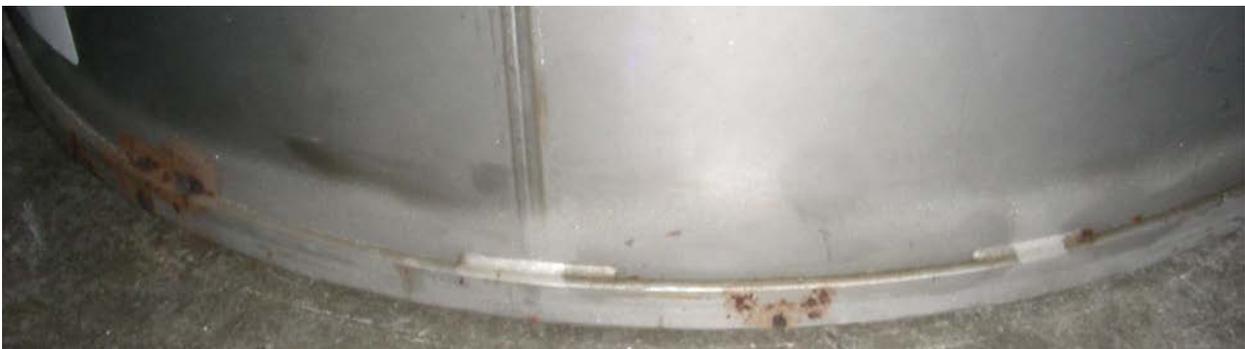
Several areas of corrosion were observed along the bottom lip of the drum (Figures 24 – 25).

Figure 24. Three areas of corrosion on 9975-02101 drum exterior bottom lip

For packages in storage, looking for corrosion on the drum side would provide a quick screening for potential internal issues without having to open the package. For packages removed from storage, examining the drum bottom as well would provide a further check against possible internal degradation. It is recommended that NMM consider implementing these screening checks, especially for higher wattage packages.

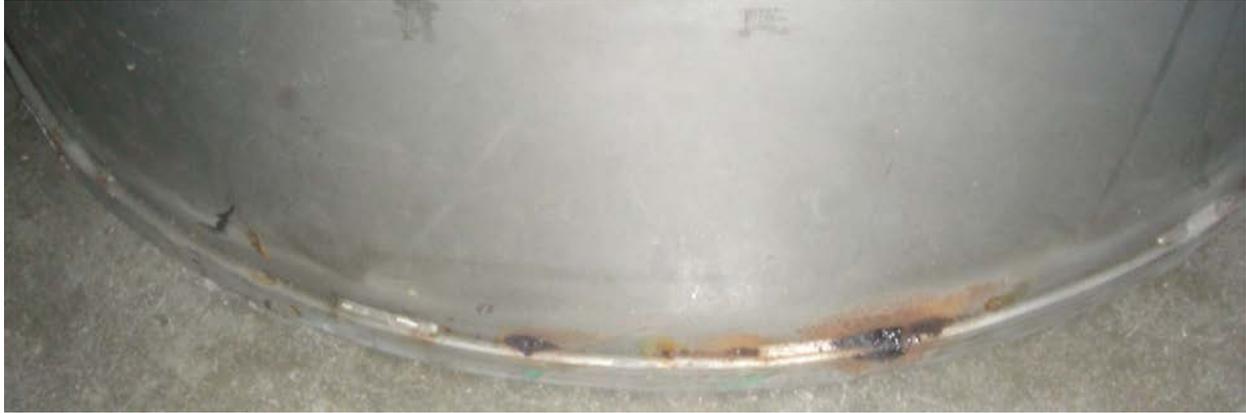
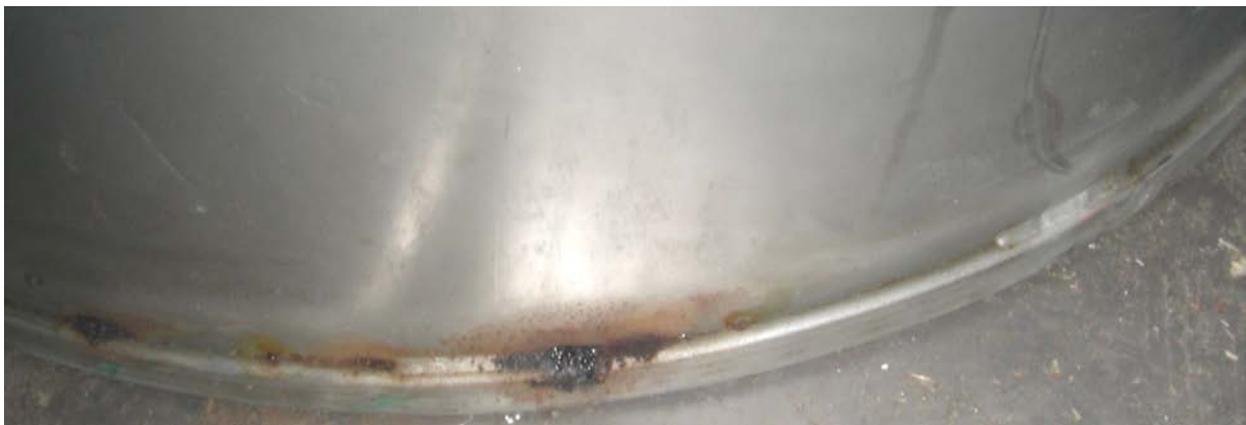
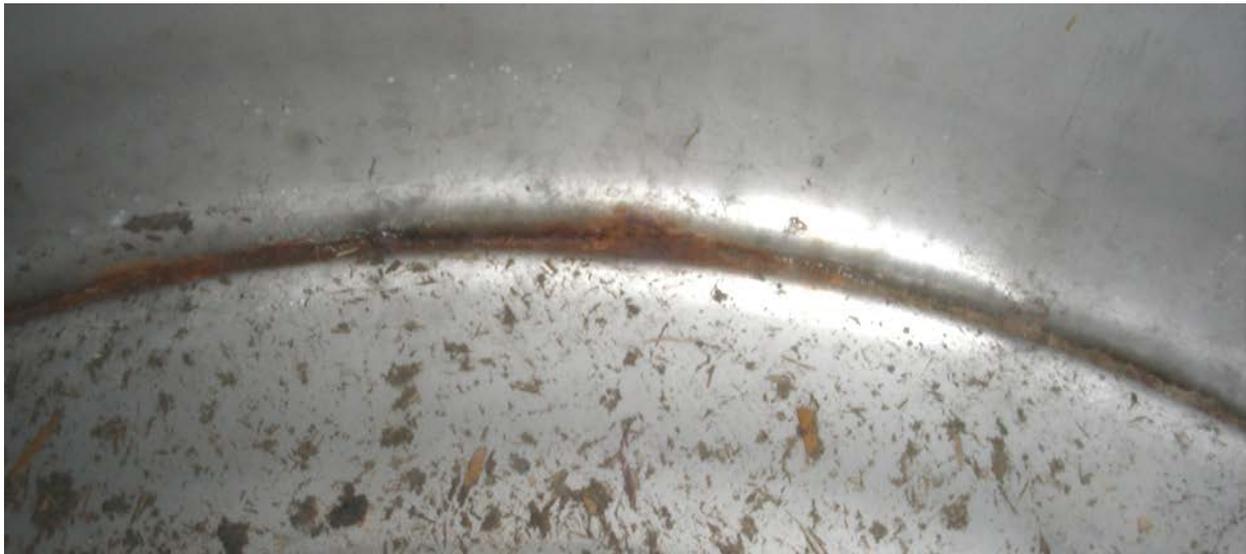
Figure 25. Region of local corrosion on 9975-02101 drum bottom lip, showing external surface (a, b) and internal surface of the same area (c).

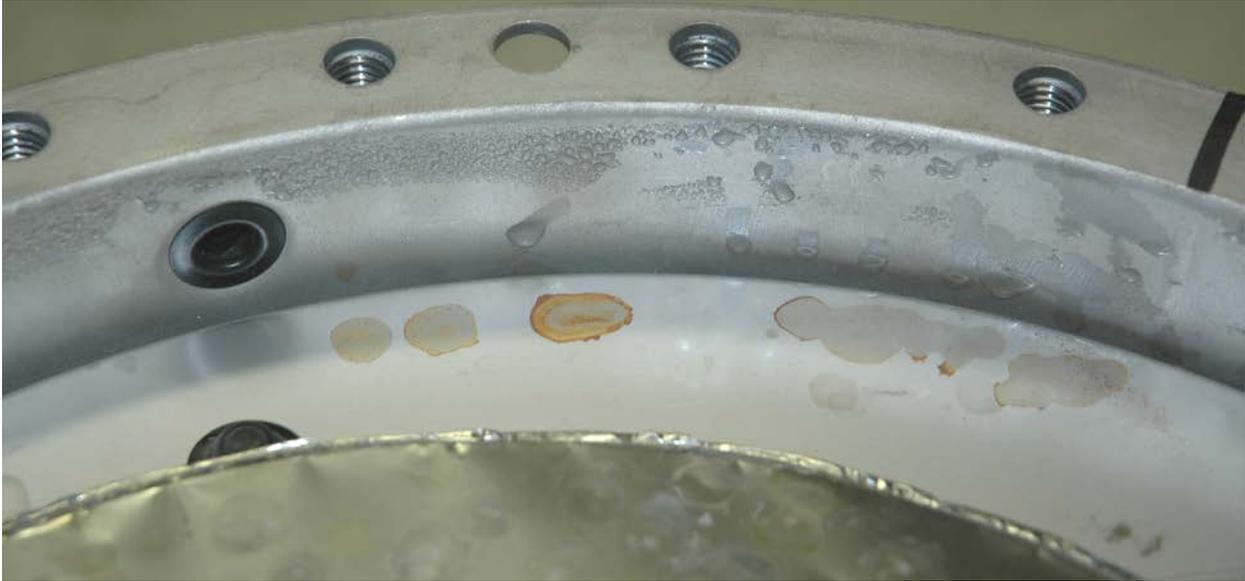
Figure 26. Condensate and stains observed in 9975-02713 upon opening the lid. Photo taken 8/13/15 by NMM personnel.

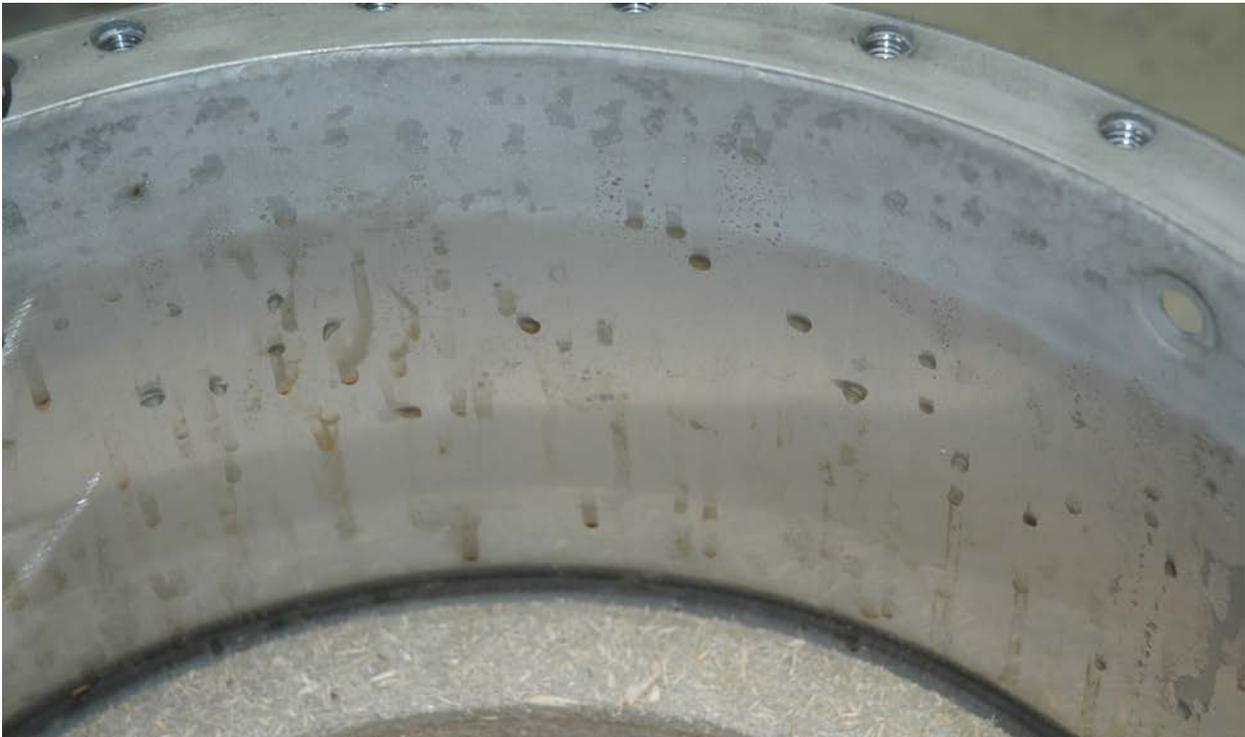
Figure 27. Condensate and stains on 9975-02713 drum interior. Photo taken 8/13/15 by NMM personnel.

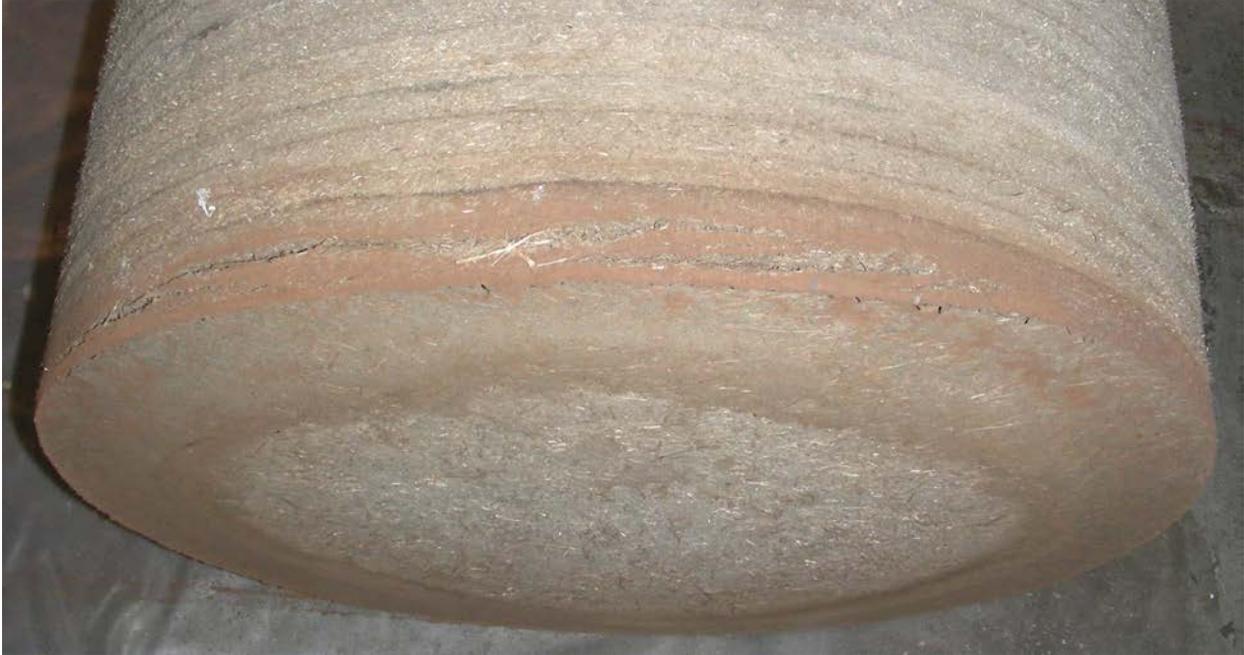
This package was sent to SRNL for additional examination, which occurred on August 20, 2015. Additional observations include mold around the bottom of the lower fiberboard assembly (Figure 28). The bottom layers of this assembly were soft, and began tearing apart during disassembly. Limited corrosion was observed on the bottom lip of the drum (Figure 29).

Figure 28. Mold around the bottom of 9975-02713 lower fiberboard assembly, and damage to layers from removal
