EXAMINATION OF SHIPPING PACKAGES 9975-01641, 9975-01692, 9975-03373, 9975-02101 AND 9975-02713

W. L. Daugherty

January 2016

SRNL-STI-2016-00014, Revision 0

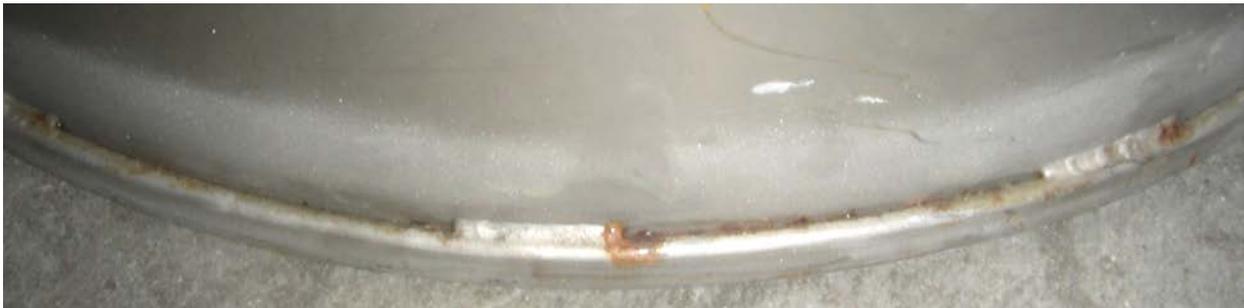
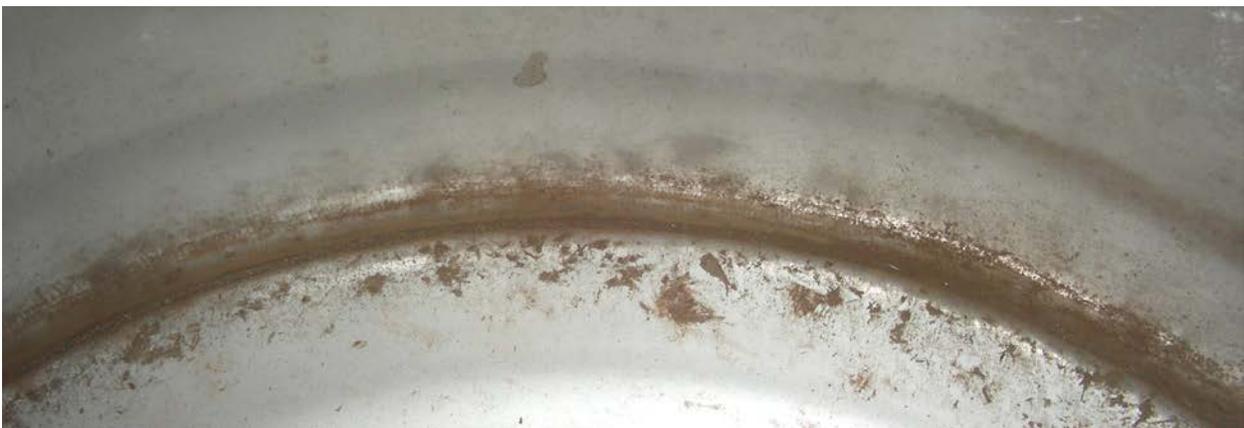
This package was sent to SRNL for additional examination, which occurred on August 20, 2015. Additional observations include mold around the bottom of the lower fiberboard assembly (Figure 28). The bottom layers of this assembly were soft, and began tearing apart during disassembly. Limited corrosion was observed on the bottom lip of the drum (Figure 29).

Figure 29. Corrosion on the bottom lip of 9975-02713 drum on the exterior (a) and matching region of the interior (b)

For packages in storage, looking for corrosion on the drum side would provide a quick screening for potential internal issues without having to open the package. For packages removed from storage, examining the drum bottom as well would provide a further check against possible internal degradation. It is recommended that NMM consider implementing these screening checks, especially for higher wattage packages.
