# **Idaho National Laboratory Quarterly Performance Analysis FY 2013 Third Quarter**

August 2013

## INL/INT-13-29860

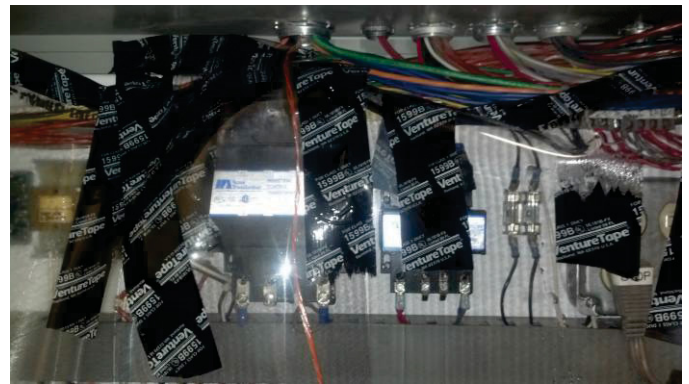
**Figure 1 Inside of the Staefa Controller Panel with the Clear Vinyl Insulation Barrier Installed**

**NE-ID-BEA-STC-2013-0002** (Significance Category 3)  
On June 5, 2013, service subcontractor electricians began work to provide support to a service subcontractor controller technician in the pulling of new controller cables through conduit to support an HVAC upgrade in the EROB West penthouse. The EROB HVAC and Fan System Controls upgrade (the upgrade) included the replacement of the existing Staefa control system to the Carrier i-Vu control system. The Staefa control panel houses mostly low voltage controllers (24V) and termination points for the sensors. However, the Staefa panel also houses a 120 VAC transformer near the top of the panel where conduit enters. The inside of the Staefa panel had been covered with a voltage rated vinyl insulated barrier (Salisbury RLBPVC1 Class 1 Clear Roll Blanket) a few weeks earlier to mitigate the 120V transformer hazard and allow energized work to be performed inside the panel. The Staefa panel was operating (energized) at the time of the event.

The electrician obtained a metal fish tape to facilitate running the cable to the panel. While pushing the fish tape, the vinyl insulation barrier slipped more than once, requiring the electrician to pull the vinyl barrier back into place to cover the work area. The action required the electrician to hold the vinyl barrier in place to prevent it from slipping while he manipulated and pushed the fish tape. During this evolution, the fish tape came into contact with a terminal on the 120V transformer. The contact resulted in a small arc, which blew an HVAC fuse and caused the fans to immediately shut down. There were no injuries to personnel.
