# **Reinforcement studies and renewal of installations for the contemporary use of the Bursa Inebey (Egne Beg) Madrasah**

**O. Koprulu Bagbanci\* and M. B. Bagbanci**

Engineering and Architecture Faculty, Uludağ University, Bursa, Turkey.

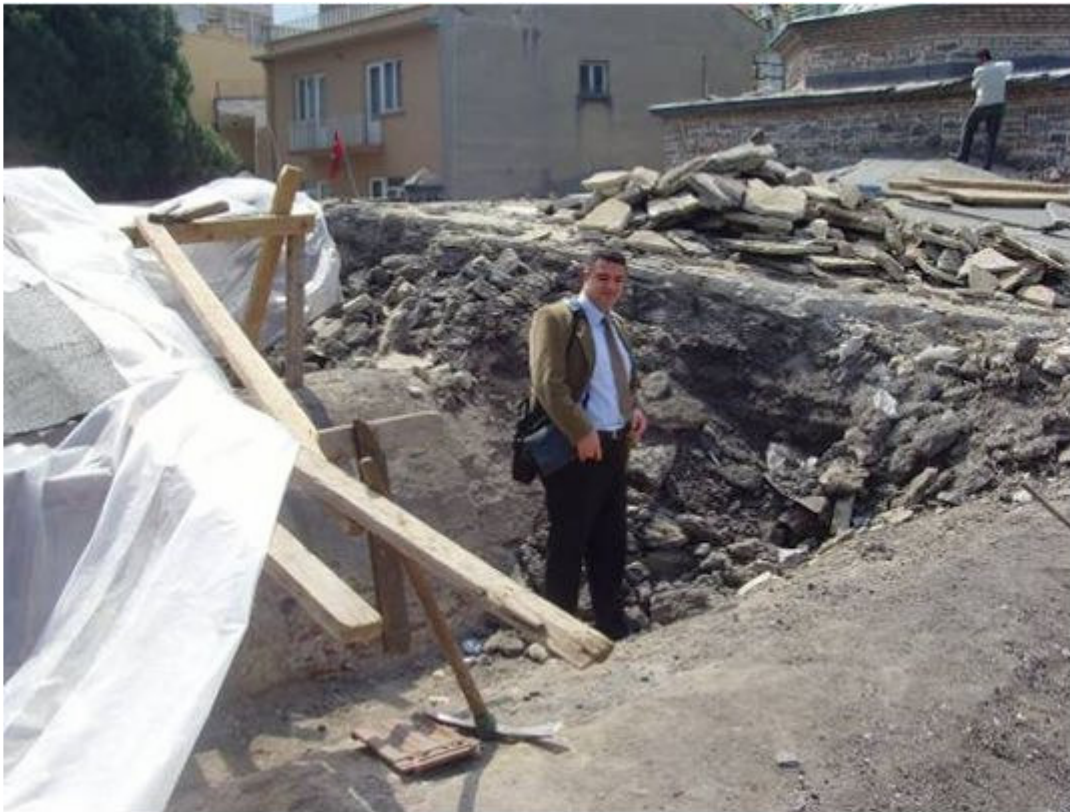
The roof of the Madrasah had been subjected to several interventions, in which filling materials were used between and above the vaults (Figure 4 and 5). The filling materials were separate layers composed of different substances, such as clinker, limestone, brick pieces, concrete and reinforced concrete. The layer of reinforced concrete was covered by insulation material. The load on and above the vaults was calculated at 700 tons per 400 m<sup>2</sup>. This showed that the roof of the Madrasah had been loaded enormously, perhaps at a rate of 1.75 ton/m<sup>2</sup> per fifteen years.

**Figure 4.** Different materials filling between and above the vaults.

material from the structure commenced, using small drilling machines to transmit fewer vibrations to the structure. During the removing work, the roof was protected against the rain. The emptied vaults are shown in Figure 10. The reinforcement work began after the load had been removed from the structure. The local cracks emerging on the walls were repaired by removing the cracked parts from the structure. The old bricks and stones that were not considered hazardous were reused for the walls. The new

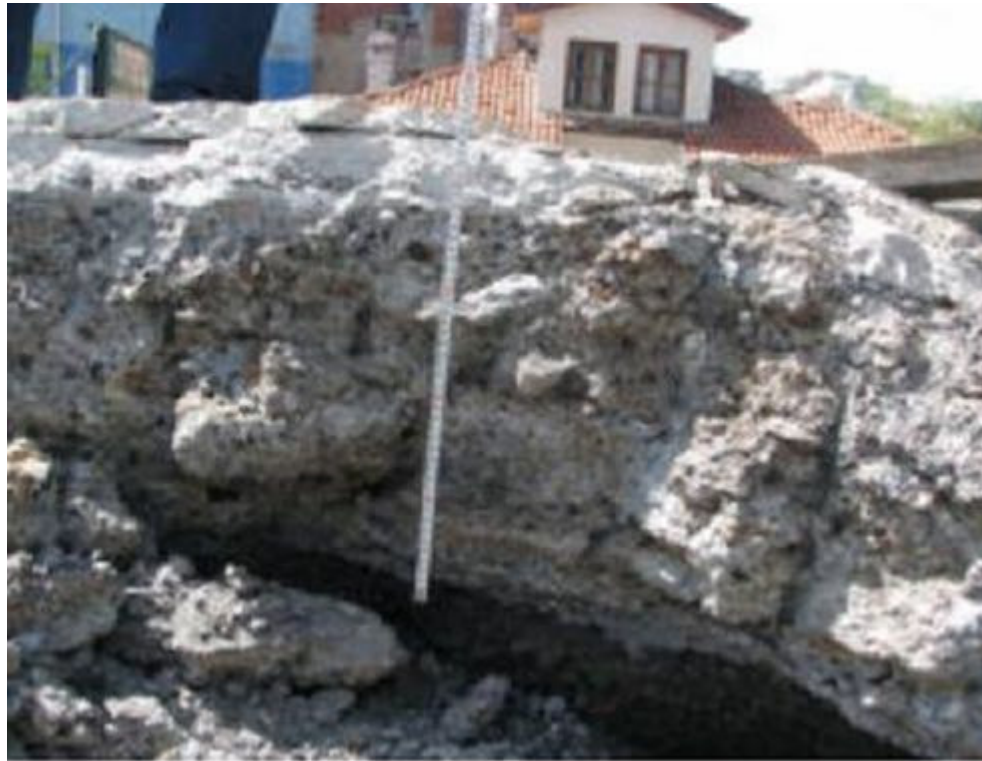
**Figure 5.** Layers of filling materials on vaults.

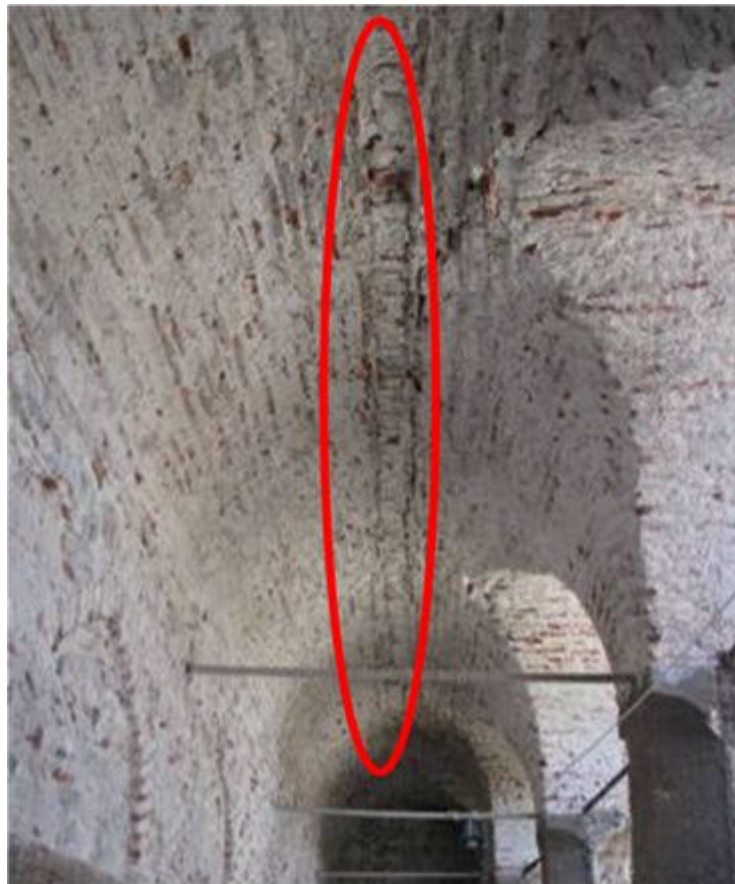
**Figure 7.** *In-situ* cracks under vaults in North-South direction.

mortar and the other new materials needed were formed or chosen to resemble the old ones as closely as possible by consulting the test results. The continuous cracks under the vaults were filled with the appropriate mortar, and the surface was made ready for the application of fibre reinforced polymer (FRP) composite material. The FRP composite material was applied to the surface along the length of the vaults without any interruption. The FRP material was also applied to the edges between the vaults and the walls (Figure 11 and 12).

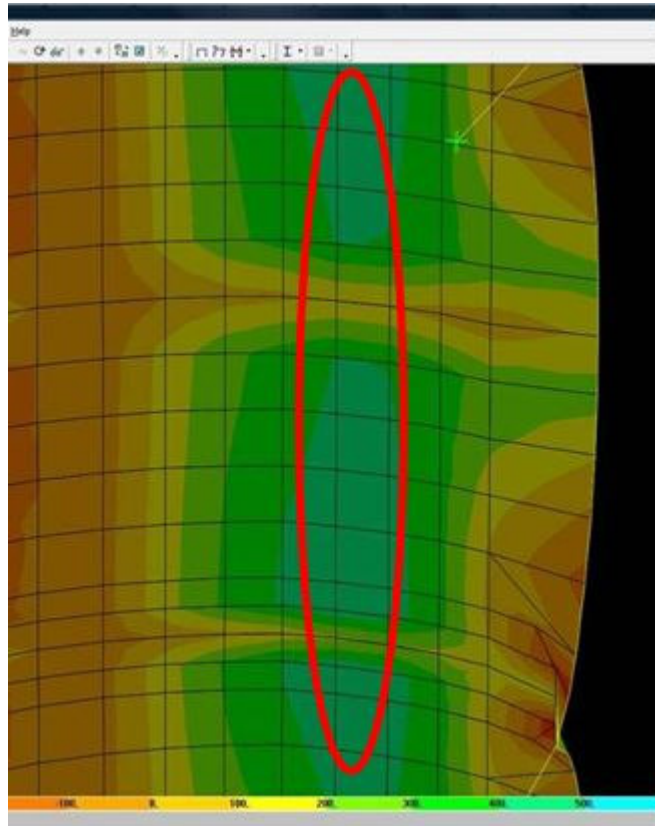
The structural analyses were conducted by using the SAP2000 finite element programme (Computers and Structures, Inc., 1998). A roof load of 1.75 ton/m<sup>2</sup> was applied to the model to find out what effect the filling material was having on the structure. The model of the Madrasah consisted of 6777 shell elements and 28 frame elements (Figure 6). In the self-weight analyses, the highest level of tensile stress, measured at around 0.4 - 0.5 MPa, was found under the vaults. *In situ* observation revealed that there were continuous cracks in these areas (Figure 7 - 9). It was clear that the load on the vaults was making the structure hazardous. The structural analyses were continued, this time by analysing the effect of removing the load from the roof. The results showed that the tensile stress under the vaults dropped to around 0.1 ~ 0.2 MPa, 3 times less than

**Figure 8.** Tensile stress areas under vaults in North-South direction.

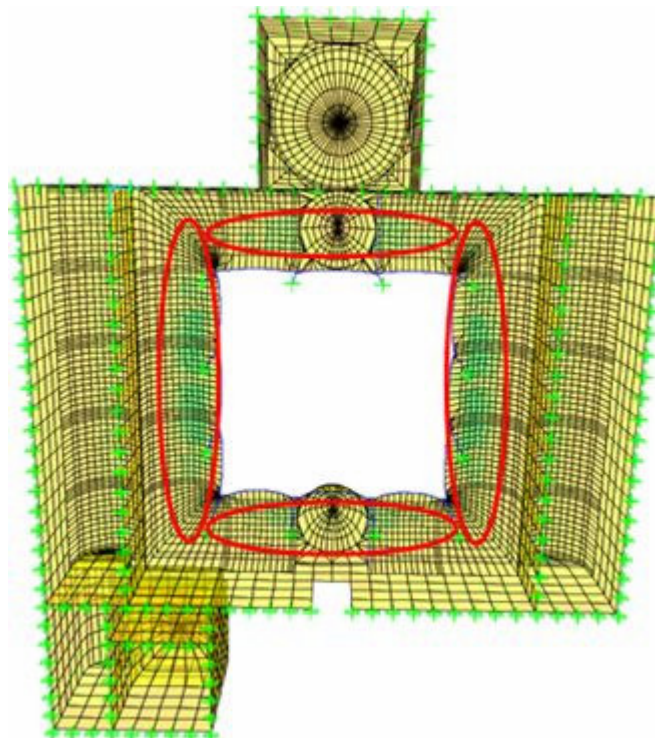
the stress from the first analysis (Bagbanci, 2008). After the analyses, it was clear that the load on the roof must be removed from the structure.

**Figure 9.** Maximum tensile stress areas under roof loads.

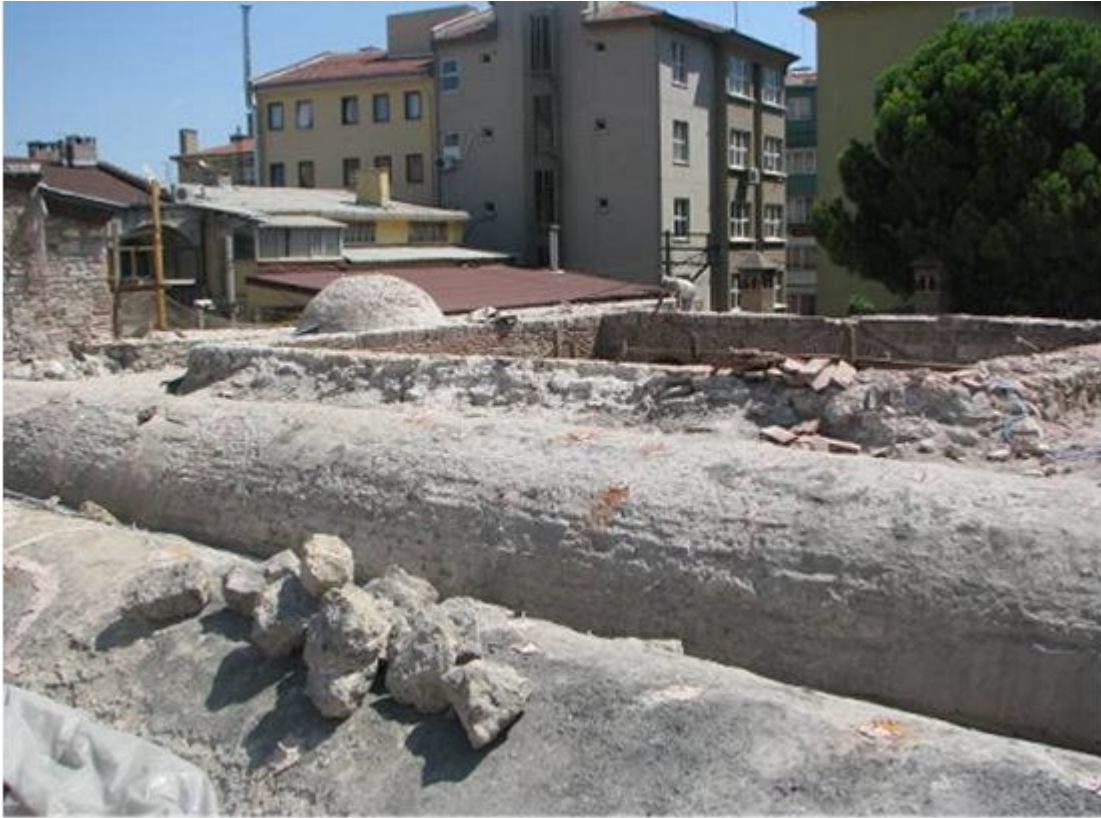
**Figure 10.** The general view of the emptied vaults.

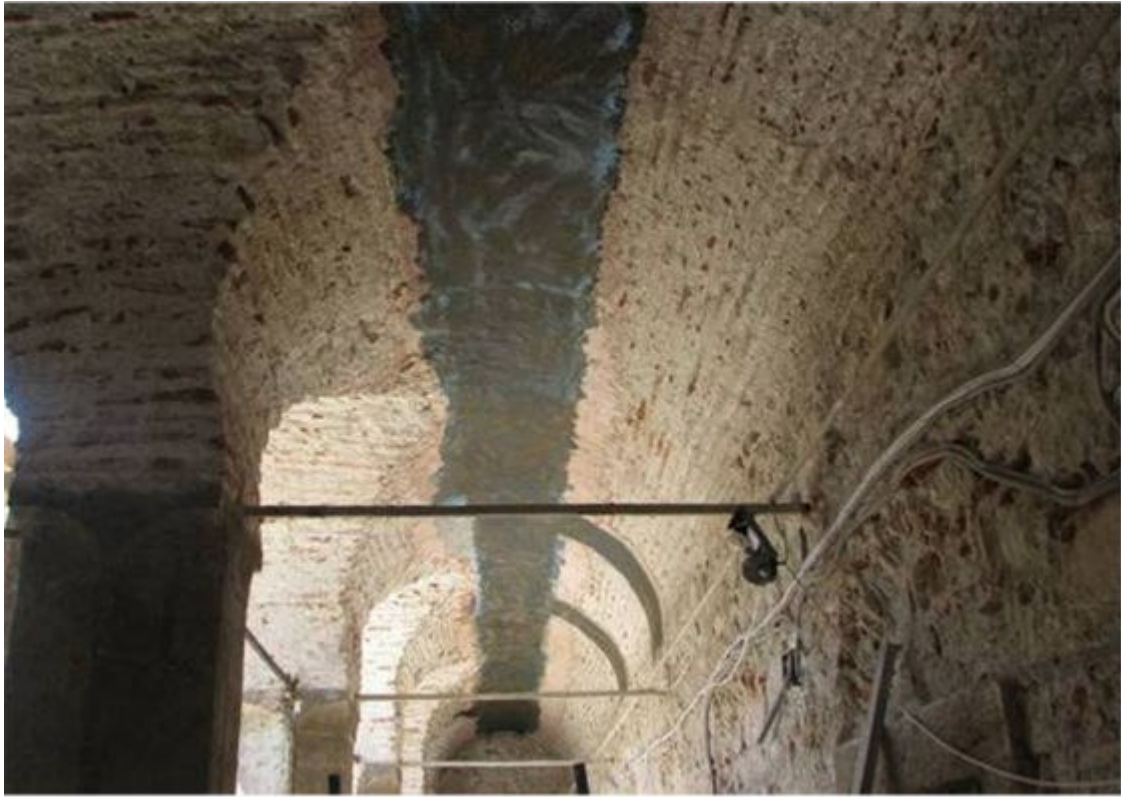
**Figure 11.** FRP applications under the vaults.

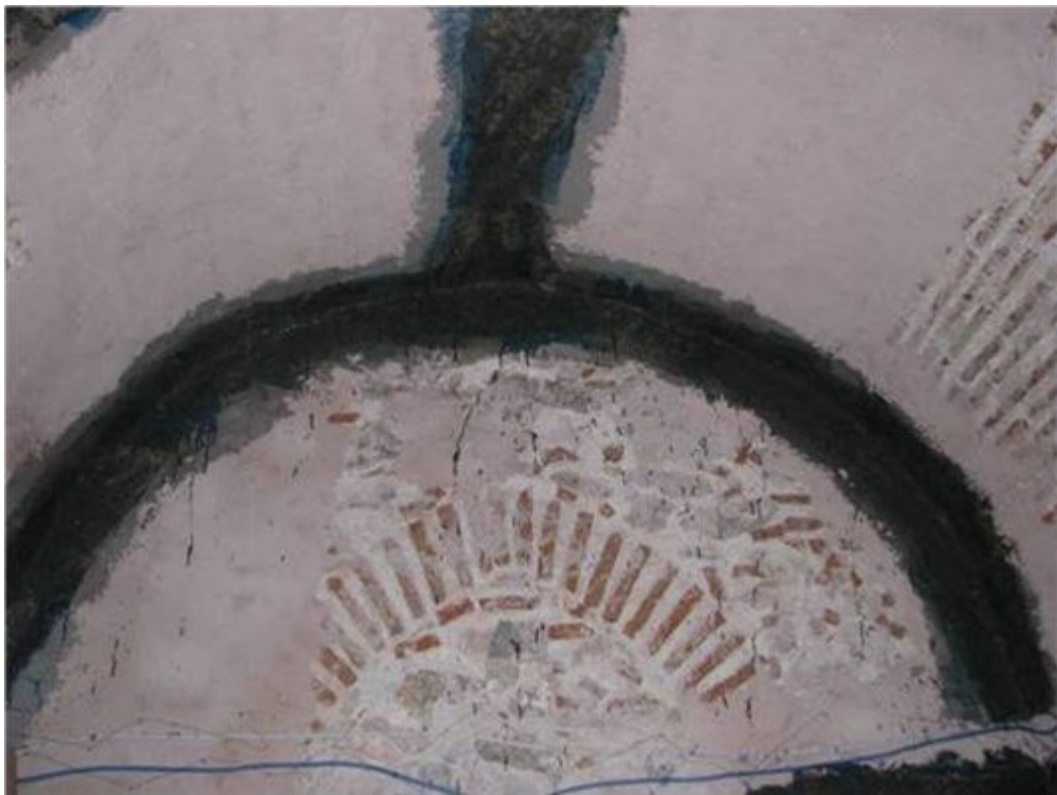
**Figure 12.** FRP applications at edge of the vaults.

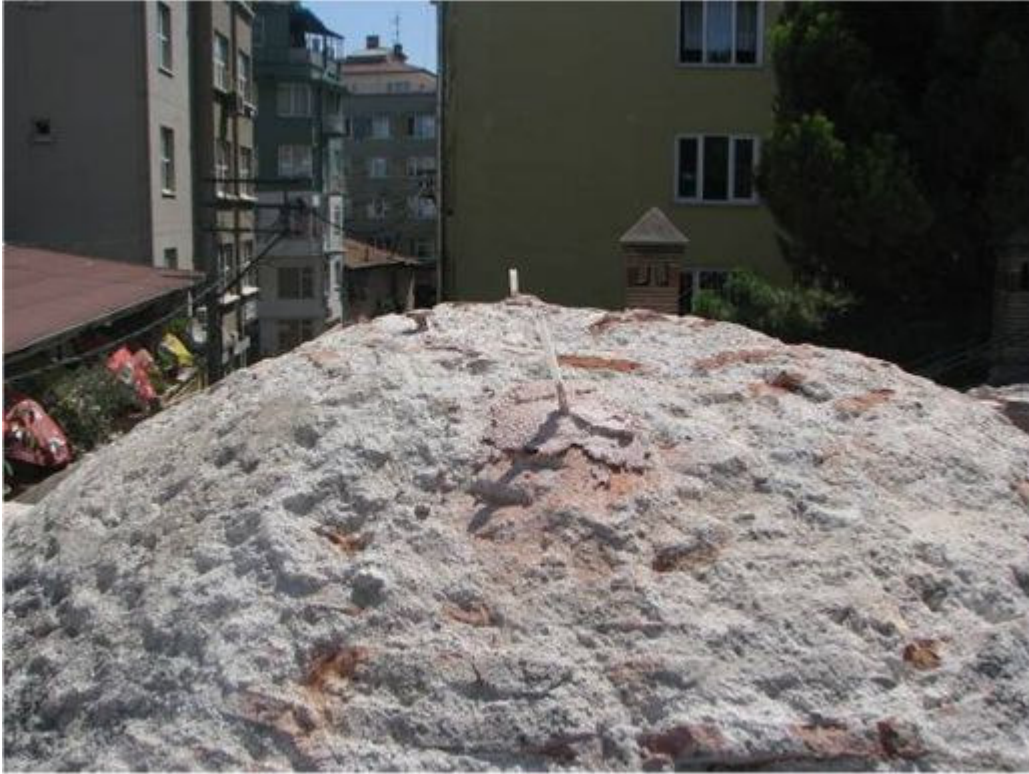
**Figure 13.** Application of injection materials above the domes.

After the application of the FRP material was completed, the inside of the building was plastered in preparation for the distribution of the injection material. All visible cracks were repaired, either by the injection of hydraulic lime mortar, or by the reconstruction of the crack parts with new materials that closely resembled the old ones. Finally, the invisible pores and cracks that were not visible were filled by an injection of hydraulic lime mortar from the cracks above the superstructure (Figures 13 and 14). After the reinforcement of the building was finished, the roof was constructed using wooden materials. Wood was chosen because of its lightness and because it was easy to make interventions with after the restoration work was finished. The wooden materials were impregnated to protect them from damage caused by fire and water. The load of the roof was carried by trusses running parallel to the vaults, the main load-bearing structures. The trusses were supported on the walls by steel plates and anchor bolts placed between the vaults and on the piers. The supporting points of the wooden trusses and the perspective view of the east side of the building can be seen in Figure 15 and 16. Lead was used as a cladding material after the construction of the wooden roof. The timber elements that had decayed were exchanged for new ones or were renewed, specifically by sandblasting the iron tie bars that had

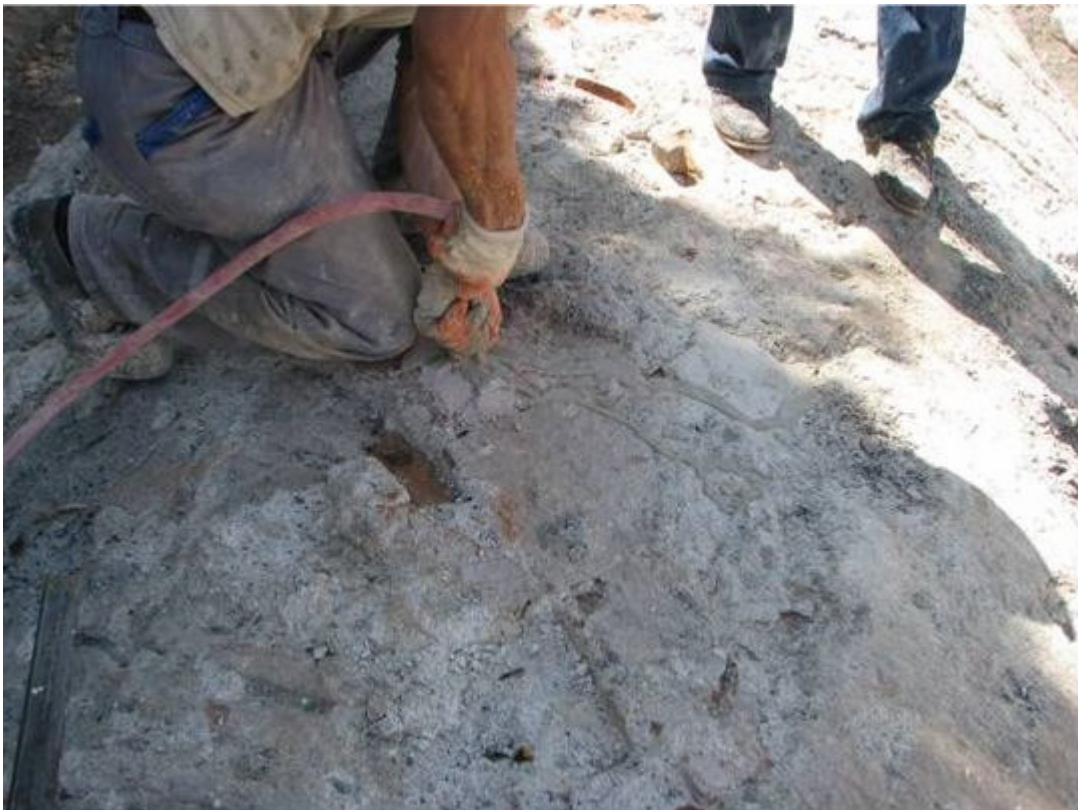
**Figure 14.** Application of injection materials above the vaults.

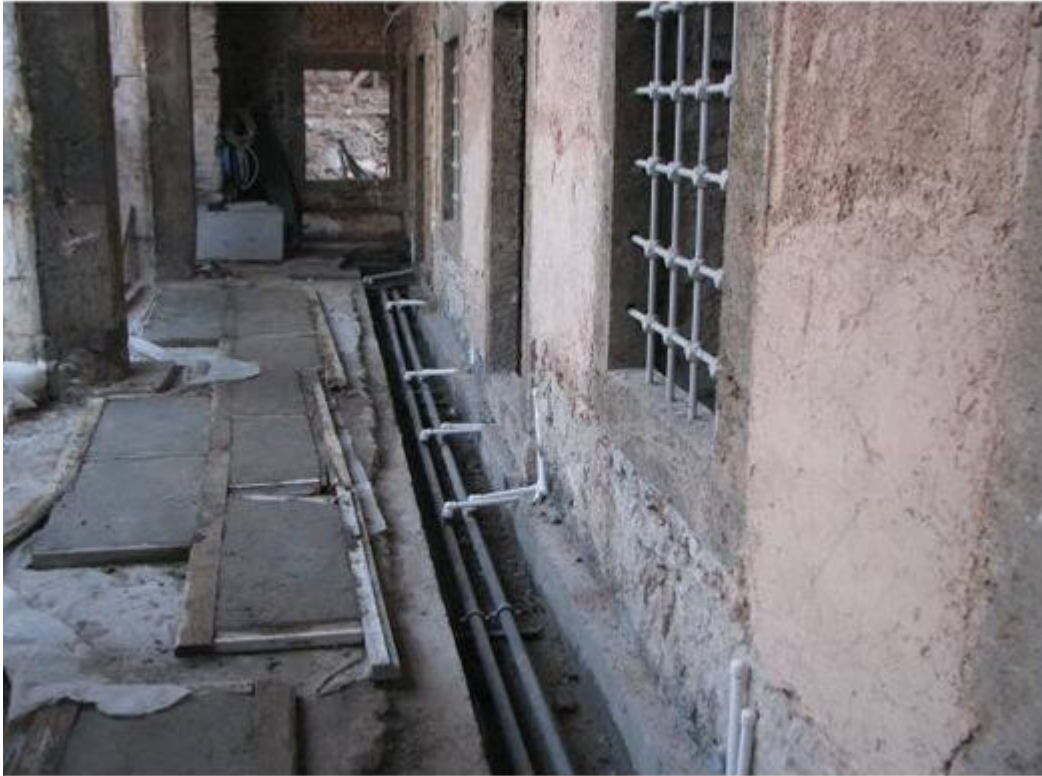
**Figure 17.** New installation systems.

The Library of Illuminated Manuscripts belonging to the Turkish Republic Ministry of Culture planned to use the Inebey Madrasah after the building's restoration. For that reason, new installations were adapted to the building and systems that had been recently installed were renewed (Figure 17). The heating, plumbing, electrical, fire protection and security control systems were chosen in accordance with modern technology and were chosen and installed with care to prevent the Madrasah from being damaged in any way. The FM200 automatic gas extinguishing system was found to be the preferable fire system for protecting the historically invaluable manuscripts in the library against fire (Figure 18). It gets activated very quickly, and the endangered area does not require cleaning after the system has been triggered (URL-1, 2010). It was installed under the new wooden roof because it could be easily accessed there.

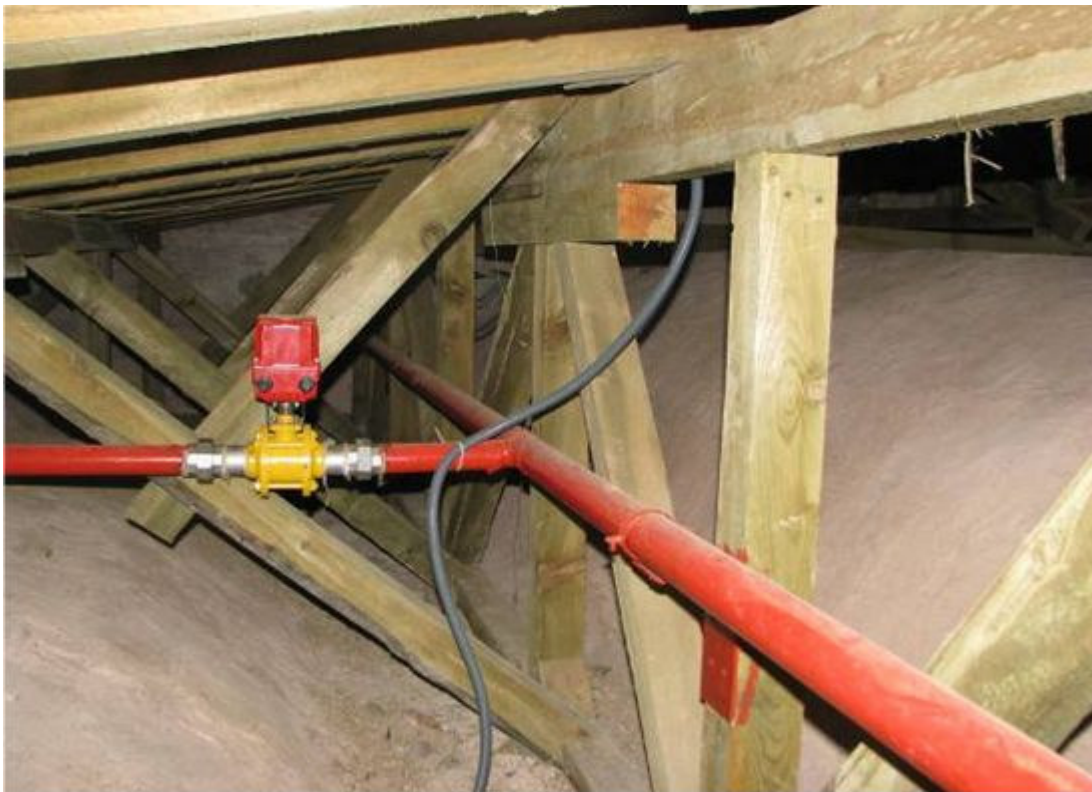
**Figure 18.** Automatic gas extinguishing system (FM200) under the wooden roof.
