EMERGENCY REPAIRS TO THE MAIN BREAKWATER OF CALSHOT HARBOUR ON TRISTAN DA CUNHA ISLAND

Paul Bouton¹, Frans van Eeden¹, Marthinus Retief¹, Francois De Roubaix¹ and Johan Kieviet²

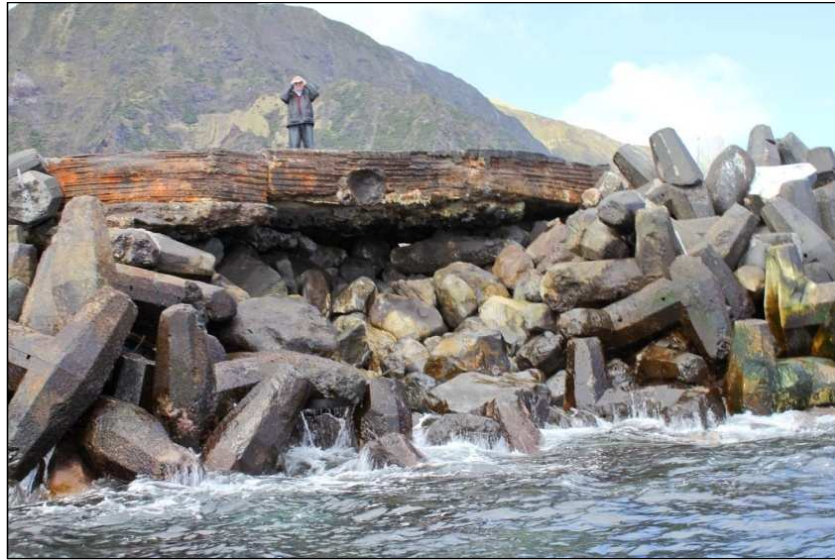
by WSP (2010) that a large scour hole had formed on the seaward side of the western breakwater head which resulted in the dislodgement and breaking of the dolos armour layer and the displacement of the breakwater capping slab, see Figure 2.

Figure 2. Photo taken 12 Sept. 2010 towards the south south-east showing the undermined deck slab and exposed core rocks near the head of the western breakwater (WSP, 2011).

It was decided to stabilise the scour hole with 10 t dolos armour units as a temporary emergency repair. In order to achieve this, it was necessary to procure a large heavy lift crane for placing concrete units up to 10 t in weight at 20-30 m off the breakwater.

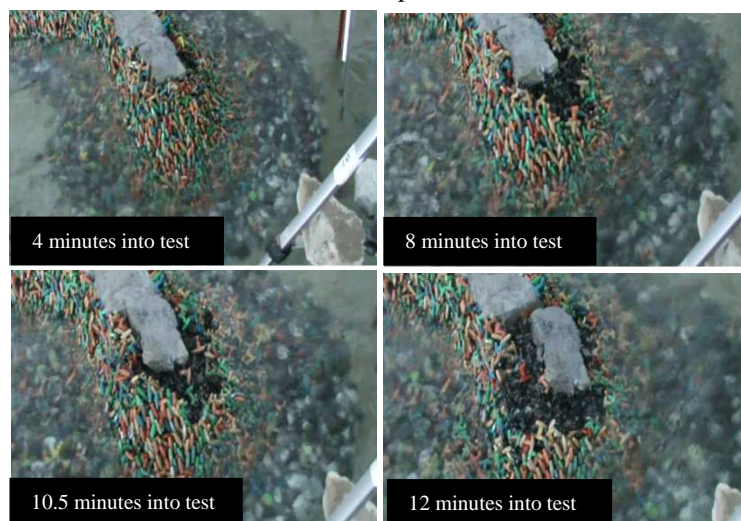
The start of failure in all the tests was always on the section of roundhead not being repaired. Test 010 proved that the roundhead failures were not a result of the 10 t dolos units on the repair section (refer to Table 3 for the packing without the 10 t dolos units). Figure 9, shows a sequence of the images illustrating the failure from start to finish without a repair done.

Figure 9. Breakwater Failure Image Sequence for Test 010.

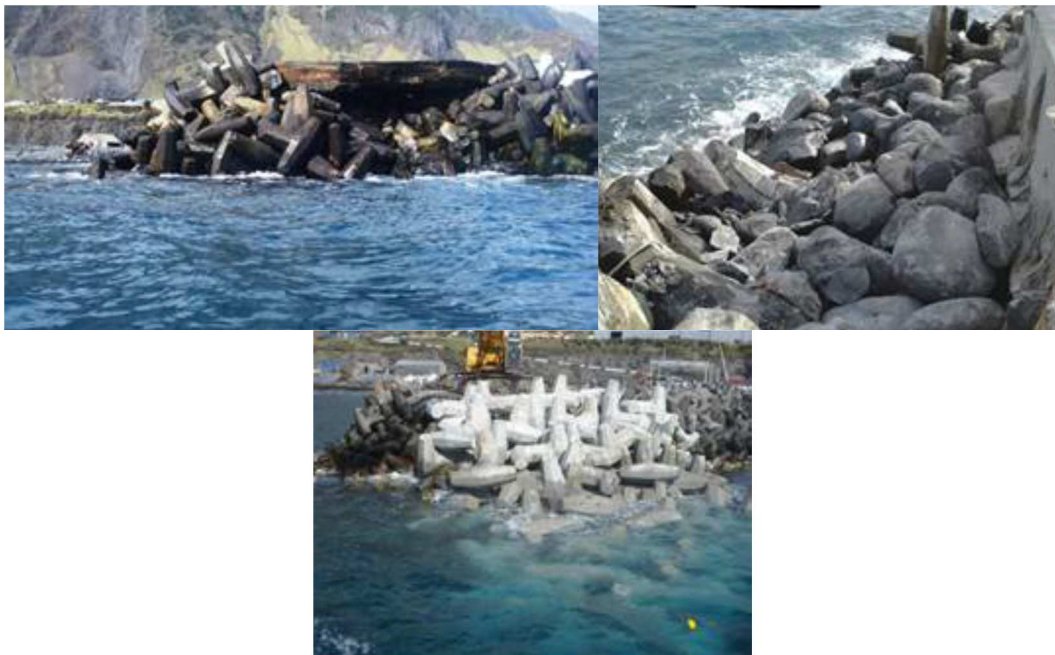
Figure 11. Stages of construction (left to right). (1) The damaged section of the Western Breakwater upon arrival of repair team; (2) the dressed armour slope; (3) completed repair – 1 April 2011.

- The dolos repair was completed by removing the broken dolosse and large temporary rocks, dumped by the islanders, from the damaged area on the breakwater slope.

- The profile slope armour was dressed to within specification tolerances. Displaced dolosse and rock directly adjacent to the repair section were repositioned in the slope to allow for knitting of the repair 10 tonne dolos units into the existing profile.

- Armour rock underlayer was placed and dressed to the design slope of 1:1.5 to within specification tolerances by excavator, above water, and a crane fitted with a hydraulic grab for submarine slope profiling. Undulations in the damaged rock slope were filled first to ensure a uniform armour rock underlayer. The rock underlayer was consisted of 1.5 t to 3 t pieces. A trench was excavated by hydraulic grab to act as a footing to stabilize the dolos slope. This trench received the first layer of dolosse at the toe of the slope. Rock and broken dolos units excavated from the toe trench or an over-profiled slope were removed to a nearby stockpile. The stockpiled material was later used to construct a rock-toe at the base of the dolos slope to act as an additional "kicker" and the remainder

- 80 No. 10 t dolosse were carefully packed on a prescribed grid to ensure that the required packing density of the dolosse was attained. Placement of a double layer (approximately 3.0 m thick) using the industry accepted packing sequence to ensure optimal interlocking between the 10 t dolos units was done. All broken or damaged units occurring during placement were removed from the breakwater. The 10 t dolosse were knitted into the existing 3.5 t dolosse adjacent to the repair section with as smooth a transition as was practicably possible, with minimal disturbance of the 3.5 t units on either side of the damaged area. All subsurface dolosse placed were carefully positioned by the contractor diver and resident engineer who were in the water during each placement, as time constraints did not allow for traditional inspection and repacking techniques. Various stages of construction are shown in Figure 11.

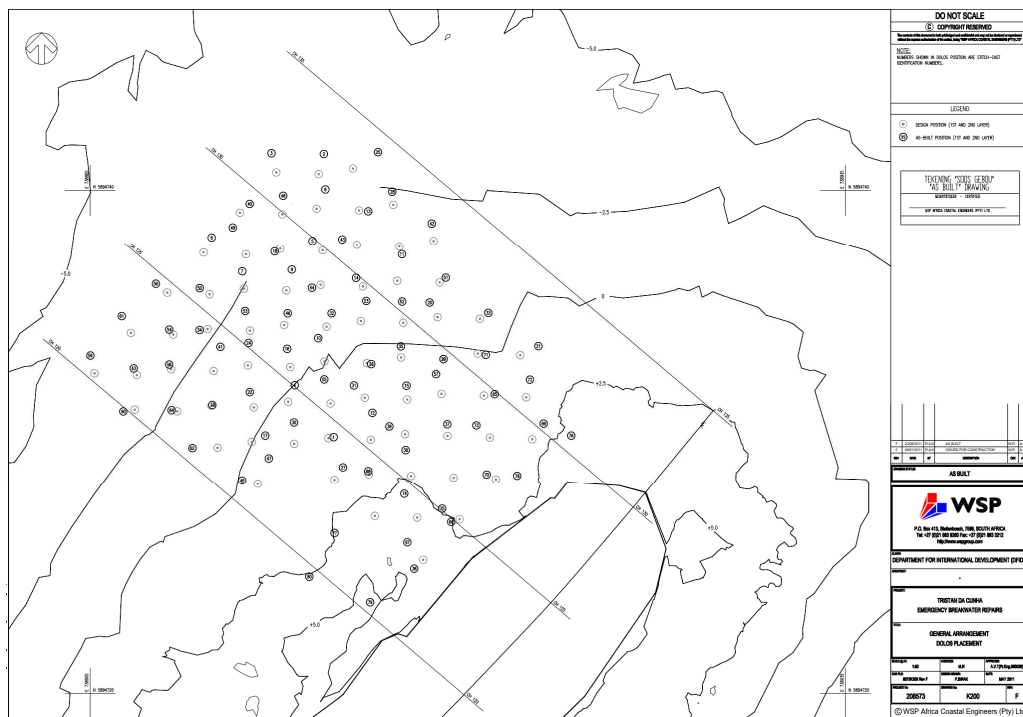
Figure 12. As-built positions of emergency repair dolosse.

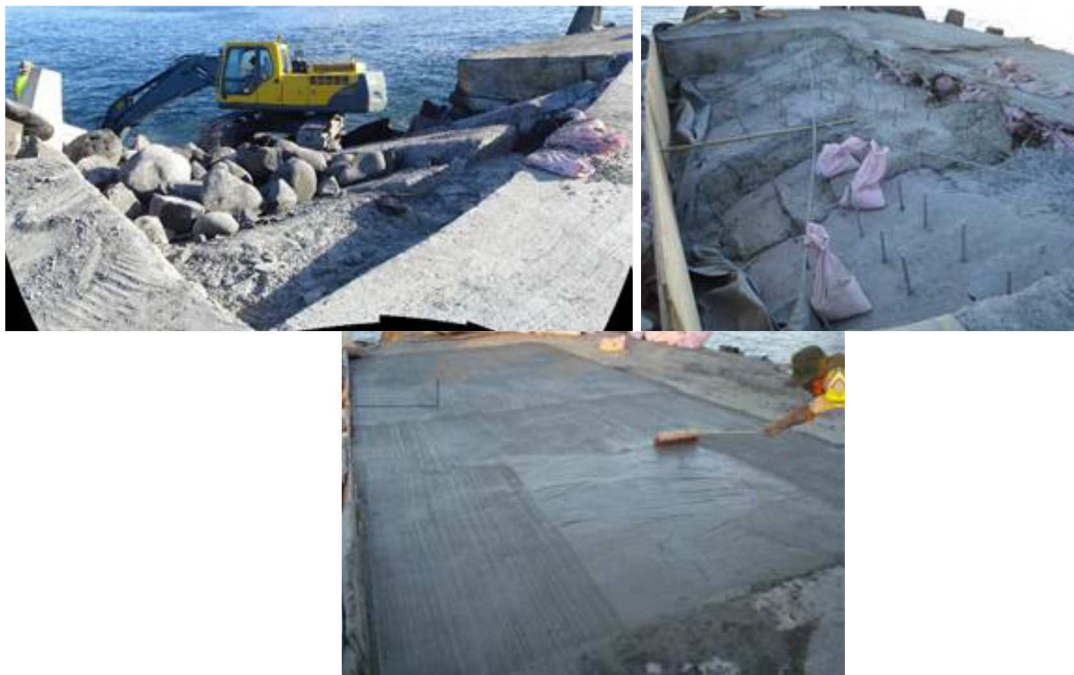
Figure 13. Stages of the concrete cap repair.

The existing cap was broken up by means of a hydraulic breaker and then, leaving the demolished material as it lay, mass capping was cast on top of this section of concrete. The concrete cap was demolished into four sections of approximately 20 tonnes each. No vehicles or personnel were allowed on top of the mass capping before it was properly repaired, including the crane for dolos placement. In an effort to increase the weight of the cap, shear links with reinforcing were drilled through the existing cap into the filling underneath to add mass to the structure. Refer to Figure 13 for stages of the repair.
