THE SERVICE LIFE OF THE REPAIR WELDED JOINT OF Cr-Mo / Cr-Mo-V

Keywords: creep, welded joint, Cr-Mo, Cr-M-V steel, residual life

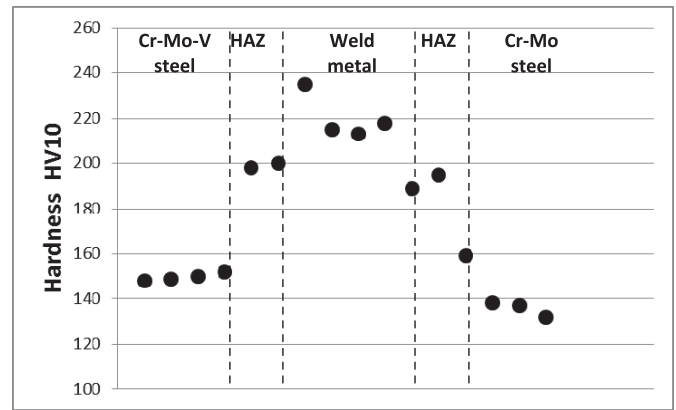
Fig. 1. Results of hardness measurements of dissimilar circumferential repair welded joint (Cr-Mo-V/Cr-Mo)

The hardness measurement through individual zones of the joint revealed no sudden changes. The maximum difference in hardness from Cr-Mo steel parent material through HAZ, weld, HAZ to Cr-Mo-V steel parent material is approx. 110 units and does not exceed the maximum acceptable value of 350 HV10.

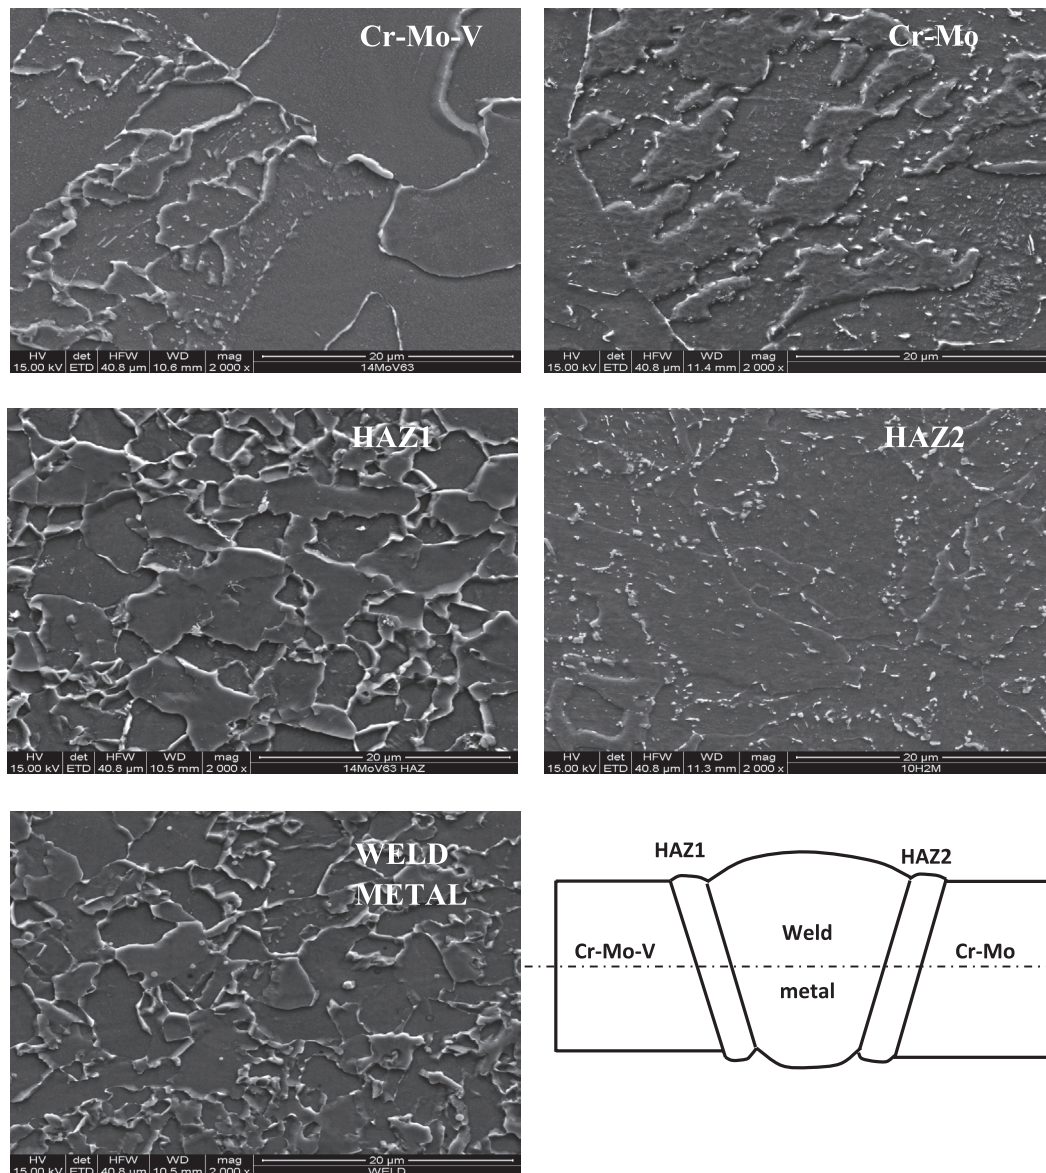
Fig. 2. Microstructure of the material of repair welded joint elements

Test area	Description of microstructure Material condition – exhaustion degree
Parent material 13HMF steel	Ferritic-bainitic microstructure. Partially coagulated bainitic areas. Precipitations of different size at the ferrite grain boundaries. Inside the ferrite grains, there are very fine evenly distributed precipitates. No discontinuities and micro-cracks are observed in the microstructure. No initiation of damaging processes is observed. Bainitic areas: class I, precipitates: class a <u>Damaging processes: class O</u> CLASS 1/2, EXHAUSTION DEGREE: approx. 0.3
Parent material 10H2M steel	Ferritic-bainitic microstructure. Partially coagulated bainitic areas. Fine precipitations at the ferrite grain boundaries. Mostly very fine precipitations inside ferrite grains. No discontinuities and micro-cracks are observed in the microstructure. No initiation of damaging processes is observed. Bainitic areas: class I, precipitates: class a <u>Damaging processes: class O</u> CLASS 1/2, EXHAUSTION DEGREE: approx. 0.3

Heat-affected zone, weld – repair joint	Heat-affected zone microstructure. No discontinuities and micro-cracking are found in the microstructure.
