THE DEFECTS OF OXIDE LAYERS FORMED ON 10CrMo9-10 STEEL OPERATED FOR 200,000 HOURS AT AN ELEVATED TEMPERATURE

The paper contains results of studies into the formation of oxide layers on 10CrMo9-10 (10H2M) steel long-term operated at an elevated temperature ($T = 545^{\circ}\text{C}$, $t = 200,000\text{h}$). The oxide layer was studied on a surface and a cross-section at the inner and outer surface of the tube wall on the outlet both on the fire and counter-fire side of the tube wall surface.

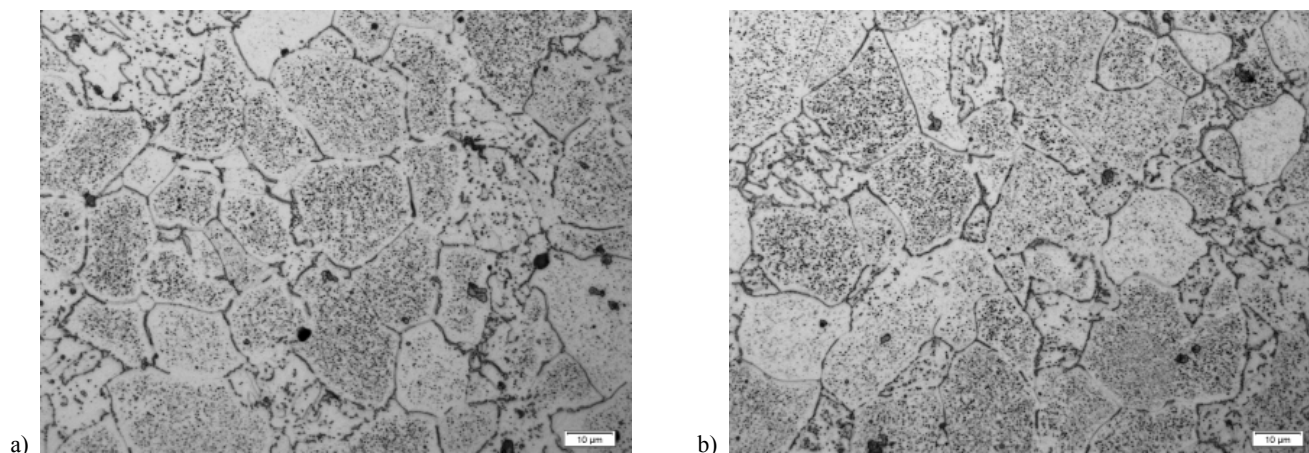
After a long-term operation ($T = 545^{\circ}\text{C}$, $t = 200,000\text{h}$) 10CrMo9-10 steel shows degradation of bainitic-ferritic structure. The extent of degradation on the fire side is much higher than on the counter-fire side, which is presented in Fig. 1. A substantial depletion of boundary areas in carbide precipitates is visible on the fire side. Instead, in both cases carbide precipitates create ‘chains’ along boundaries, in certain places there are also cases of etching around sulphide precipitates and sporadic creep micropores on the

Fig. 1. Microstructure of 10CrMo9-10 steel operated for 200,000 hours at the temperature of 545°C , LM: (a) fire wall, (b) opposite fire wall

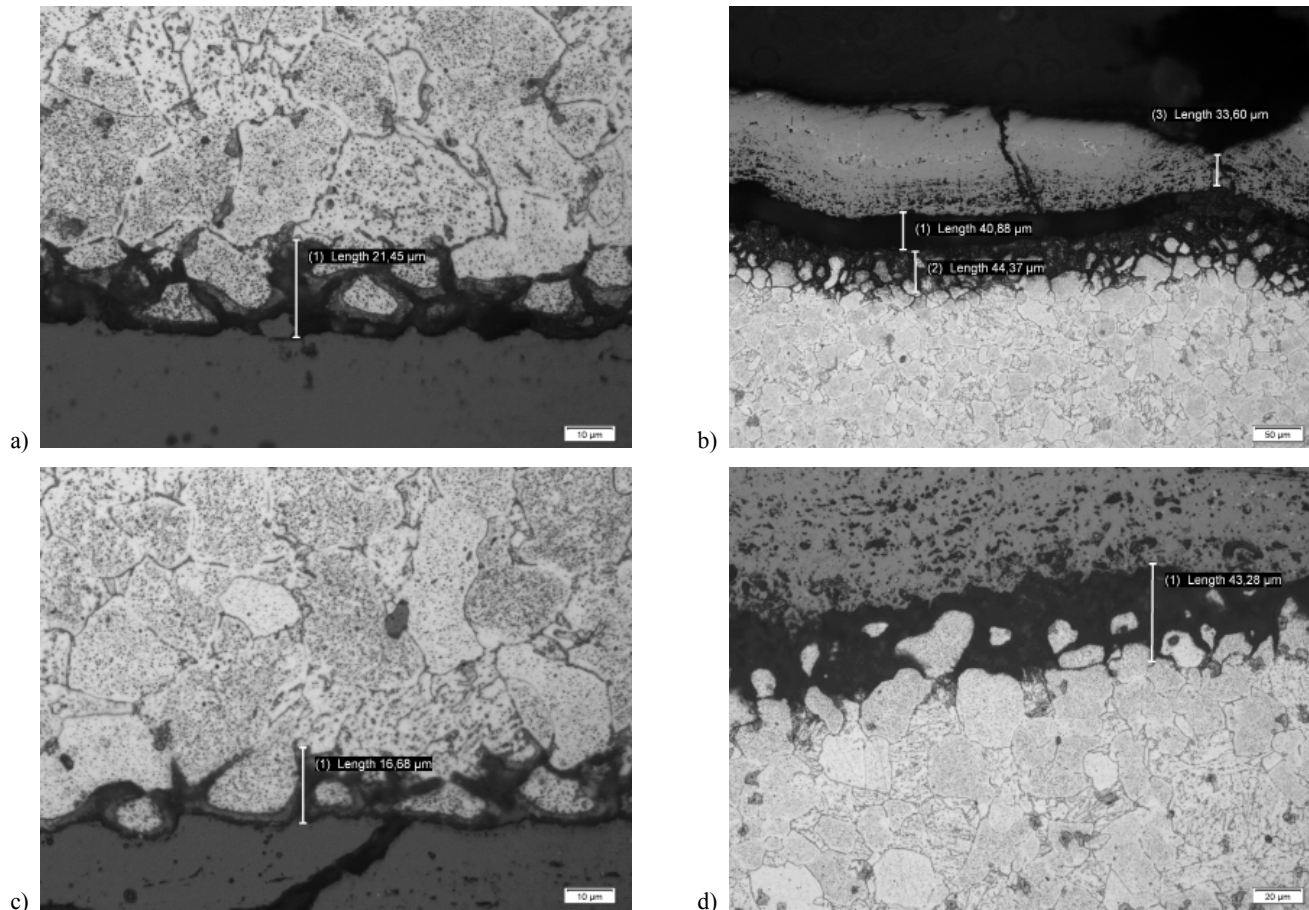
fire side. Corrosion on the grain boundaries also exists, both on the fire and counter-fire side, which is presented in Fig. 2. Such corrosion together with crevice corrosion to the largest extent occurs at the outside wall on the fire side, reaching $84\text{ }\mu\text{m}$ in depth. While on the counter-fire side at the outside wall corrosion exists on the grain boundaries to the depth of $43\text{ }\mu\text{m}$. At the inside wall, on the fire and counter-fire side, corrosion on the grain boundaries exists to the depth of $21\text{ }\mu\text{m}$ and $17\text{ }\mu\text{m}$, respectively.

Fig. 2. Corrosion on the grain boundaries at: (a) inner surface – fire wall, (b) outer surface – fire wall, (c) inner surface – opposite fire wall, (d) outer surface – opposite fire wall

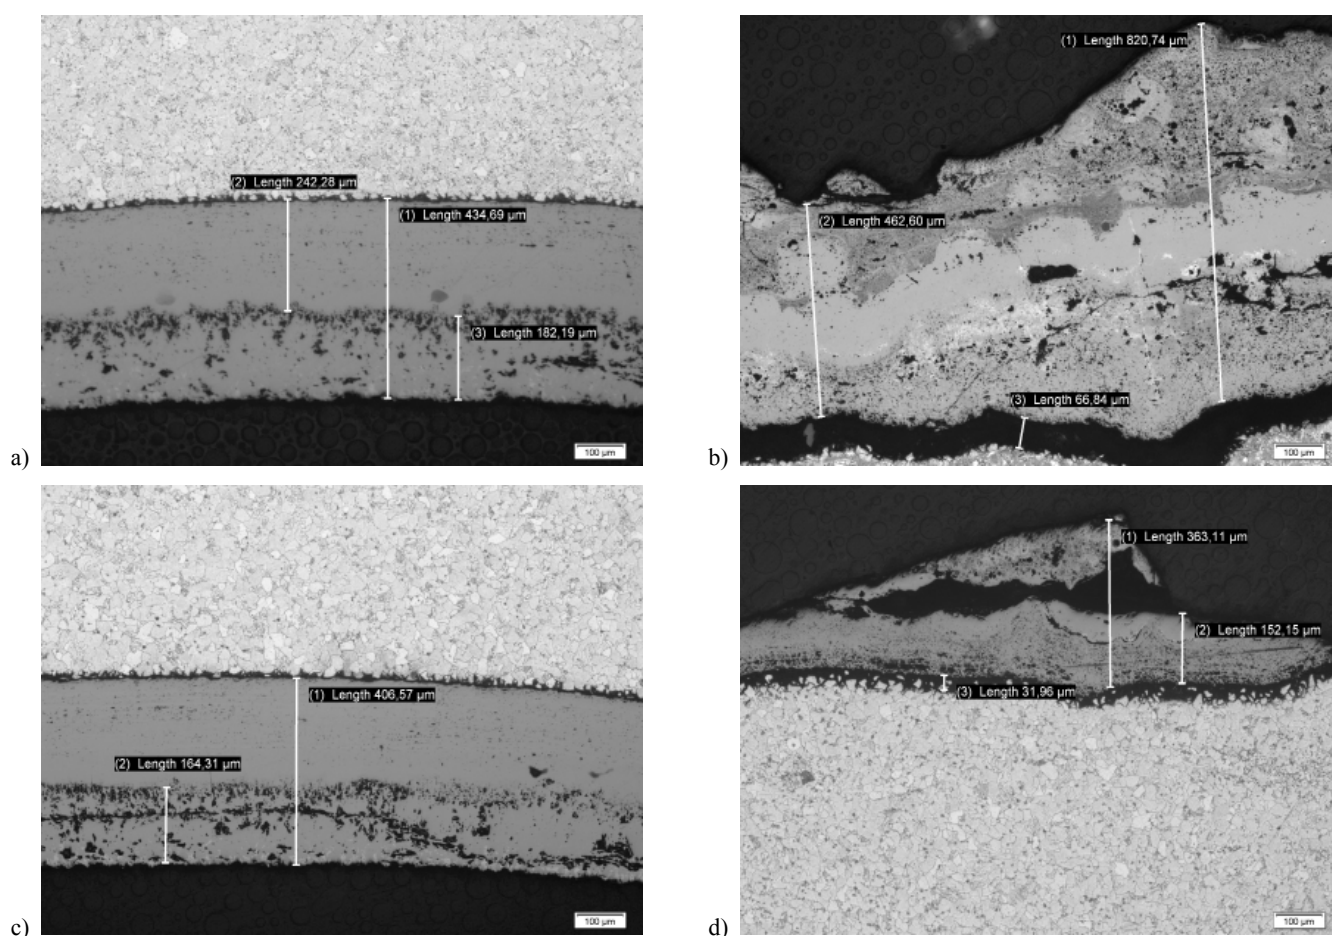
The oxides layer thickness together with deposits on the fire side was 435 μm and 820 μm on the flowing medium and

flue gas side, respectively (Fig. 4a, b). For the counter-fire side on the inside the oxides layer thickness is smaller by 30 μm , while on the outside by as many as 460 μm (Fig. 4c, d). The layer formed on the fire outside shows high degradation, which is presented in Fig. 5b, where a surface after spalling of a thick deposit layer is visible. In addition, a very large fissure reaching the depth of 235 μm may be noticed. Instead, on the inside only local spalling in the oxides layer may be observed directly on the flowing medium side (Fig. 5a).

Fig. 4. The thickness of oxides layer formed on the steel examined, LM: (a) inner surface – fire wall, (b) outer surface – fire wall, (c) inner surface – opposite fire wall, (d) outer surface – opposite fire wall

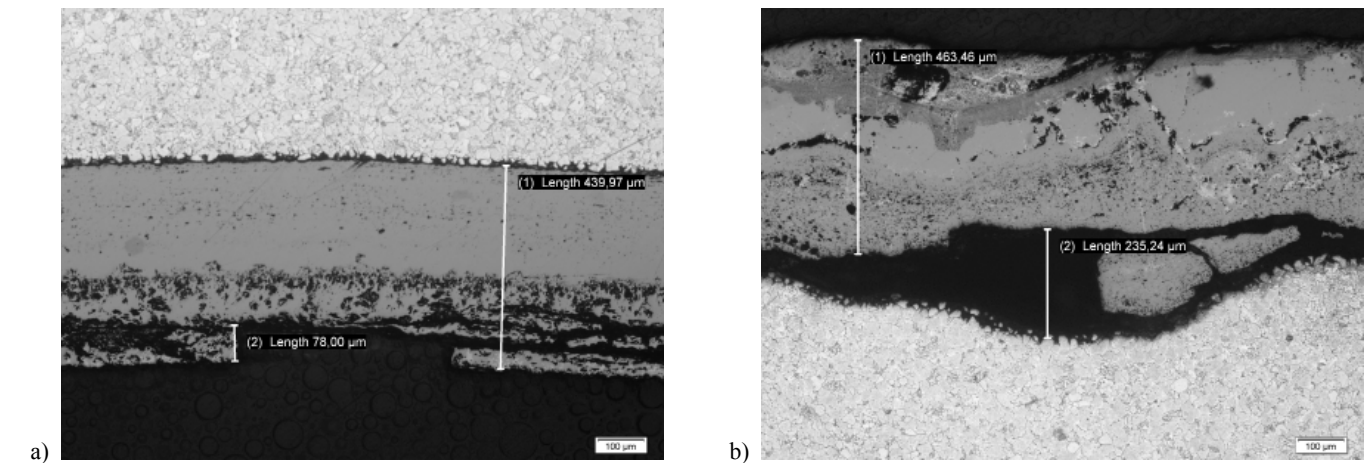
Fig. 5. The damage of oxide layer; cross section: (a) inner surface – fire wall, (b) outer surface – fire wall

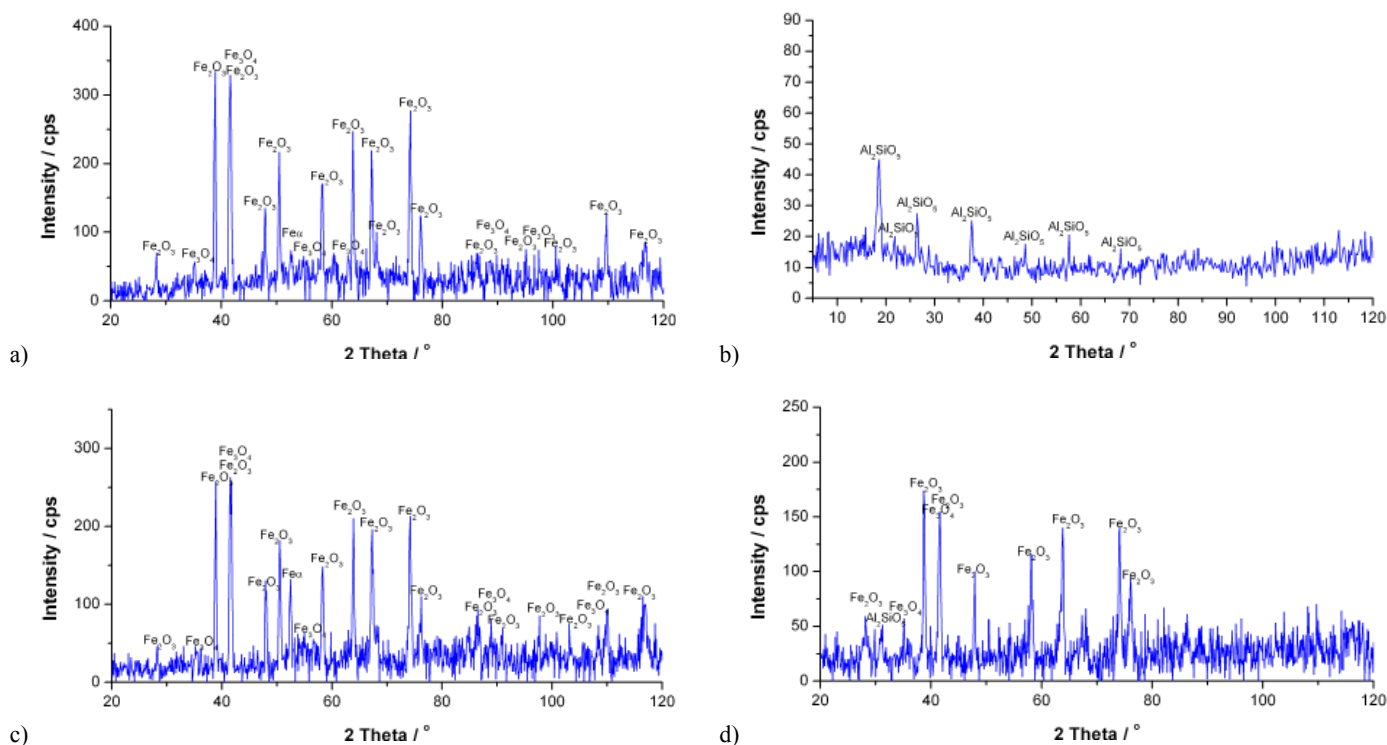
Performed EDS analysis of chemical composition (Fig. 6) combined with X-ray phase analysis (Fig. 7) has shown that oxides occur on the inside surface of tube. Based on DHN PDS and PDF4+2009 crystallographic database it has been found that the forming oxides are: Fe_2O_3 and Fe_3O_4 in accordance with the catalogue card numbers: 01-079-0007, 01-089-0951, respectively. In the case of the outside surface of tube from opposite fire wall apart from the aforementioned compounds also Al, Si, K, Ca, Ti, Mg, Na and S based compounds exist, such as: Al_2SiO_5 . The other elements, such as K, Ca, Ti, Mg, Na, occur in small amounts. Instead, directly on the fire outside only Al_2SiO_5 exists and small amounts of K, P, S, Ca, Ti, Mg and Fe. After removing the external deposit layer on the outside and repeating the XRD analysis it has been shown that the forming oxide layer is built of Fe_2O_3 and Fe_3O_4 (Fig. 8).

Fig. 7. Diffraction pattern of oxide layers obtained using the XRD technique: (a) inner surface – fire wall, (b) outer surface – fire wall, (c) inner surface – opposite fire wall, (d) outer surface – opposite fire wall
