SAND2011-6579

## **Stainless Steel Corrosion by Molten Nitrates: Analysis and Lessons Learned**

Alan Kruizenga

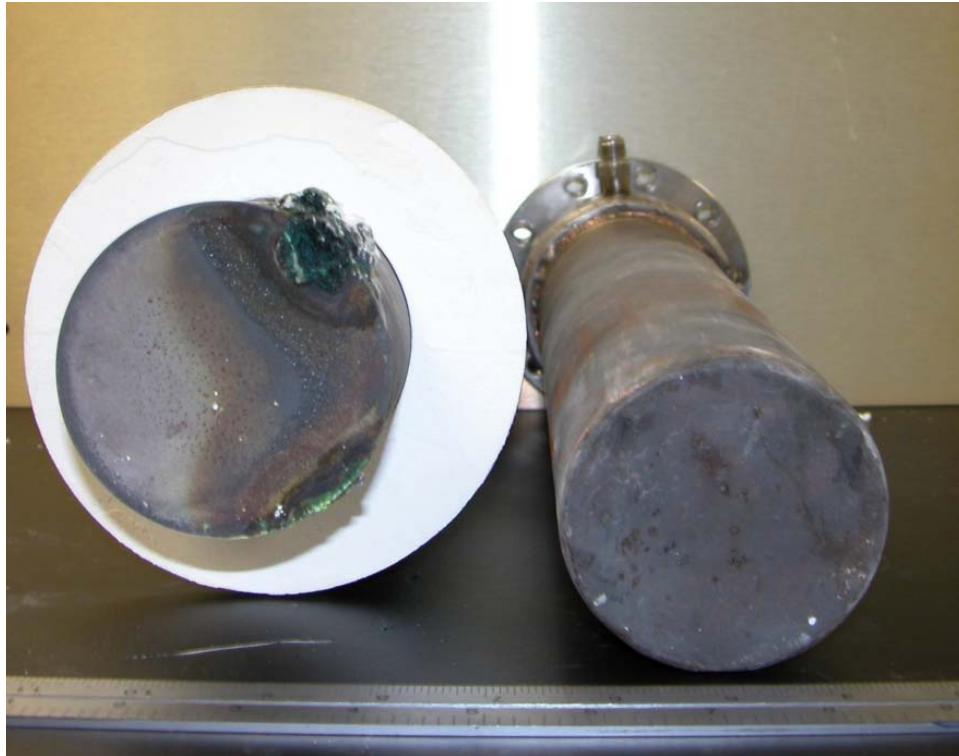
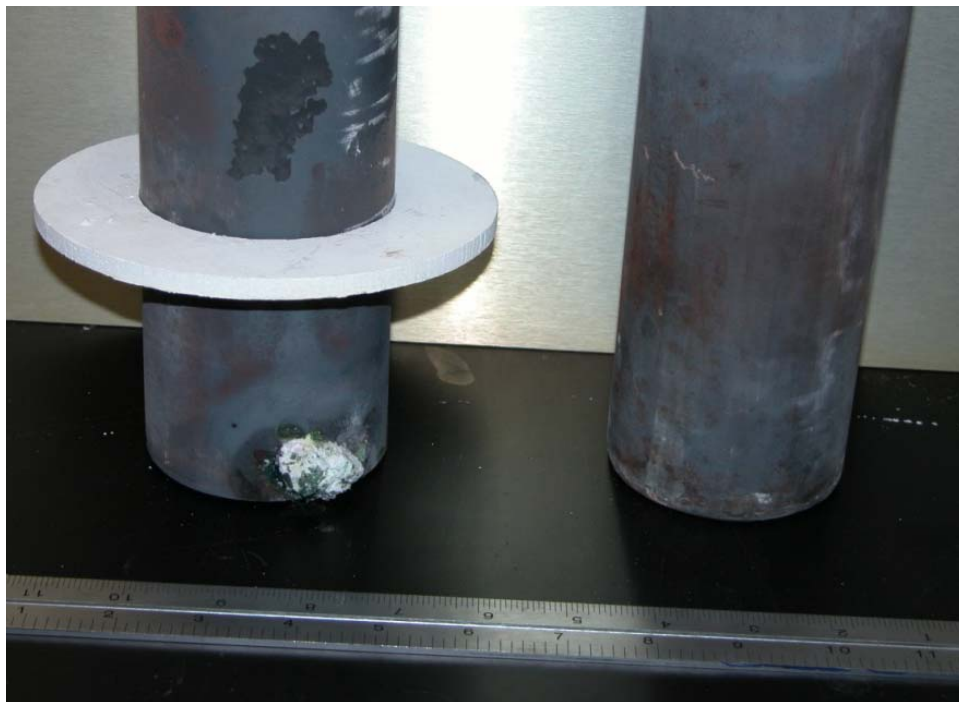
Molten nitrate solar salt (89%  $\text{KNO}_3$ , 11%  $\text{NaNO}_3$  by weight) was used during chemical stability experiments, with an oxygen cover gas, at a salt temperature of 350-700°C. Nitrate salt was primarily contained in an alumina vessel; however salt crept into the gap between the alumina and 316 stainless steel. Corrosion occurred over a period of approximately 2000 hours, with the end result of full wall penetration through the stainless steel vessel; see Figures 1 and 2 for images of the corrosion damage to the vessel.

Wall thickness was 0.0625", which, based on previous data, should have been adequate to avoid corrosion-induced failure while in direct contact with salt temperature at 677°C (0.081"/year). [Ref. 1] Salt temperatures exceeding 650°C lasted for approximately 14 days. However, previous corrosion data was performed with air as the cover gas. High temperature combined with an oxygen cover gas obviously drove corrosion rates to a much higher value.

**Figure 1.** Stainless steel containment vessel, corroded (left) and uncorroded (right).

The primary containment vessel should be alumina that extends to the top of the secondary containment. Cooling at the top of the vessel will help mitigate creeping behavior of the salt into the gap between the stainless steel. Additionally, a nickel stainless steel, if not prohibitively expensive, should be used as the secondary vessel. Typically nickel steel has a corrosion rate that is about half of 316 stainless steel.

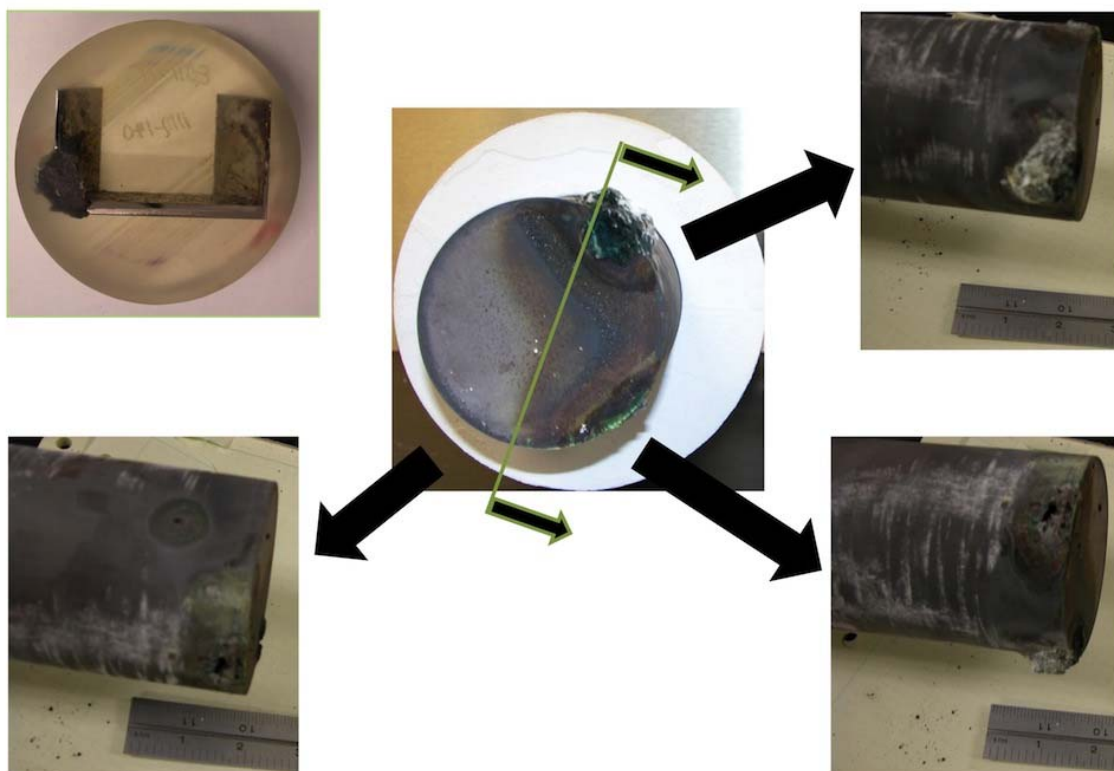
All data indicated that corrosion initiated internally and moved outward. There was no evidence of intergranular corrosion nor were there any indication of fast pathways along grain boundaries. Much of the pitting occurred near welds; however this was the hottest region in the chamber. Pitting was observed up to two inches above the weld, indicating independence from weld effects.

**Figure 2.** Images of corroded vessel, showing blister (top right), hole (bottom right), position of weld compared to hole (bottom left), and cross-section (top left).

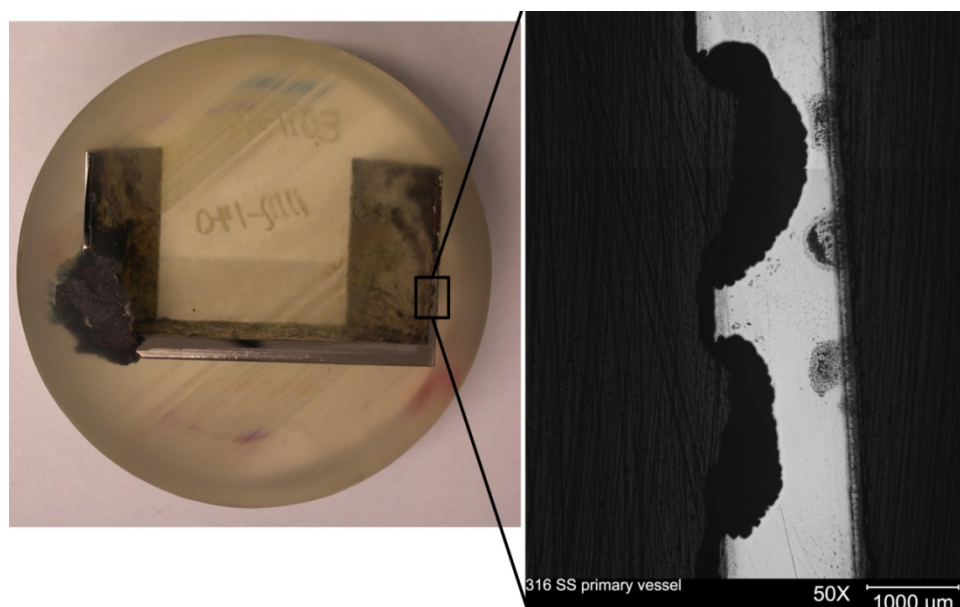
Corrosion resulted in the form of uniform pitting (Figures 3 and 4). Based on SEM and EDS data, pits contained primarily potassium oxide and potassium chromate, reinforcing the link between oxides and severe corrosion (Figure 6). In addition to the pitting corrosion, a large blister formed on the side wall, which was mainly composed of potassium, chromium and oxygen (Figure 7).

**Figure 3.** Cross-section of corroded vessel (left) and optical microscopy image of pitting corrosion in the vessel wall (right). A large blister can be seen on the left bottom corner of the cross-section.

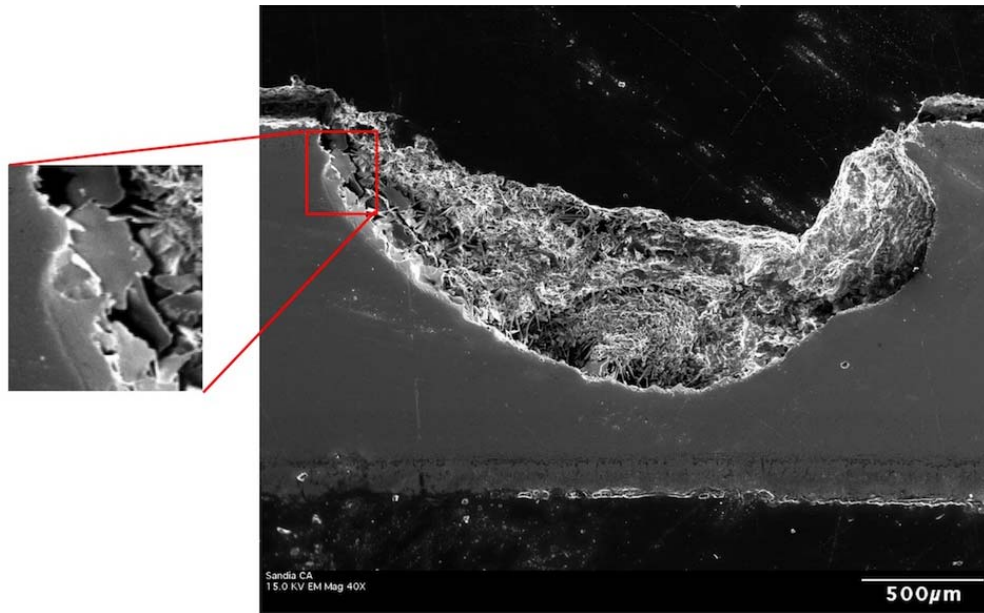
**Figure 4.** SEM image of corroded pit and close up of oxide formation on pit surface (left).

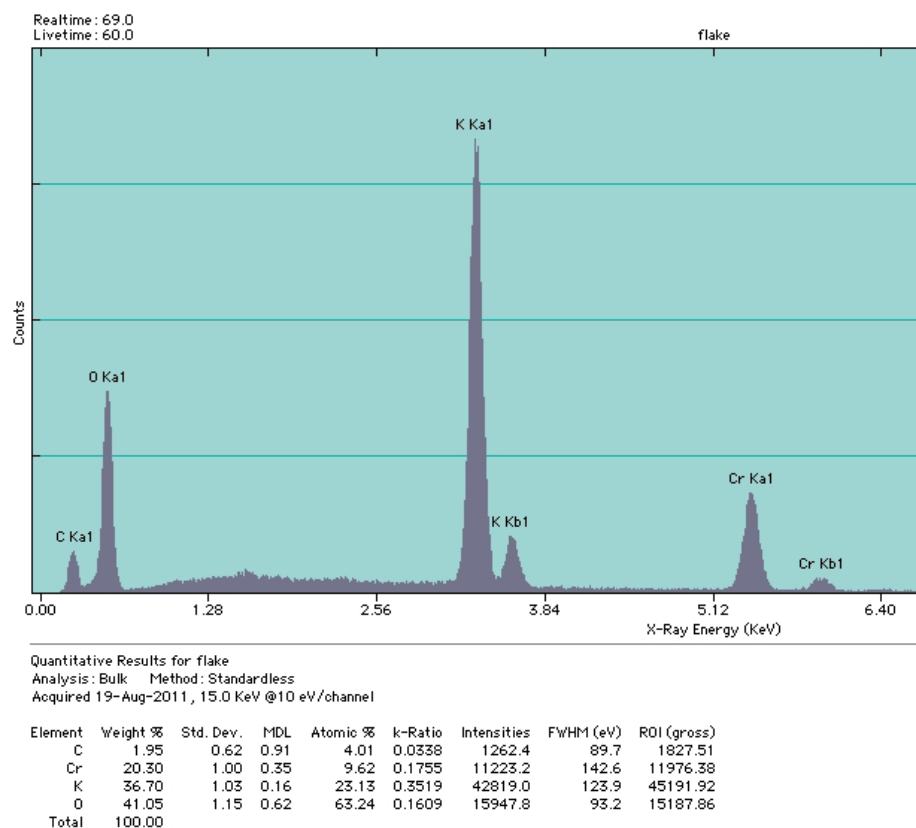
**Figure 6.** EDS analysis of oxide layer on corrosion pit.

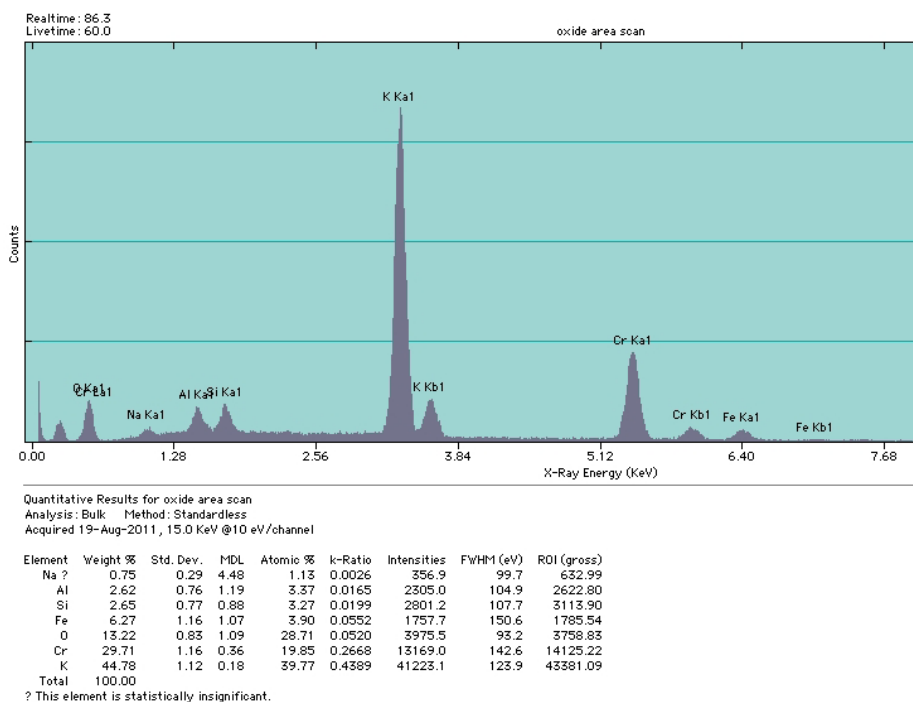
**Figure 7.** EDS analysis of blister formed on corroded stainless steel vessel.
