Light Water Reactor Sustainability Constellation Pilot Project FY13 Summary Report

R. Johansen

September 2013

**Idaho National Laboratory
Idaho Falls, Idaho 83415**

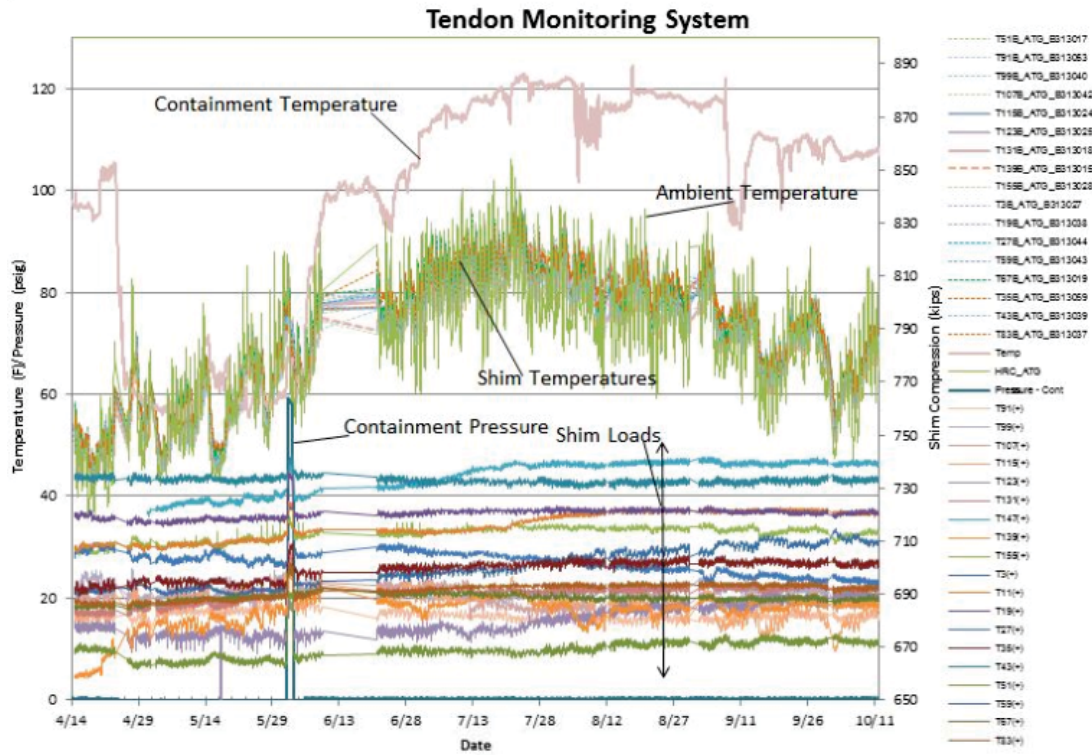
Figure 1. Tendon data from 4/14/11 to 10/12/11.

In FY10, twenty of the vertical tendons and one exposed circumferential rebar were outfitted with a fiber optic strain gauges (Figures 1 and 2) connected to a Data Acquisition System (DAS) to monitor temperature and strain of the containment wall and tendons. Tendon strain gage data has been collected except for the period from 4/14/11 to 10/12/11 and from 2/28/12 to 5/8/12. The data gap resulted from a power disruption which exceeded the capability of the UPS. The data indicates that the tendon load is not significantly affected by shim temperature since the lines are relatively flat except for the SIT (pressure test) performed in early June 2011.

The data from the tendon, rebar, and concrete strain gage instrumentation has been collected for the past 2-1/2 years and compared. Some gaps in data exist due to the system being off-line due to power interruptions. However, the response of the tendons and the concrete during the pressurization test was consistent with analyses that were performed. The change in tendon loads over a two year period showed that the tendon loads were fully acceptable at the end of the monitoring period. A small number of strain gages on tendons are not providing data that is consistent with the expected performance of the tendons. These gages should be monitored in the future with additional data to improve the understanding of their behavior.

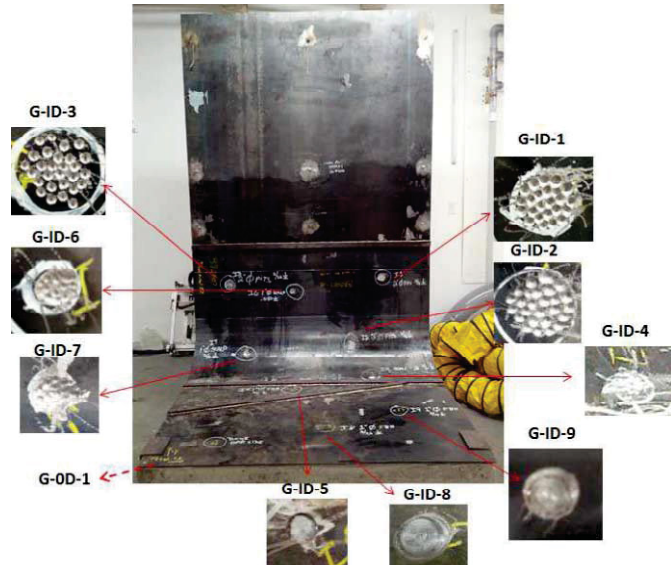
Figure 6. Flaws located in the Ginna containment mockup.

The liners were fabricated and tested without flaws prior to concrete placement. The flaws were introduced to simulate reproducible flaws representing corrosion. The flaws are located in both accessible and inaccessible regions. Figure 6 shows the flaws located in the Ginna containment structure. Once the concrete was cured testing resumed using Guided Wave and SAFT-UT method.

- Flaw detection possible in visually inaccessible areas of the mockups is possible. Simulated corrosion-type flaws as small as 2 inches in diameter could be detected at a distance of several feet.
- Flaw presence was more effectively detected using the guided wave system
- Flaw size determination was better using the SAFT. However, both systems were not adequate.
- The SAFT system was more effective on thicker components (NMP1 drywell shell mockup).

Based on the results additional work is necessary to refine the detection methods. Refer to Reference 4 for additional information.

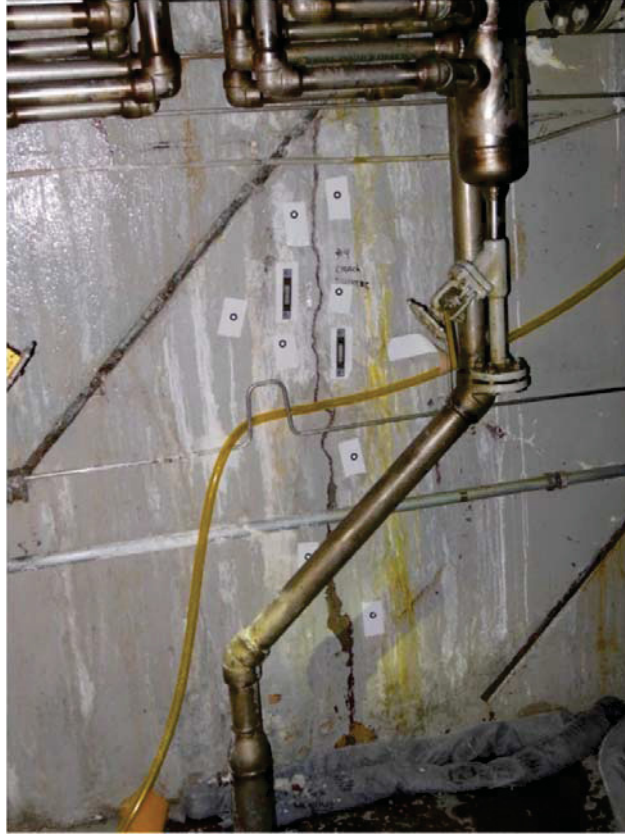
Figure 7. Example of crack monitoring.

Cracks were mapped at Ginna and NMP1 during the augmented inspections as part of the demonstration project. The mapping was performed a high resolution digital camera to map the extent and the width of the concrete crack along its length. High resolution photography allows for precise measurements of the crack widths and layout. Calibrated markings placed on the wall, in the form of bars and dots, are used in benchmarking and scaling dimensions from the high definition photographs. The technique involves taking several photos with varying lighting conditions. The photos are then digitally analyzed with specialized computer software to produce a precise layout of the crack widths along the crack. An example of map cracking is shown in Figure 7. See Reference 3 for additional information.
