**Pacific Northwest  
National Laboratory**

**Ultrasonic Examination of  
Double-Shell Tank 241-AN-105  
Examination Completed  
September 2002**

AF Pardini  
GJ Posakony

January 2003

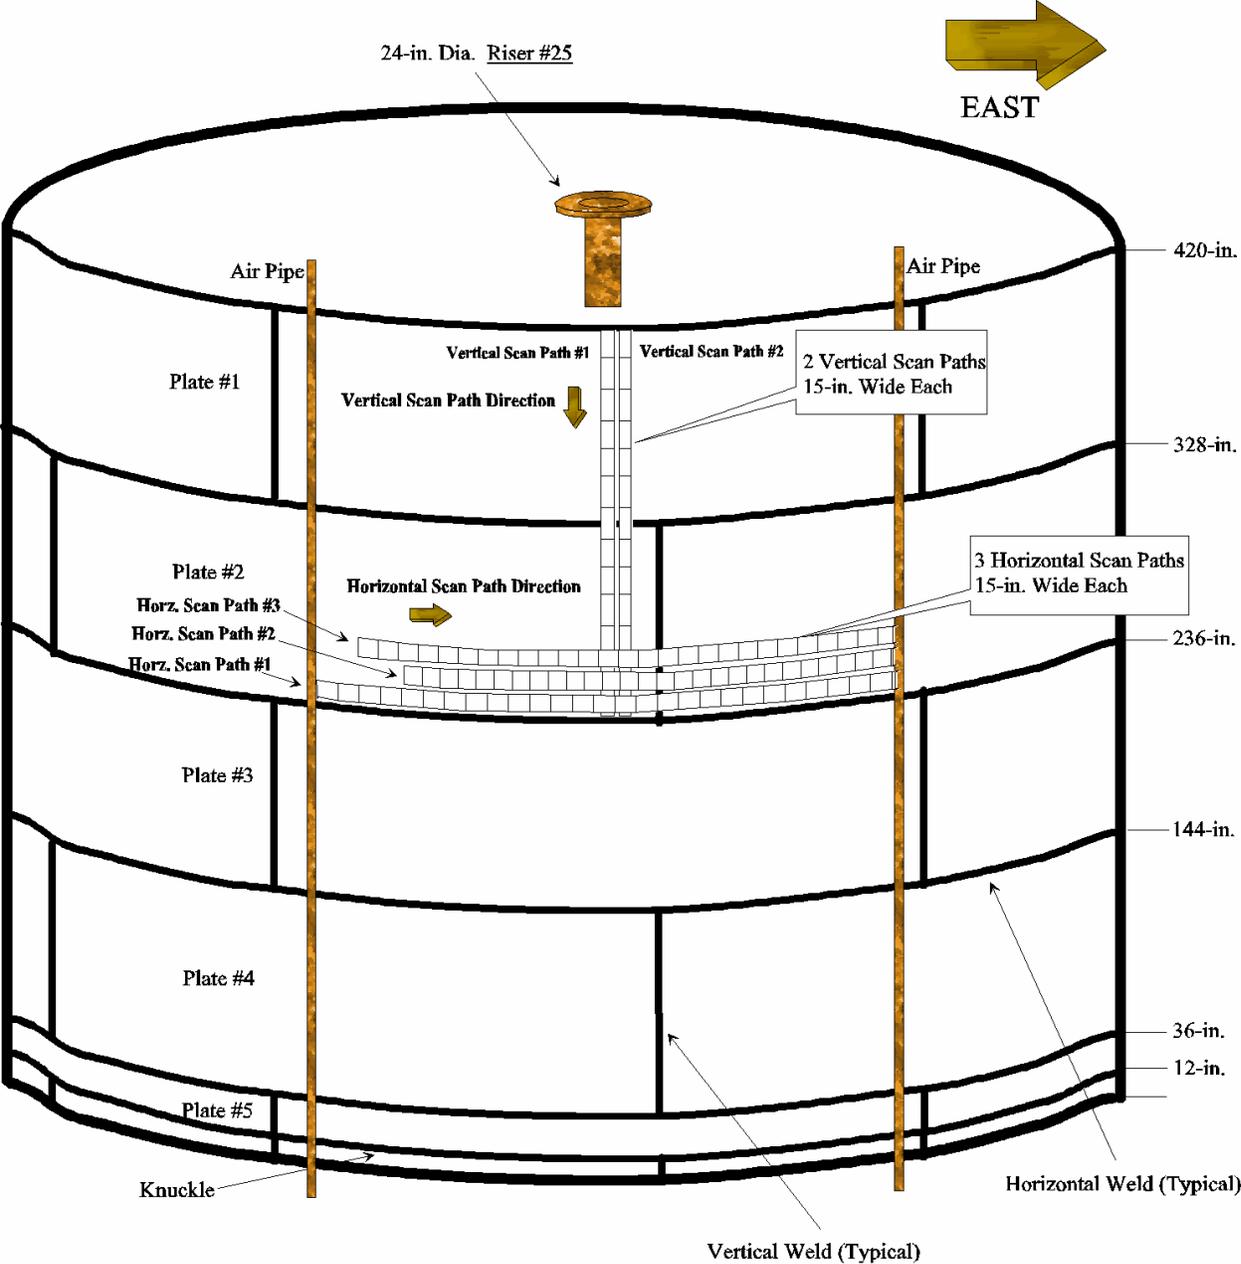
Figure 4.2. Sketch of Vertical and Circumferential Scan Paths on Tank 241-AN-105

Figure 4.2 describes the areas on the primary wall of Tank 241-AN-105 that were ultrasonically examined. Two 15-in.-wide vertical scan paths were performed on Plates #1 and #2 below the entrance to Riser 25. Three additional horizontal scan paths were performed near the lower section of plate #2.
