**Pacific Northwest
National Laboratory**

Ultrasonic Examination of Double-Shell Tank 241-AN-105 Examination Completed September 2002

AF Pardini
GJ Posakony

January 2003

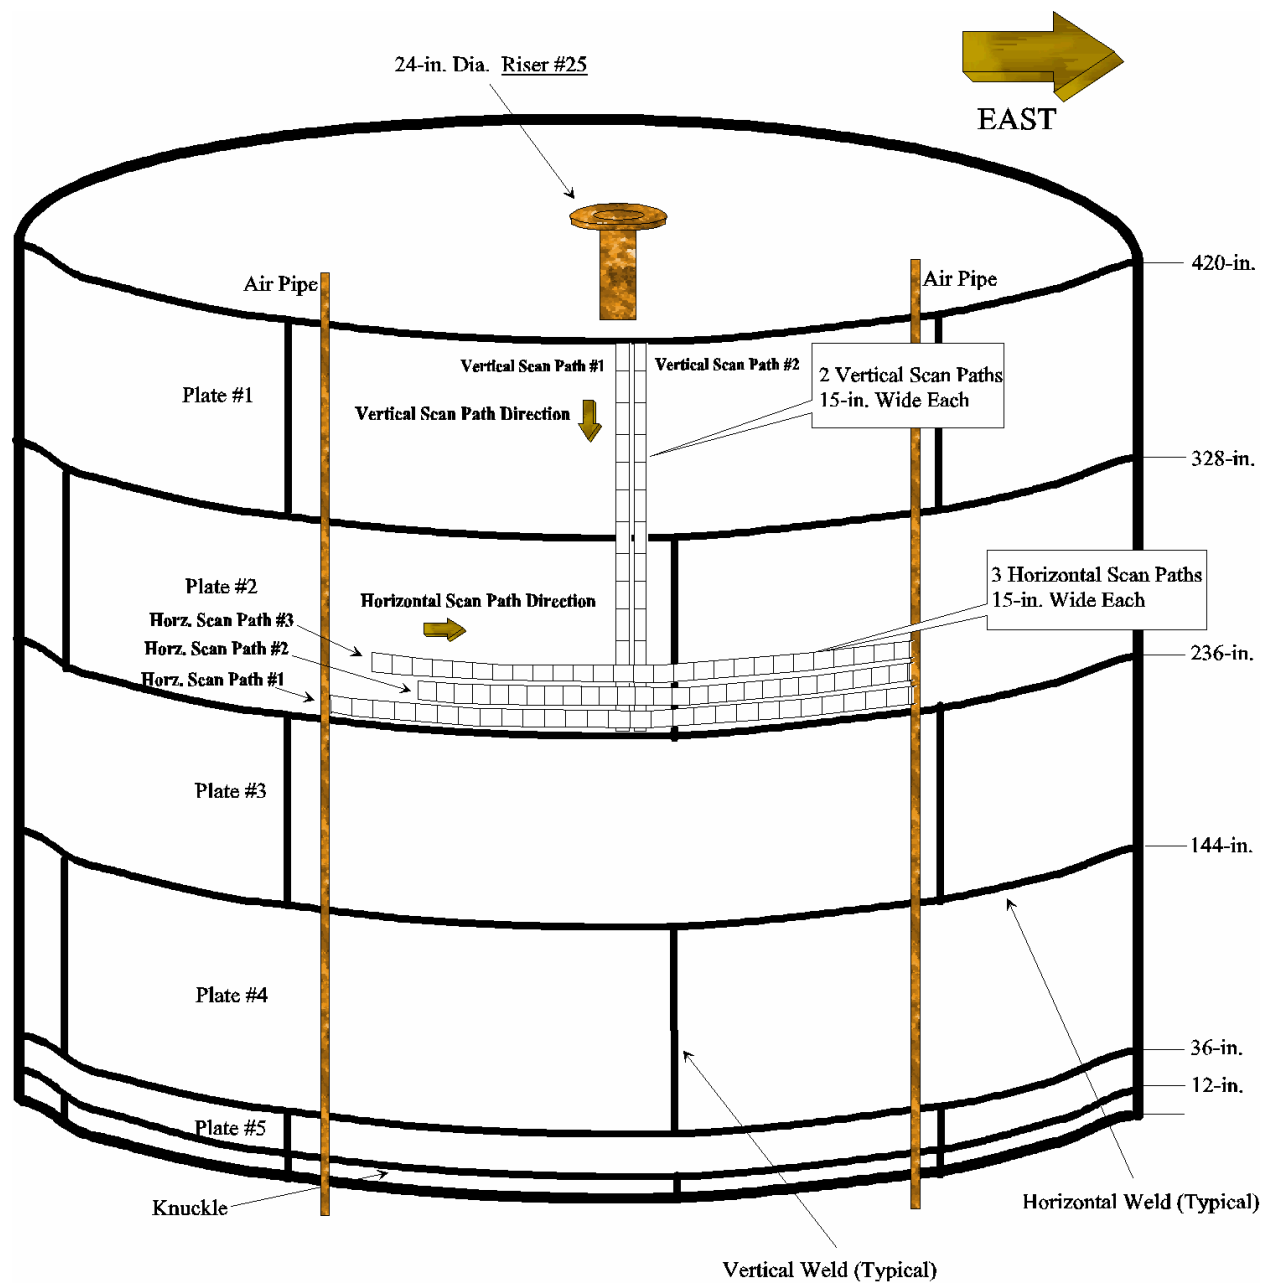
Figure 4.2. Sketch of Vertical and Circumferential Scan Paths on Tank 241-AN-105

Figure 4.2 describes the areas on the primary wall of Tank 241-AN-105 that were ultrasonically examined. Two 15-in.-wide vertical scan paths were performed on Plates #1 and #2 below the entrance to Riser 25. Three additional horizontal scan paths were performed near the lower section of plate #2.

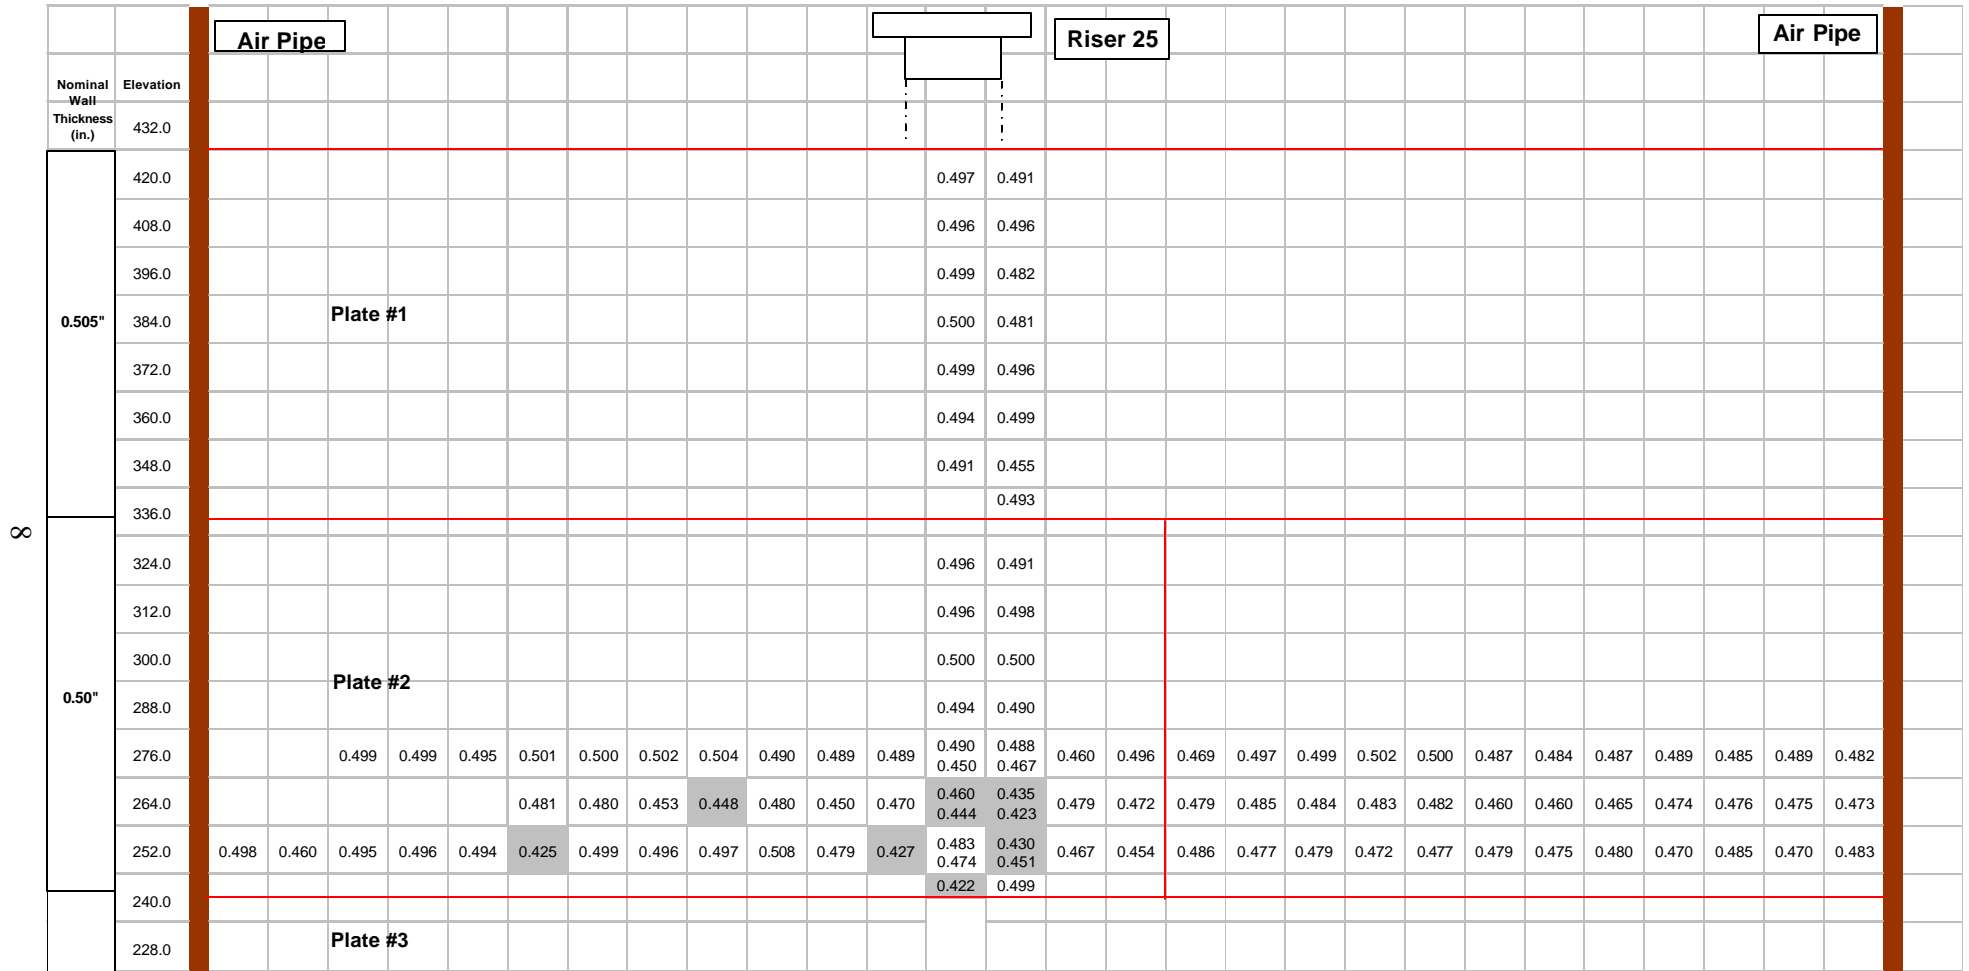
Figure 5.1. UT Data from Tank 241-AN-105

COGEMA has provided detailed reports including T-Scan and P-Scan hard copies of all areas that were ultrasonically examined to PNNL for third-party review. The data was analyzed by COGEMA Level III Mr. Wes Nelson and peer reviewed by JBNDT Level III Mr. Jim Elder. The results of the examination of Tank 241-AN-105 are presented in Figure 5.1.

Figure 5.1 shows that the examination consisted of two vertical and three horizontal scan paths beneath the 24-in. diameter riser. Vertical scan #1 was 15-in. wide on Plates #1 and #2 and was directly below the 24-in riser. Vertical scan #2 was adjacent to vertical scan #1 and was also 15-in. wide on Plates #1 and #2. Three horizontal scan paths, 15-in. wide, were completed on the lower section of Plate #2 and basically extended between the two vertical air pipes. Due to poor visibility with the camera overview, the starting points of each of the three scan paths were different. Areas that show two measurements are the result of the vertical scan paths overlapping the horizontal scan paths. Figure 5.1 displays the minimum reading taken in each 15-in. wide by 12-in. long portion of the scan. In the overlapping areas, both minimum readings from each of vertical and horizontal scan paths are given.

Pit-like indications were observed in the shaded areas of Figure 5.1. There were eight pit-like indications that exceeded the 10% wall thinning criteria. However, none of these pit-like indications exceeded the pitting criteria of 25% of nominal plate thickness and are therefore not reportable.

Examination for cracks oriented vertically was performed during the two vertical scan paths in Plates #1 and #2. No vertical crack-like indications were noted.

Examination for cracks oriented circumferentially was performed during the three horizontal scan paths in Plate #2. No circumferential crack-like indications were noted.
