Washington Phase II Fish Diversion Screen Evaluations in the Yakima River Basin

Annual Report 2000

March 2001

DOE/BP-00000652-3

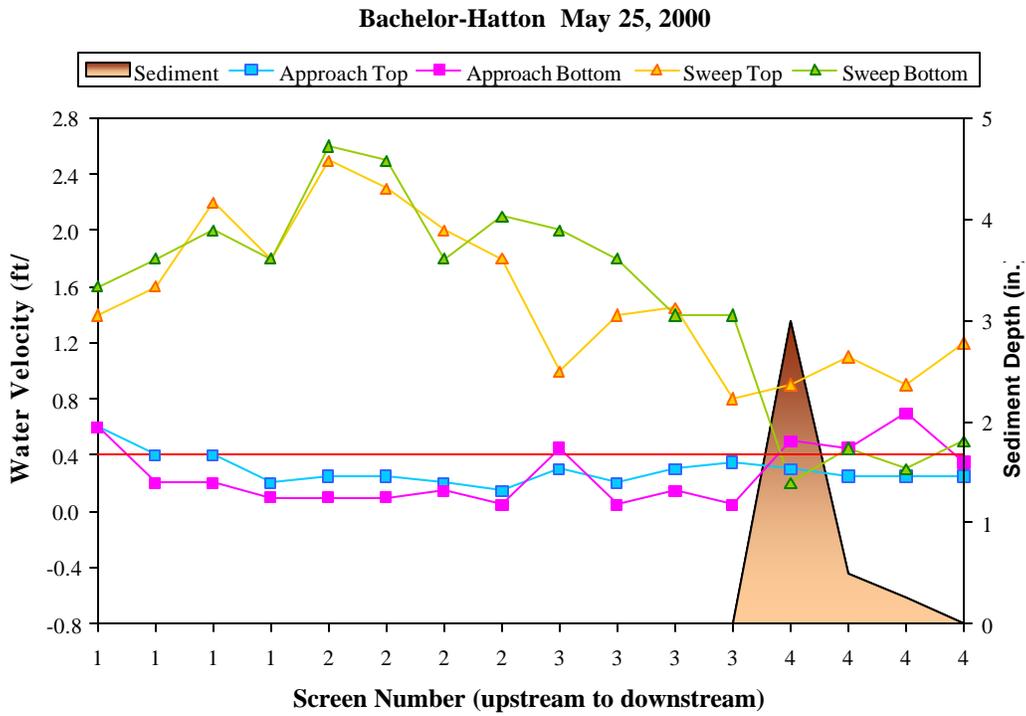
The gap noted last year between the seal and the bottom of screen 2 was still present in 2000. A video survey could not be performed in June. Water was no longer running through the facility by July 25 when we went out to perform a video survey. Videotape of the site in September showed one of the bolts holding the bottom seal in place at screen 3 had broken off. This could potentially allow the seal to move away from the drum in that spot. Screen submergence was above NMFS criteria in May, with approximately 90% submergence, and within the criteria in June with 71% submergence.

Figure 4. Water Velocities and Sediment Depths at Bachelor-Hatton, 5/25/00

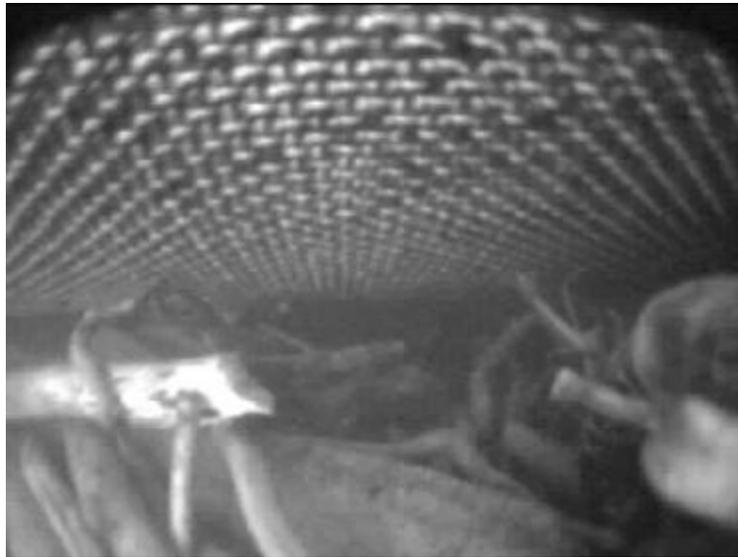
Sediments were only 3 in. or so deep near the screens, but there was still a fair amount of twigs and debris that accumulated in front of the seals and in the bypass (Figure 6). There was up to 6 inches of sediment accumulation in the bypass as well. The accumulation of sediment in the bypass may indicate bypass velocities were not fast enough to flush the sediment through, or there was too much debris to allow proper flow. Bypass outfall conditions were good for fish passage in May and marginal in June. There is a small pool immediately in front of the outfall, and when the river level is high, fish coming out of the bypass can easily move into the river. However, when the river level is low, as in June, there is a ridge of gravel between the main channel and the outfall pool that is covered by only a couple of inches of water, making passage into the main channel more difficult. If possible, a deeper channel should be created to allow fish easier access to the main channel of the river, even during lower river levels.

Figure 6. Woody Debris in Front of the Bottom Seal of Screen Number 1 at Bachelor-Hatton on 5/25/00

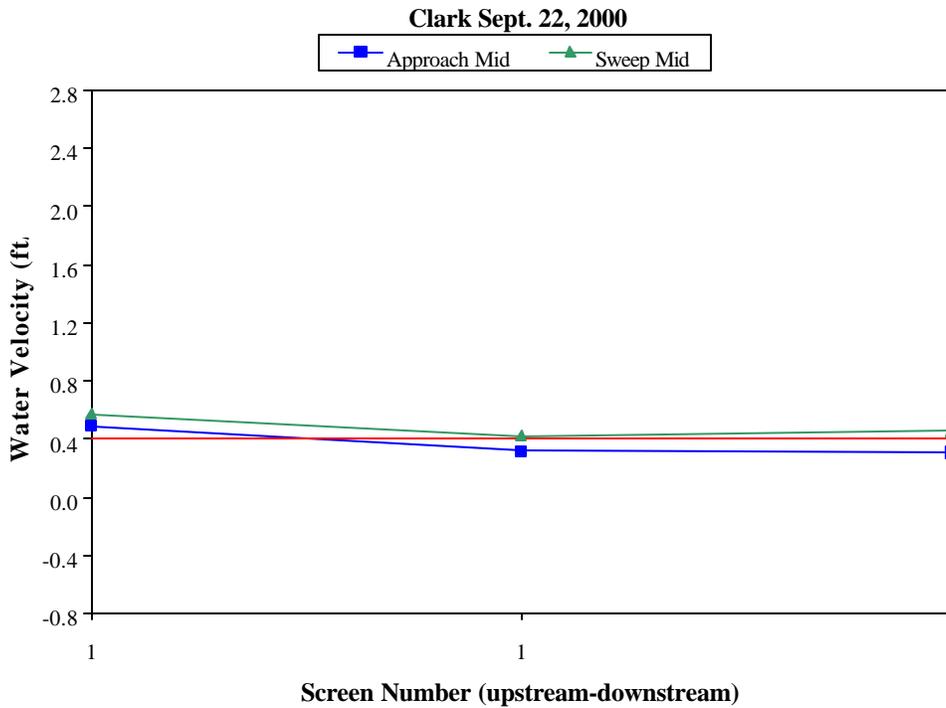
Electrical interference prevented the collection of velocity measurements with the Marsh-McBirney probe during the first two surveys. The Sontek ADV is not affected by electrical interference, and flow was measured using the ADV in September. During that survey, sweep was greater than approach, but did not increase toward the bypass. Mean approach was less than 0.4 ft/s. Screen submergence was above the NMFS criteria of 85% in May, but was within criteria in June and September. The single drum screen operates off a paddle wheel and rotates very slowly. The site logbook noted on 8/15/00 there was not enough flow to run the paddle wheel.

Figure 7. Water Velocities at the Clark Site, 9/22/00

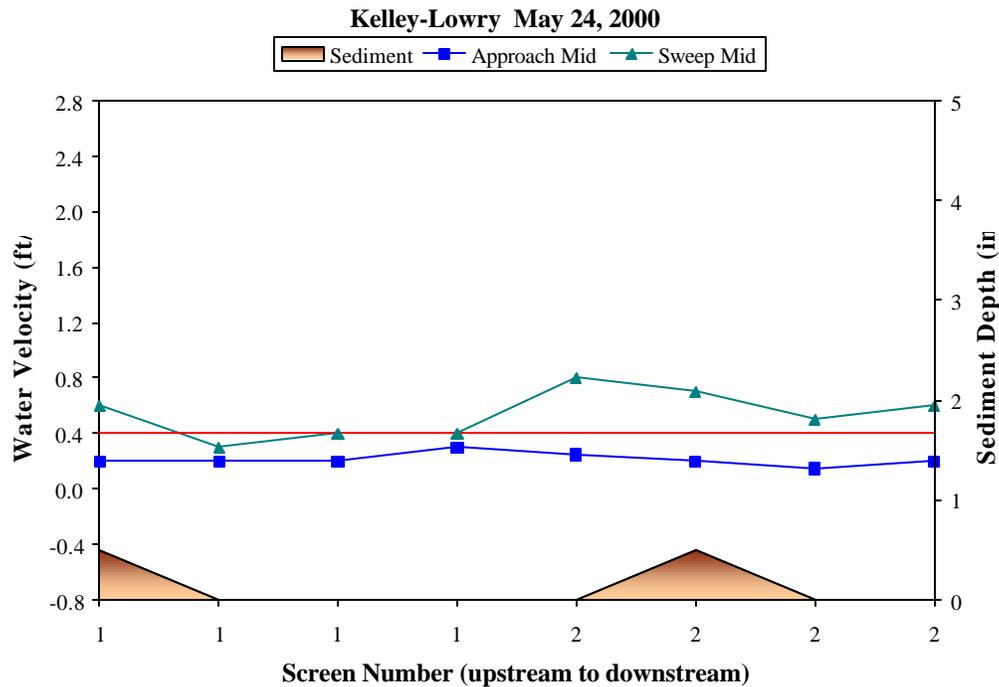
The trashrack often had a lot of sticks and garbage accumulated and did not appear to be cleaned regularly in-season, and this caused up to 6 in. of headloss across the trashrack in June. The amount of debris and sediment in the forebay in 2000 was much less than in 1999, but still covered the bottom seals in places.

Figure 13. Water Velocities and Sediment Depths at the Kelly-Lowry Site, 5/24/00

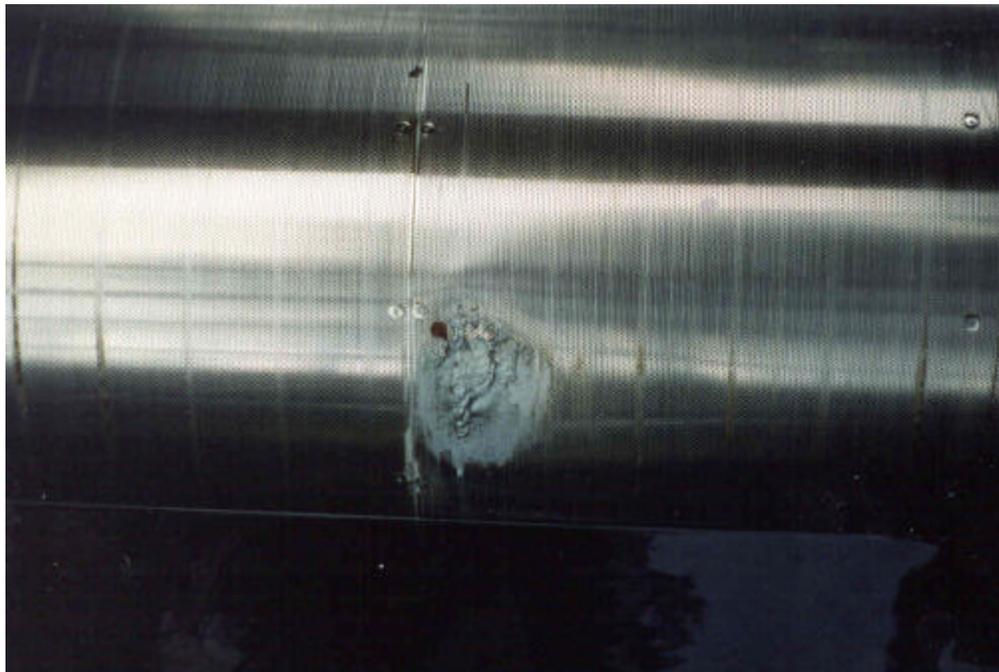
The side seals were in good condition, and the screen always rotated evenly. A small gap between the bottom seal and drum was noticed in June. A note in the logbook indicated a dent in the right side of the screen had been filled on 9/1/00 (Figure 18). Water ran freely behind the bypass weir. Levels of silt and woody debris were not a problem, though there were some leaves and sticks in the forebay. The bypass was operating effectively and discharged into water over 1 ft deep. One small fish of unknown species was noted in the forebay in September.

Figure 18. Photograph of Patched Screen at Lindsey, 9/18/00

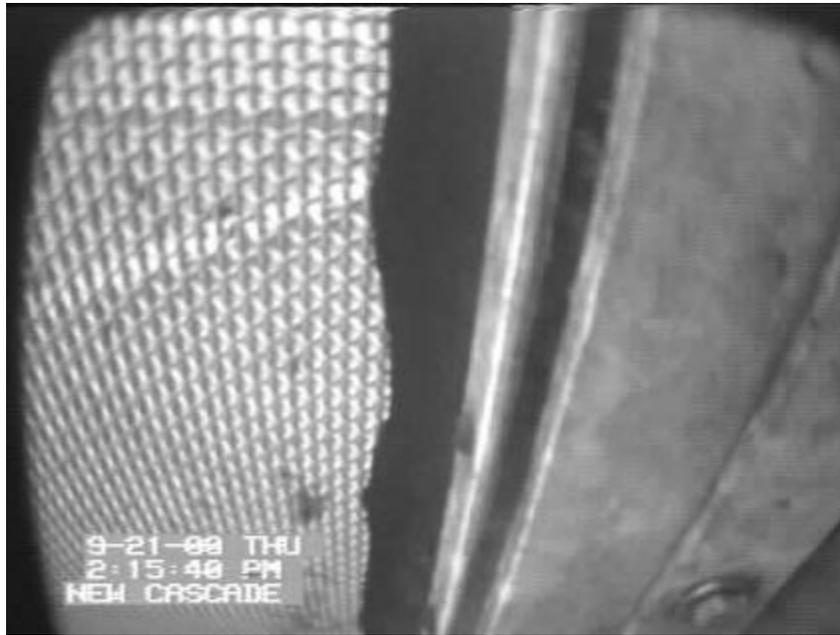
Figure 26. Notched Side Seal on Screen 8 at the New Cascade Site, 9/21/00

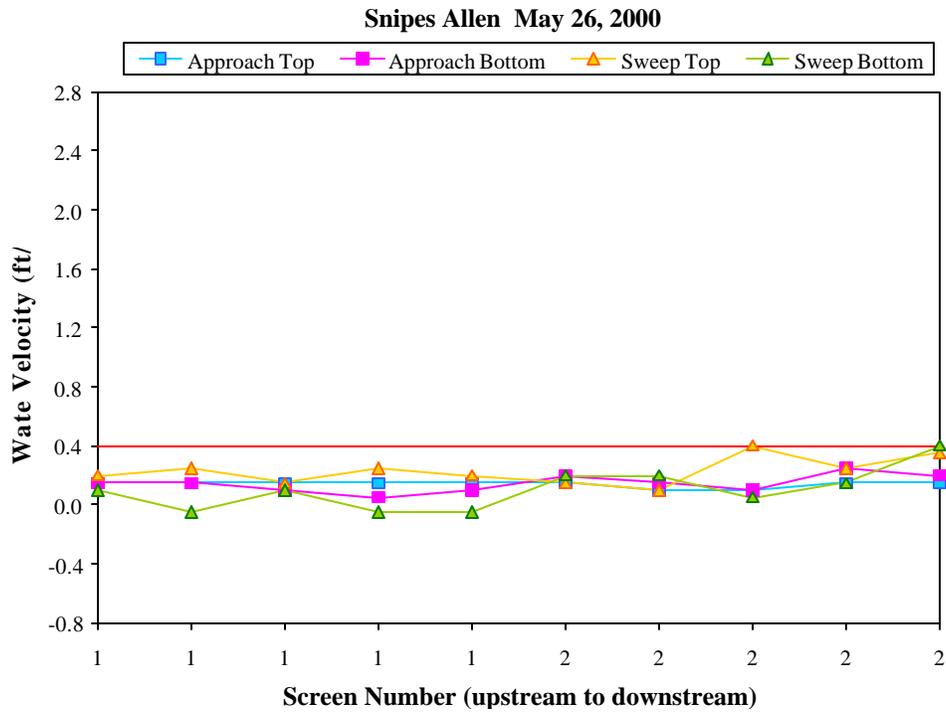
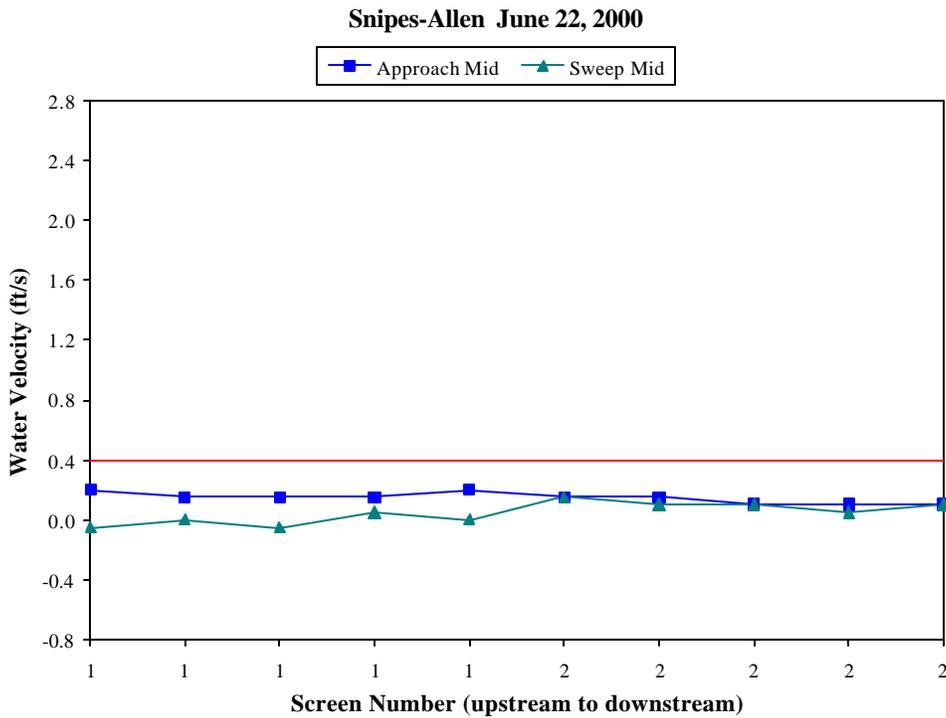
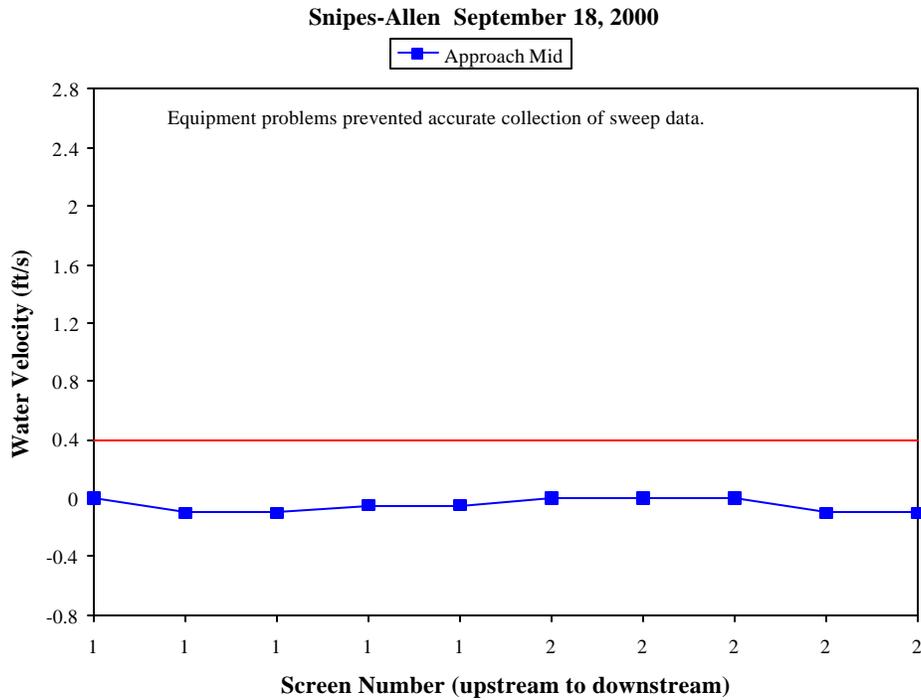
The Snipes-Allen site was evaluated 5/26/00, 6/22/00, and 9/18/00. Approach velocities recorded in May and June were below 0.4 ft/s (Figures 27, 28, and 29). In June, maintenance crews stopped flow over the weir and through the bypass because the outfall pipe had been vandalized with logs and rocks plugging up the outlet. The drum screens were still turning, and apparently water was still moving into the canal (Figure 28) until the outfall was repaired on June 23. We measured water velocities (Figure 28) but they were not representative of typical conditions. Sweep velocities were slightly higher in May and slightly lower in June than their corresponding mean approach velocities. Sweep did not tend to increase near the bypass, although the bypass velocity was higher than the sweep velocity in May. Equipment problems prevented accurate measurement of sweep and possibly approach velocities in September.
