Annual Radioactive Waste Tank Inspection Program - 2002^(U)

Westinghouse Savannah River Company
Savannah River Site
Aiken, SC 29808

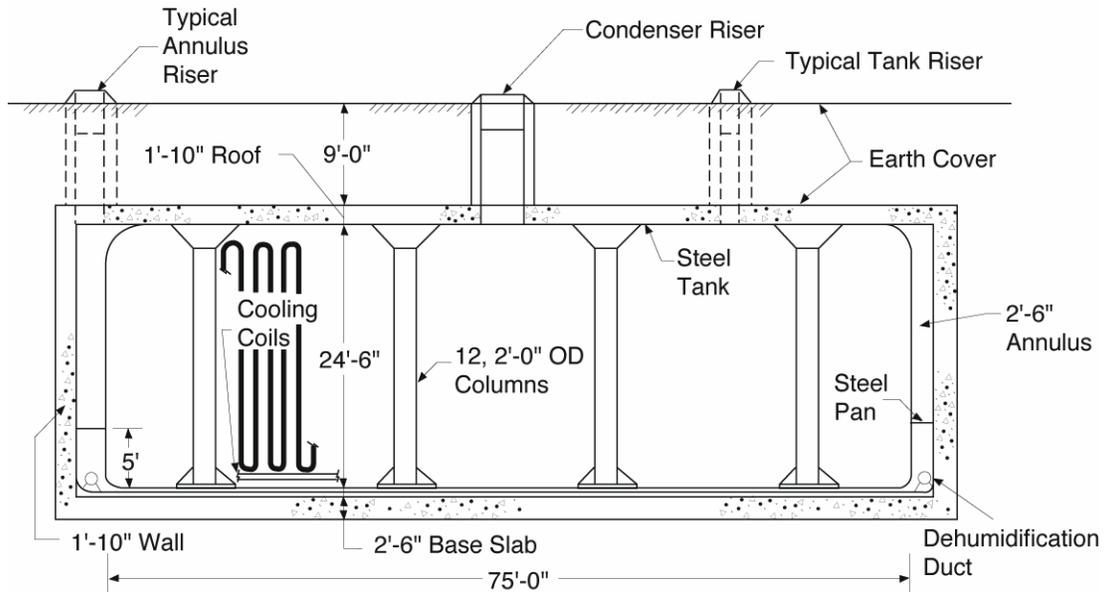
Figure 1. Cooled Waste Storage Tank, Type I (Original 750,000 Gallons)

The primary container is a closed cylindrical tank with flat top and bottom constructed from 1/2-inch-thick steel plates. The top and bottom are joined to the cylindrical sidewall by curved knuckle plates. The primary tank is set within a circular pan of 1/2-inch-thick steel plates. The annulus pan is 5 feet deep and 5 feet larger in diameter than the primary tank, thus forming an annular space 2 1/2 feet wide. The tank and pan are set on a 30-inch-thick base slab and are enclosed by a cylindrical 22-inch-thick reinforced concrete wall and a flat concrete roof, also 22 inches thick. There are twelve 2-foot-diameter concrete columns within the primary tank to support the roof. Each column has a flared capital and is encased in 1/2-inch-thick steel plate.

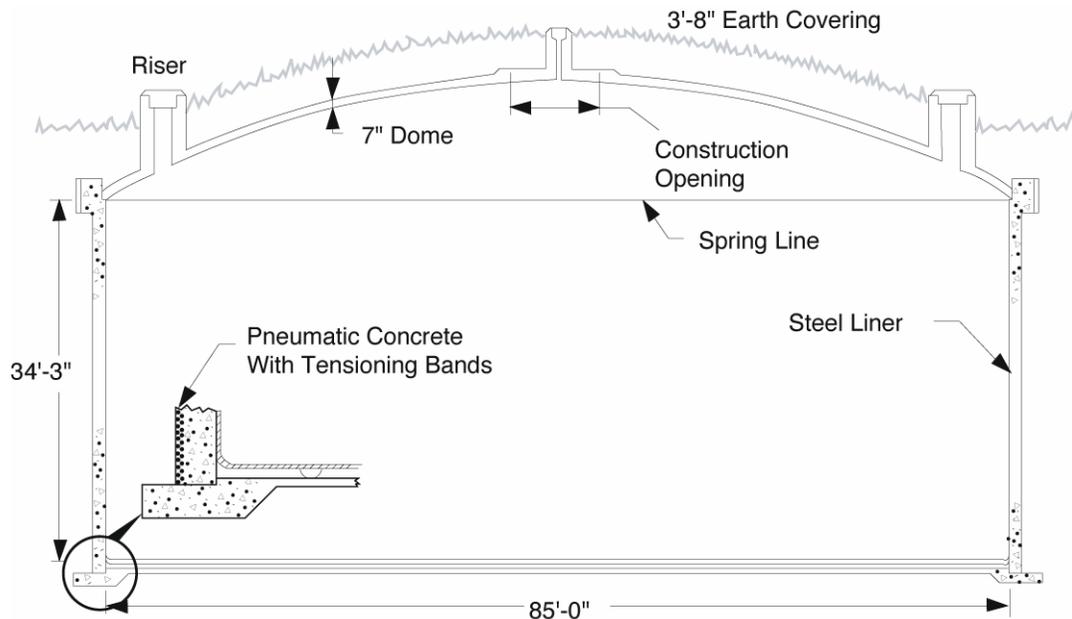
Figure 3. Uncooled Waste Storage Tank, Type IV (Prestressed Concrete Walls, 1,300,000 Gallons)

Each Type IV tank is basically a steel-lined, prestressed-concrete tank in the form of a vertical cylinder with a domed roof. Carbon steel plates, 3/8 inch thick, were used to form the cylindrical sides and flat bottom portion of the steel liners. The knuckle plates at the junction of the bottom and the sidewall are 7/16 inch thick. Concrete was built up around the steel vessel by the "shotcrete" technique.
