WSRC-TR-2003-00426
Revision 0

DWPF AIR LIFT PUMP LIFE CYCLE EVALUATION (U)

DWPF Air Lift Pump Life Cycle Evaluation (U)

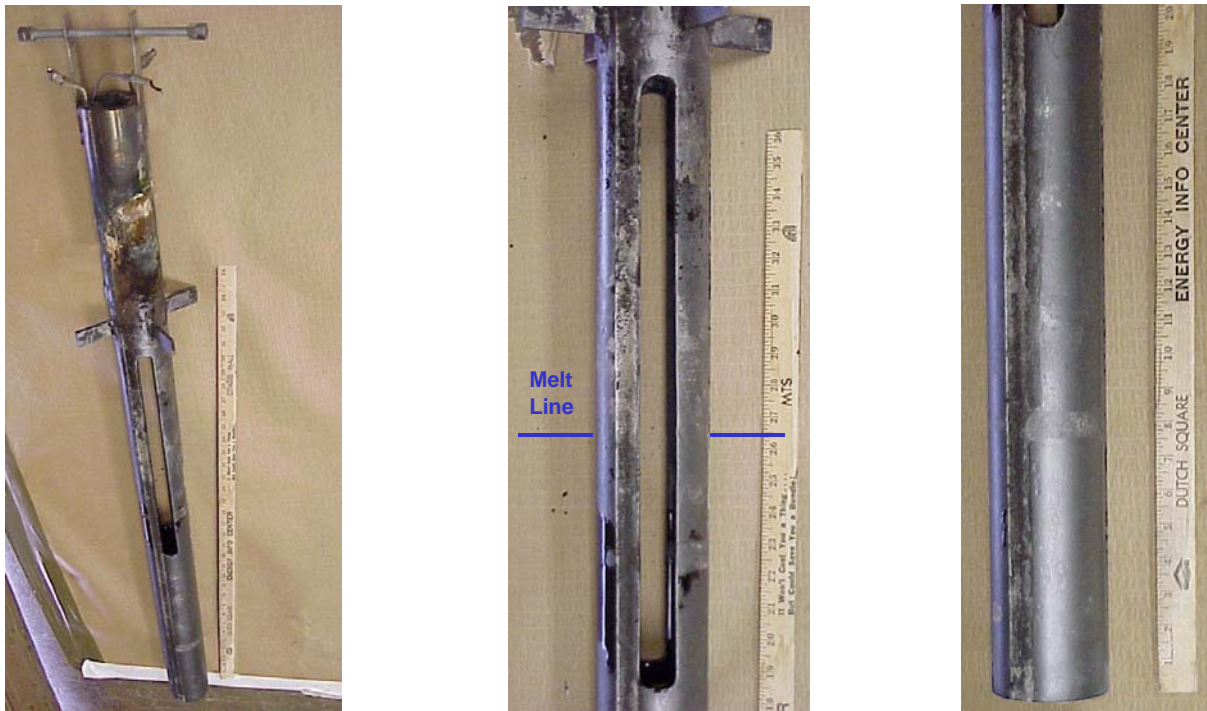
Visual examination of the 690 pump was performed and did not reveal any areas of significant degradation, i.e. corrosion or erosion. All edges appeared sharp and no material loss was noted in the high glass flow regions or at the melt air interface. Photographs of the pump are shown in

Figure 3. Photographs of the airlift pump after testing. Only etching of welds and slight melt line attack were observed.

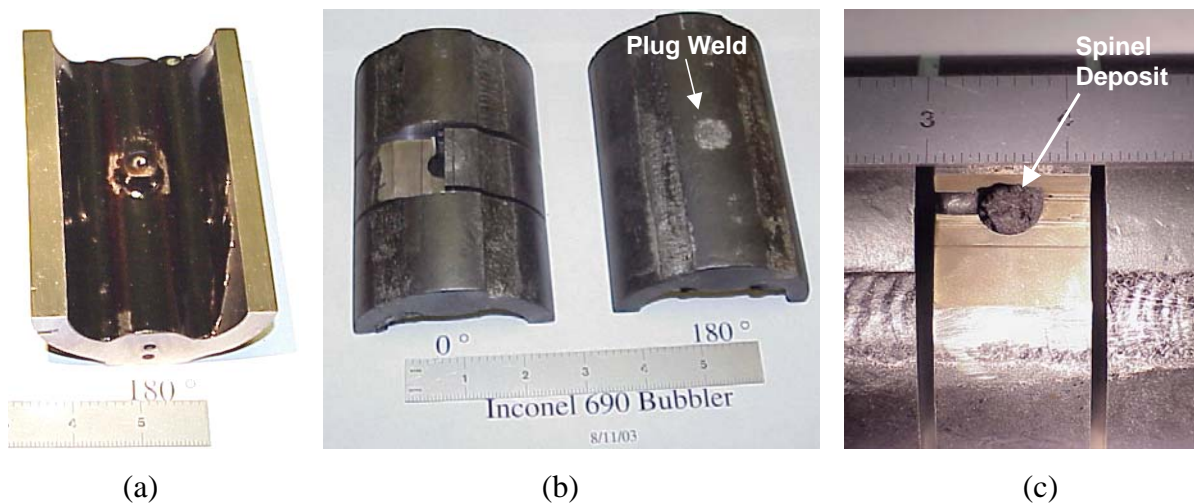
After completing the UT and visual examinations, the lower portion of the pump was cut off approximately 3 inches above the nozzles. This segment was then cut longitudinally between the nozzles (Figure 4). The halves were further sectioned approximately 0.5" above and below the nozzles exposing the air supply passage. The air supply on the side labeled 180 ° was completely blocked with glass. This probably resulted when the air supply from this side was cut off during removal from the molten glass. The other air supply passage from the side labeled 0 ° was free of any glass or other obstructions, i.e. oxide build up. Glass was fractured on the platinum nozzles using a vibra tool with light pressure. The pump segments containing the nozzles were then placed in boiling sodium hydroxide over the weekend to facilitate glass removal. Visual examination of the nozzles confirmed that no significant degradation had occurred. Shoulders used to screw the platinum nozzle into the 690 tube were distinct. Some minor roughening of the platinum had occurred.

Figure 4. Photographs showing sectioning of the lower half of the pump. a) Thick coating of glass on inner diameter, b) Outer diameter showing longitudinal and seal welds, and c) Spinel deposit at inlet of nozzle.

Spinel formation was noted at the inlet of each nozzle. The deposits were large enough to completely cover the air passage at the inlet of the nozzle. Although the deposits were extensive, they were porous and did not impede the air flow for the duration of the test. The propensity of the glass to form various spinel phases during the test at Clemson may have been increased because the melter pot was made entirely from 690. Even minimal corrosion of the 690 in this system may have increased the concentration of transition metals in the glass because of the large surface (690) to volume (glass) ratio. However, to minimize spinel formation during the operation of the DWPF production air lift pump, argon should be used rather than air to minimize oxidation of the 690 air passage. Disruptions in gas flow should also be avoided in order to minimize glass intrusion into the air passage. These operational controls should minimize the formation of spinel deposit and extend the life of the pump. The use of platinum or a platinum/rhodium alloy to line the air passage and as a nozzle should be further investigated in order to extend the operational life of the production pump.

- Argon gas should be used with the Inconel 690 pump to minimize oxidation and possible spinel formation.
- Recommendations for pump insertion, operation, and performance are as follows:

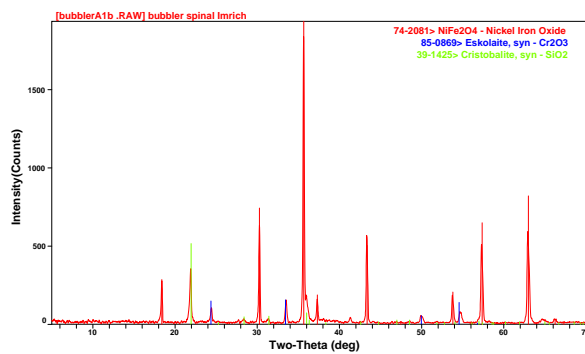
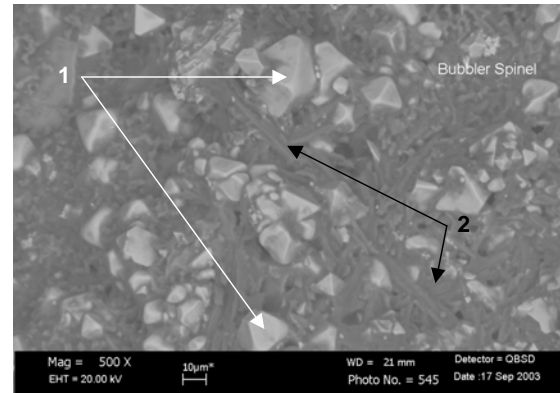
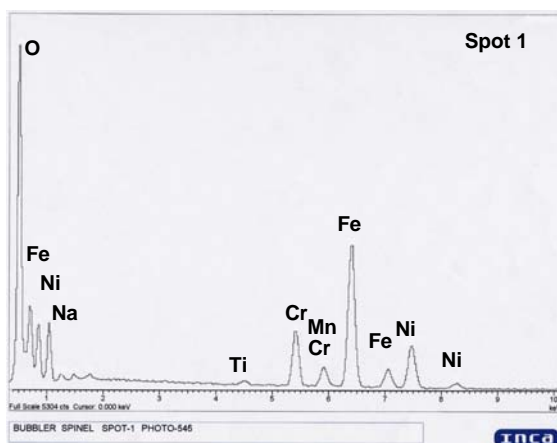
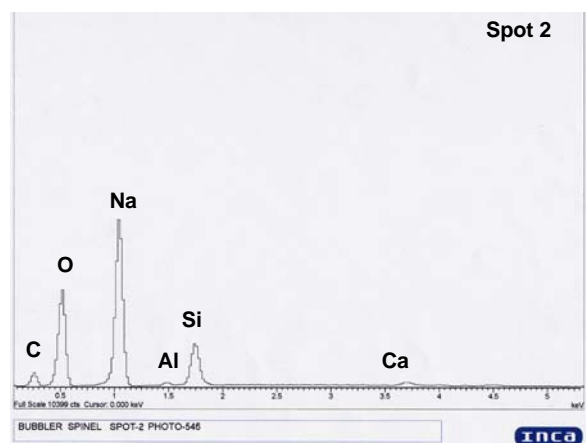
Figure 5. Analysis of deposit at inlet of the platinum nozzle. a) XRD spectrum of spinel deposit, b) SEM photograph of spinel deposit, c) EDS spectrum of spinel crystal, and d) EDS spectrum of a second phase in the deposit.

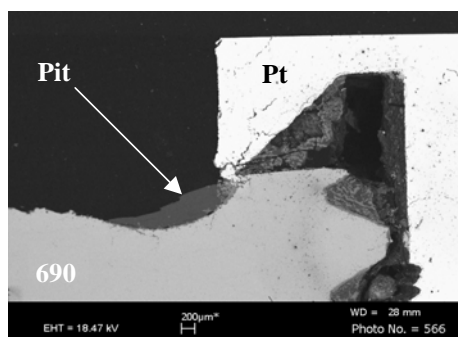
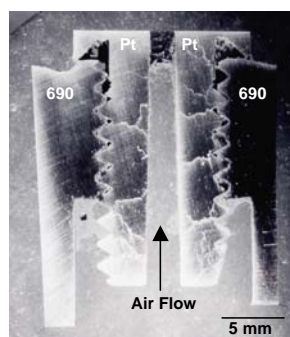
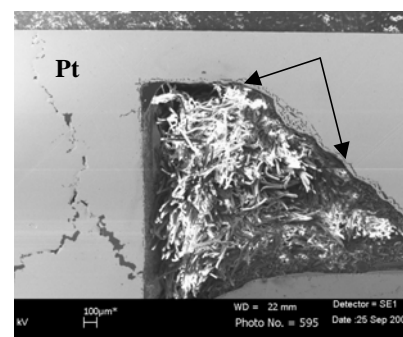
During metallographic preparation of the nozzle it became apparent that it had numerous cracks. Most were radially oriented between the threads to the air passageway but some were observed parallel to machined surfaces (Figure 6). Both the platinum and 690 threads showed evidence of degradation. A large pit was also observed in the 690 adjacent to glass sealing surface between the housing and the nozzle. This was observed on both nozzles. A thick chromium oxide layer had developed on the threads indicating that oxidation of the 690 had occurred (Figure 7). Glass was found in all of the radial cracks, however; it was depleted in iron. Small particles of chromium oxide were also found deep within the cracks. It most likely originated from oxidation of chromium in the 690 and was carried into the cracks by the molten glass. Microstructural examination revealed intergranular cracking of the platinum with cracks running generally in a

Figure 6. Photographs of Pt nozzle and Inconel 690 housing. a) SEM photograph of pit adjacent to Pt nozzle, b) As-ground metallurgical specimen showing numerous radial cracks in the platinum, and c) SEM photograph showing cracking parallel to machined surface (arrows).

Severe intergranular cracking of the platinum/rhodium alloy had occurred. Several possibilities exist but the actual cause could not be conclusively determined. One possible explanation is that the melting practice and starting material may have embrittled the alloy. The starting material was old discarded crucibles, which were cleaned prior to processing, and were melted in an induction furnace using a graphite crucible as a susceptor. The reducing environment inside the crucible along with impurities in the crucibles may have reduced the contaminants and embrittled the alloy. Although this is plausible, no mention of cracking or unusual machining characteristics were observed during fabrication of the nozzles. A second explanation is that an interaction with the molten glass had occurred resulting in the observed intergranular attack. The pitting attack of 690 observed in the contact region between the Pt nozzle and the 690 housing most likely resulted from a galvanic attack (Figure 6a). Considering a galvanic couple between 690 and platinum, 690 would be more anodic and would therefore be expected to corrode preferentially. This galvanic interaction may have played a role in the initiation of the cracks. As-cast material was not saved; therefore, a direct comparison with the starting material was not performed. Generally the cracks were oriented in a radial direction which was perpendicular to the direction of the tensile force as the nozzle engaged the pump to form the glass seal. Cracks were also located around the nozzle outlet. This region should have been unaffected by the tightening of the threads, and therefore, in a low state of stress. It is possible that the peening operation may have induced some stress in this area but no gross deformation was visible. This may suggest that the applied stress did not play a significant role in the cracking of the nozzle and that chemical attack was the most likely cause. Further investigation

- Platinum or a platinum alloy should not be used on the production pump until the degradation mechanisms are fully understood. Immersion tests should be performed to evaluate the cause of the intergranular cracking, the extent of the galvanic potential between platinum and 690 under these conditions, and to optimize the design in order to increase performance and extend the pumps service life. The use of grain stabilized alloys should also be investigated.

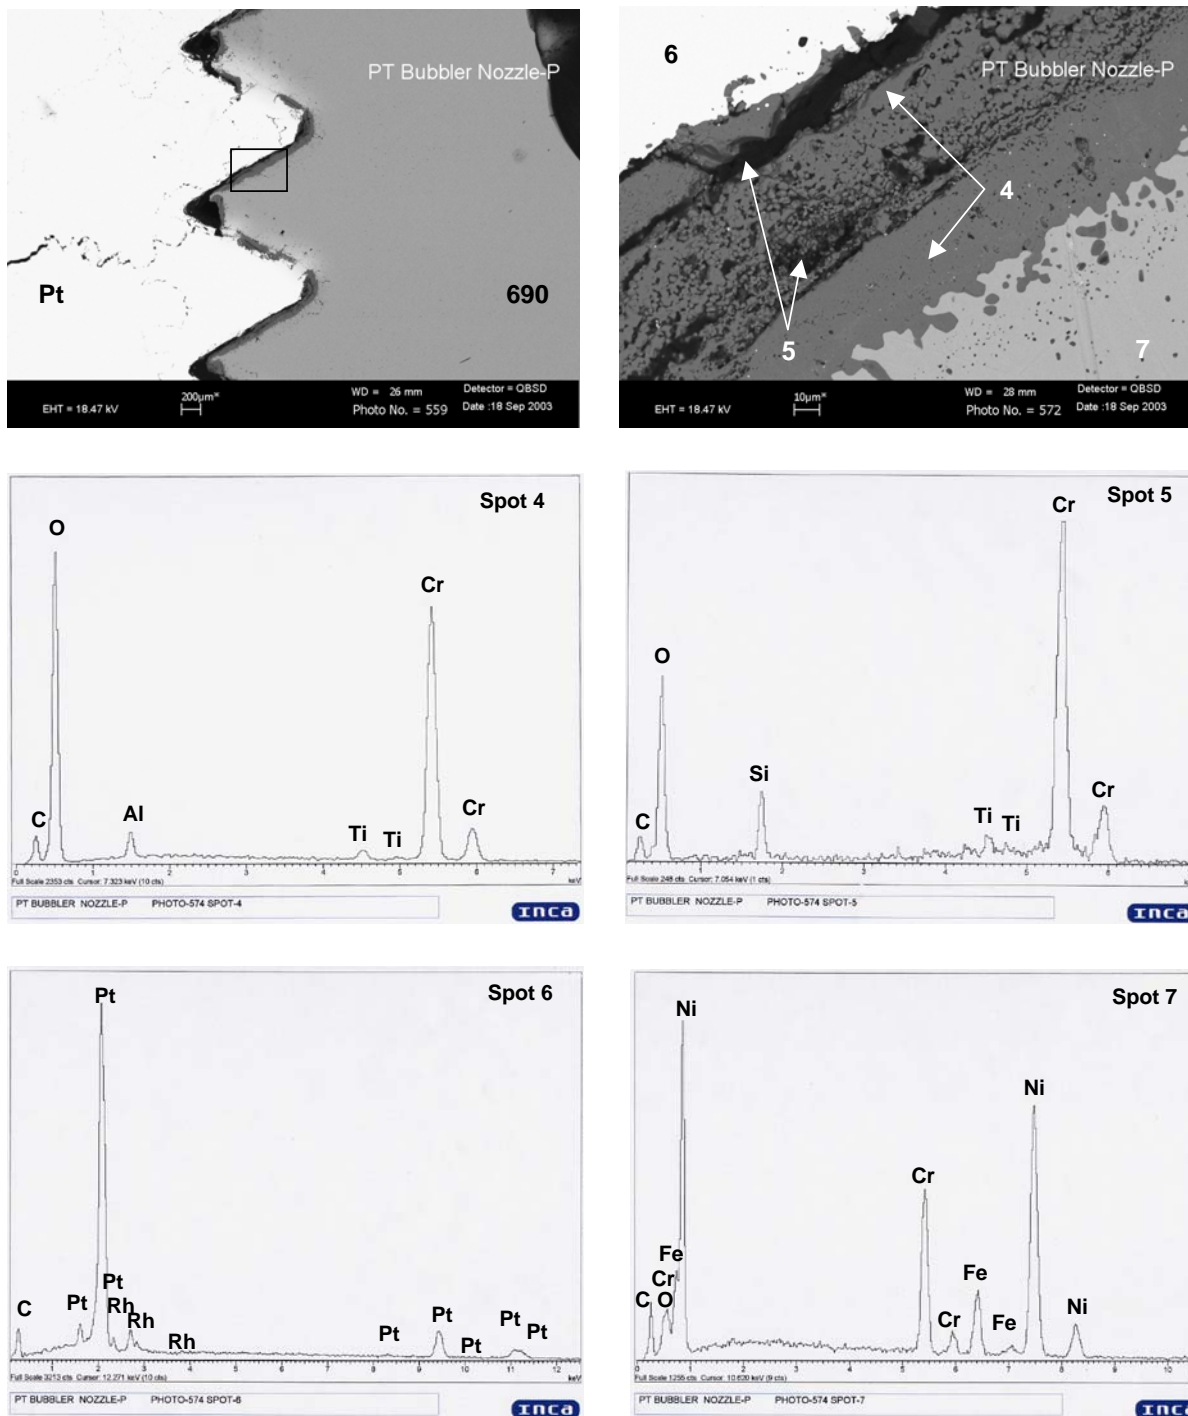
Figure 7. SEM photographs of mating Inconel 690 and Platinum threads and corresponding EDS spectra for the various regions. Spot 4 consisted mainly of chromium oxide. Spot 5 also contained chromium oxide and a small amount of silicon most likely from the glass. Note all samples analyzed in the SEM were carbon coated.

The platinum nozzles were securely fastened into the pump by the use of threads and peening the back of the nozzles. This means of securing the platinum nozzles to the 690 housing appeared to be adequate. Some glass had seeped into the threads but this did not compromise the integrity of the joint. Increasing the area of the sealing surface on the nozzles should help minimize glass intrusion into the threads. There was also some oxidation of the 690 threads most likely resulting from air in leakage around the threads. Although there is a slight thermal expansion mismatch between platinum and 690, the volume increase associated with the oxide formation may have helped secure the nozzles in place at elevated temperatures.

- The technique used to secure the nozzles to pump (threaded joint and peening) were adequate for its length of service. If platinum nozzles are used in the future, the contact area between the platinum and 690 should be increased to minimize glass intrusion into the threads.

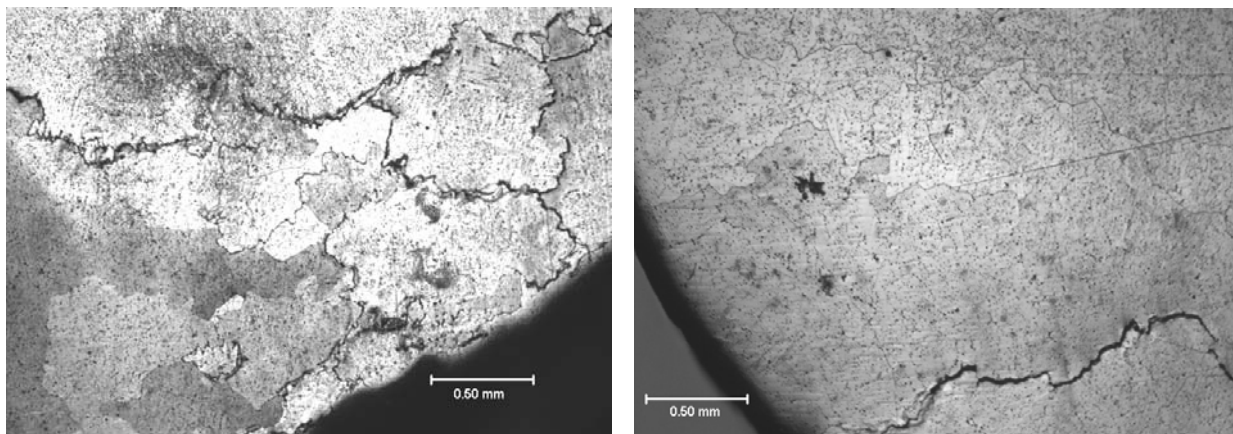
radial orientation. Grain size varied dramatically with some grains exceeding several millimeters in length (Figure 8).

Figure 8. Photomicrograph of the platinum nozzle. Cracks can be seen following grain boundaries. Some grains were as large as several millimeters in length. Etch, aqua regia, 60°C 20 to 40 minutes.

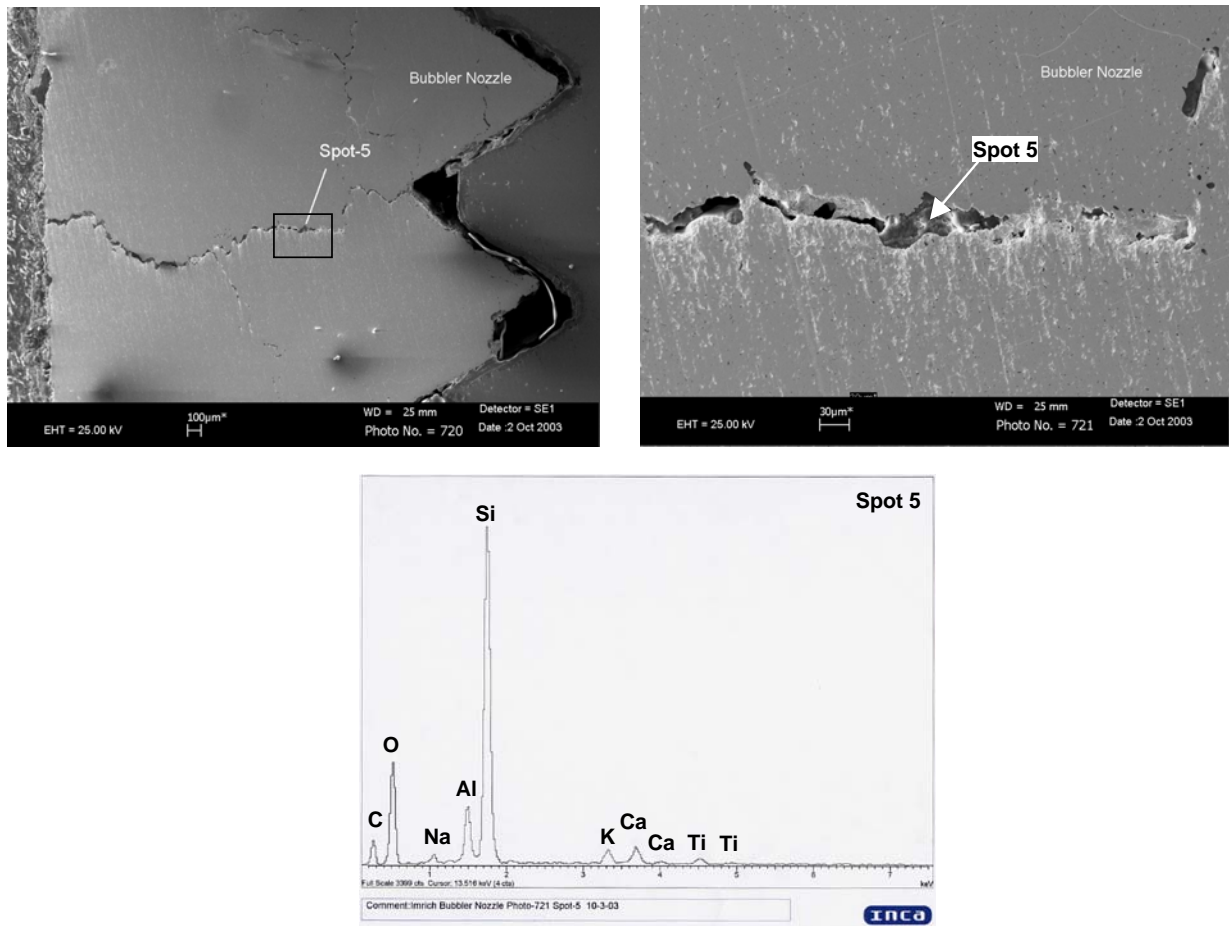
Investigation of the glass within the cracks using the EDS system on the SEM revealed that the glass was depleted in iron. Numerous locations were evaluated and yielded the same results. SEM photographs and EDS spectra of the glass from inside the crack and from inside the air passage are shown in Figures 9 and 10. The latter sample is consistent with the bulk glass chemistry. The composition of various phases located adjacent to the platinum in the air passage is shown in Figure 11. One of the phases contained mainly silicon and was significantly depleted in iron. The second phase contained a significant amount of iron and smaller amounts of nickel and chromium. This iron enriched phase, most likely a spinel, was only found adjacent to the platinum surface in the nozzle air passage.

Figure 9. SEM photographs showing location of EDS spectra of glass taken from within a crack at mid-wall between the threads and air passage of the nozzle. Note absence of iron in glass composition from the crack.

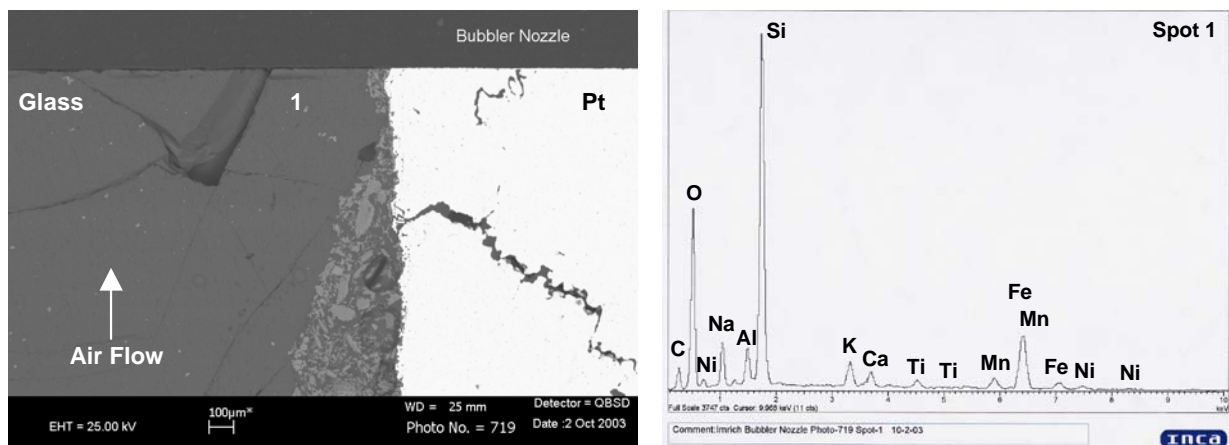
Figure 10. SEM photograph showing the air passage of the nozzle and a EDS spectra of the solidified glass. The glass is representative of the bulk chemistry and contains iron.

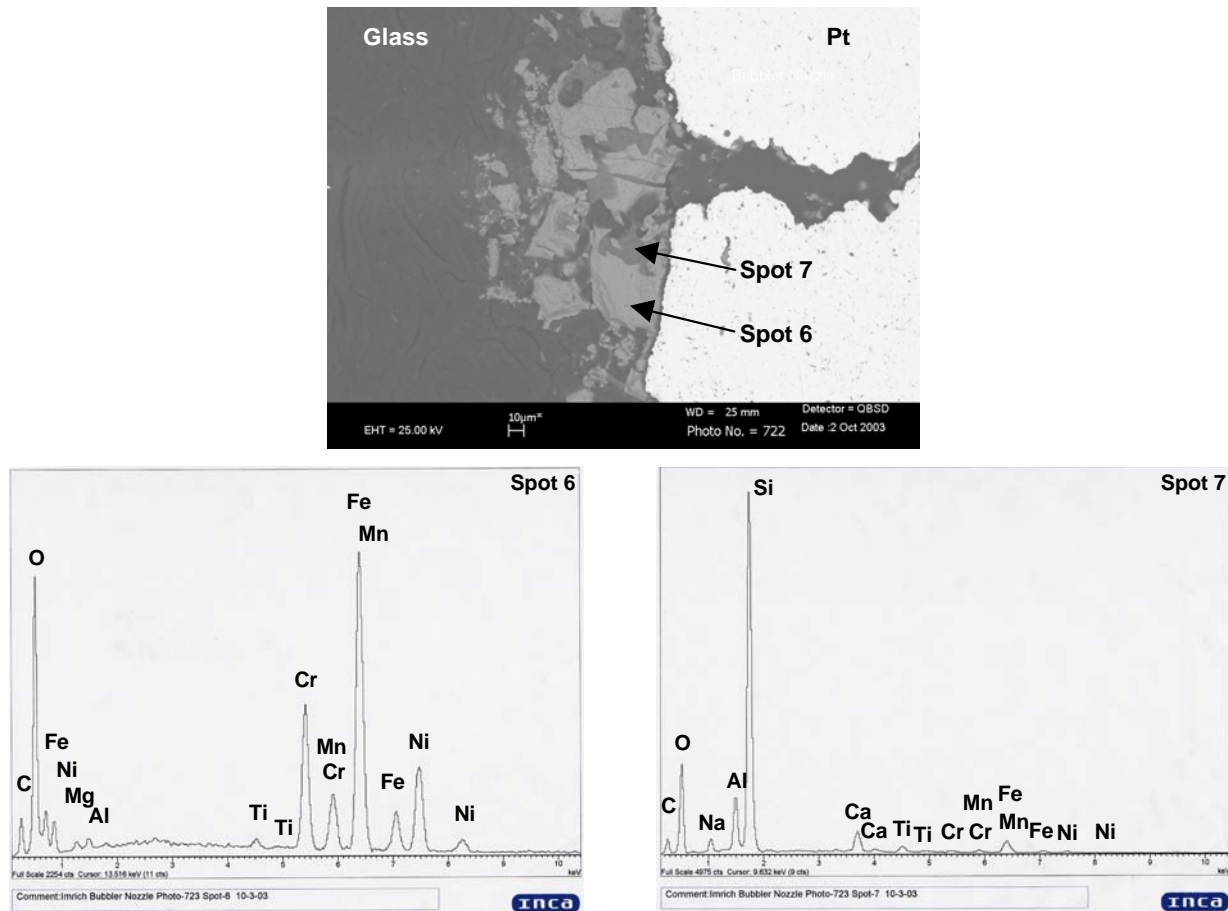
Figure 11. SEM photograph showing the mouth of a crack located on the inner diameter of the nozzle. EDS spectra from spot 6 shows a phase that is enriched in iron.

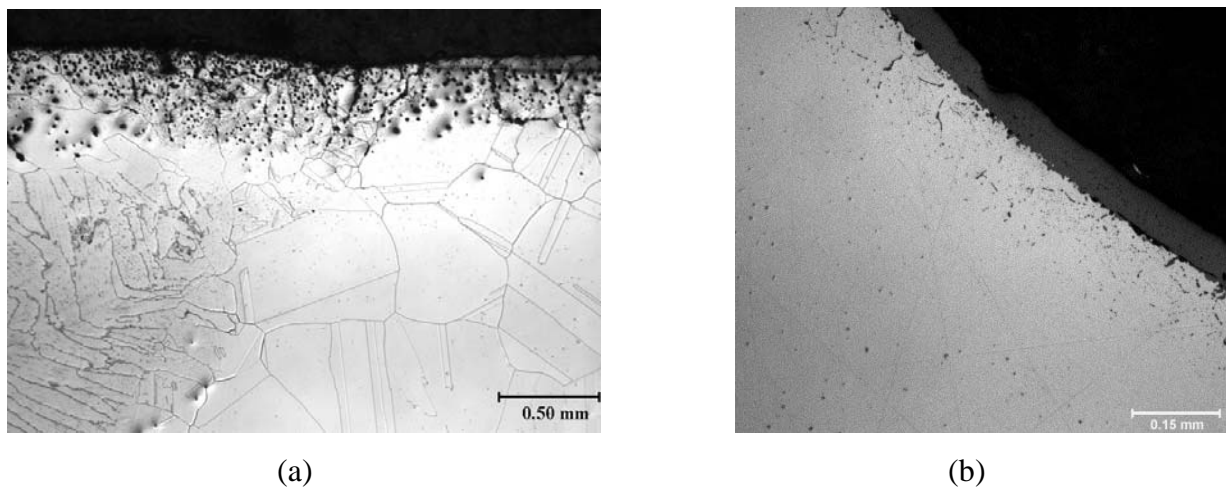
Metallurgical samples from the 690 portion of the pump were removed for optical metallography. One sample was cut from the outer diameter and included a portion of a longitudinal weld and the base material. A second sample was removed which included a cross-section through one of the air vertical passages. The samples were prepared by standard metallurgical techniques and electrolytically etched using a 10 % nital solution. Significant grain growth was observed in the base metal (Figure 12). Maximum depth of internal attack in both the weld fusion zone and the base metal was approximately 0.1 inch. The air passageway diameter was measured using a measuring microscope and averaged 0.195 inches (0.19 inches per the print) indicating a slight wall loss due to oxidation. Depth of internal oxidation around the air passageway was approximately 0.003 inches (Figure 12).

Figure 12. Optical micrographs of the Inconel 690 pump. a) Weld fusion zone and base metal for outer diameter of the pump. b) Oxidation of the air passageway, depth of attack was approximately 0.003 inches.
