# Failure Analysis of 6.8 Evaporator Thermowell (U)

Savannah River Technology Center  
Strategic Materials Technology Department  
Materials Technology Section

June, 2004

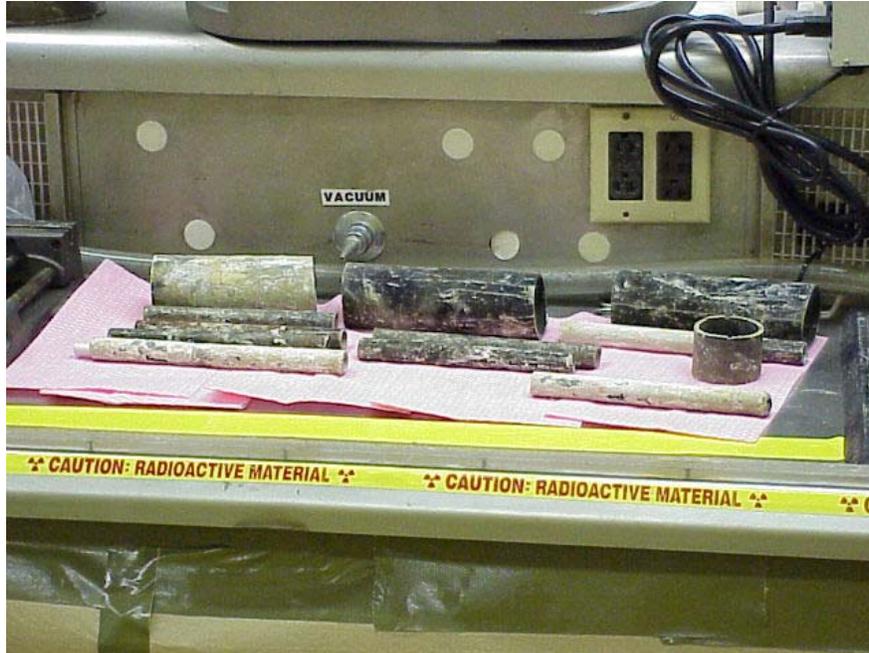
Eleven pieces were received for analysis; 8 inner tube sections of approximately 8 – 10 inches long, 4 outer tube sections that were approximately 8-10 inches long, and one short section 3 inches long as shown in Figure 2. Three sections were selected for closer examination. The sections were the bottom and end cap of the inner tube, the vapor/waste interface area of the inner tube, and a section of the outer tube. The end-cap design for this thermowell is shown by the arrow in Figure 1. The bases for these selections were formed from the previous thermowell failure analysis results [1] and the known corrosion processes of 304L stainless steel [4]. The other sections were removed from the hood to reduce the radiation dose rate during the failure analysis.

The tube sections, as shown in Figure 2, had either a dark or light appearance. The light appearance was associated with a light gray deposit that occurred on sections exposed to the

waste. The darker sections were presumed to have been exposed to the vapor only. The inner tube end-cap and the vapor/waste transition sections were covered with the deposit that appeared to have precipitated from the waste. Scrapings from each of the inner tube sections were taken for x-ray analysis. The black layer on the outer tube appeared more tenacious and was probably an oxide. Though high extremity radiation dose rates were still present, collection of the scrapings had to be accomplished before decontamination was attempted. Scrapings of the outer tube were not taken since the failure point was suspected to be in the waste-exposed sections. The x-ray analysis showed that the deposits were calcium sulfate, both the anhydrous and hydrated forms.

Figure 2. 6.8 Thermowell received in SRTC for analysis

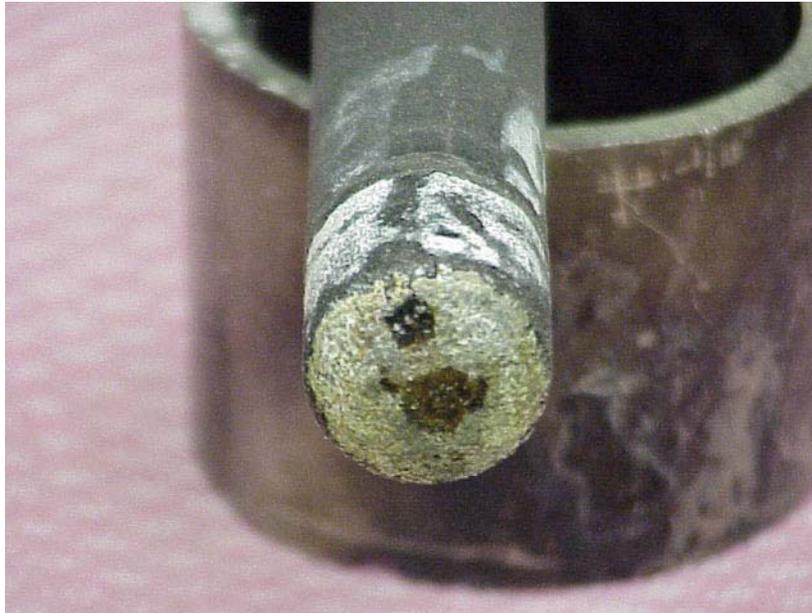
A closer visual examination was conducted of the end-cap and vapor/waste transition sections. Discoloration was noted in two specific areas on the end cap. Corrosion pits were found in both discolored areas as shown in Figure 3. Overall corrosion was found on the entire length of the end-cap section with the greatest distribution of pits on the end. The general degradation was manifested as a roughened surface. Recall that this section was composed of a short piece of tube, the tube/end-cap weld, and the end cap. The end cap had not been buttered or coated with weld metal. The tube/end-cap weld had less apparent corrosion than had generally occurred over the remainder of the section. Closer examination of the vapor/waste transition section showed heavy discoloration with general intergranular attack along the entire outer surface. This general attack seemed to indicate the corrosion was similar for both the vapor space and liquid region.

Metallographic analysis of the end cap revealed that pitting and intergranular attack (IGA) had lead to penetration of the end-cap wall from the outside. Although only one corrosion pit was examined extensively on the particular polished plane, additional corrosion pits had been noted initially (Figure 3) and may have also penetrated the end-cap wall. The largest pit breached the wall in 3 main places; one location is shown in Figure 5. IGA was present over the entire outer surface of the end cap. Note the highly worked microstructure of the bottom inner surface on the end cap near the top of Figure 5. This microstructure had a circuitous grain boundary. The corrosion products were analyzed from the inner surface of the end cap and found to be ferrous and aluminum oxides and hydroxides.

Figure 3. 6.8 Thermowell End cap showing oxide covered surface with corrosion pits

The failure of the 6.8 thermowell and RTD resulted from IGA of the end cap and general corrosion of the RTD components. The end cap microstructure probably accelerated the attack because of end grain effects. A metallographic examination of an unexposed end cap is recommended to confirm the expected microstructure. If confirmed, changes in the end cap may be necessary to extend the life of the thermowell.

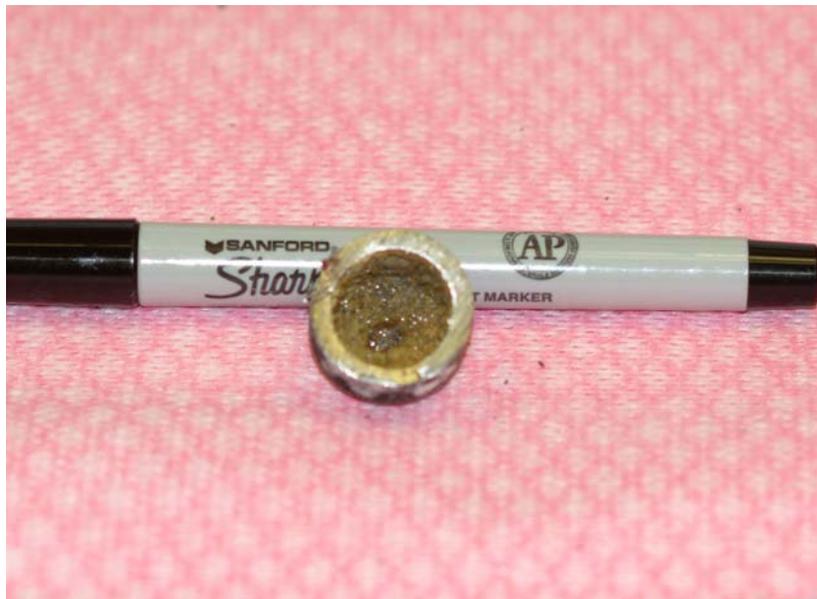
The end cap and the tube/end-cap weld were sectioned into separate pieces prior to mounting as shown in Figure 4. Note the reddish corrosion products on the interior of the end cap, which give a rough appearance. The outer tube was not sectioned for metallographic analysis to reduce personnel exposure. Also, more severe corrosion occurred on the inner tube as shown by a previous thermowell failure analysis [1]. The weld and end-cap pieces were then split longitudinally to expose the inner and outer surfaces in a metallographic mount. By sectioning and mounting in this manner, the specific leak path, direction of pit growth and general condition of the inner and outer walls could be determined. Following grinding, the mounts were polished per standard 304L techniques and etched using 10% oxalic acid at 6.0V dc current.

Figure 4. Sectioned end cap showing interior corrosion product

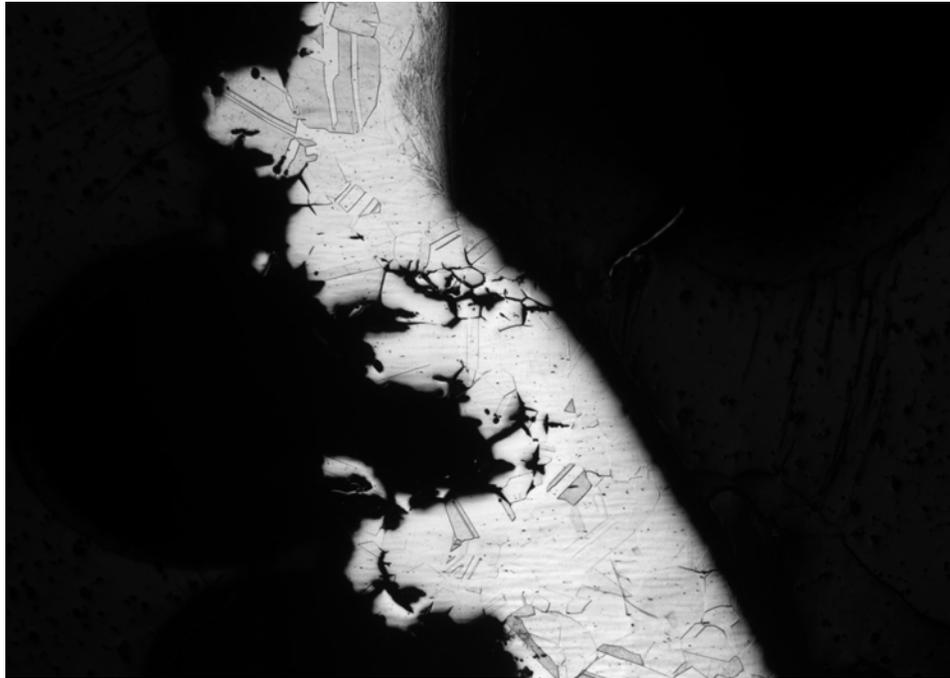
The failure analysis results showed that IGA, pitting, and general corrosion were the active corrosion processes that lead to the penetration of the thermowell and failure of the RTD. IGA was noted on both the tube outer wall and the end-cap. Significant pitting was not detected on the tube wall. The primary corrosion mechanism was then IGA. Microstructural differences between the end cap and the tube probably lead to different rates of degradation. The end cap is suspected to have had exposed end grains, which are not apparent in the tube microstructure as shown in Figure 6. For the end cap, IGA may have lead to eventual grain drop out, thereby increasing the degradation rate and leading to pit-like formations. The IGA continued to progress until the end cap was penetrated, providing a pathway for the waste to inside the tube.

The corrosion rate of the thermowell end cap was large. The inner tube is made from ½” schedule 40 pipe, which has a nominal thickness of 0.109”. The RTD/thermowell assembly failed in 14 months (approximately 1.2 years). Although at temperatures over 100 C, the assembly had 3,440 hours (approximately 0.4 year). The corrosion or degradation rate would fall between 95 to 280 mils per year. The conditions, including the exposure and material, are extremely aggressive.

Figure 5. Through wall corrosion pits in bottom of the end cap

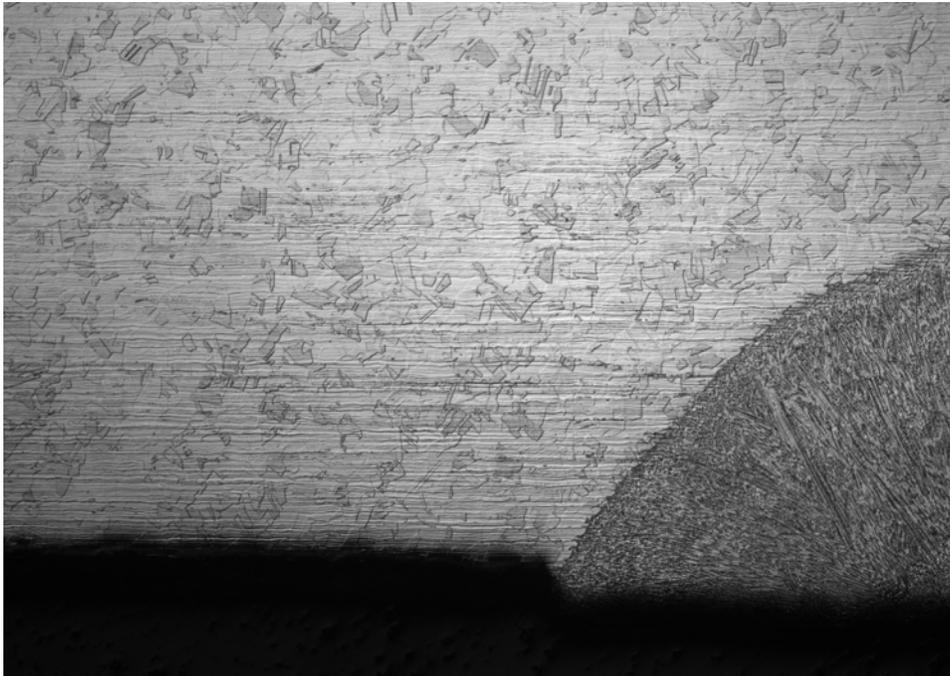
The tube/end-cap weld was examined and found to be less susceptible to corrosion than the end cap as shown in Figure 6. A previous examination of a failed thermowell indicated that weld metal was less susceptible than the tube material. In fact, the only material left from the bottom section of the previously examined thermowell was just a strip of the longitudinal weld. During the current failure analysis, a marked difference in the grain size and microstructure was noted between the tube and end cap indicating a difference in manufacturing of the two components. Also, noted but not deemed to be a factor in the failure was the lack of fusion of the end cap weld on the interior of the tube. Lack of fusion could cause problems and should be addressed.

Figure 6. Weld between end-cap side wall and inner tube

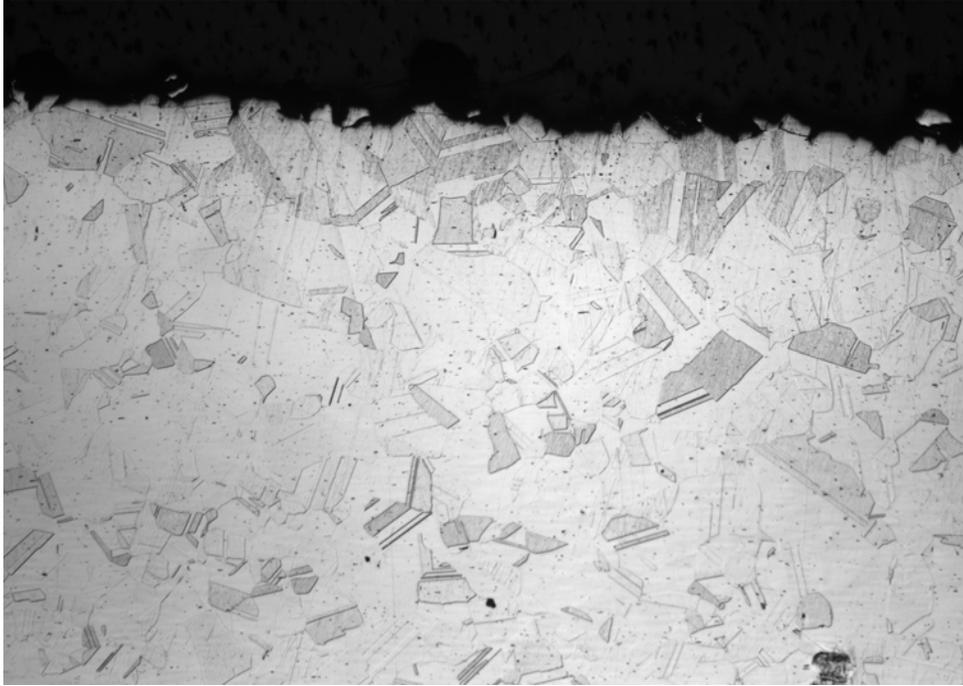
The vapor/waste transition of the tube was examined for differences in the corrosion with the vapor and liquid exposure. A difference in corrosion was not found and the entire transition region was degraded from IGA, similar to the tube/end-cap weld region. However, the IGA was not as substantial in the transition region as on the end of the tube as shown in Figure 7. Compare this figure with Figure 6.

Figure 7. Intergranular attack of the inner-tube surface in the vapor/waste transition region.
