**Pacific Northwest
National Laboratory**

**Ultrasonic Examination of Double-Shell
Tank 241-AP-106 Examination
Completed November 2004**

AF Pardini
GJ Posakony

December 2004

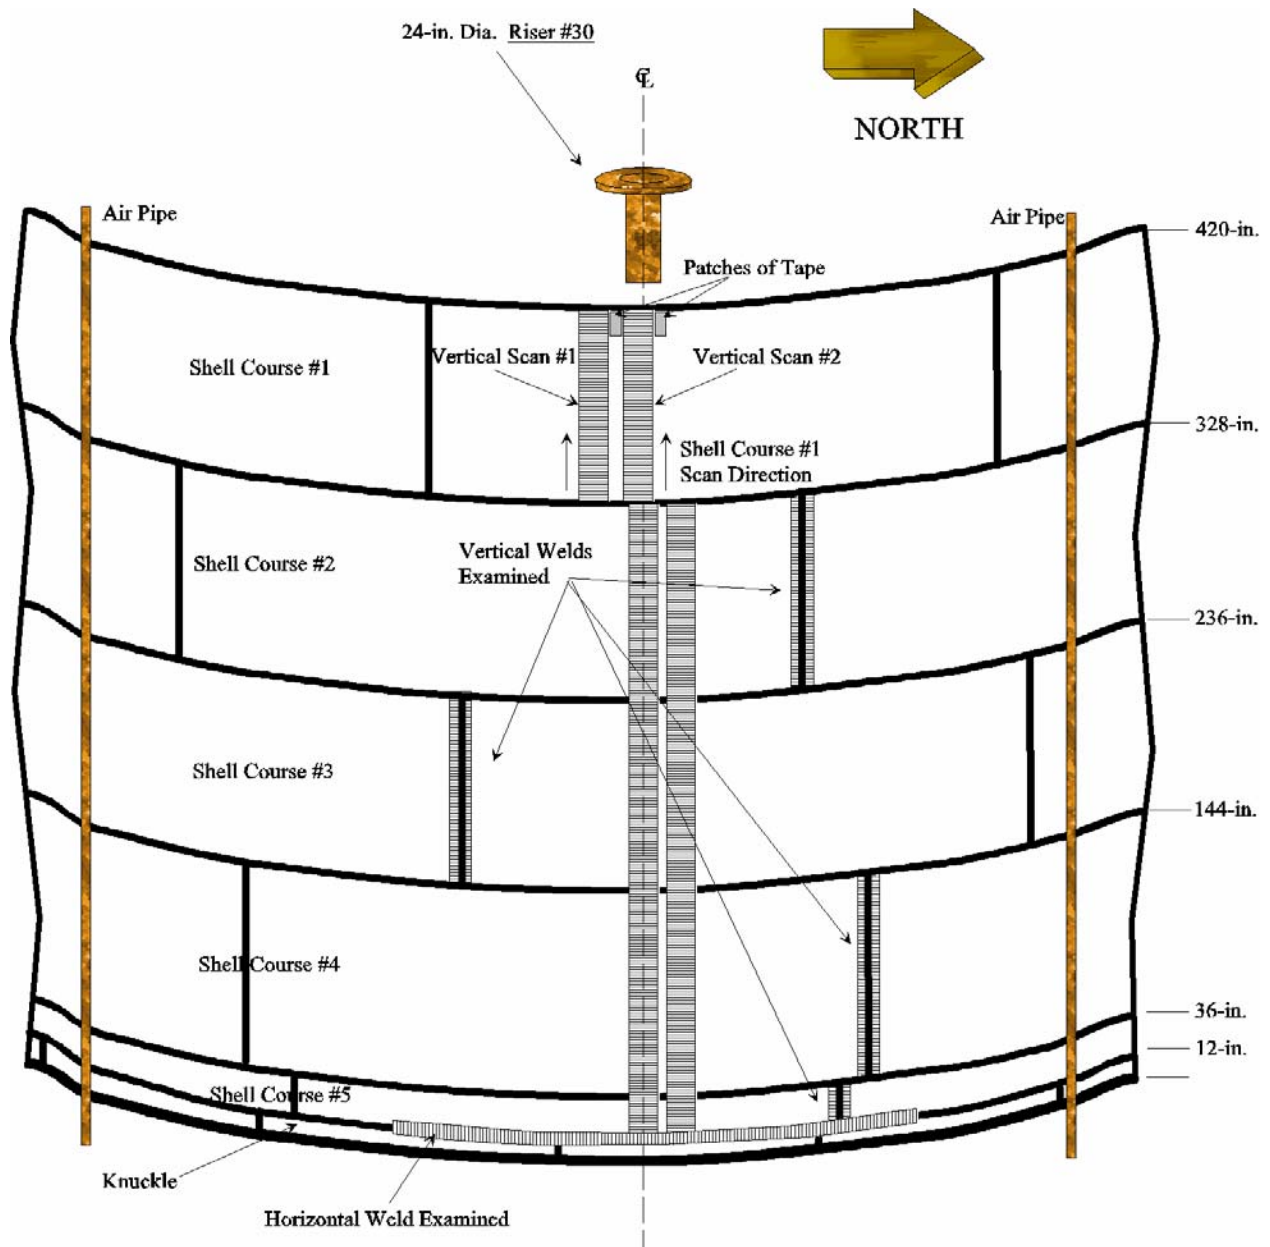
Figure 4.2. Sketch of Scan Paths on Tank 241-AP-106

Figure 4.2 describes the areas on the primary wall of Tank 241-AP-106 that were ultrasonically examined. Two 15-in.-wide vertical scan paths were performed on shell courses #1, #2, #3, #4, and #5 below the entrance to Riser 30. Vertical weld HAZ examinations were done on shell courses #2, #3, #4, and #5, and the horizontal weld HAZ examination was done on the transition shell course #5 to knuckle weld.

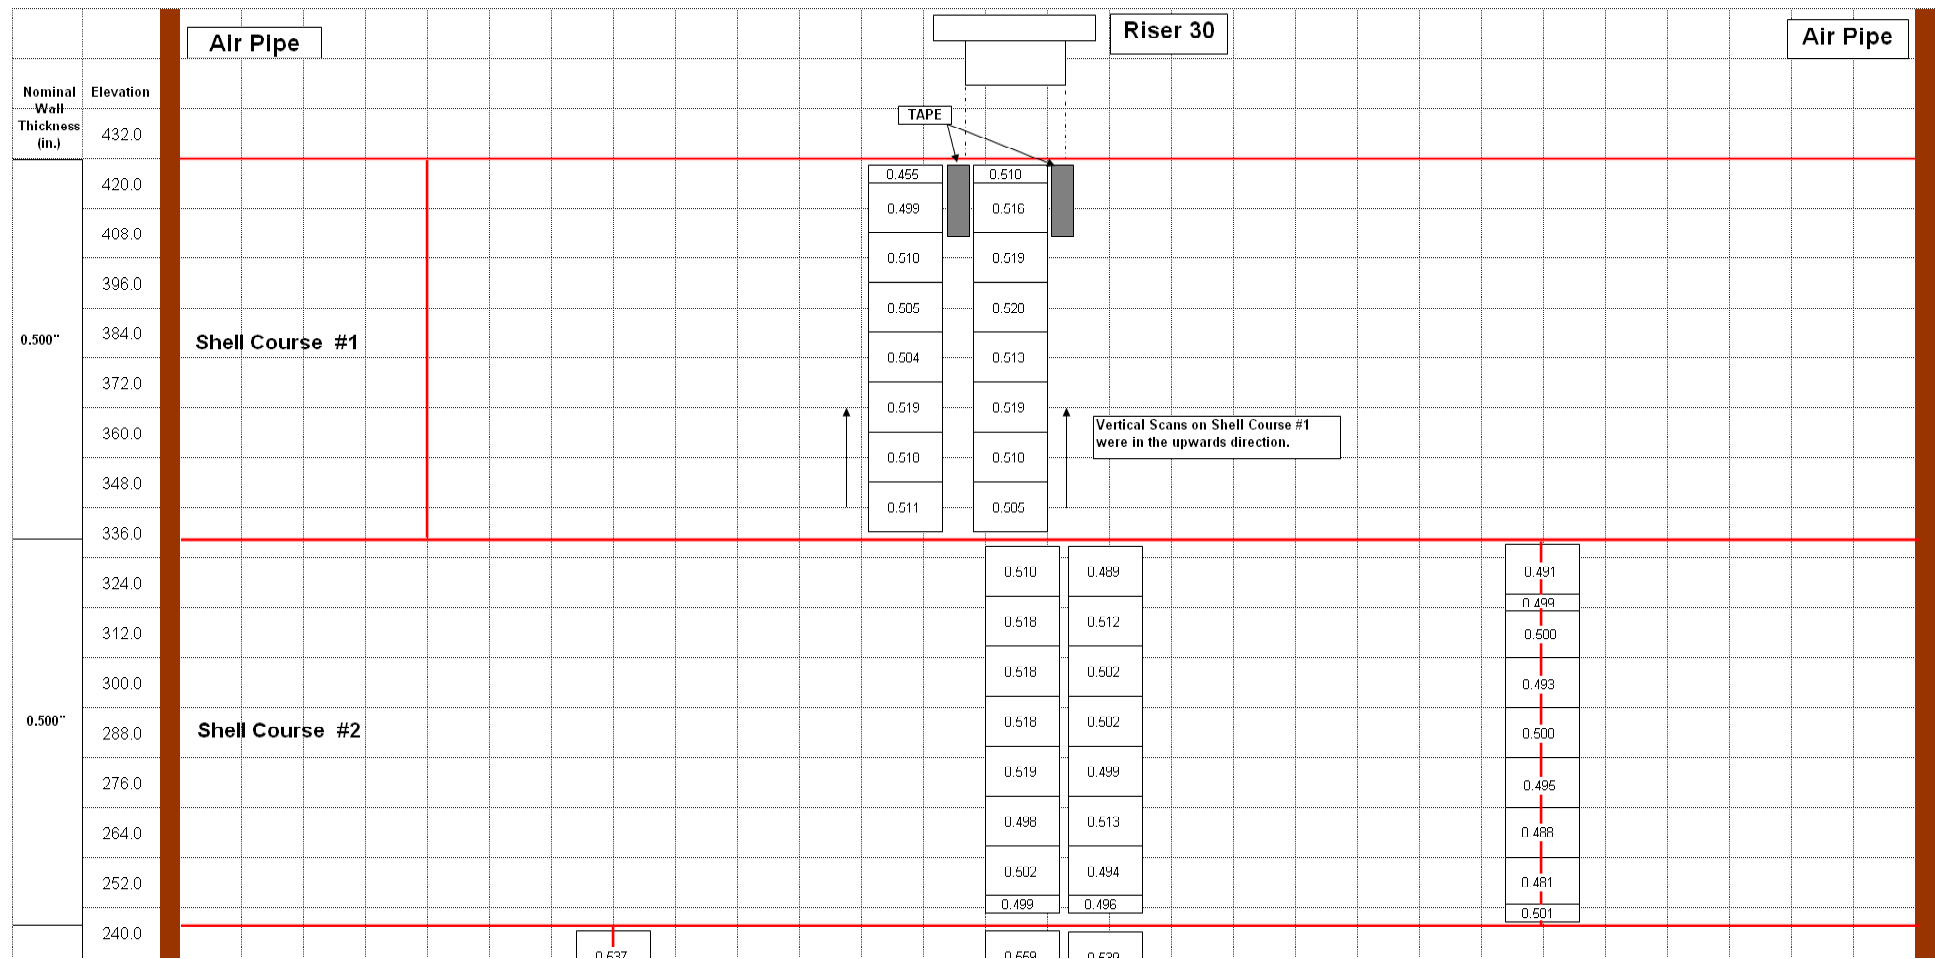
Figure 5.1. UT Data from Tank 241-AP-106

Figures 5.1 and 5.2 show the wall thickness examination results for the primary tank wall and the HAZs of both vertical and horizontal welds. The examination consisted of two vertical paths beneath the 24-in. diameter riser. Vertical scan #1 was 15-in. wide on shell courses #1, #2, #3, #4, and #5 near the centerline of the 24-in. riser. Vertical scan #2 was adjacent to vertical scan #1 and was also 15-in. wide on shell courses #1, #2, #3, #4, and #5. Due to patches of tape on the surface of shell course #1, scans were performed from the bottom of the plate to the top. This obstruction was only on shell course #1, all other plates were scanned from the top down. The HAZs of vertical welds in shell courses #2, #3, #4, and #5 were examined and the HAZ in the horizontal weld between shell course #5 and the knuckle section was also examined. Areas in the figures that show two measurements in the same box are the result of the vertical scan paths overlapping the horizontal HAZ scan paths. Figures 5.1 and 5.2 display the minimum readings taken in each 15-in. wide by 12-in. long area of the scan. In the overlapping areas, both minimum readings from each of vertical and horizontal scan paths are given.

Two 15-in.-wide scan paths were performed on shell courses #1, #2, #3, #4, and #5. The shell courses were examined for wall thinning, pitting, and cracks oriented vertically on the primary tank wall. The results indicated that the minimum thicknesses in the areas scanned with nominal thickness of 0.500-in. were as follows; shell course #1 was 0.455-in. and shell course #2 was 0.489-in. The nominal thickness in shell course #3 is 0.5625-in. and the minimum thickness in this area was 0.539-in. The nominal thickness in shell course #4 is 0.750-in. and the minimum thickness in this area was 0.747-in. The nominal thickness in shell course #5 is 0.875-in. and the minimum thickness in this area was 0.854-in. There were no areas of wall thinning that exceeded the reportable level of 10% of the nominal thickness. No pitting or vertical crack-like indications were detected in shell courses #1, #2, #3, #4, or #5.

The HAZ of vertical welds in shell courses #2, #3, #4, and #5 were examined for wall thinning, pitting and cracks oriented either perpendicular or parallel to the weld. The results indicated that the minimum thicknesses in the weld areas scanned were as follows: The nominal thickness of shell course #2 is 0.500-in. and the minimum thickness in this weld area was 0.481-in. The nominal thickness in shell course #3 is 0.5625-in. and the minimum thickness in this weld area was 0.532-in. The nominal thickness in shell course #4 is 0.750-in. and the minimum thickness in this weld area was 0.723-in. The nominal thickness in shell course #5 is 0.875-in. and the minimum thickness in this weld area was 0.848-in. There were no areas of wall thinning that exceeded the reportable level of 10% of the nominal thickness. No pitting or crack-like indications were detected in the weld areas in shell courses #2, #3, #4, and #5.

The HAZ of the horizontal weld between shell course #5 and the tank knuckle was examined for wall thinning, pitting and cracks oriented either perpendicular or parallel to the weld. The results indicated that the minimum thickness in the weld area with nominal thickness of 0.875-in. on shell course #5 was 0.825-in. The minimum thickness in the weld area with nominal thickness of 0.9375-in. on the knuckle was 0.904-in. There were no areas of wall thinning that exceeded the reportable level of 10% of the nominal thickness. No pitting or crack-like indications were detected in the weld areas on shell course #5 side or on the knuckle side of the horizontal weld.
