Projected Life of the SLAC Linac Braze Joints: Braze integrity and corrosion of cooling water hardware on accelerator sections

W.F. Glesener and E. L. Garwin
Stanford Linear Accelerator Center
2575 Sand Hill Road
Menlo Park, CA 94025

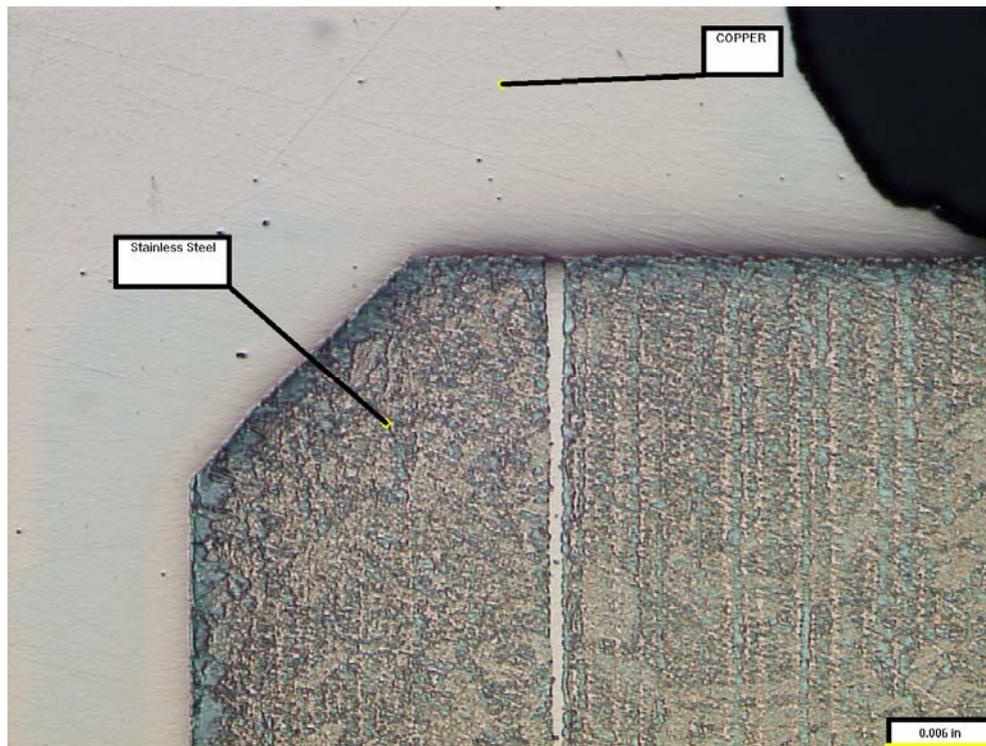
Photo 1: Stainless steel to copper joint 50x

Metallographic analyses of the different braze joints showed no internal operational damage or external environmental effects. Atmospheric corrosion occurs when a thin film of electrolytic solution, such as water, condenses on a metal surface. The humidity content of the air is a critical parameter in determining corrosion activity. Lack of surface corrosion indicates the operating relative humidity of this section was sufficient to yield a negligible corrosion rate. In addition, there was no visible corrosion due to galvanic coupling at the copper-347 stainless, copper-304 stainless or copper-CuAu interfaces.

The end flange assembly showed no internal operational damage, galvanic corrosion or external environmental effects.

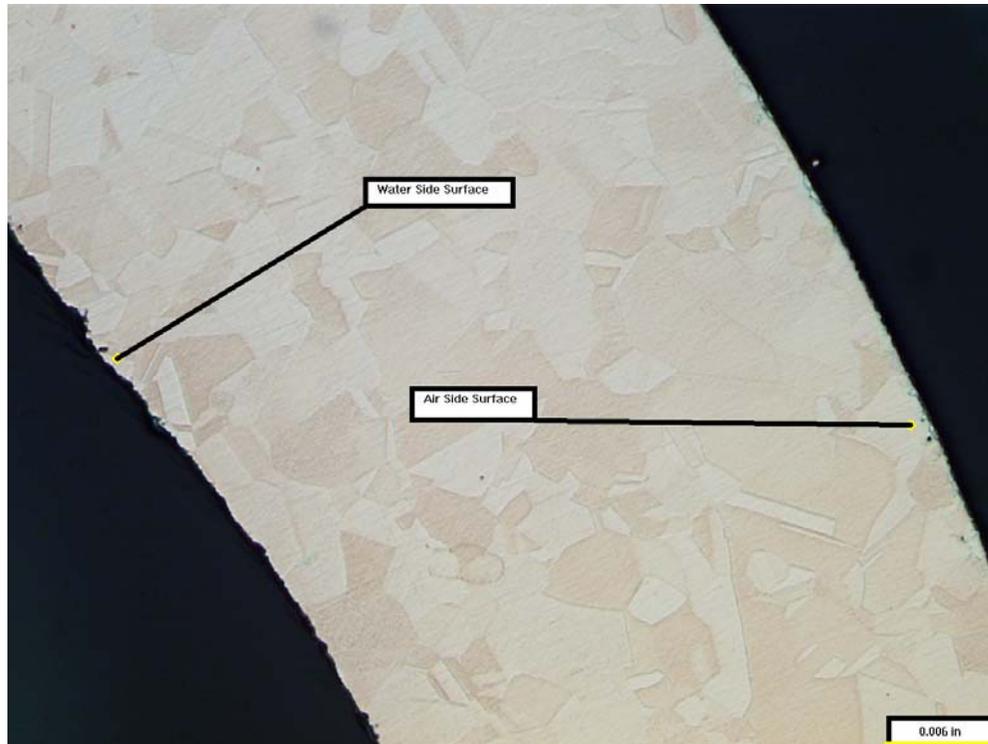
External surface oxidation of the cooling tubes (PF 751-044) was visible by metallographic analysis at 200x magnification. Environmental corrosive attack occurred along surface grain boundaries to a depth of .003". See Photo 2 on next page. General pitting was not observed on internal tubing walls. Wall thickness measurements were made in numerous locations on several different tube sections. The original nominal wall was .080" thick. The thinnest wall thickness was found to be 0.051".

Photo 2: Internal surface of cooling water tube 50x
Note evidence of uniform corrosion on both surfaces

The internal cooling water tubing is uniformly corroding at a rate of about 1 mil per year. The tee fittings have good braze joints however the internal surfaces are corroding at non-uniform rates due to general corrosion and pitting. The LCW supply pressure of 250 psi will (approximately) exceed allowable fitting pressure in the year 2027.

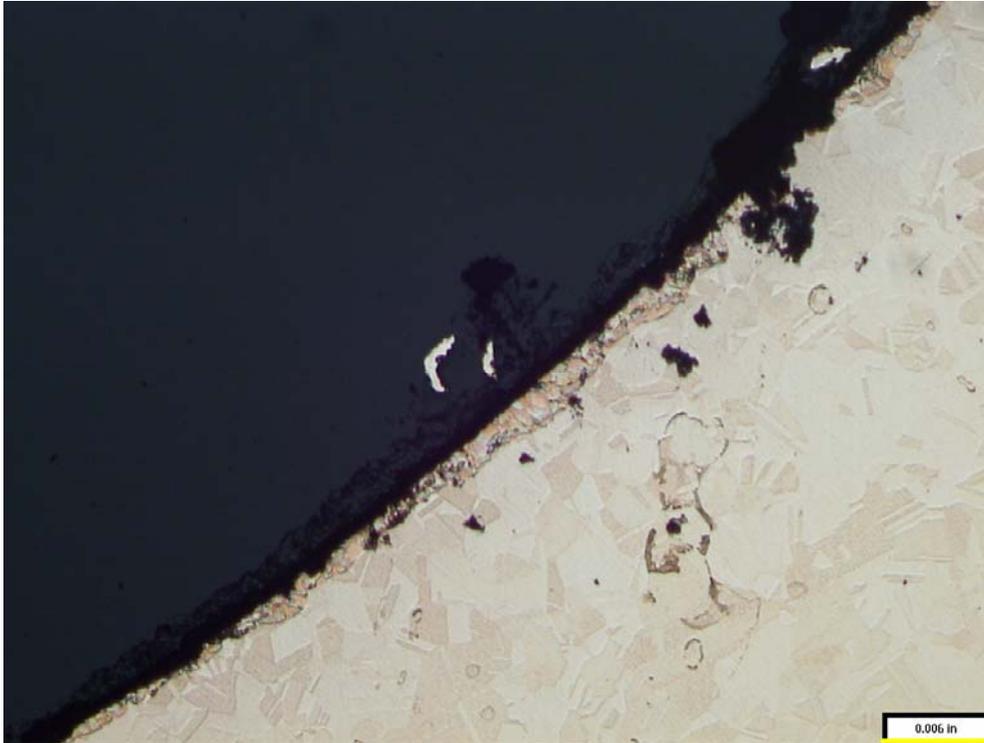
Tee fittings (PF 751-037) joined the cooling water inlet and outlet feed tubes (PF 751-043) to the eight hairpin cooling tubes (PF 751-044). Each tee contains 3 braze joints. The joints did not show evidence of corrosion or erosion but contained localized porosity, which occurred during the manufacturing process. The internal walls of the tee showed uniform corrosion and pitting. Wall thickness varied by location. The center stem wall of .040" decreased to .029" and contained pits to a depth of .010". In the region of the two branches, wall thickness decreased from .0245" to .020" with pitting to .003". Inlet and outlet tee wall condition did not vary with flow direction. See photos 3 and 4 on next page for pitting morphology.

Photo 3: Internal surface of outlet Tee with pitting corrosion 50x

The value of S is the allowable design strength for continuous long term service of tubing, as determined by the ASME Boiler and Pressure Vessel Code, Section 1-Materials. Annealed ratings were used since the entire structure was subjected to several braze cycles. The weak link in the system appears to be the thin walls of the tee fitting. The specific location is about 1/8" long on the branch stem next to the tubing-tee braze joint. The LCW supply pressure of 250 psi will exceed allowable fitting pressure in about the year 2027.

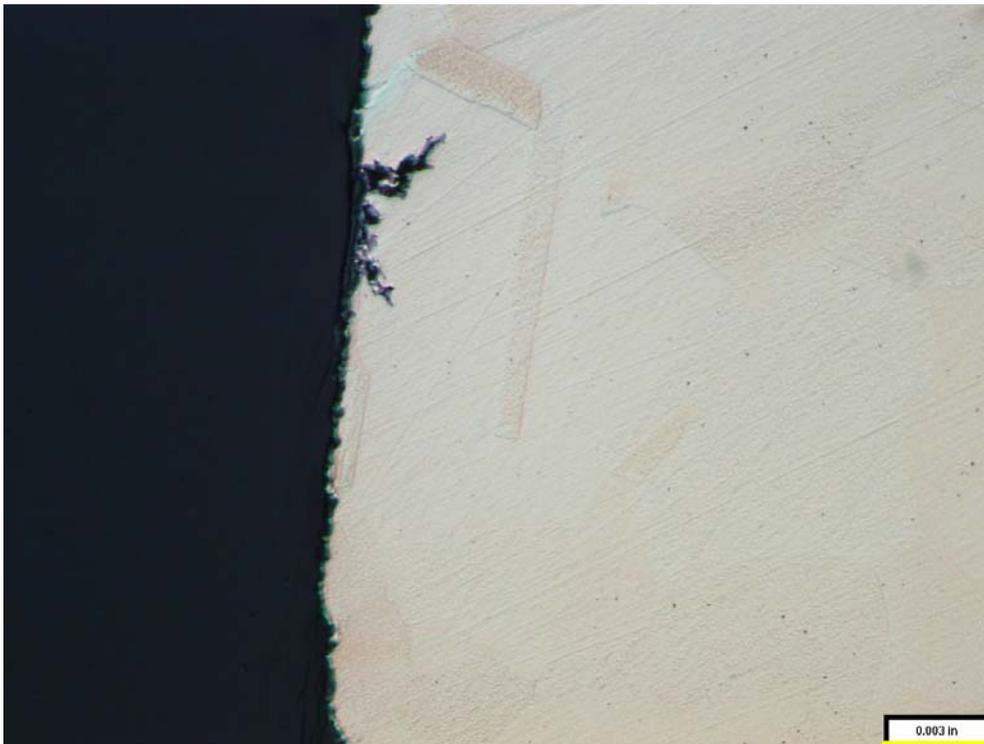
Photo 4: Internal surface of outlet Tee with pitting corrosion 100x
