Technical Progress Report • August 2006

## Diffusion Coatings for Corrosion-Resistant Components in Coal Gasification Systems

Quarterly Technical Progress Report 11

SRI Project P13063

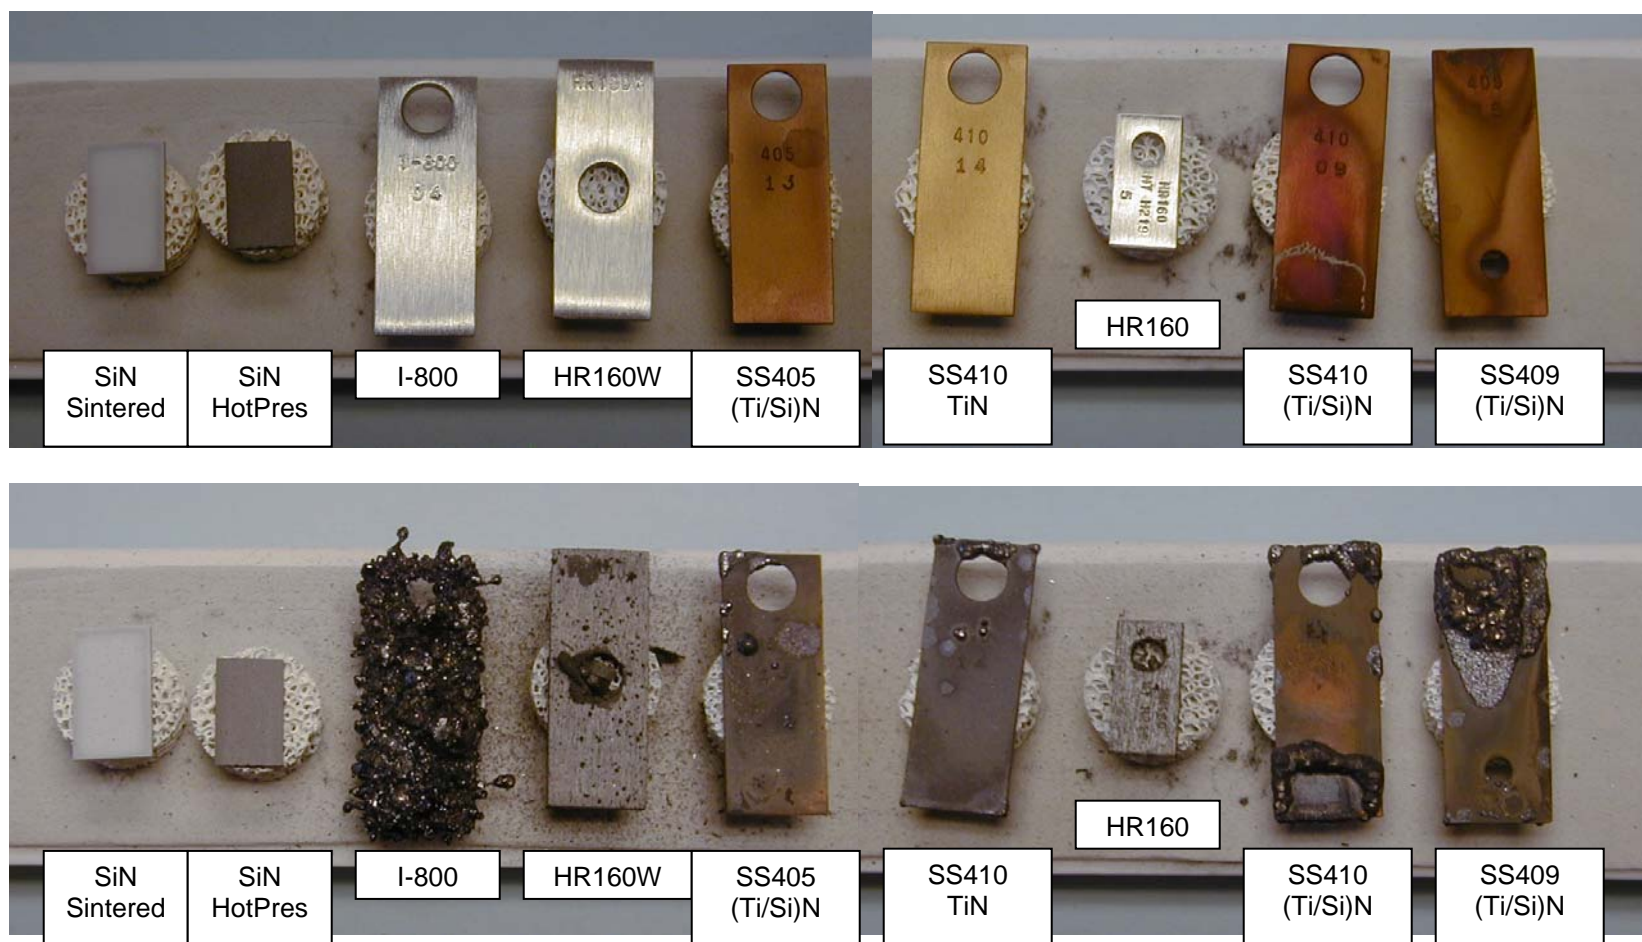
The top panel of Figure 1 shows the picture of the samples before they were exposed to simulated gasifier conditions at 900°C. The bottom panel is a photograph of the samples after exposure after 308 h. Table 1 lists the samples, the specific coatings, and some general observations.

Figure 1. Samples before and after exposure for 308 h at 900°C in simulated gasifier Test 10.

This batch included two samples of silicon nitride. One of them was reaction-sintered material, the other was hot pressed and highly dense. Neither sample showed any sign of sulfidation attack or mass loss, indicating that the formation of SiO or SiO(OH)<sub>2</sub> was negligibly small under the tested conditions.

The third sample was a coupon of an Inconel alloy. This sample was severely corroded. There was a friable deposit (mostly FeS, as determined by XRD) deposit all over the sample, and it adhered to the disc of porous alumina on which it was resting. The test also included two samples (#4 and #7) of another specialty alloy, HR 160. One of these (#4) was of the welding grade, and it developed some flakes. Both these samples lost a small amount of their weight, possibly from the loss of CoS, but they otherwise maintained their integrity. This result is in contrast to the fate of the HR160 coupon in the actual gasifier stream discussed below during which they underwent extensive corrosion/erosion.

The remaining four samples were various 400 grade steel coupons coated with TiN or (Ti/Si)N. There was varying amount of corrosion in these samples mostly evidenced as deposits of FeS. The corrosion was not uniform on the sample, but seemed to be localized in certain regions. In Samples 8 and 9 the corrosion occurred where the coatings were visibly defective.

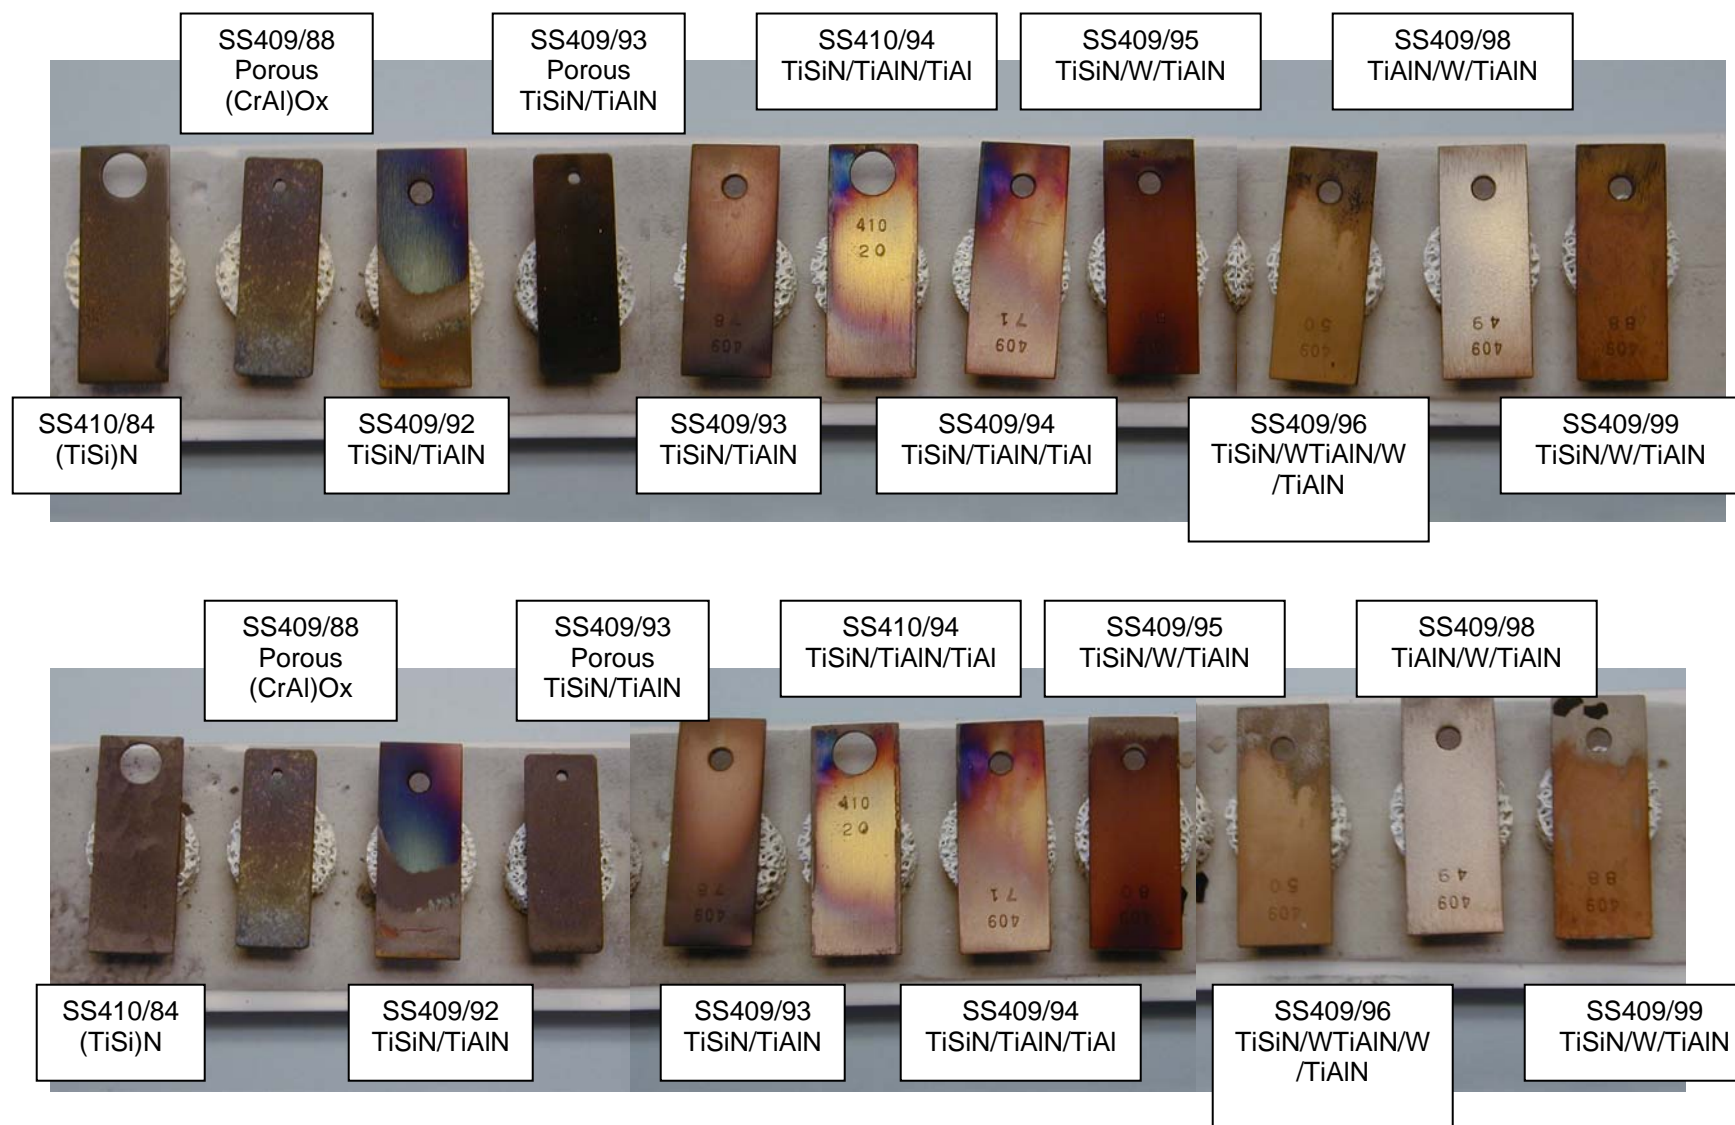
All the samples looked almost exactly as they went in. At this relatively lower temperature, we did not expect any of the nitride coatings to show any corrosion. The only sample to gain significant weight was the TiN coated porous SS409 coupon (Sample 4). This weight gain is surprising because there was hardly any visible change. Following the exposure, cross sections of both of the porous samples were prepared analyzed by SEM-EDX and XRF. Preliminary examination showed the presence of Ti on the interior surfaces, in the depths of the porous sample, a clear indication of the ability of our fluidized bed process to deposit metals in the pores that would not be covered in processes that operate by line-of-sight deposition methods.

Figure 2. Samples before and after exposure for 300 h at 937°C in simulated gasifier Test 12.

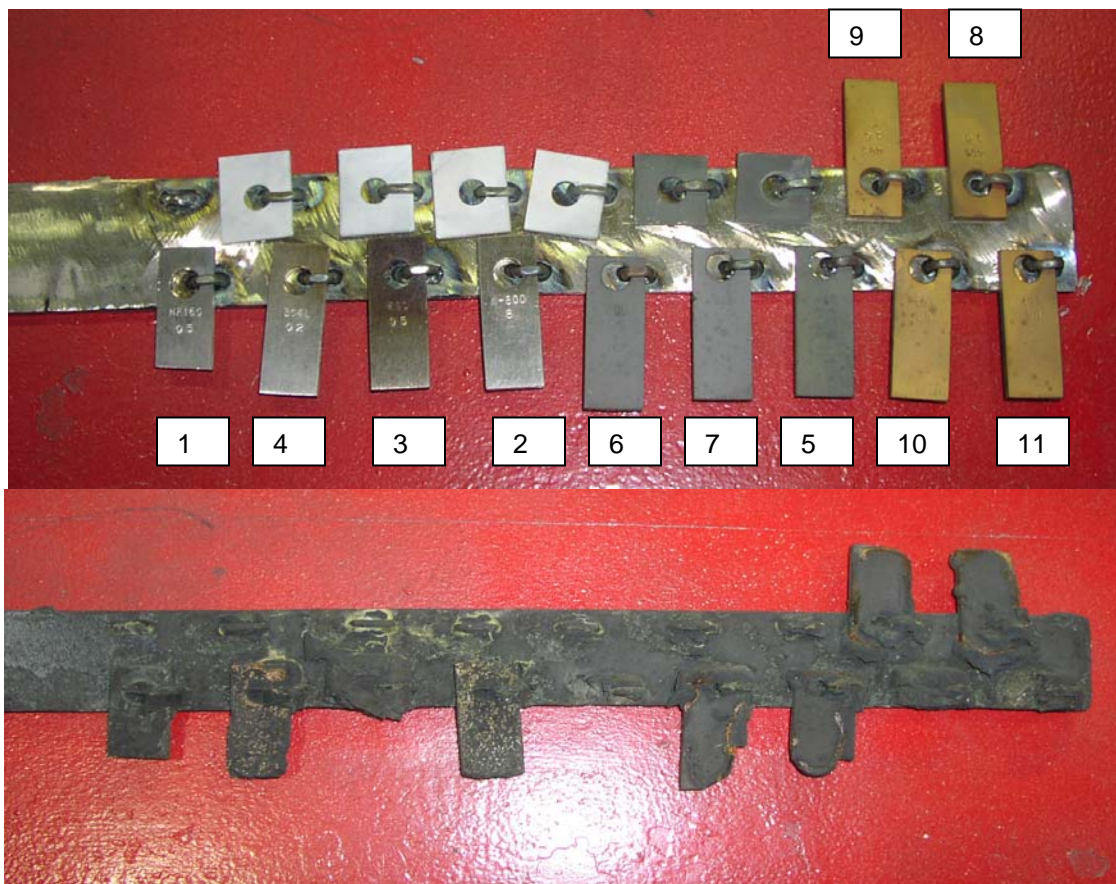
Figure 3 shows a picture of the samples before and after exposure. The unlabeled samples were those that ConocoPhillips had put in for their own work. The samples were subjected to 1,100 h of the high-temperature synthesis gas environment. All the samples were severely damaged, with many of them even falling off the coupon tree and getting lost in the gasifier. One of the samples (#5) SS409 coated with Cr/Al oxide had already survived over 500 hours in simulated coal gas stream with no apparent degradation. Only the Haynes alloy (#1) remained on the sample holder, but even this sample showed extensive sulfidation attack. Other samples that seemed to have survived to some extent were Inconel 800 (#2), austenitic stainless steel SS304 (#4), and two SS409 samples coated with TiN (#10 and #11). Note that the Inconel 800 coupon was severely sulfided even in the laboratory test. The severity of damage in all these samples suggests that the environment in the gasifier is much harsher than that provided in the laboratory test. To a large extent this may be due to the erosion by particles that is not provided in the lab set up. However, the specific problem of tube sheet corrosion is not exacerbated by erosion due to ash particles, and so the coupon tree set up may represent a vastly more severe a test.

Figure 3: Samples before and after exposure to the hot gas stream in the Wabash River Plant during May-Sep, 2005 (1,100 hours, petcoke syngas)

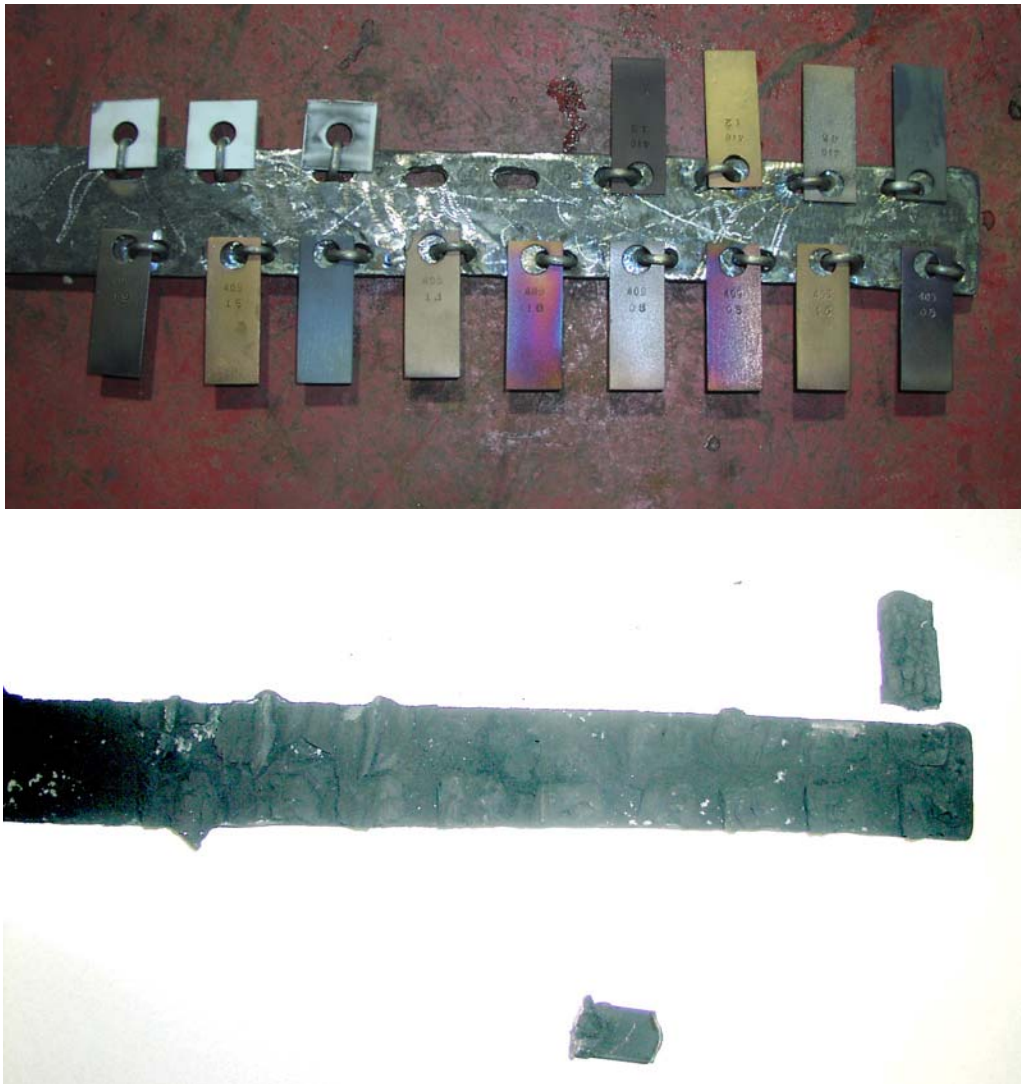
A second batch of samples was submitted to ConocoPhillips for testing in their gasifier in October 2005. They are listed in Table 4, and Figure 4 shows their photographs of the tree with the samples before and after exposure in the high temperature, abrasive synthetic gas stream for 3,814 hours. During removal of the coupon tree, the coupon designated as 410-01 was inadvertently broken off. This was the only coupon to have remained intact. A second detached coupon that can be seen in the photo was recovered during an earlier vessel inspection, as it had already broken off.

Figure 4. Samples before and after exposure to the hot gas stream in the Wabash River Plant during May-Sep, 2005 (3,814 h)
