COMBUSTION TURBINE (CT) HOT SECTION COATING LIFE MANAGEMENT

Semi Annual Technical Progress Report

***Agreement Number:* DE-FC26-01NT41231**

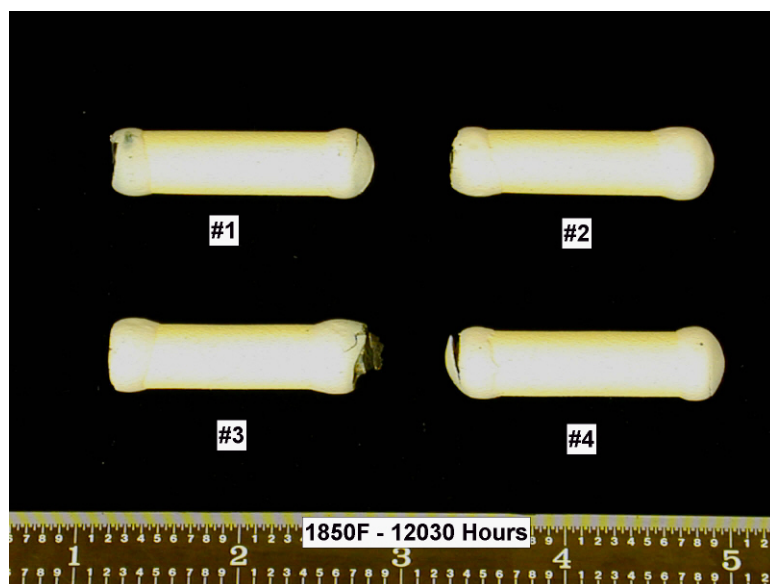
Figure 5-1: Condition of Coated Specimens after 12030 hours Exposure 1010°C (1850°F). Note that there were no visible cracks.

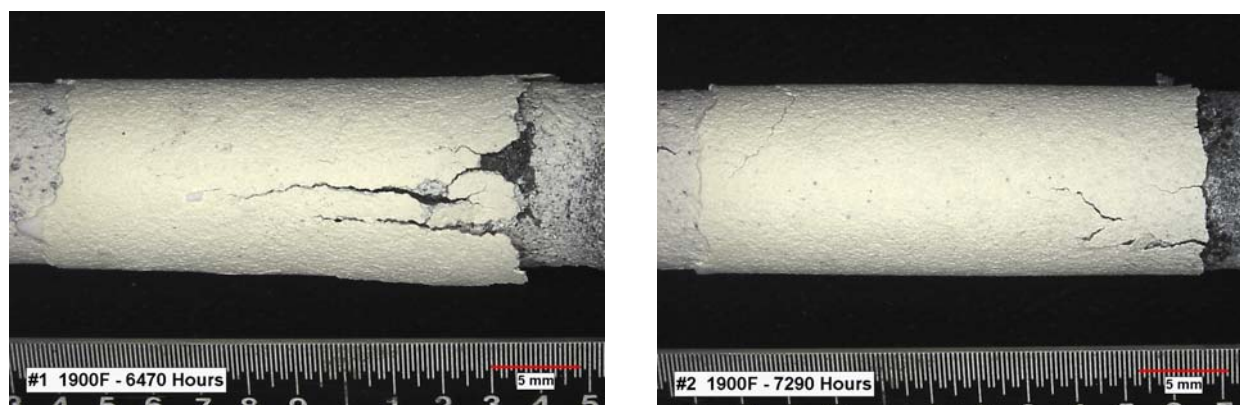
slightly longer life. Typical morphology of cracking or spallation of the TBC on the specimens are illustrated in Figure 5-2

Figure 5-2: Photographs of coated specimens after exposure at 1038°C (1950°F).

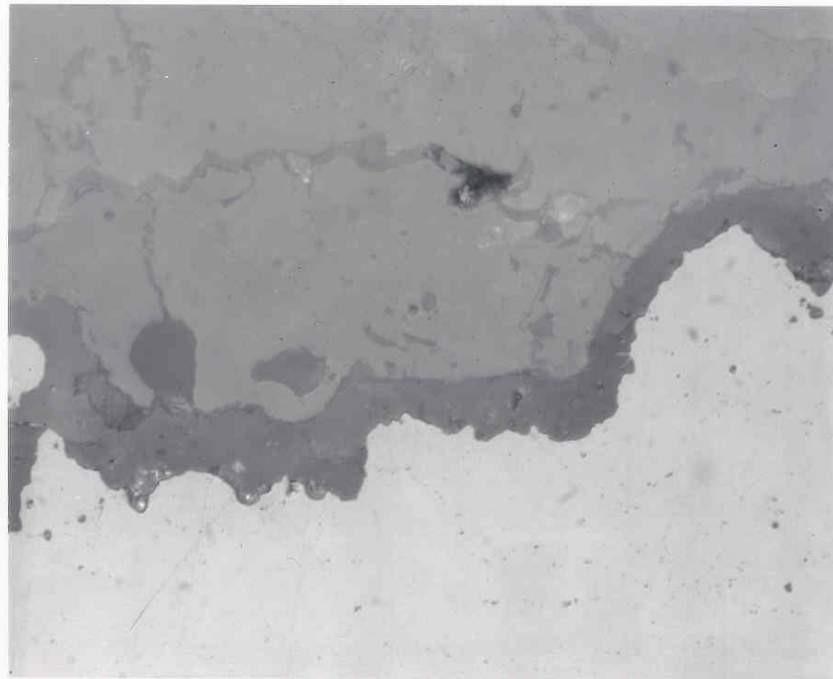
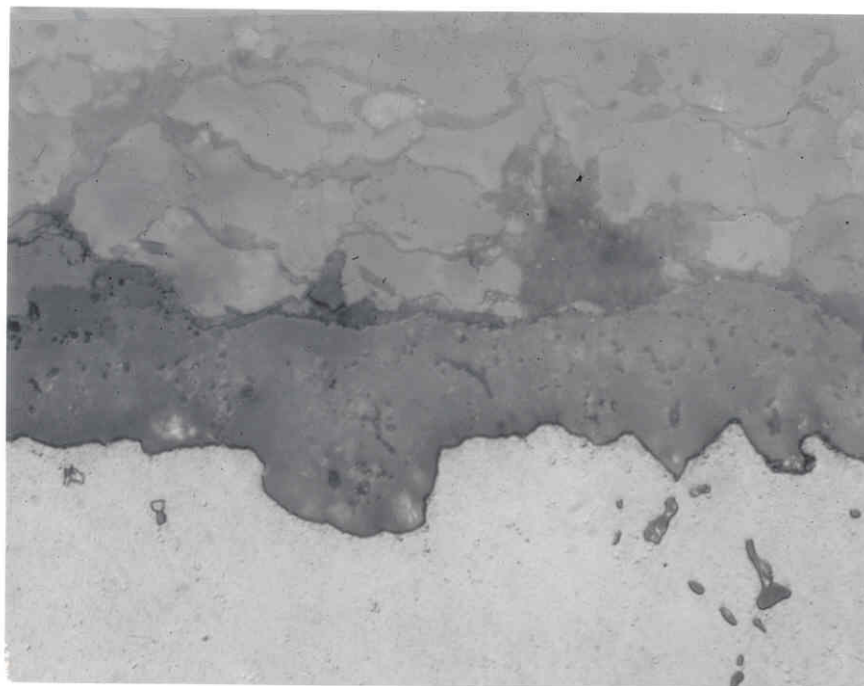
Figure 5-3 Optical micrographs showing variation of TGO thickness (a) after 1510 and b) after 2785 hours exposure at 1066°C (1950°F)

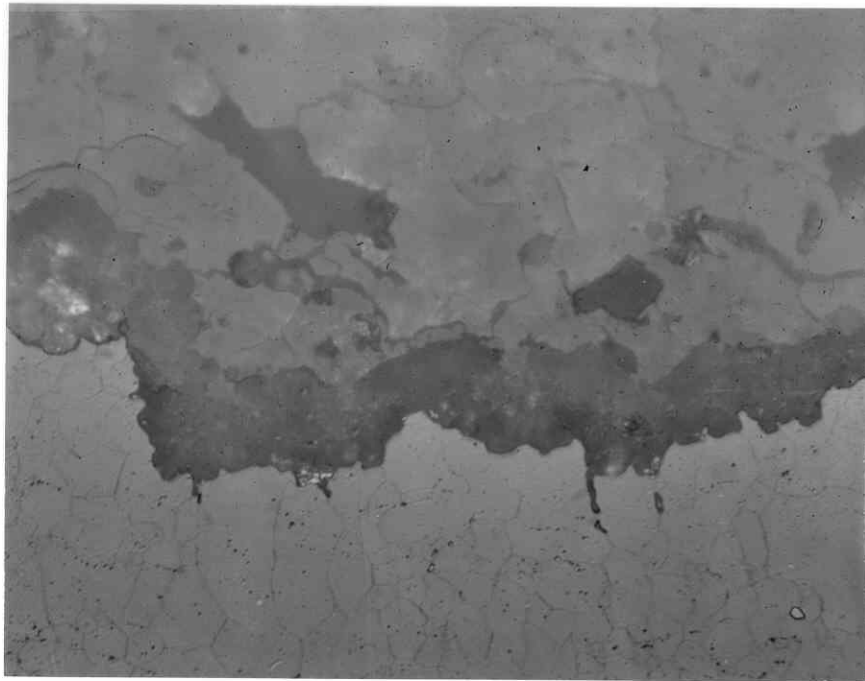
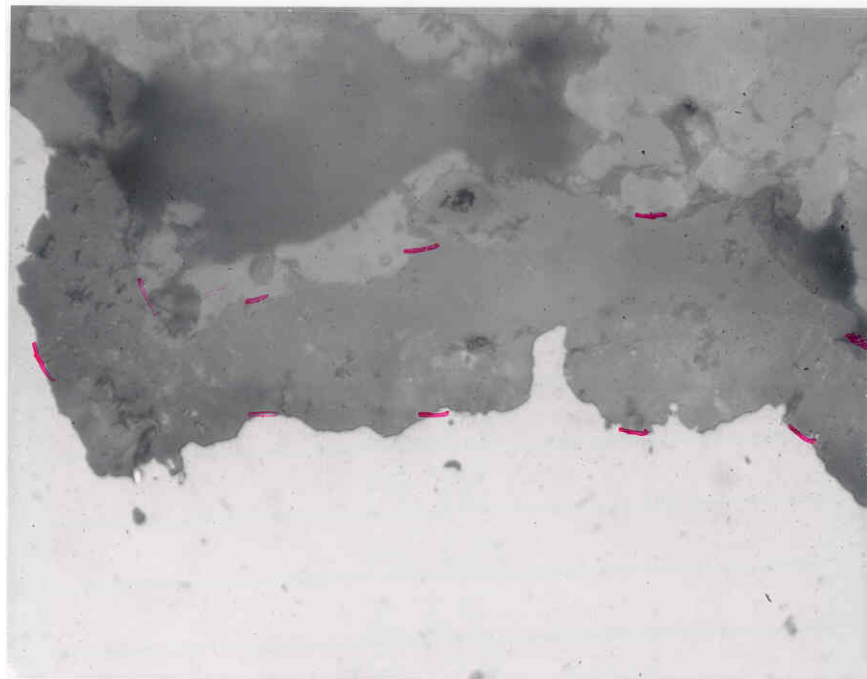
Figure 5-4 Optical micrographs showing variation of TGO thickness (a) after 1510 and b) after 2785 hours exposure at 1010°C (1850°F)

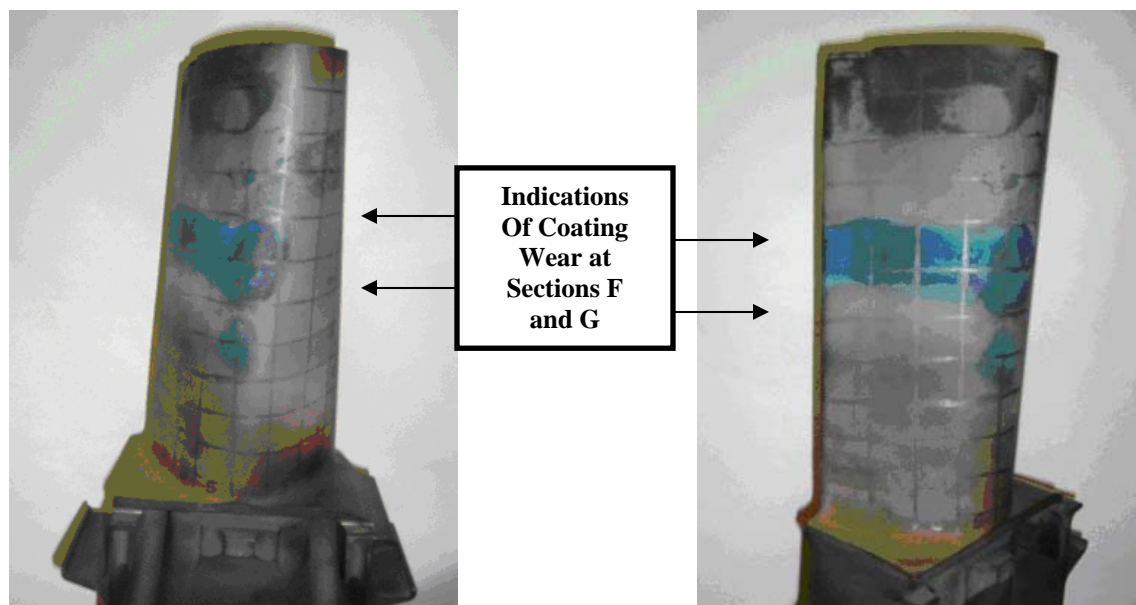
2 shows visual appearance of the blade bucket, where wear (highlighted by the darker gray mark) was noted at approximately 50% of the blade height.

Figure 6-2. Suction Side of Blade 53 showing coating wear highlighted by the darker gray mark

As shown in Figure 6-2, there were obvious areas of coating wear that were noticeable after 12,000 hours of operation. The F-SECT system's flexibility and capability to inspect unknown coating conditions were demonstrated even on the bucket that was found to be magnetic. Having no access to as-coated blade bucket or information about coating conditions, no quantitative coating evaluation was possible.

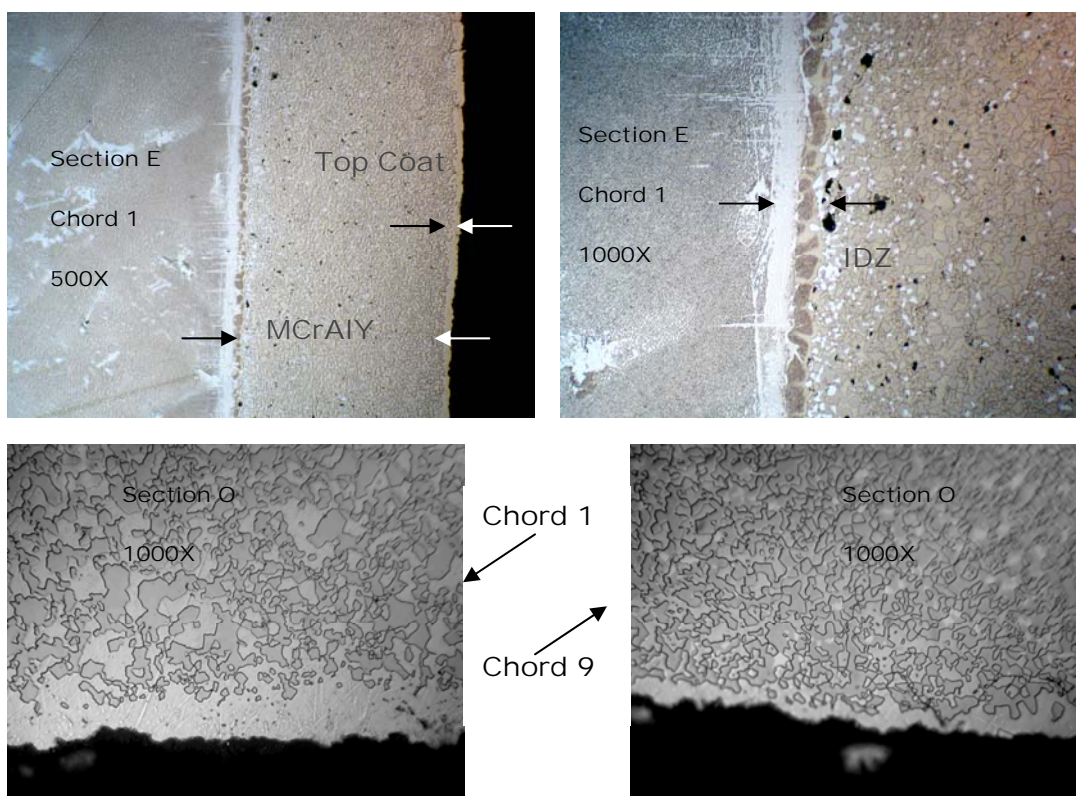
Figure 6-4 shows representative views of the coating conditions from Sections E and O using an electron microscope at respective magnifications. There was no evidence of topcoats or over-aluminized coatings present beside the bond coat.

The indicated topcoat represented either the β -phase depletion of topcoat or beta-phase depletion of top bond coat. In either case, the destructive test results showed no presence of over-aluminized topcoats.

Figure 6-4. Coating Profiles from Sections E and O at Respective Chord Locations Showing Presence of no Over-aluminized Topcoats

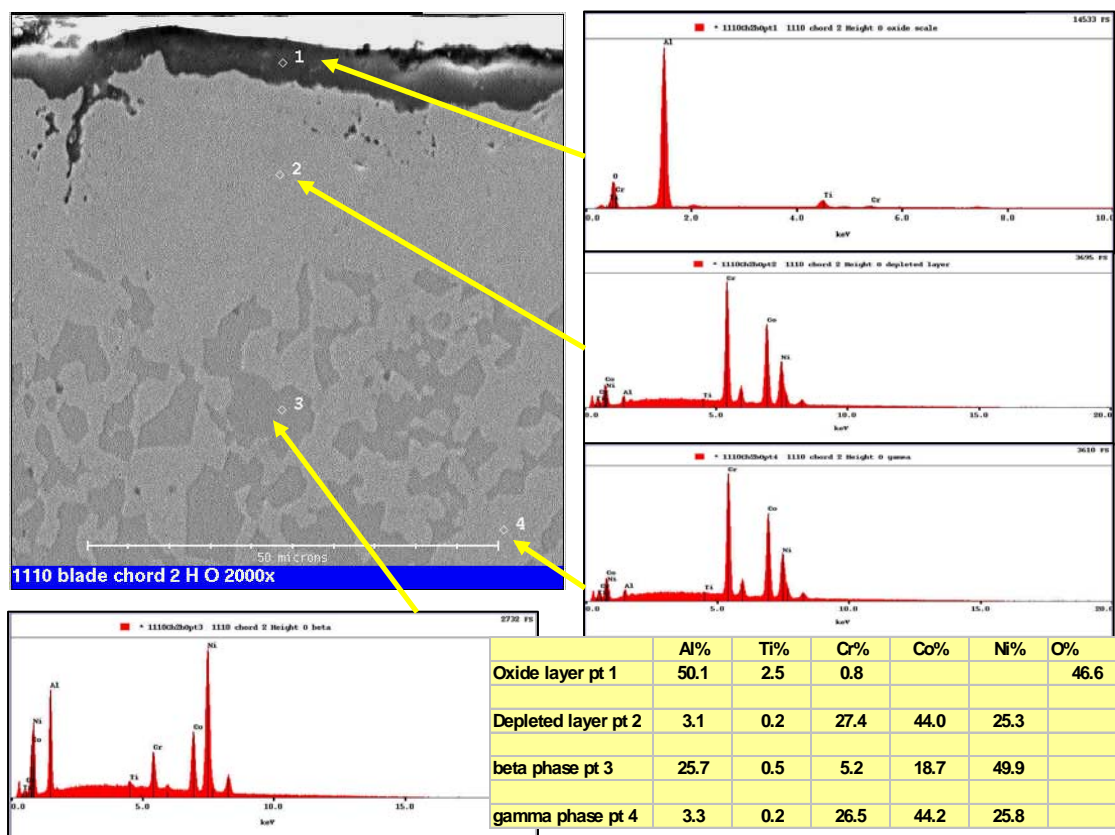
Figure 6-5 shows details of the coating composition from chord O2. The topcoat is devoid of β phase and is replaced by gamma phase. Since the average weight percent of aluminum in the topcoat is around 3% from the maximum of 26%, the topcoat was all but gone. The overall eddy current measurements were reflective of the combined topcoat and bond coat conditions. Without the as-coated sample, it was only possible to monitor changes in the combined effect of both coatings. Because of this condition, the eddy current estimates represented the combined thickness values of the topcoat and bond coat.

Figure 6-5. Detail Coating Composition of Beta- and Gamma-Phase Found in Chord O2

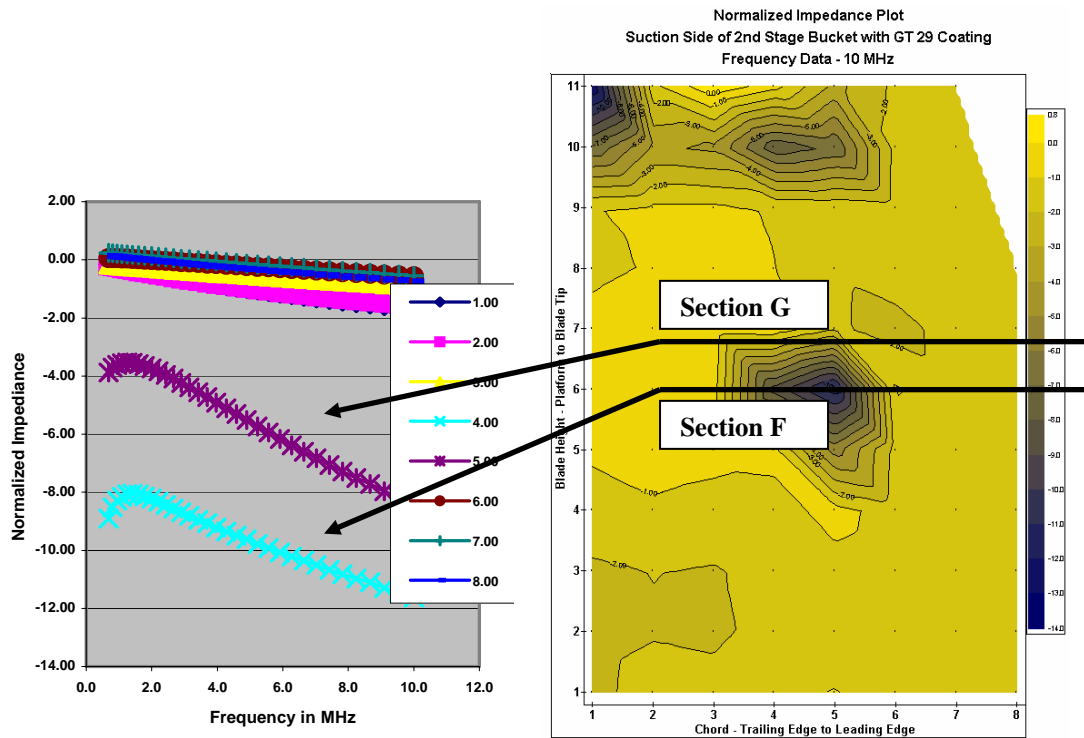
Figure 6-6. Suction side of Blade 53 showing cut lines across Sections F and G and associated decrease in normalized coil impedance values

The next question involved the explanation for the characteristic “hook” pattern observed at a lower frequency (see Figure 6-6). As mentioned earlier, this coated bucket exhibited magnetic characteristics based on the attraction of a small magnet placed alongside each of the outlined grid squares. The areas such as F4 and G4 exhibited stronger attractions than other outlined grid areas. Since the nickel-based GTD-111 substrate alloy is not magnetic, this magnetic behavior is more likely to cause depletion of chromium, which results in chromium oxide deposits. The chemical composition by weight percent for chromium in CoCrAlY coating, based on a literature survey, showed a range of 25-33%. According to the EDS results, the chromium content averaged from a low of 8.4% at F4, 15.6% at F6, and 18.6% at F5. The resultant oxide can be found both on the top scale, which can spall off, and in the diffusion interface. The F5 cross-section showed the presence of a deposit approximately 35 microns thick, while no appreciable deposit was noted at F6. The spectrum analysis by weight percent of deposit at F5 showed 40% carbon, 21% cobalt, 13% chromium, 10% aluminum, 9% nickel, and 7% oxygen. Based on the spectrum analysis of the diffusion interface, the chromium content was found to be 10% at F4, 22% at F5, and 16.2% at F6. So, it's possible that the combined presence of chromium oxide both on the top surface and in the diffusion interface may have resulted in the “hook” pattern noted at F5 but not at F6.

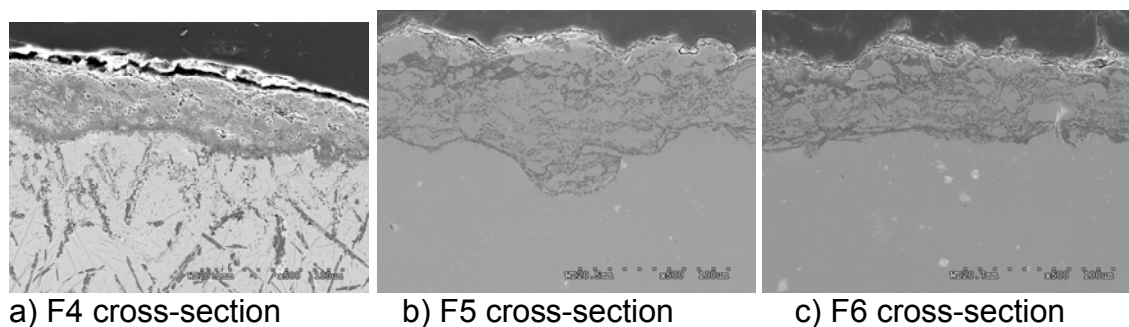
Figure 6-7. SEM photomicrographs of F4, F5, and F6 Transverse Sections

Figure 6-7a) clearly shows oxidation of CoCrAlY coating accompanied by diffusion of aluminum into the base metal. This diffusion process into the base metal is shown as

columnar AlN and finely dispersed TiN precipitates. As will be shown later from the chemistry of coatings by wt %, aluminum is decreased to 10 % along with chromium, which is also down to 8.4%. The oxygen concentration, however, was high at 24.5%. The coating on this F4 section was heavily oxidized and offered no protection to the base metal. These precipitates lead to weakening of the base metal alloy due to high residual stresses. In comparison, no base metal precipitates were visible from Sections F5 and F6. Within coating, no obvious oxidation of the coating was noted except for the oxide deposits on top of the coating. Also, it was possible to see darker β -phase (CoAl) particles dispersed unevenly within gray-colored γ -phase solution. The average coating thickness was 45, 60, and 55 microns for F4, F5, and F6, respectively. Visually, no obvious differences were noted at F5 and F6 but the eddy current responses at positions 5 and 6 clearly showed two different signal responses. Once again, it was necessary to look at the chemistry of coating based on the EDS results in wt% Al remaining. After averaging the spectrum readings, it was determined that aluminum content was around 10% at F4, 12.5% at F5, and 19.9% at F6. These differences in the aluminum content were detected reliably by using the sensitive F-SECT system.

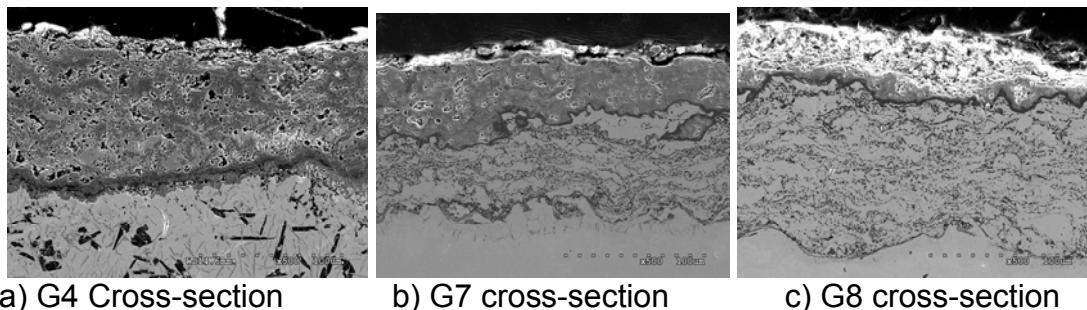
Figure 6-8. SEM Photomicrographs of G4, G7, and G8 Transverse Sections

As in F4, the G4 coating is heavily oxidized, resulting in the AlN and TiN precipitates to form in the base metal. There is no effective coating left at this location. Noticeable deposit layers were observed at G7 and G8, where average deposit thickness was around 55 and 40 microns, respectively. However, the respective coating thickness of around 60 and 100 microns remained with associated aluminum weight percent of 10.5% and 11.8%. Based strictly on the aluminum weight percent, the G8 cross-section should have a slightly higher conductivity value associated with the higher coil impedance values. The eddy current signal response showed just the opposite effect where G7 coil impedance values were higher than G8 coil impedance values. There were no visible oxidation at the diffusion interface at G7 and G8. The spectrum analysis of the interface showed, on the average, 16.4% aluminum concentration at G7 and 11.4% aluminum concentration at G8. Perhaps, this higher combined aluminum concentration at G7 resulted in the eddy current signal responses to be higher at G7 than G8.

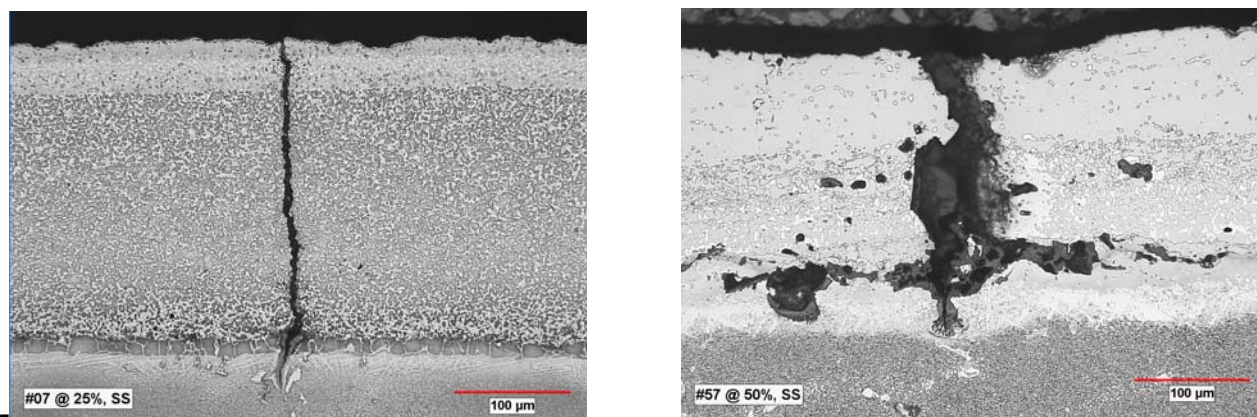
These examinations of the mounts showed that these blades had over aluminized NiCoCrAlY coating (GT 33 Plus). Thermal-mechanical fatigue (TMF) cracks were seen on the convex side of the airfoil near the leading edge of Blade 7. Majority of the cracks in this blade were shallow and only a crack in the blade at 25% height had extended into the substrate. Blade 57 was more severely cracked than Blade 7. On Blade 57, TMF cracks were observed on both the convex (suction) and concave (pressure) sides of Blade 57. Several cracks in Blade 57 at different blade heights were extended into the substrate. Morphology of TMF cracks is shown in Figure 7-3.

Figure 7-3 Optical Micrographs of sections of Blades 7 and 57 Showing TMF Cracks

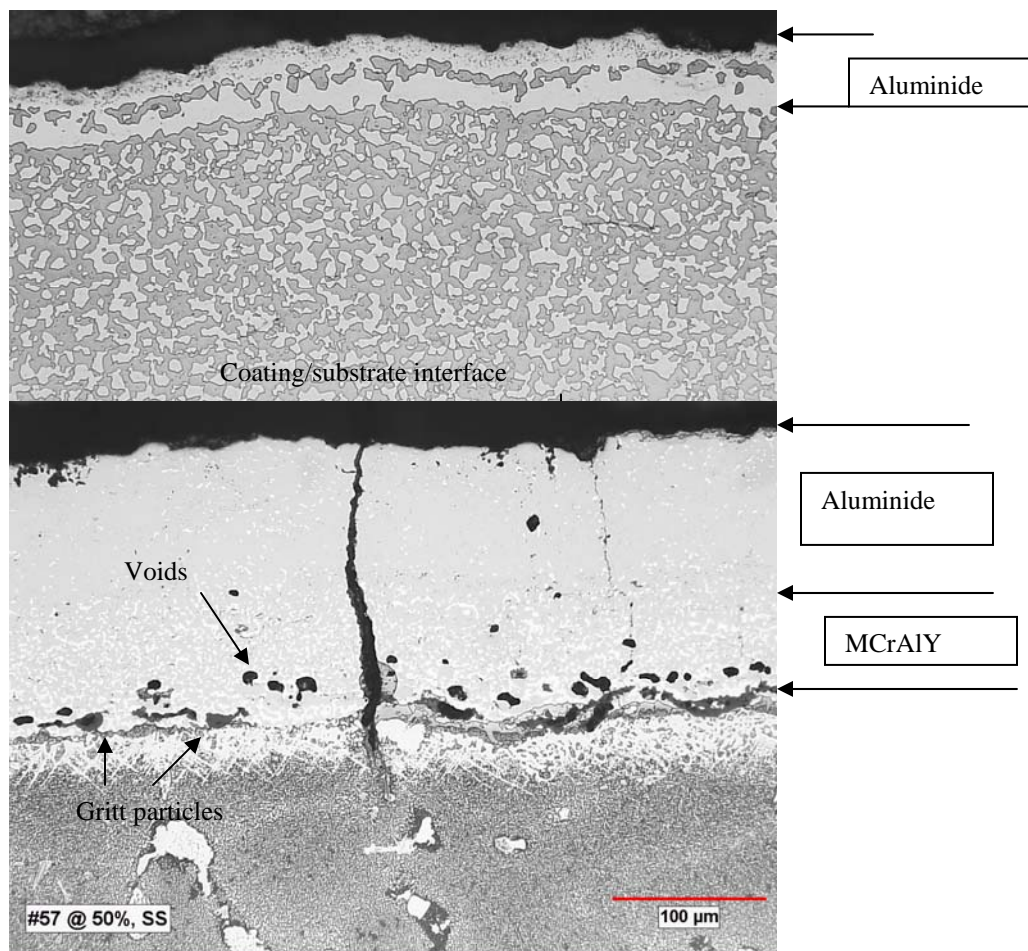
The quality of the coating on Blade 57 was poor. The thickness of MCrAlY and aluminide coatings on this blade was not uniform. In addition, several grit particles were observed at the MCrAlY/substrate interface. Blade 7 exhibited an uniform top aluminide (0.002 inch thick) layer both on the convex and concave sides of the airfoil. Variation of the quality of the coating on the two blades is compared in Figure 7-4.

Figure 7-4. Optical micrographs of coating on Blade 57 and 7 showing variation of aluminide/MCrAlY thickness and grit particle contamination at the coating/substrate interface.

Energy dispersive spectroscopy (EDS) analysis was performed at several locations on the mounts to determine the chemical composition of the coatings. Typical results are presented in Table 7-1. The results showed that the aluminum content in the MCrAlY coating on Blade 57 was significantly higher than that of coating on Blade 7. The higher aluminum content in the coating may have contributed for extensive TMF cracking of Blade 57.
