# **SANDIA REPORT**

SAND2006-6551

## **Laser Engineered Net Shaping™ (LENS®) for the Repair and Modification of NWC Metal Components**

David D. Gill, John E. Smugeresky, Clinton J. Atwood

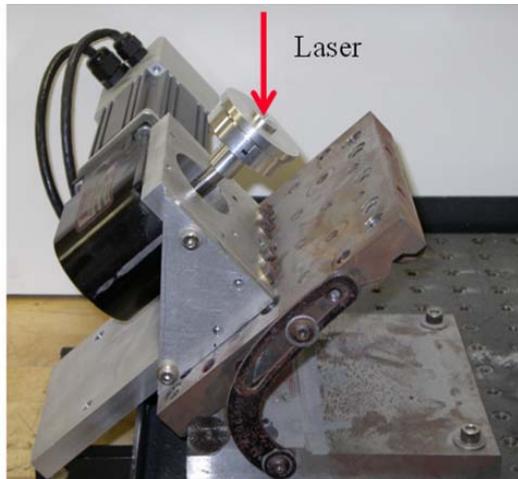
**Figure 1. The Reclamation Weld Bases Were Repaired Using the 4th Axis Mounted in the LENS machine at 45° to Horizontal**

The bore was filled utilizing the 4<sup>th</sup> axis mounted in the LENS machine with the axis of rotation at an angle of 45 degrees from horizontal as shown in Figure 1. This approach was used to allow the laser to deposit material on both the bottom of the bore as well as the walls. Rings of material with decreasing radius were deposited on the bottom of the bore from the OD to the center. The laser then incremented up one layer and deposited the next layer from the outside to the center again. In this way, the bore was filled. In the initial efforts, the rotational speed of the weld base on the 4<sup>th</sup> axis was increased as the radius of deposit was decreased such that the apparent feedrate remained constant regardless of radius. The method presented several challenges, however. As seen in Figure 2, as the laser approached the center of the bore, the heat built up and caused excess powder to be entrained in the melt pool, thus creating a bump. By the second pass, the bump became tall enough to grow into the beam even when the laser was depositing at the outer edge. This caused the beam to be obscured at the outer edge and caused the bump to grow at a very high rate all the time. To address this issue, the rotational speed of the axis was increased near the center to considerably higher speeds than used previously. In addition, the very center of the part was not filled on the first several passes. This allowed good material to be deposited on the walls of the part without any obscuration by the center bump. It did mean that the center material was not of good quality (as shown in Figure 3), but this was not important as the hole was going to be bored again anyway. The center material was just provided to allow the hole to be drilled if desired rather than helically interpolated with a mill which is a more time consuming process.

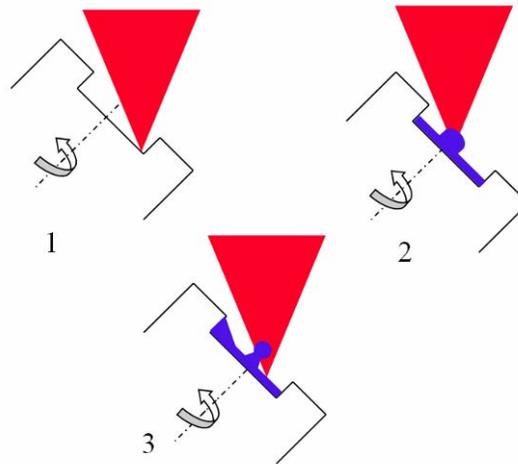
**Figure 2. The Repair Proceeded for the OD to the Center of the Bore with the Axis Greatly Increasing in Rotational Speed for Each Subsequent Ring**

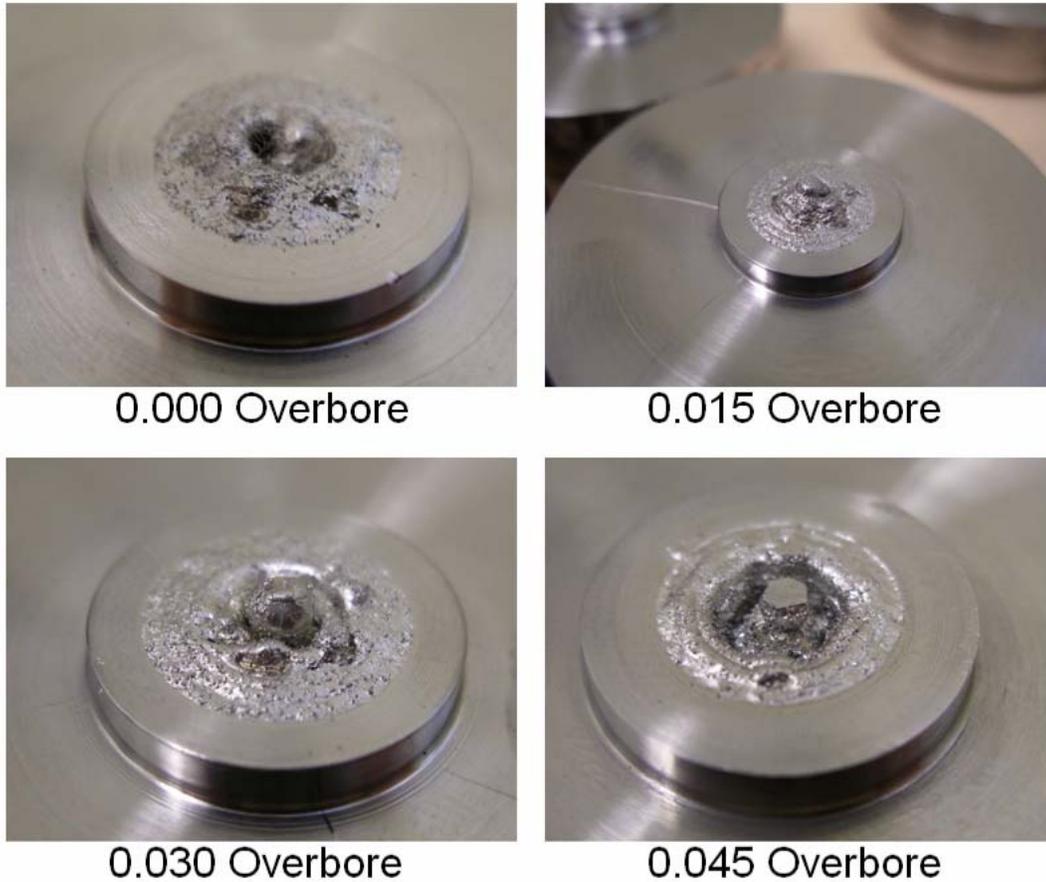
**Figure 3. The Repaired Bores Had Excellent Adhesion at the Walls and Bottom of the Bore, But the Material Was Not Very Good At the Center**

Figure 3 shows the quality of the deposit from a macro standpoint. It is important to note that differences in the quality of the fill are not due to the diameter of the oversize bore, but are instead due to process improvements made throughout the repair of these components. The 0.045" overbore bases were done first and have the worst center bump. The 0.030" overbore bases had the improvement of higher rotational speed at the center of the deposit, and the 0.000 and 0.015" overbore bases had further improvements in not building all the way to the center of the bore with 0.000" having a slightly improved definition of where the final radius should be for each layer. A difficulty of the process development was that the LENS team had a total of 2 process setup pieces which was insufficient. As shown by Figure 3, considerable improvement in the process was made by the 7<sup>th</sup> component (the first of the 0.015" overbore repairs). Additionally, as the amount of overbore changed, the diameters of the deposited rings changed which added another variable to the process development challenges. All of the repaired weld bases are shown in Figure 4.

Because of the difficulty with the center of each hole, an additional weld base was created. In this weld base, instead of building at a 45° angle, a form tool similar to that shown in Figure 16 was used to slightly angle the side walls of the bore. This bore was then filled from the top with the laser perpendicular to the bottom of the bore and the X and Y axes interpolating a circle. This method quickly filled the bore, provided good adhesion to the bore walls, and gave superior appearance to the previous method. Unfortunately, these parts were not completed in time to be included in the testing so the results of this building technique are unknown.

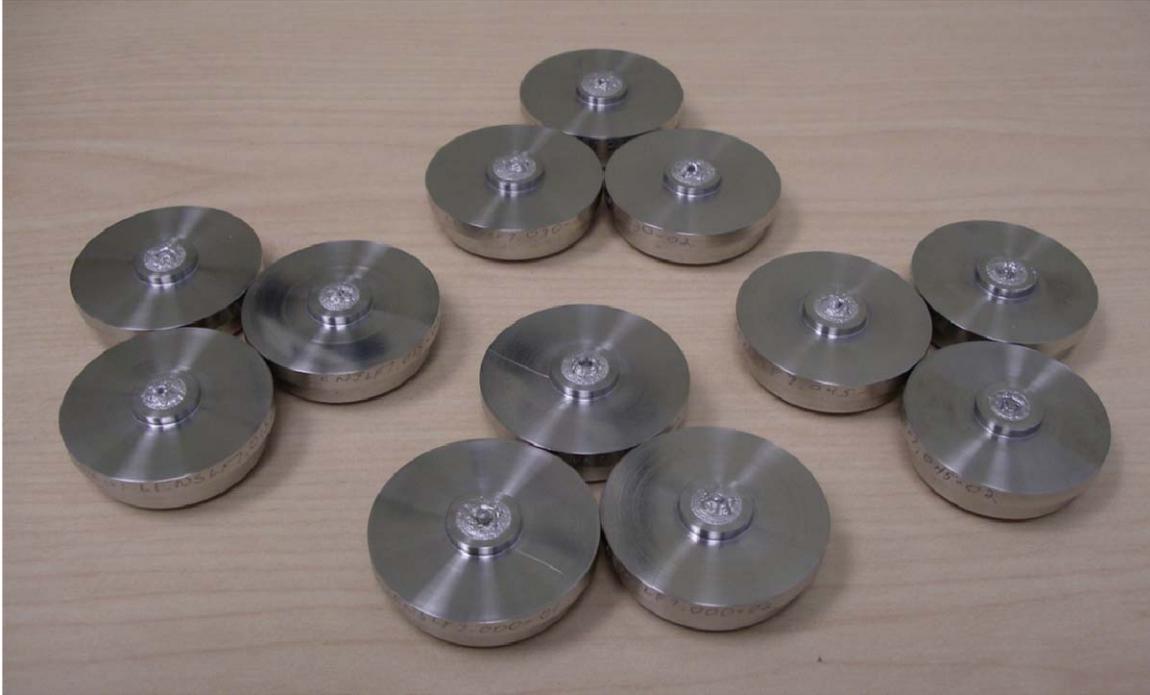
**Figure 4. The Full Set of Repaired Weld Bases with Bore Diameters Oversized by (CW from Left) 0.015", 0.030", 0.045", and 0.000"(Nominal)**

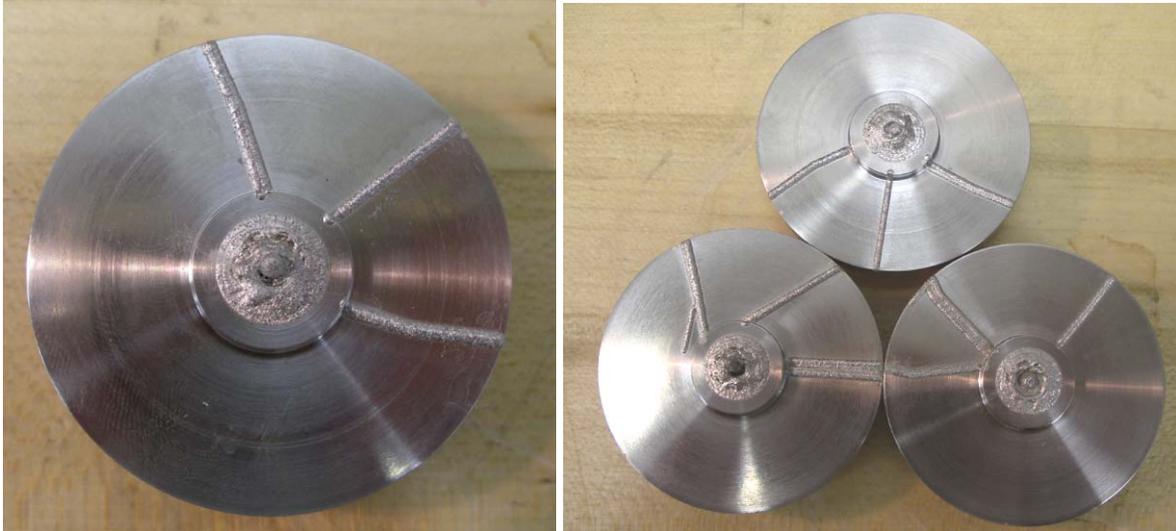
In addition to filling the weld base bores, the bases had surface flaws to be repaired. These flaws were typical of shipping, usage, and handling scratches as might be found on any part that had been through a number of machining processes. The repaired scratches are shown in Figure 5 with the radial deposit lines showing the location of the scratches. The challenge of repairing these flaws is that the flaws were truly random (created with a hand awl) so process planning was a bit challenging. However, by “blipping” the laser on and off, the end points of straight lines were determined that would cover the flaws.

**Figure 5. The Radial Lines are Repaired Scratches on the Surface of the Weld Bases**

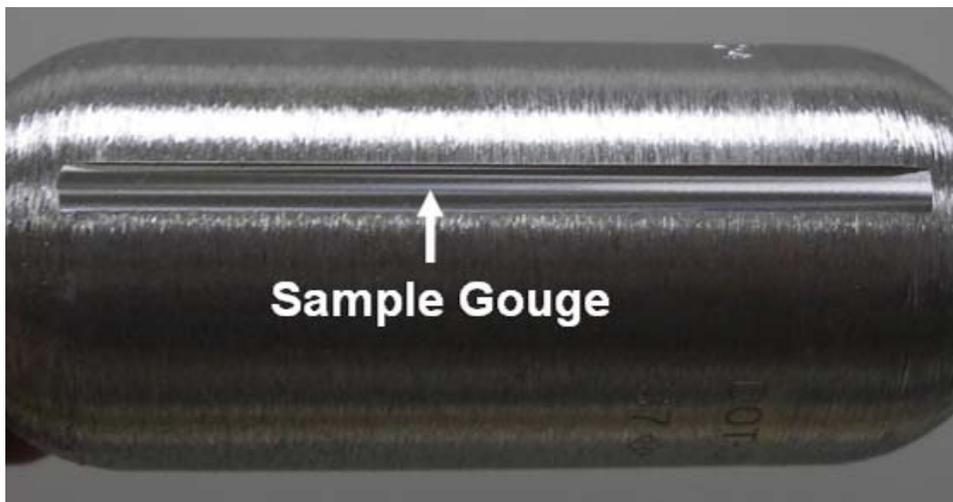
The second set of components provided for LENS repair was gouged sample gas bottles. These items represented bottles that are rejected by the customer if there is any visible surface flaw in the bottles. Sample gouges were put into each bottle. The gouges were 0.100" wide and either 0.010" or 0.020" deep and were made by an endmill as shown in Figure 6. The bottles were positioned in the LENS machine in a Vee block and toe clamped as shown in Figure 7. The bottle was positioned against a pin at the end of the vee block for positioning and a vee block clamp was used to roll the bottle until the gouge was perpendicular to the laser axis and centered. The toe clamps were then lightly tightened to hold the bottle. The laser, set at low power, traced the edges of the gouge to check alignment. The LENS repair then occurred with the laser depositing 2 or 3 layers (for 0.010" and 0.020" deep gouges, respectively) as shown in Figure 8.

Figure 6. Sample Gouge in Sample Gas Bottle. Gouges were 0.100" Wide and Either 0.010" or 0.020" Deep

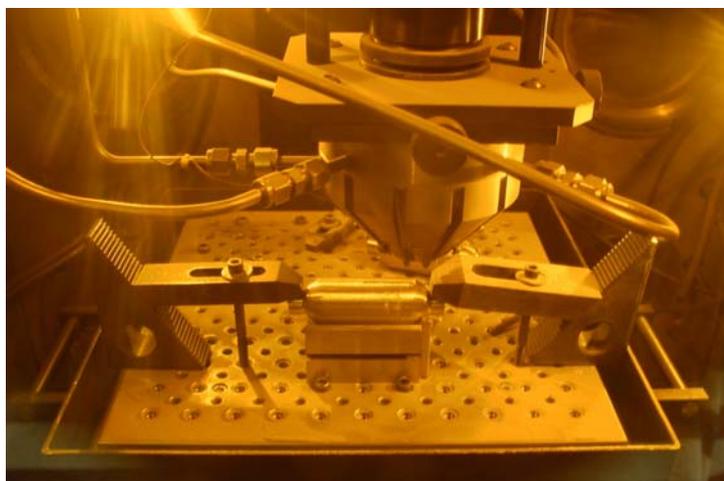
**Figure 8 . Sample Gas Bottle Gouge Being Repaired in LENS Machine**

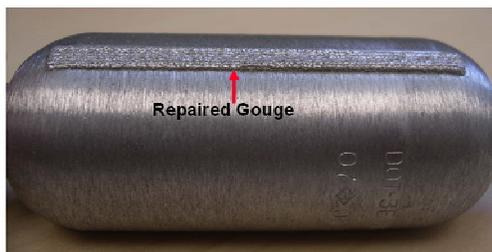
The LENS repairs for the sample gas bottles were generally successful with the repaired gouges looking really good as shown in Figure 9. Upon hydrogen charging and burst testing, the bottles all passed the required pressure before bursting, but the bottles did burst along one edge of the gouge. Further analysis and sectioning showed that the LENS material did not quite fill the bottom corner of the gouge in some cases. This bottom corner of the gouge acted as a stress riser causing failure to occur at the site. To achieve better results in the future, it is suggested that a ball end mill or angled mill be used to make the bottom corner easier to fully fill with LENS material and to remove the stress riser. It is expected that this modification would make the failure much less likely to occur at the gouge location. The process parameters for the bottle repair are given in Table 2 along with the process parameters determined for depositing large blocks for comparison.

**Figure 9. Repaired Gouge in Sample Gas Bottle**

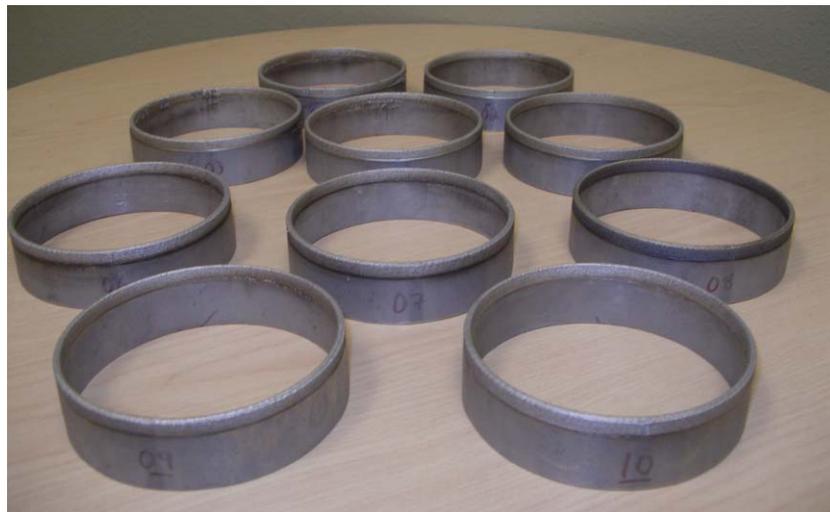
Figure 10. The Full Set of LENS Repaired Step Joint Rings

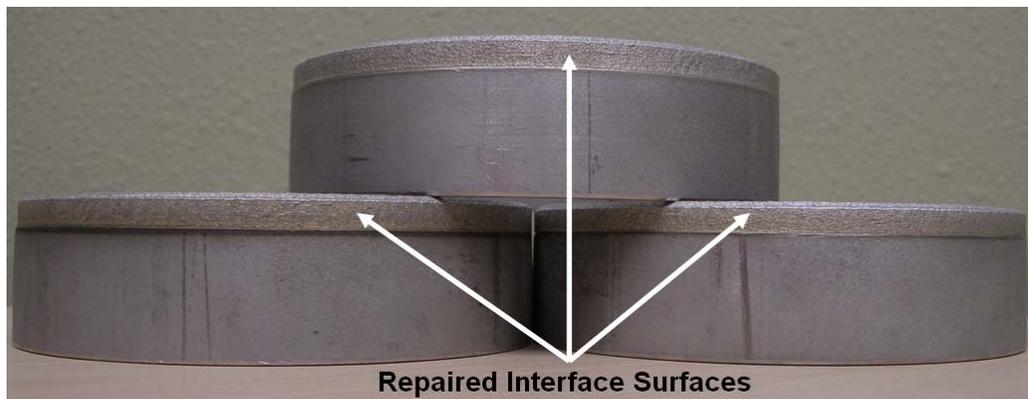
Figure 11. Close Up View Shows the LENS Repaired Section of Step Joint Rings

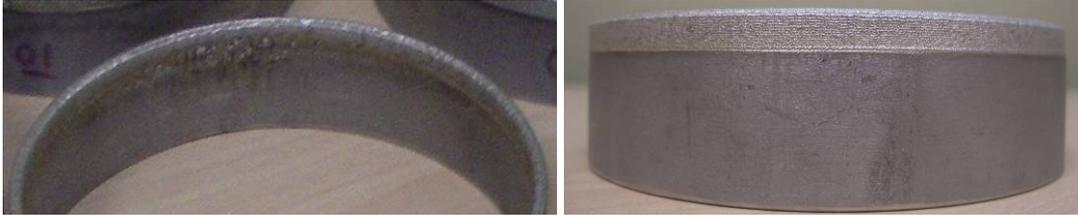
**Figure 12. Some Rings Were Not Very Round Causing The Laser To Fall Down the Side of the Bore Leaving Spatter (Left) with a Round Ring for Comparison (Right)**

The LENS process parameters are given in Table 3 along with a comparison with process development parameters determined on large 304L blocks. The LENS depositing of the step joint rings showed that improved fixturing might be an area of potential improvement. First, the fixturing was done by pinning the ring between 2 bolt heads and a clamping bolt. This method provided too much opportunity to further deform a ring that we already not round. In the future, it would be much better to do these rings with a 3 or 4 jaw chuck that would not only center and positing the ring, but also might help to make it round. The LENS material deposited on top of the ring would then help to hold the ring in a circular geometry. It might also be helpful to mask the lower portions of the ring so that any laser fall off would not cause spatter to adhere to the walls of the rings. A final process improvement would be to randomize the start position of the LENS passes. In this testing, the laser started and stopped at the same X-Y location for each ring deposited. This area then had the seam as well as small irregularities because of the finite time for the laser to develop a melt pool after the shutter opens. The randomization of start location would cause more uniform properties around the ring.

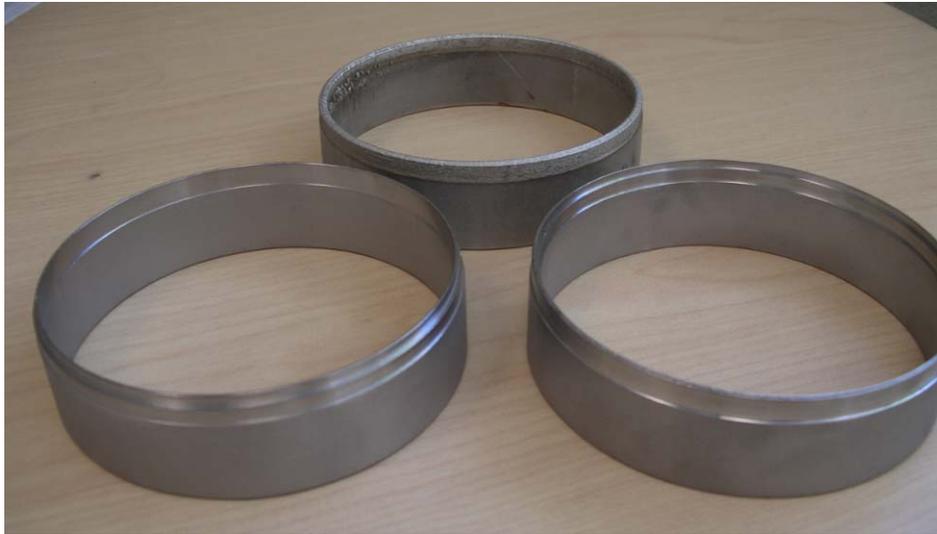
**Figure 13. Two Rings with the Step Joint Machined Into the LENS Material with a Net Shape LENS Ring Shown for Comparison**

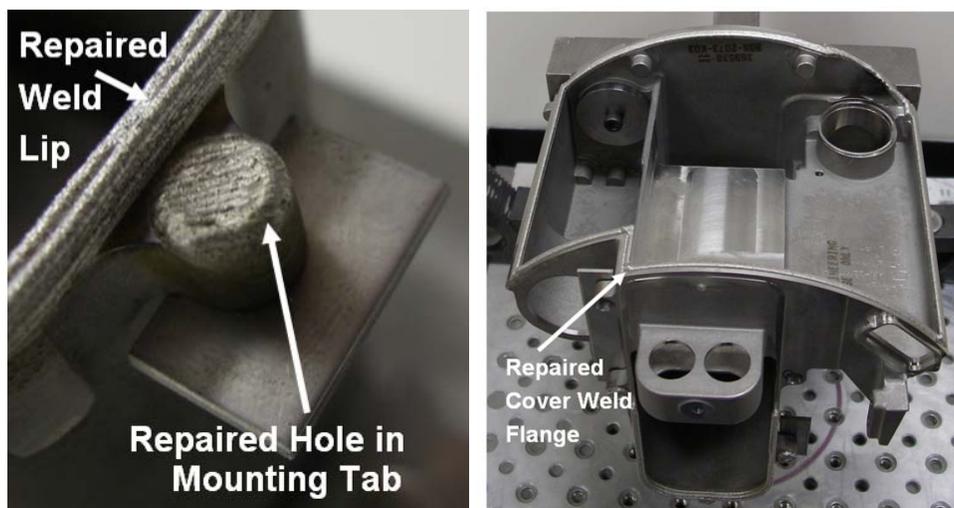
The LENS repair of the W87 Firing Set Housing required deposition on 3 features. These features, shown in Figure 15, were the cover weld flange, the can weld lip, and holes in mounting bosses around the can lip. The cover weld flange and can lip needed to be rebuilt from a machined state and the mounting bosses required that the holes be filled so that they could be drilled and tapped again. The W87 housing is 17-4 stainless and the LENS repair was done with 13-8 stainless, a similar, precipitation hardening material.

**Figure 15. W87 Firing Set Housings Were Repaired by the LENS Process. Repaired Features Include the Can Weld Lip and Mounting Holes (left) and the Cover Weld Flange (right)**

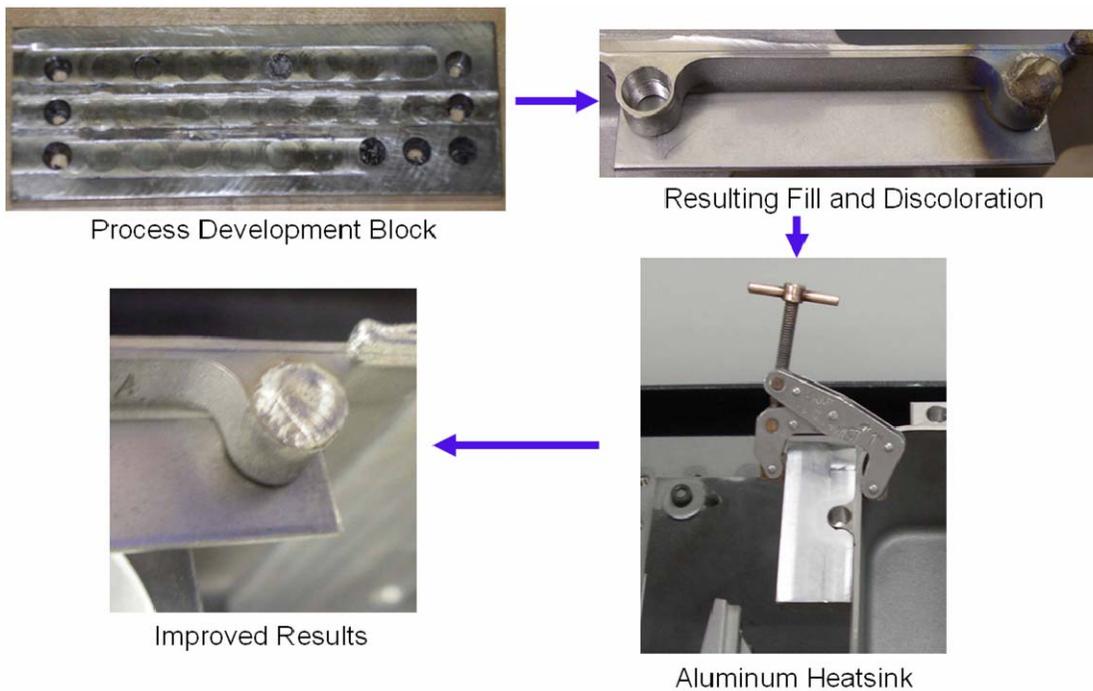
**Figure 17. The Process Development Block for Hole Filling Had Different Heat Conduction Characteristics Than the Real Part Resulting in Discolored Parent Material. An Aluminum Heat Sink was Added and the Hole Filling Improved Significantly.**

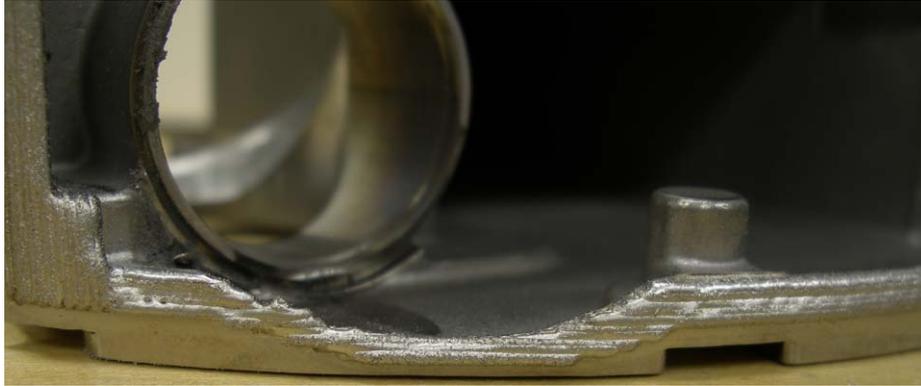
**Figure 18. This Cover Flange Weld Lip Feature Presented Problems Due to No Existing Material On Which To Build the LENS Weld Flange. This Would Be Easier with 5 Axis Depositing or a Different Fixture.**

the weld flange sides, up and over the arcs, and around the compound curve near the fixture. With the newly installed elevation and azimuth rotary axes in the LENS machine, this part would be repaired differently with the part rotating under the laser to keep the incident beam normal to the flange face. The face required multiple layers with 0.020" nominal layer thickness. The face was a challenge to fill because it tended to be thick at the outer edges and sometimes knife-edge thin at the inside edges, thus giving different heat conduction paths. In one location the face was completely missing as is shown in Figure 18. The LENS team attempted build up the face in this location, but was somewhat unsuccessful due to the angle of the incoming laser, a difficulty that would no longer be an issue. Overall, however, the flange was satisfactorily repaired. There was some possible lack of adhesion discovered in the weld flange during the machining stage. In these areas, it is surmised that the LENS deposits for the large arc did not sufficiently overlap the straight passes on the edges of the flange. A process improvement would be to offset the passes on alternating layers to assure full adhesion layer to layer and to eliminate any possibility of voids between hatch lines.

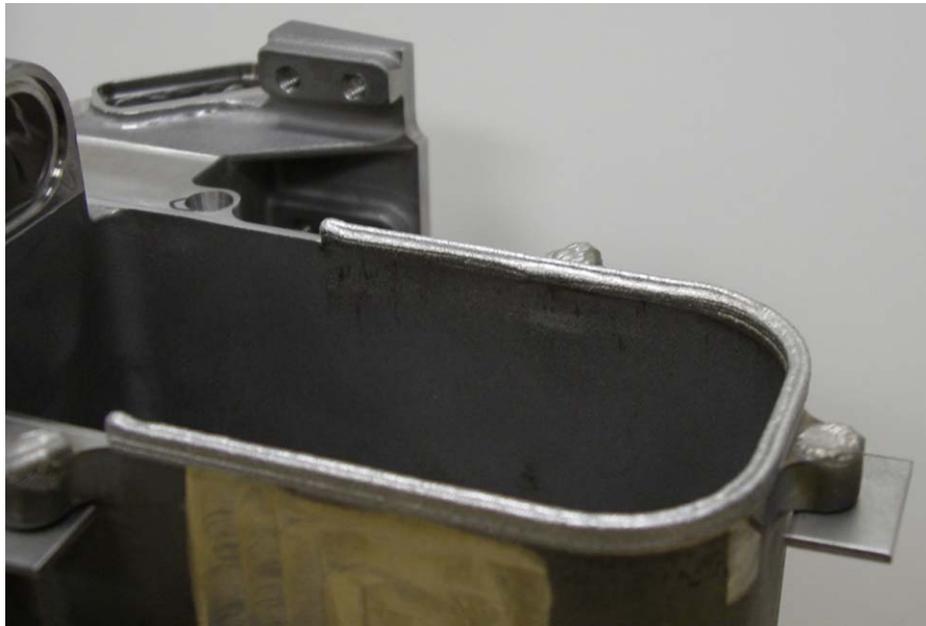
The final repaired feature was the can lip which was repaired by placing two side-by-side LENS passes around the periphery of the can as shown in Figure 15. Again, KCP created a fixture for precise location of the housing as shown in Figure 20. Because of the axis limitations of the LENS machine at the time of the repair, a tall feature at one end of the lip (left side of Figure 21) prevented the entire can lip from being repaired. The feature would not prevent the repair on the current LENS axis system with tilt capability. This repair was easy to align and quick to repair. During testing, it was discovered that there was incomplete bonding between the parallel LENS passes. This incomplete bonding could be easily avoided by programming an overlapping LENS pass in between the two parallel passes.

**Figure 21. The Completed Can Lip and Filled Bolt Holes. Note the Large Feature on the Far Left Prevented the Entire Can Lip from Being Completed. Also Note the Support Plate Used Under Each Hole to Help the LENS Build Start**
