INL Sitewide Operations and Maintenance Report for CERCLA Response Actions—FY 2006

October 2006

Idaho Cleanup Project

DOE/ID-11294
Revision 0
Project No. 23689

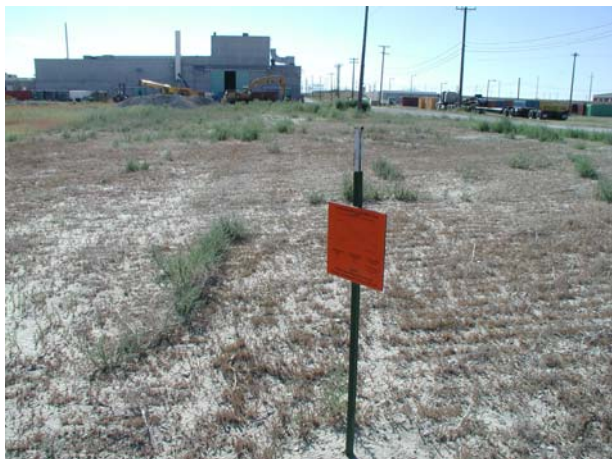
Figure 3. TSF-06, Area B Soil Contamination Area, looking southeast, 2006.

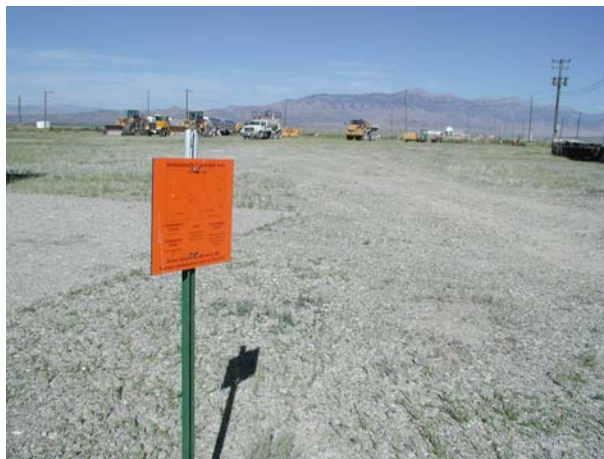
Figure 4. TSF-26, PM-2A Area, looking west, 2006.

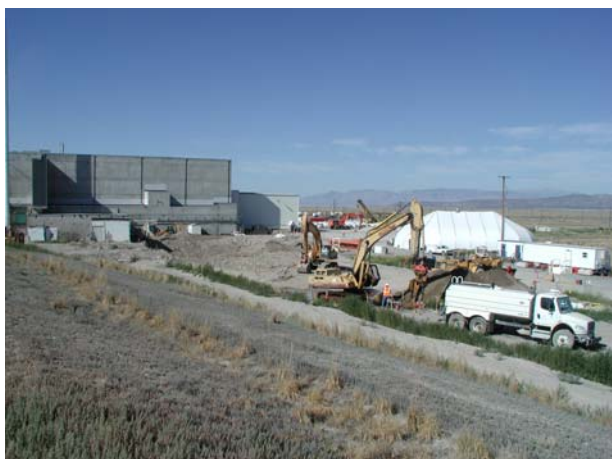
Figure 5. TSF-09 & 18, V-Tanks Site, looking west, 2006.

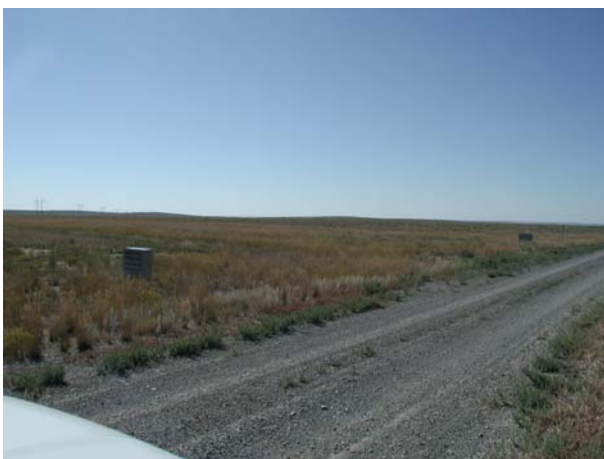
Figure 6. WRRTF-01, Burn Pits II and IVa, looking southeast, 2006.

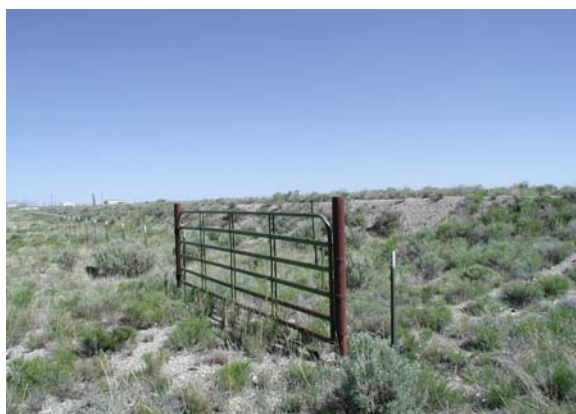
Figure 7. TSF-07, disposal pond, looking west, 2006.

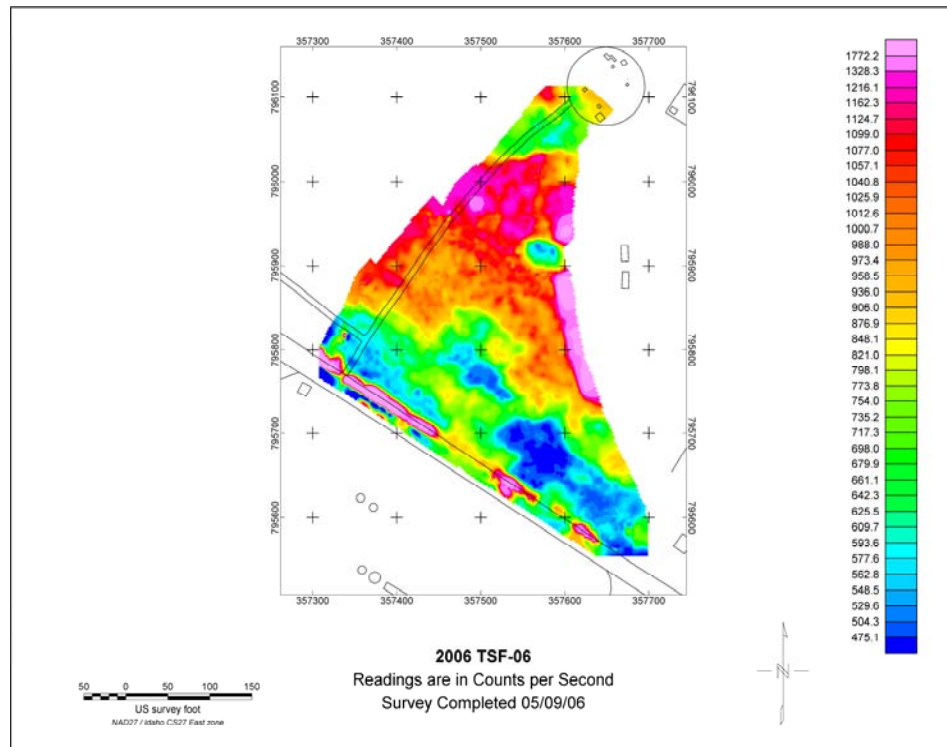
Figure 8. TSF-06 GPRS radiological survey, 2006.

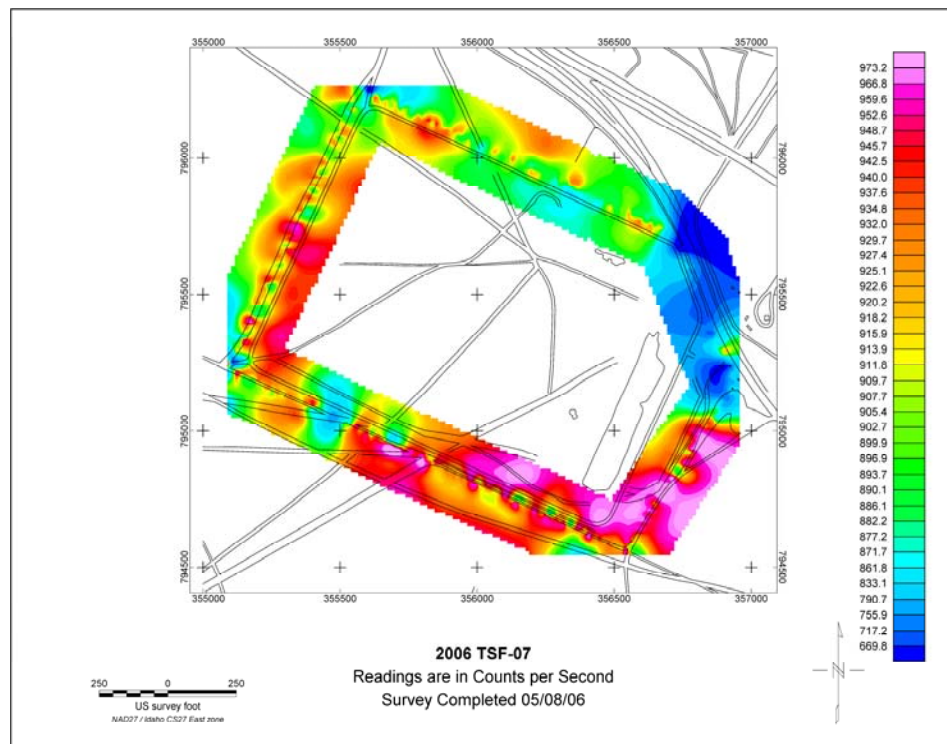
Figure 9. TSF-07 GPRS radiological survey, 2006.

For comparison purposes, results of the annual TSF-07 perimeter scans between 2001 and 2006 are given in Table 1. The data indicate relatively stable yet declining levels of radioactivity for the collective site perimeter.

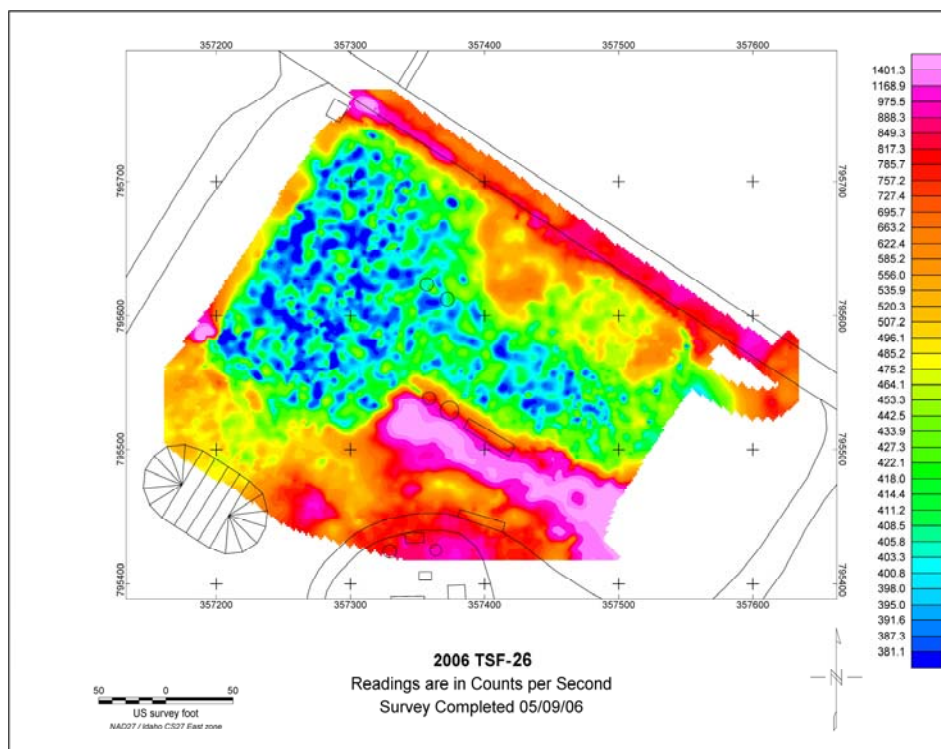
Figure 10. TSF-26 GPRS radiological survey, 2006.

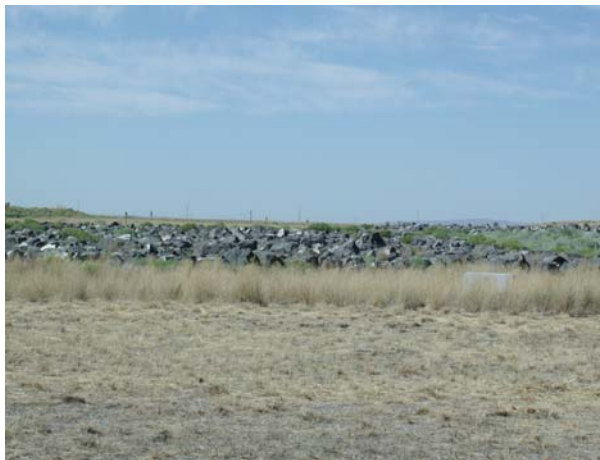
Figure 12. TRA-03 Warm Waste Pond, 2006.

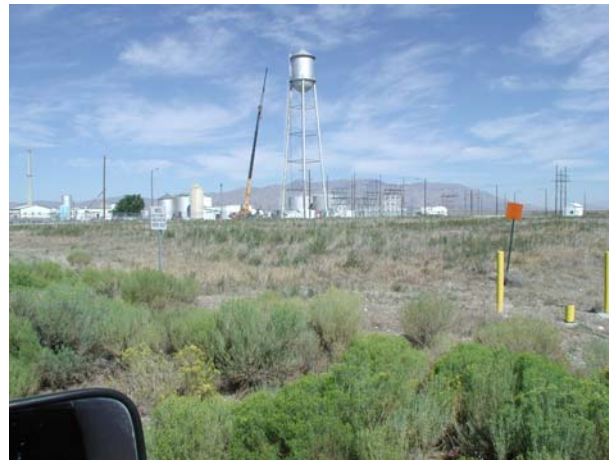
Figure 13. TRA-06, Chemical Waste Pond, 2006.

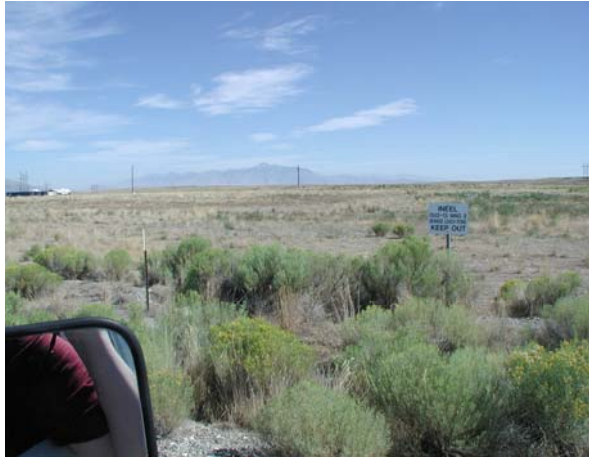
Figure 14. TRA-13 Sewage Leach Pond, 2006.

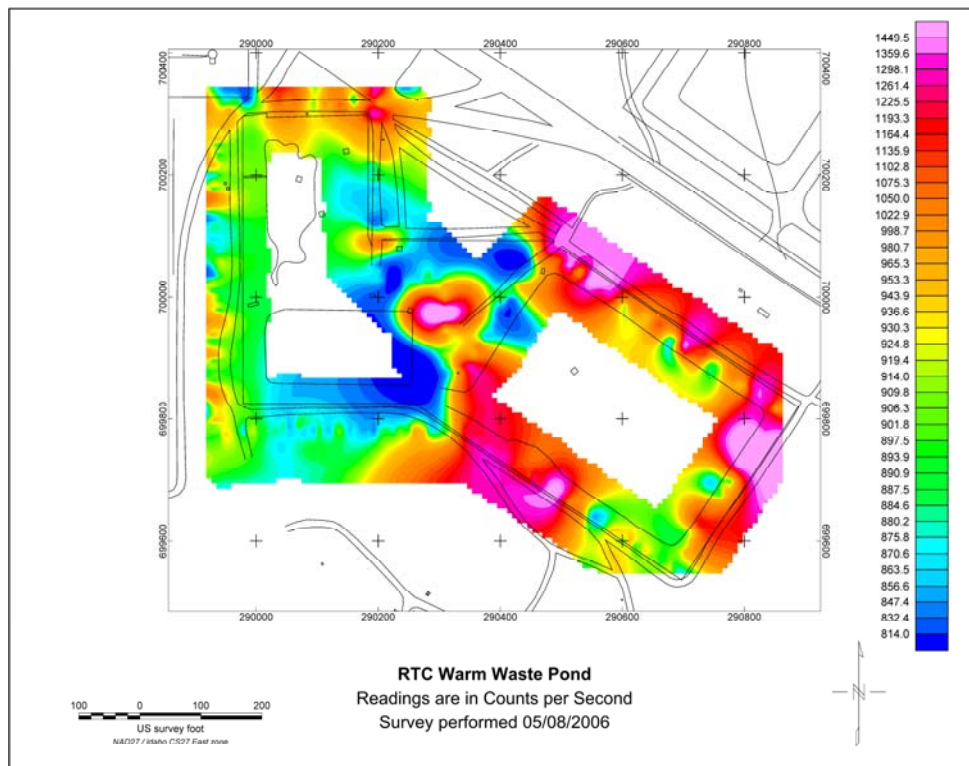
Figure 15. TRA-03 GPRS radiological survey, 2006.

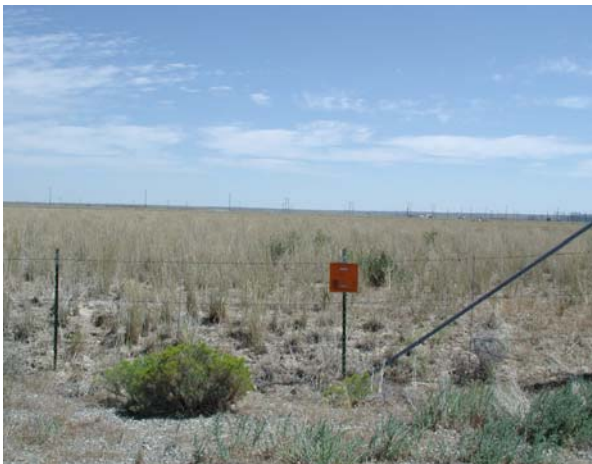
Figure 18. CFA Landfill 1, 2006.

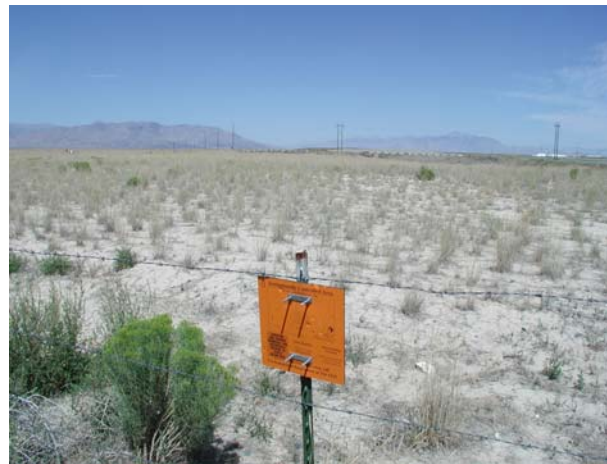
Figure 19. CFA Landfill 2, 2006.

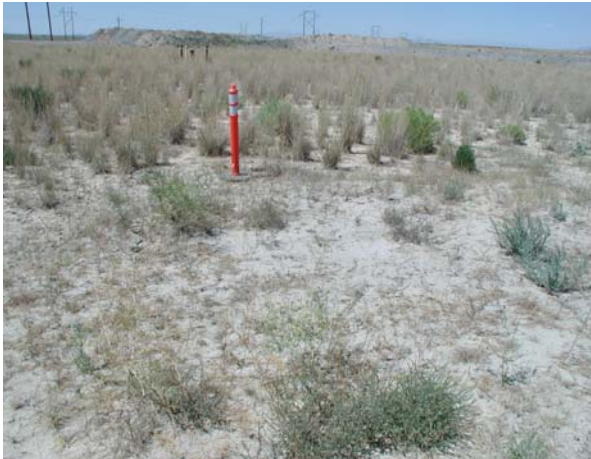
The photograph in Figure 20 was taken in the CFA-03 landfill where subsidence had been reported and repaired in 2004. And although a few small holes were found within the surface of this landfill (see Figure 21), the site appears generally stable. But because subsidence had been reported and repaired in 2004, Table 2 provides a comparison of its measured elevations corresponding with a calculated maximum subsidence from average grade elevation of 2.25 inches.

Figure 20. CFA Landfill 3, at area of former subsidence, 2006.

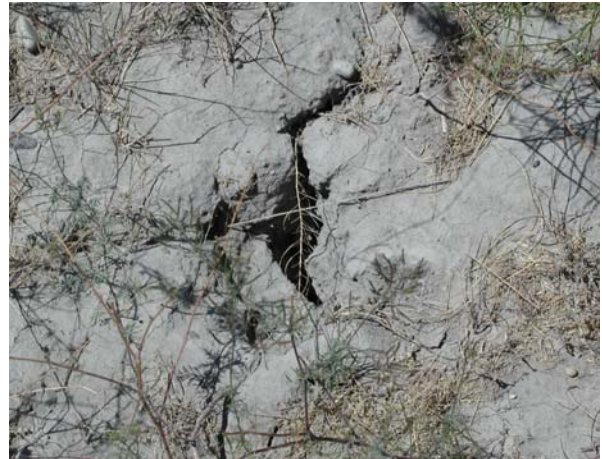
Figure 21. CFA Landfill 3, example of small hole, 2006.

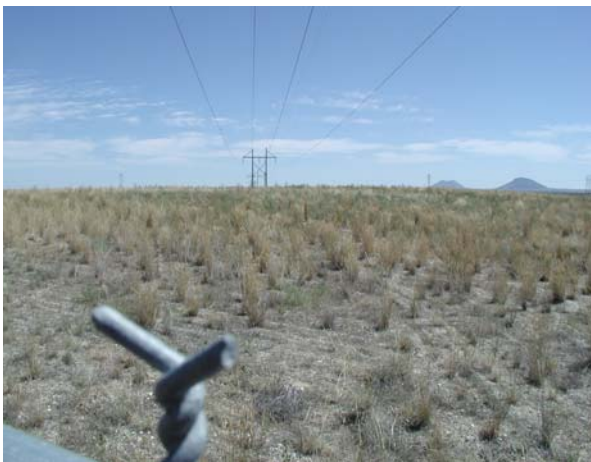
Figure 22. CFA-08, Sewage Plant Drainfield, 2006.

The results of the survey indicate an absence of Cs-137 activity above background in the surface soils of the CFA-08 drainfield cover.

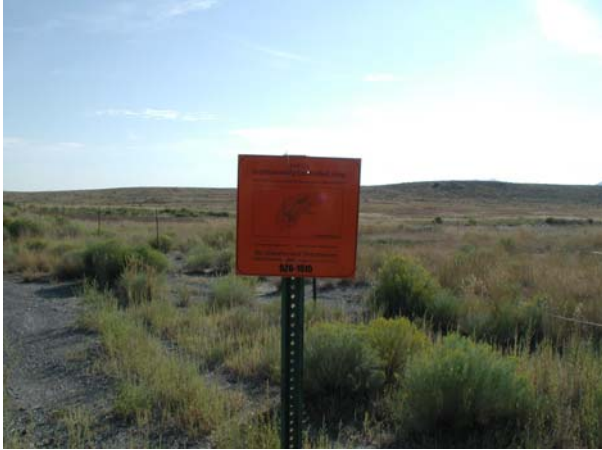
Figure 24. ARA 23 area looking easterly, 2006.

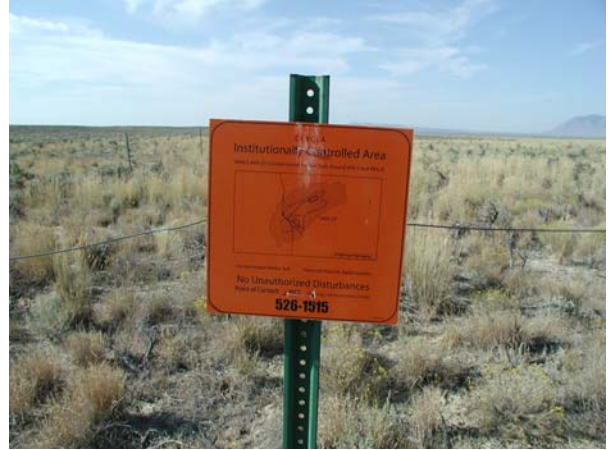
Figure 25. ARA 23 area looking southerly, 2006.

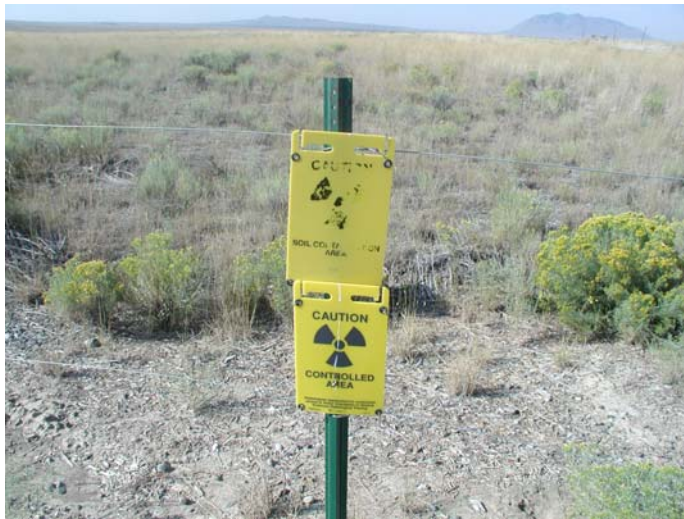
Figure 26. ARA 23 area looking southerly, 2006.

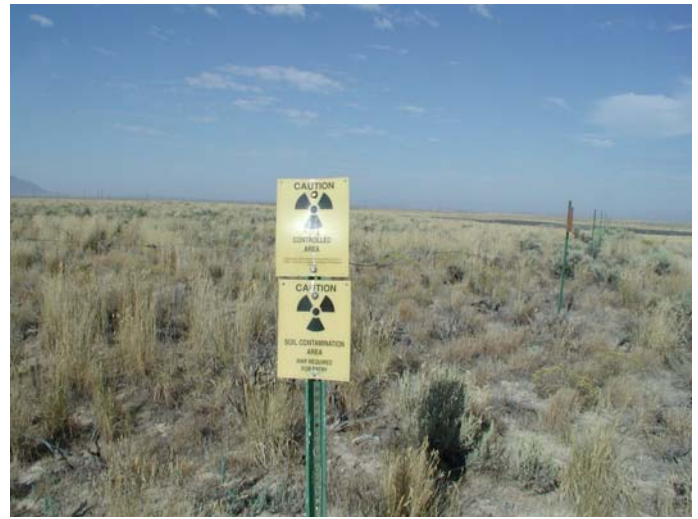
Figure 27. ARA 23 area looking westerly, 2006.

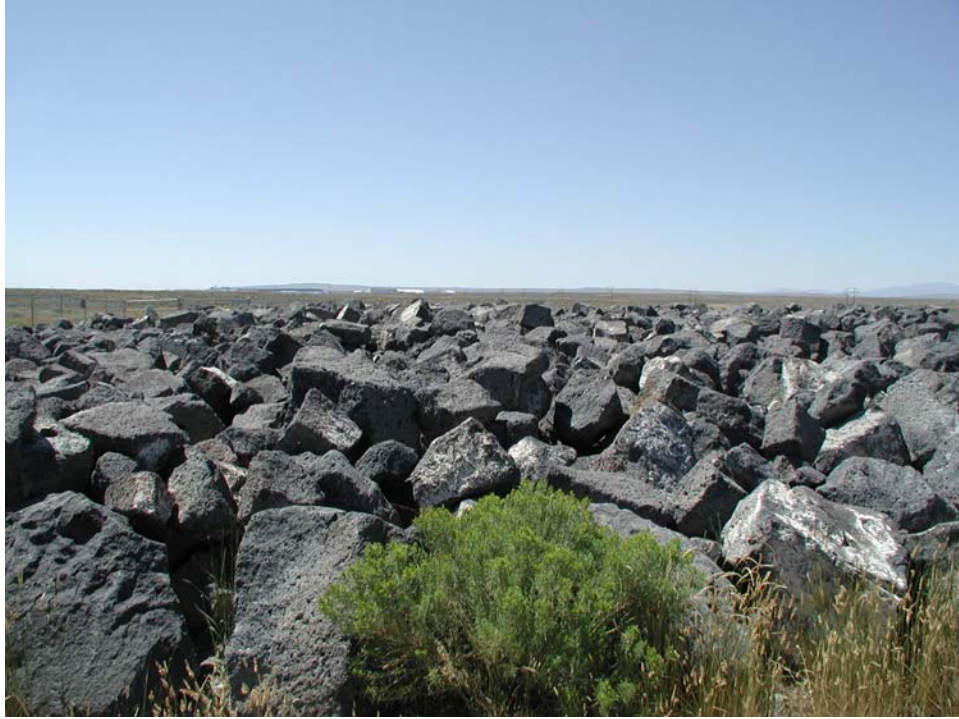
Figure 30. Borax-1 Burial Ground, 2006.

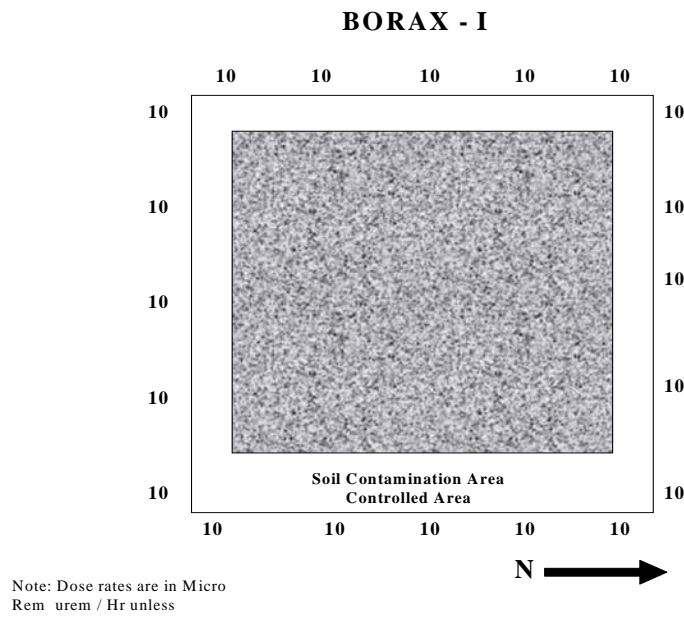
Figure 31. BORAX-01 Burial Ground Annual Perimeter Survey, Log 1472 LE, 08/16/2006, units are microrem per hour.

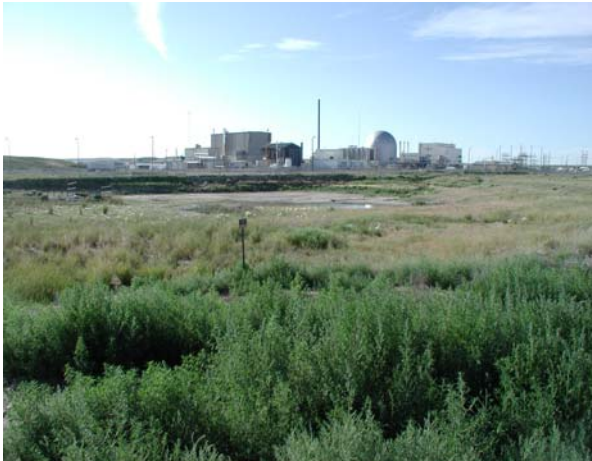
Figure 33. ANL-01, looking southeast, 2006.

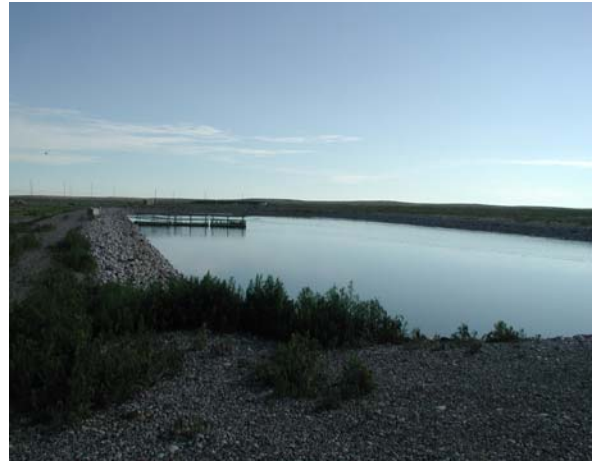
Figure 34. ANL-04, North Pond, looking north, 2006.

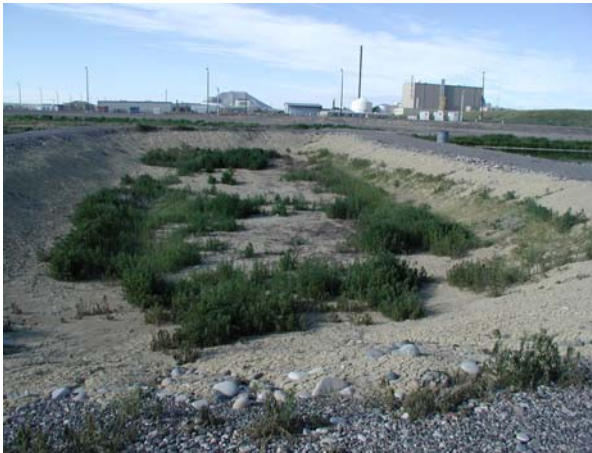
Figure 35. ANL-04, South Dry Pond, looking south, 2006.

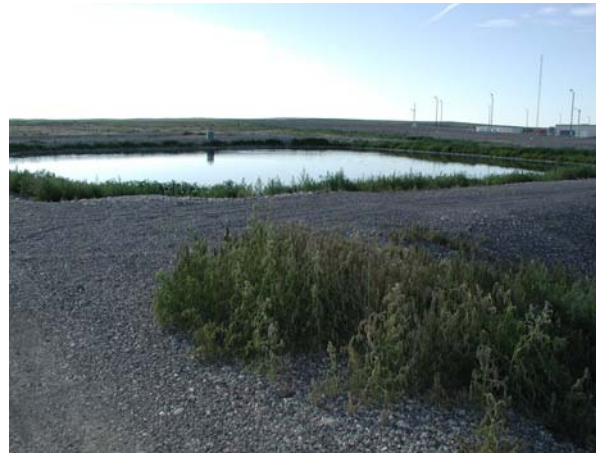
Figure 36. ANL-04, South Pond, looking east, 2006.

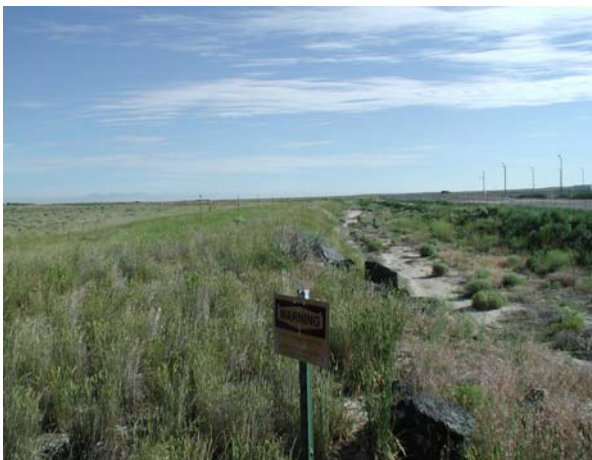
Figure 37. ANL-09, Mound and Canal, looking north, 2006.

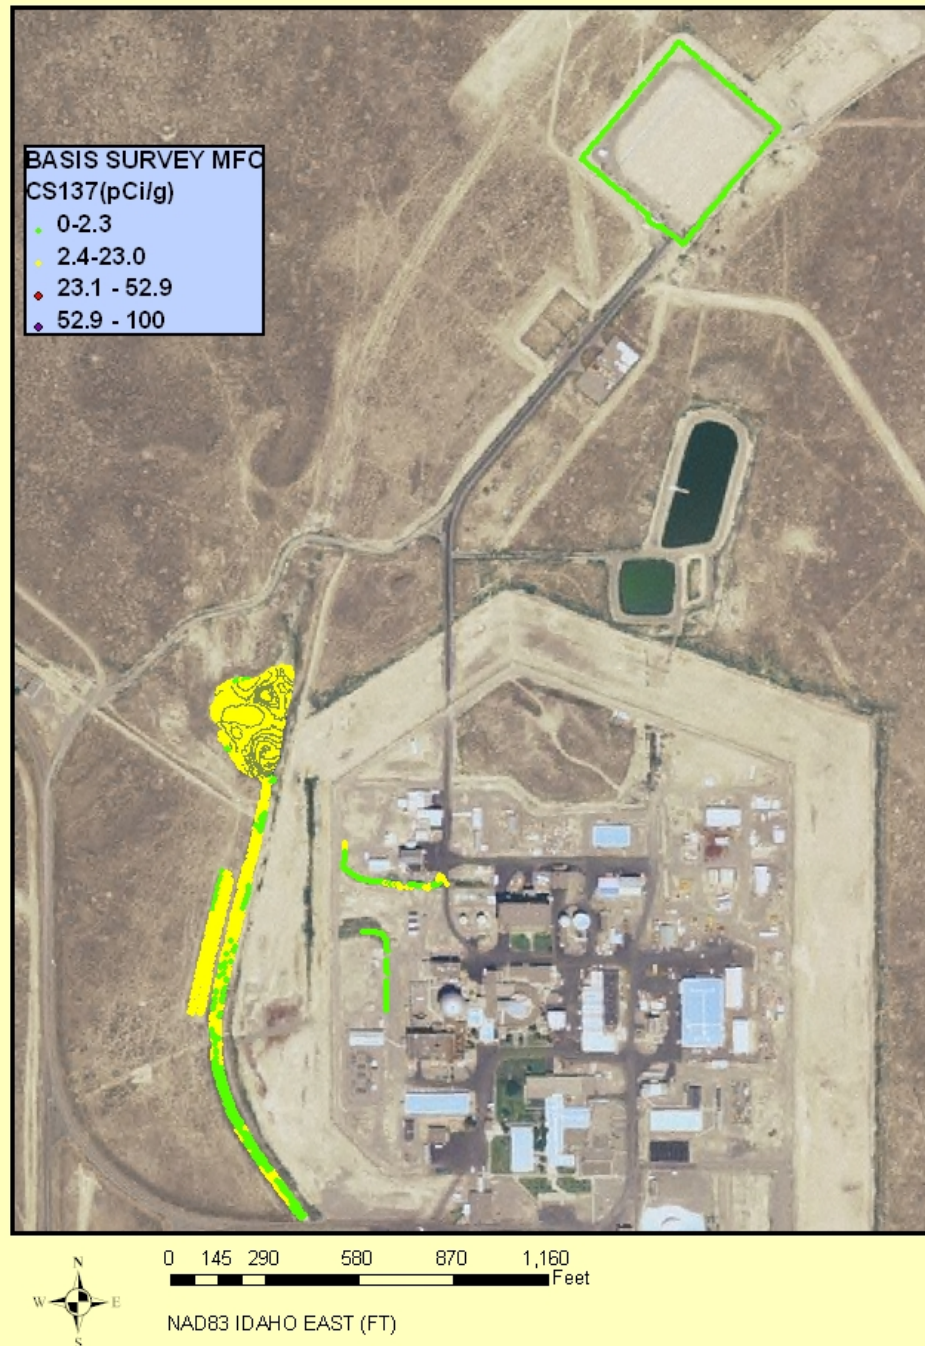
Figure 38. Radiological Survey for WAG 9, 2006.
