Washington Phase II Fish Diversion Screen Evaluations in the Yakima and Touchet River Basins

Annual Report 2005 - 2006

February 2006

DOE/BP-00000652-31

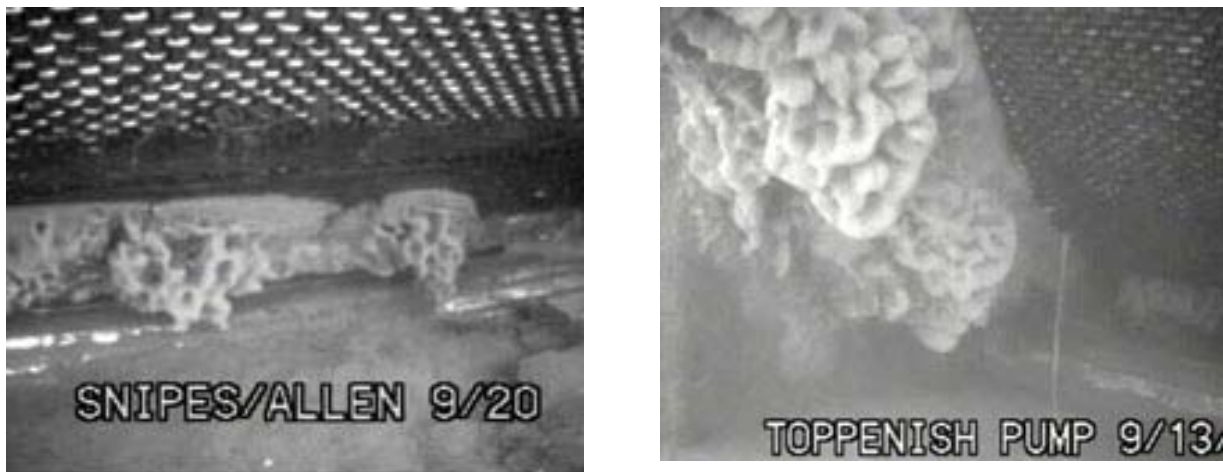
We observed freshwater sponges growing on the drum frames at Snipes-Allen and Toppenish Pump in 2004, but they have grown noticeably larger in 2005 (Figure 5).

Figure 5. Sponges growing on screen frames

One interesting note was the growth of what are apparently sponges on the bottom framework for the drums (Figure 5). These were observed in 2004 but have grown noticeably since then. These should probably be removed before they impact flow patterns and seals.

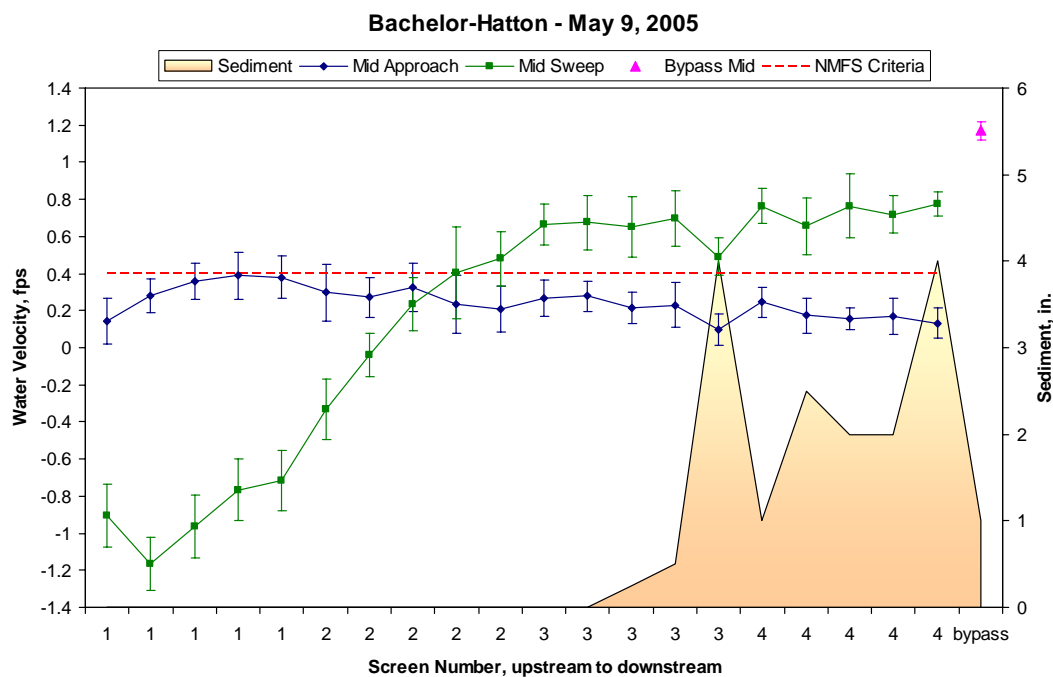
Figure 6. Water velocities and sediment accumulation, Bachelor-Hatton, May 2005. Error bars represent turbulence.

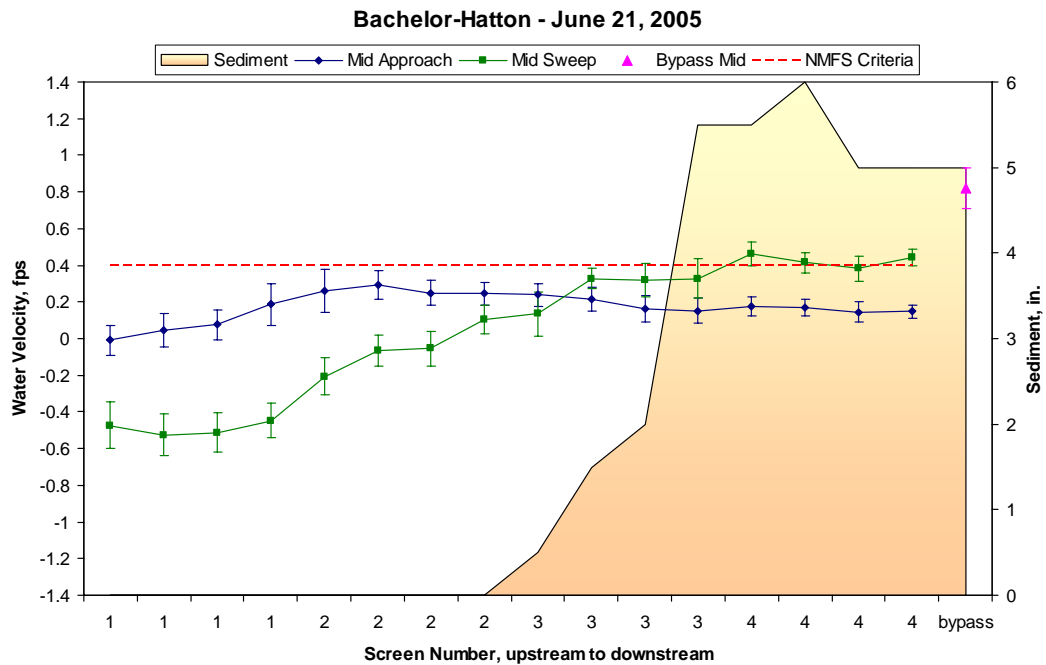
Figure 7. Bachelor-Hatton water velocities and sediment accumulation, June 2005. Error bars represent turbulence.

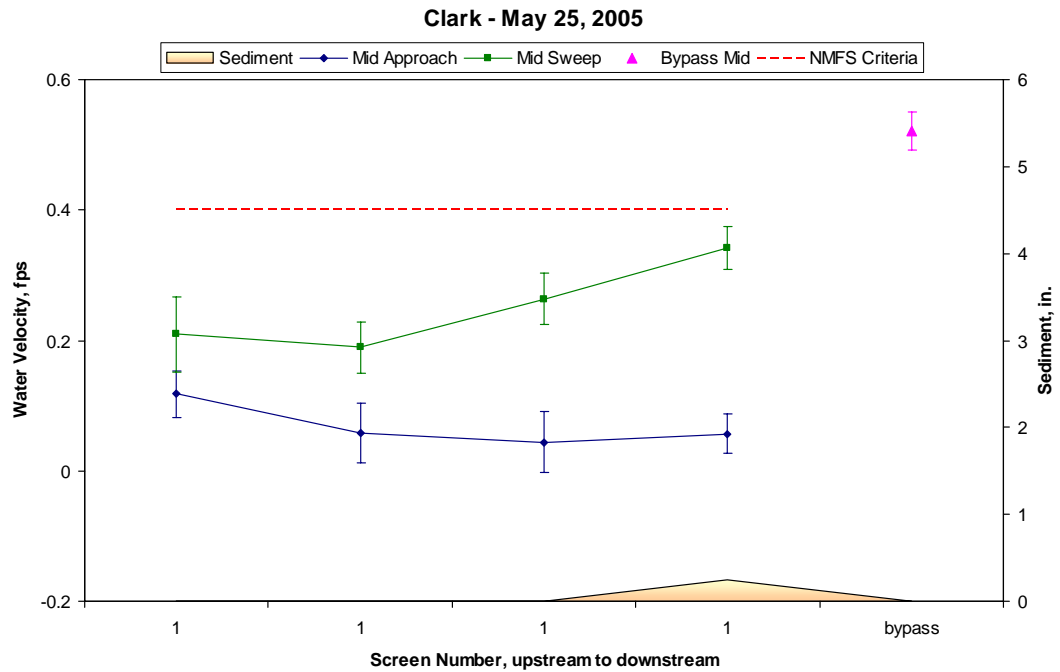
We evaluated the Clark site on May 25, June 28, and September 19, 2005. Submergence was at 74, 56, and 71% from May through September, respectively. Approach velocities all were below 0.4 fps and were always less than the sweep velocities (Figures 8 through 10). Sweep velocities increased toward the bypass in May and September. Water levels were low in June, which caused the site to fall outside NMFS, with less than 2 in. of water spilling over the weir, only 5 in. of water in the bypass pipe, and less than 1 ft of water at the point of discharge. Bypass velocity was slightly higher than the sweep, but sweep decreased toward the bypass. After flip-flop in September, sweep increased toward the bypass. Water flowed smoothly over the weir and through the bypass during all evaluations. There were no problems with water overflowing the headgates as in previous years.

Figure 8. Clark water velocities and sediment accumulation, May 2005. Error bars represent turbulence.

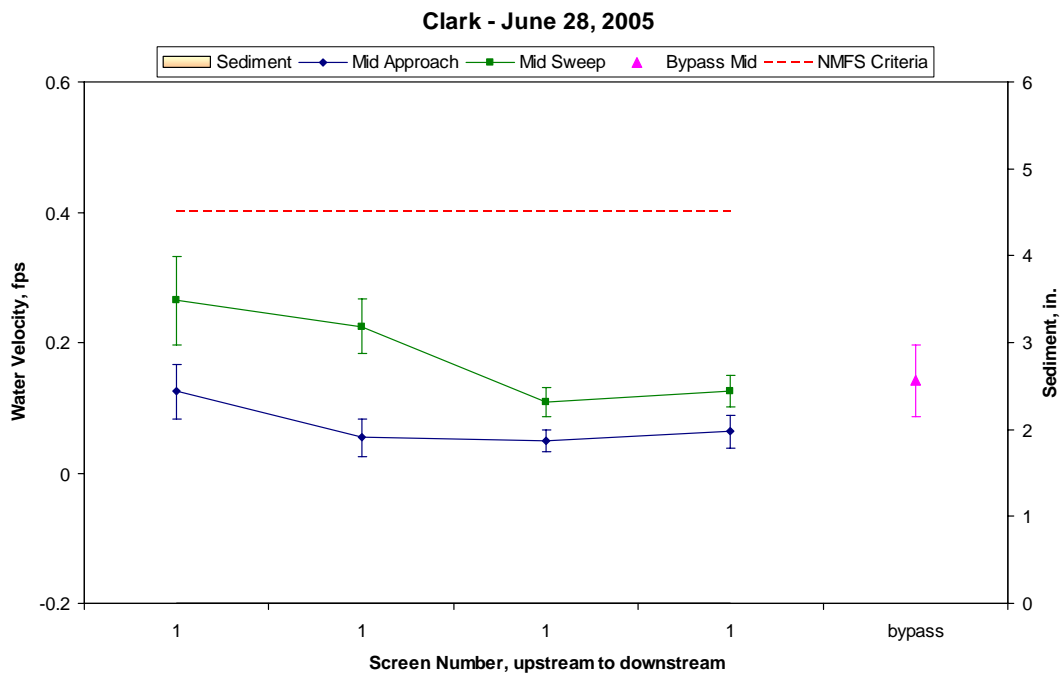
Figure 9. Clark water velocities and sediment accumulation, June 2005. Error bars represent turbulence.

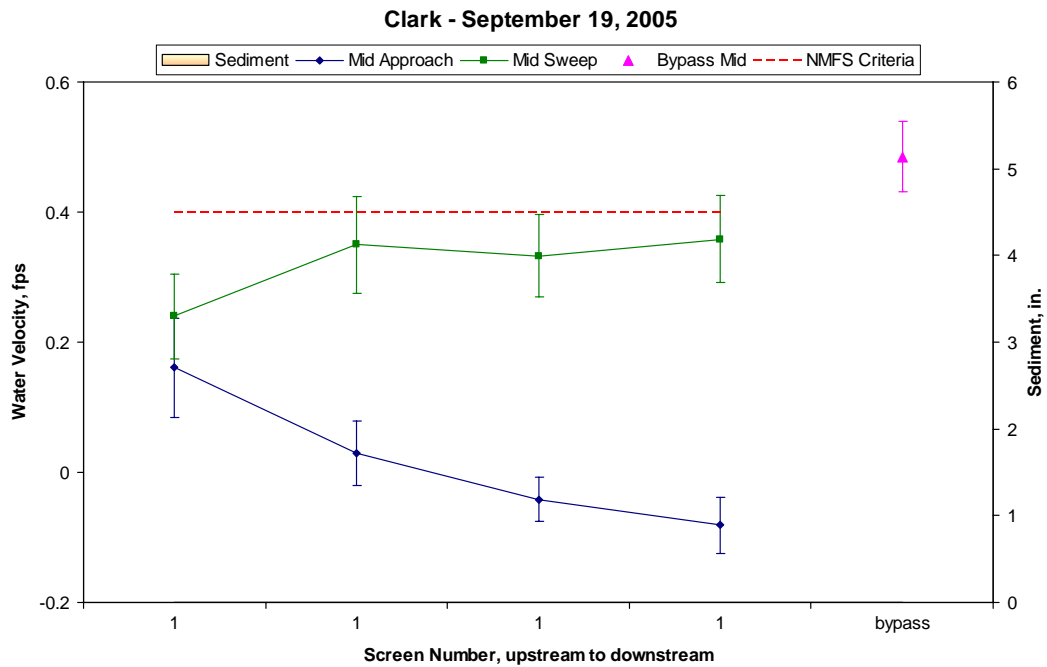
Figure 10. Clark water velocities and sediment accumulation, September 2005. Error bars represent turbulence.

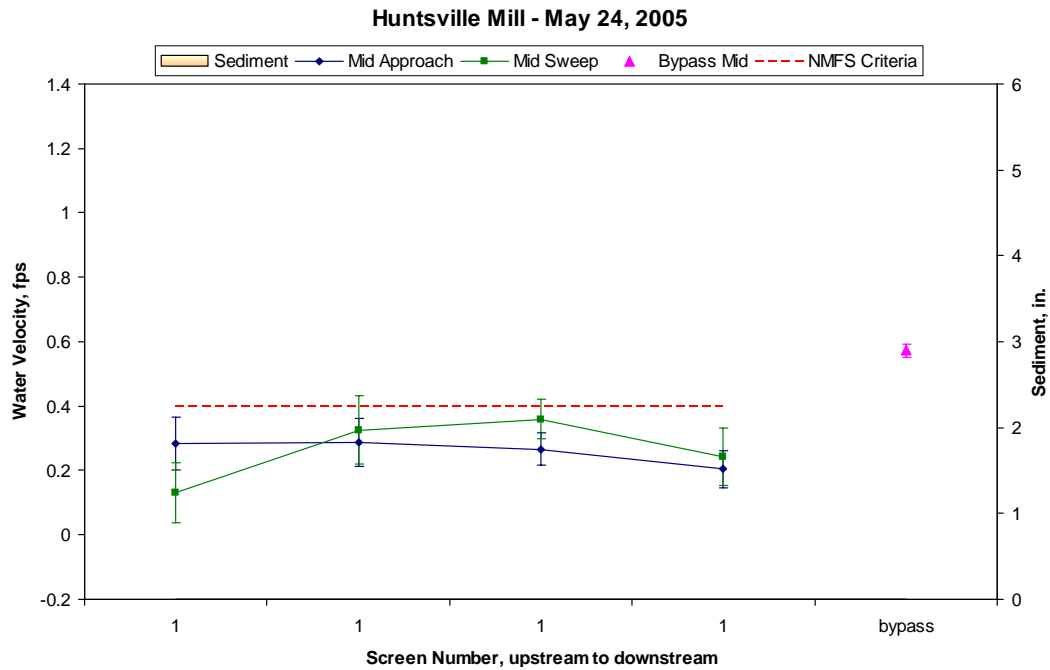
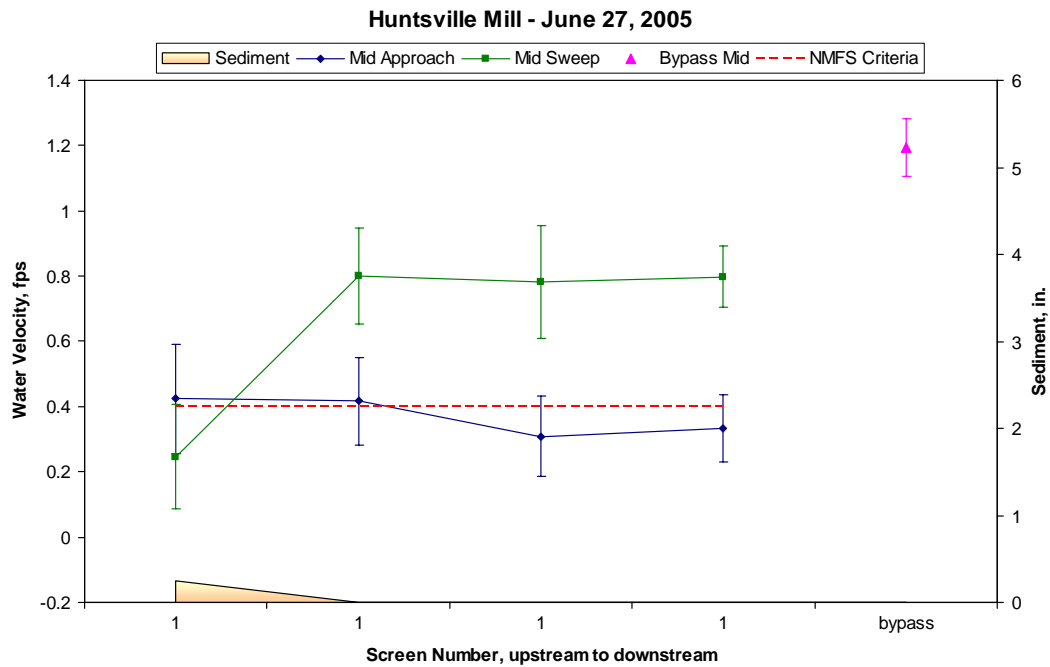
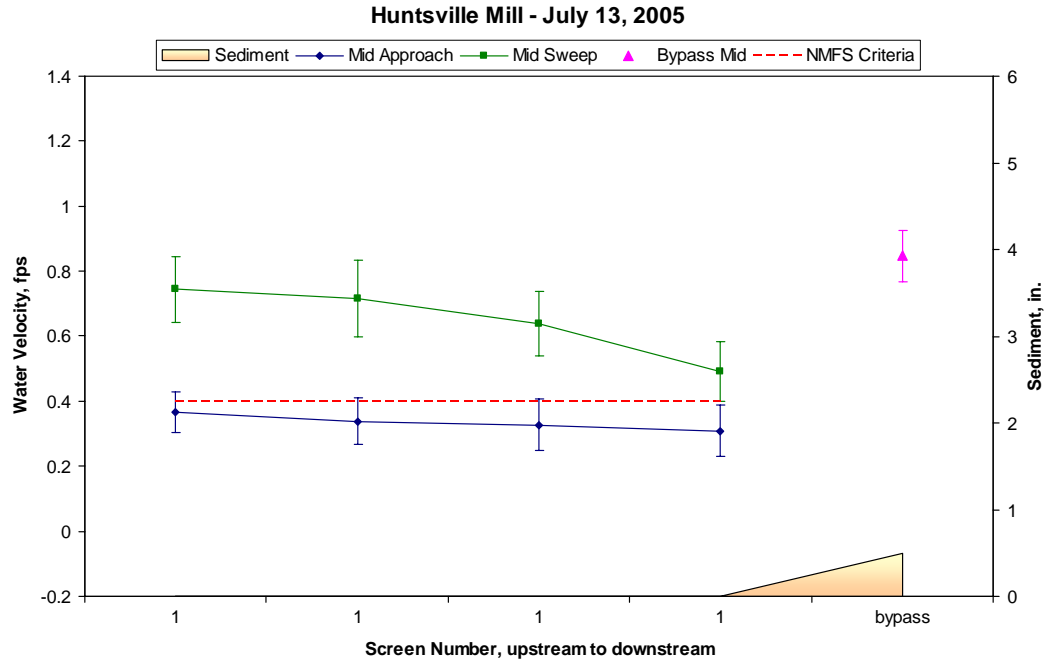
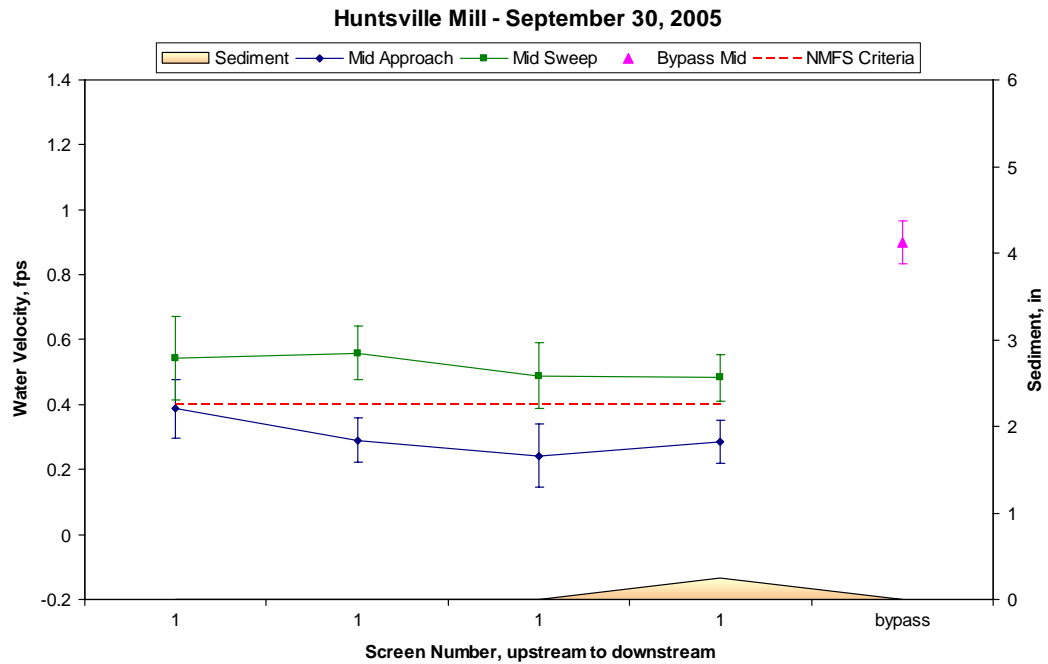
Sweep velocities were generally constant or decreased slightly toward the bypass during all visits (Figures 16 through 19) and were greater than approach velocities except at the upstream position in May and June. Bypass flows were greater than sweep in all cases. Approach velocities exceeded the NMFS criterion only in June. Seals and the drum were in good condition. Water moved smoothly through the bypass whenever water was running through the site. Checkboards are used in the downwell to create a plunge pool. Juvenile salmonids were noticed in the pool at the bypass outfall in July. This site does not yet have gages, a logbook, any site design or operating criteria, or contact information.

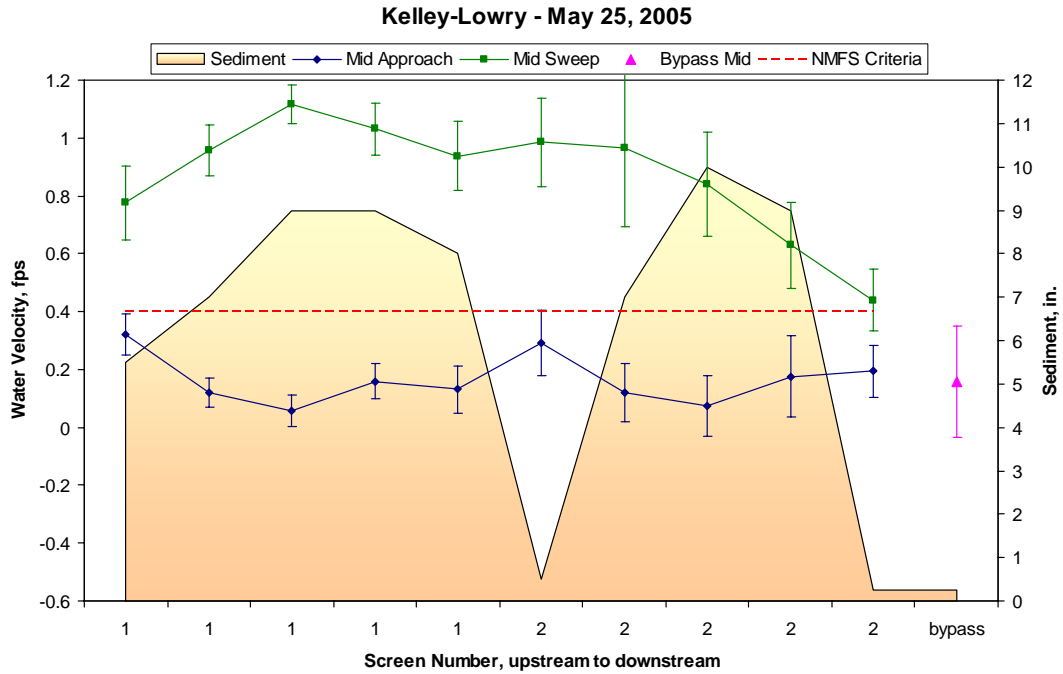
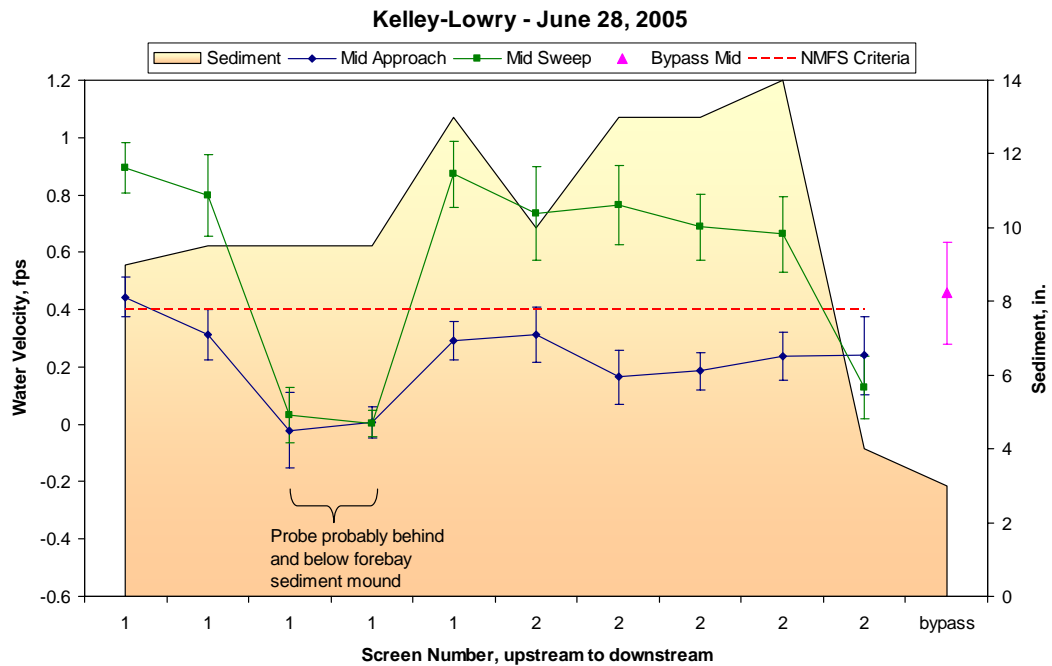
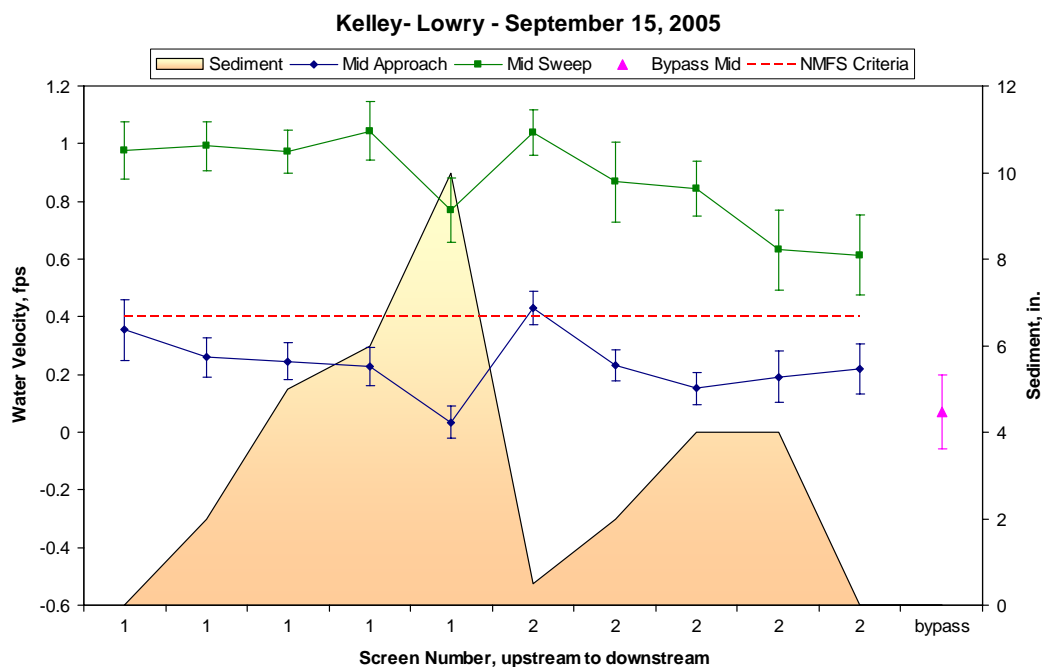
Sweep velocities always were greater than approach values (Figures 22 through 24) and also were greater than bypass velocities. Approach values were less than the NMFS criterion of 0.4 fps 100, 90, and 90% of the time from May through September. Submergence was at 80, 85, and 87% from May through September. Bypass flows ran freely through the downwell, which has checkboards to make a plunge pool. The outfall is difficult to see from within the facility, and dense vegetation kept us away when we tried to find it from the other side.

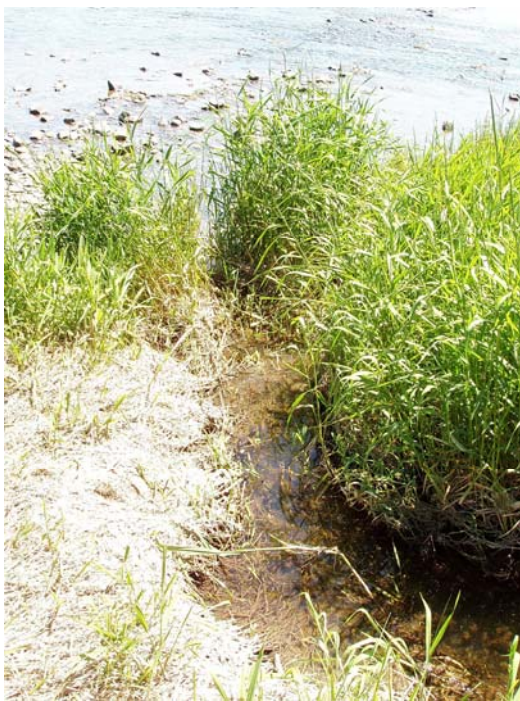
Figure 41. Taylor outfall channel and the river beyond it in June

- Alternatives to a screen site at Taylor should be considered. A lot of effort was spent trying to increase water to the site, but it still was unable to operate within NMFS criteria for most of the year and may be a hazard to juvenile salmonids.

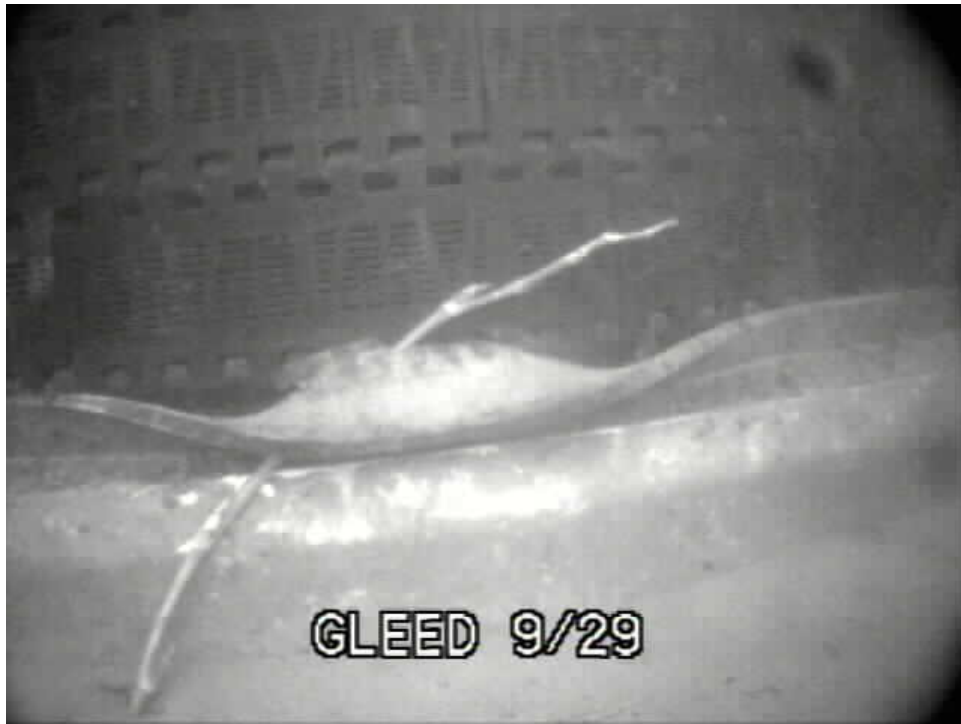
Figure 81. Stick twisted through a bottom seal at Gleed
