Effects of Protective Plates and Stoplogs on Water Flow Through the Glead Fish Screen Facility

April 2007 – September 2007

Project Number: 1985-062-00
Contract Number: 26934 Rel 1

October 2007

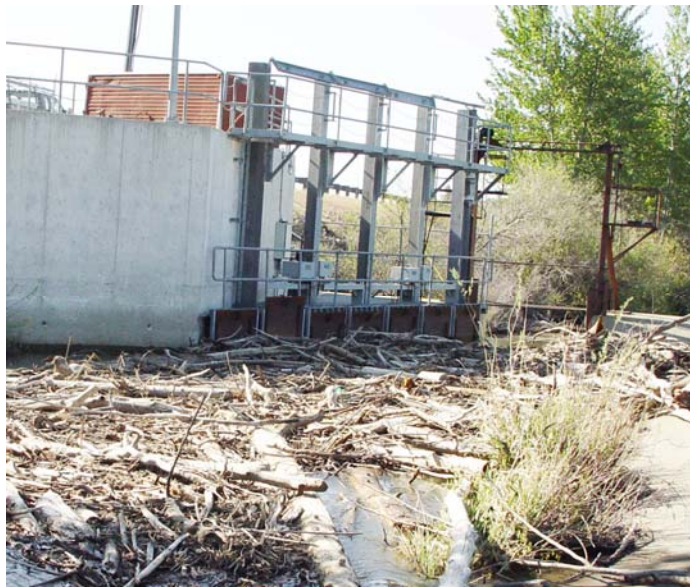
By 1997, seven heavy metal plates had been added to the outside face of the trash rack to provide the screens with additional protection from large woody debris in the winter and spring (Figure 1). The metal plates are each approximately 50 in. wide, with 6-in. gaps between them, and sit on the forebay floor and extend above the top of the screens. Although the plates are meant to be used in winter and spring, they have been left in place even later in the season, and one year remained in place the entire season.

Figure 1. View Downstream at Log Jam and Protective Metal Plates on May 1, 2006. Control gate is not raised.

As seen in Figure 1, the Gleed site accumulates a lot of large woody debris every winter and spring when high river levels carry logs and root wads downstream. Because of the site's location on the outside of the river bend, much of the woody debris is funneled into the site, requiring additional protection for the screens in the form of the metal plates.

- Raise the control gate when flood events are anticipated. Washington Department of Fish and Wildlife personnel try to leave the control gate raised during winter and spring. During flood events, there is probably no shortage of head for the canal flows, even with the control gate raised. Figure 1 appears to show the control gate down in early May in this particular year.
- If the trash rack is not moved upstream, consider asking the irrigation district to push a dam across the entrance to the diversion at the end of the irrigation season, extending from the concrete "arm" to the shore. This would prevent most debris and fish from entering the site but might be difficult to remove later in the spring.

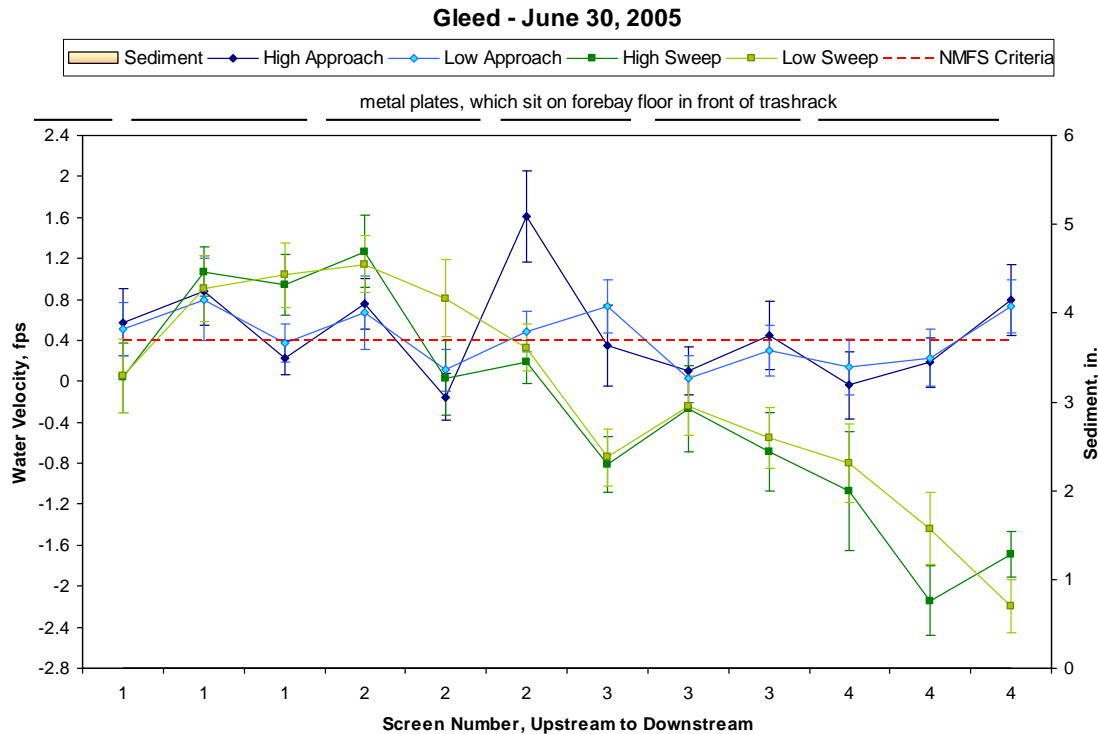
PNNL has been evaluating the Glead site since 1997. A strong back eddy has been noted at the downstream end of the site since the first evaluation performed in 1997 (shown by the negative sweep values at screens 3 and 4 in Figure 2). Sweep velocities at 80% of forebay depth are consistently upstream in the spring and early summer evaluations. Sweep velocities at 20% of forebay depth are less consistent and not as strong but follow the same trend. In addition, approach velocities have shown very erratic and abrupt changes, depending on measurement location relative to the gaps between the metal plates.

Figure 2. Water Velocity Measurements when Protective Metal Plates were Set on Forebay Floor. River discharge was approximately 335 cfs.

The apparent effects of the metal plates can be seen in plots of velocity measurements taken about 2 weeks apart at river levels between 335 and 355 cfs. In the June 2005 plot (Figure 2), the protective metal plates were down; in the July 2005 plot (Figure 3), the protective plates had been raised.

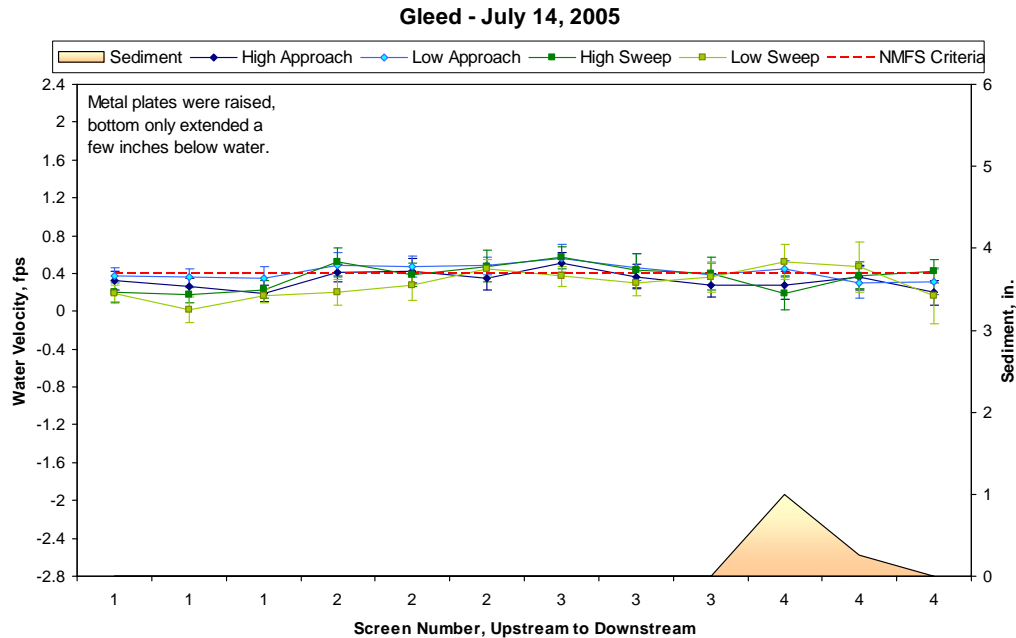
Figure 3. Water Velocity Measurements when Protective Metal Plates were Raised Above Water Level. River discharge was approximately 355 cfs.

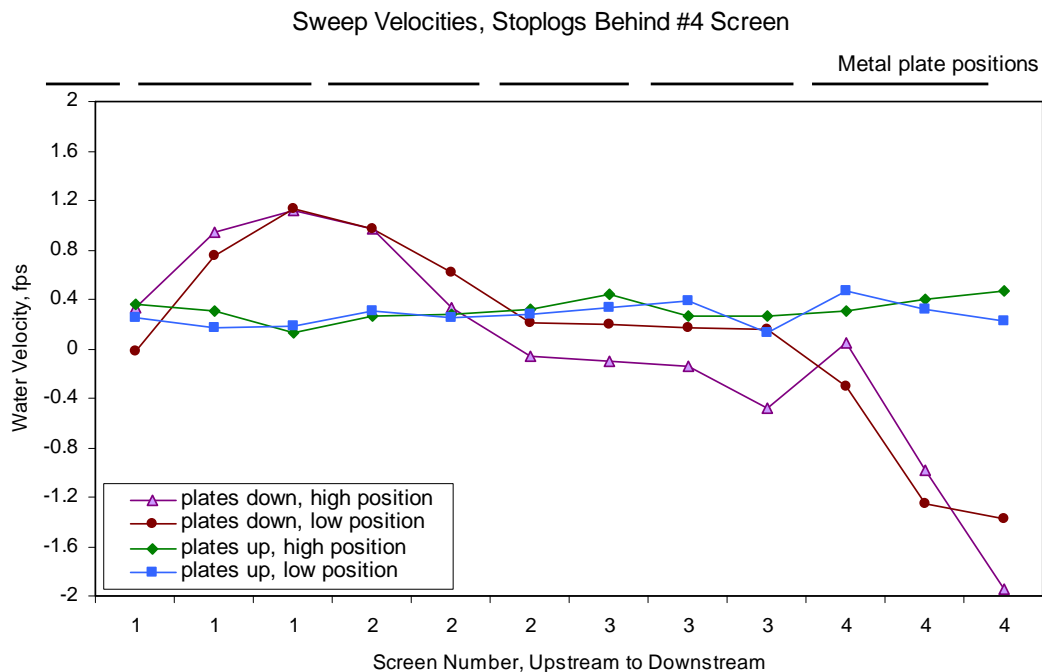
Almost all of the approach velocities in the baseline measurements were below the National Marine Fisheries Service (NMFS 1995) draft criterion of 0.4 fps. Figure 4 shows sweep velocities comparing Conditions 2 and 3, in which the only change is whether or not the protective metal plates are set to the bottom of the forebay. Figure 5 shows the difference in approach velocities between the same two conditions. From the data shown in Figures 4 and 5, it is obvious that the metal plates cause the erratic approach velocities as well as the strong eddy at the downstream end of the site. The stoplogs did not affect flow significantly.

Figure 4. Sweep Velocity Measurements at High and Low Positions for Conditions 2 and 3 in May 2007

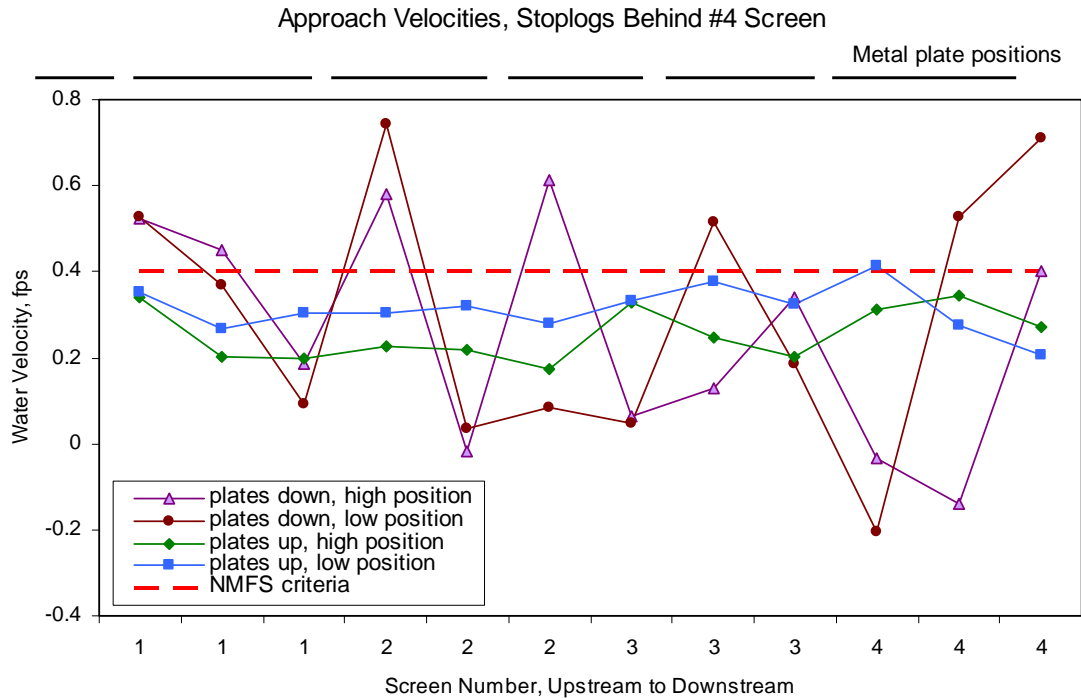
Figure 5. Approach Velocity Measurements at High and Low Positions for Conditions 2 and 3 in May 2007

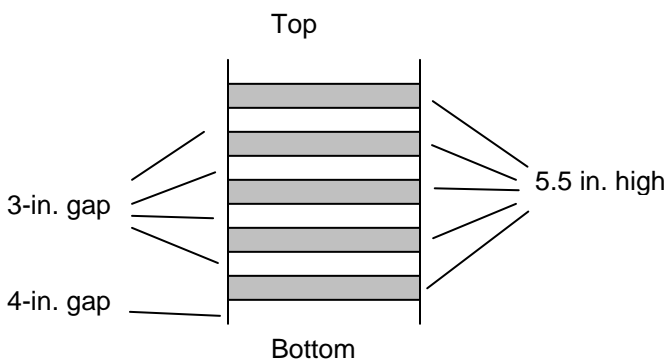
1. a baseline before any stoplogs were put in place.
2. stoplogs spaced as shown in Figure 6 were placed behind both screens 3 and 4.
3. stoplog slats behind screen 4 were spaced only 2 in. apart, and an extra board was set near the top, reducing flow over the top board to 3 in. Stoplogs behind screen 3 were raised to sit 6 in. off the bottom, and spacing between slats was left at 3 in.

Figure 6. Stoplog Configuration Tested in July 2007 Behind Screens 3 and 4

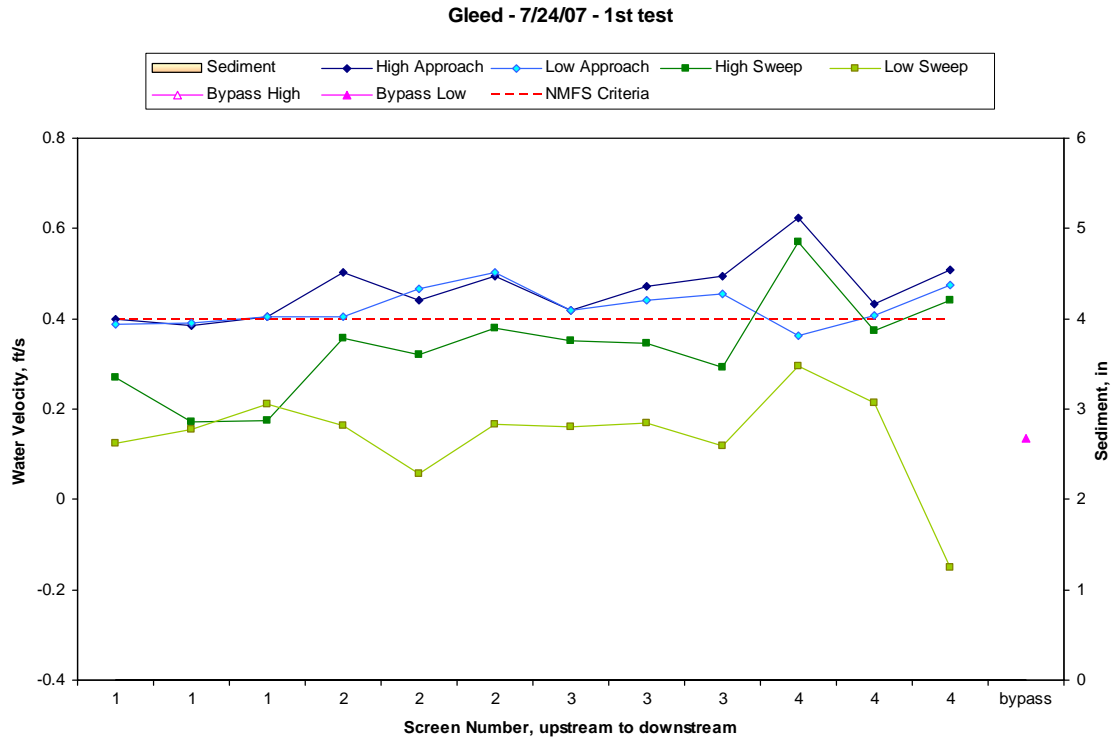
During baseline measurements, only 4 of 24 approach velocities were below the NMFS criterion (Figure 7). With the stoplogs set for Condition 2, approach velocities improved slightly; with 6 of 24 velocities were ≤ 0.4 fps (Table 1). Under Condition 3, when the stoplogs were spaced more closely together behind screen 4, it appeared that more water was “pushed” through screens 1, 2, and 3 and that approach velocities at the upper three screens were increased. Stoplogs in the above configuration did not significantly moderate the high approach velocities.

Figure 7. Baseline Measurements Before Stoplogs were Installed in July 2007

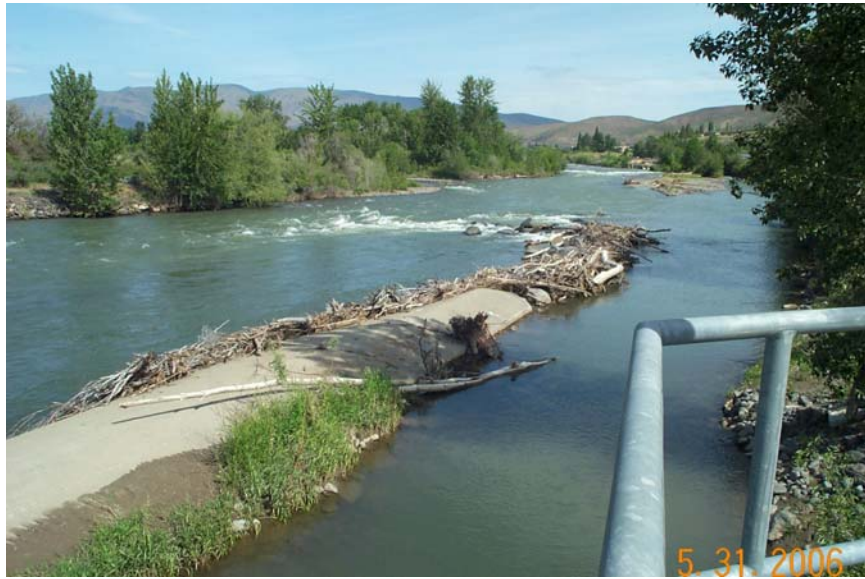
Problems at the Glead fish screen facility are longstanding and appear to be related to the site configuration and design. The facility is located on the outside bend of the Naches River with water diverted to the site by rock dams pushed into place every year by the irrigation district. These push-up dams remain in place at the end of the season, eventually washed out by high river levels during flip-flop or in the winter and spring (Figures 8 and 9).

Figure 8. View Upstream from Glead of Concrete Arm and Remnants of 2005 Push-Up Dam that Form the Glead Diversion, May 2006

Stoplogs behind the screens were ineffective at significantly reducing the erratic and excessive approach and sweep velocities caused by the metal plates. The quick partial remedy to smooth out flows would be to make it easier to raise and lower the metal plates and then do so more often as conditions change. The plates are very heavy and cumbersome to work with, so they are raised and lowered as infrequently. A more permanent solution is to install a primary trash rack upstream at the head end of the diversion, leaving the existing trash rack (without the metal plates) as secondary protection. The exact position of the new trash racks would need to be carefully chosen to facilitate debris removal without restricting irrigation district access for push-up dam construction. An alternative to this might be construction of a permanent wall with a head gate.

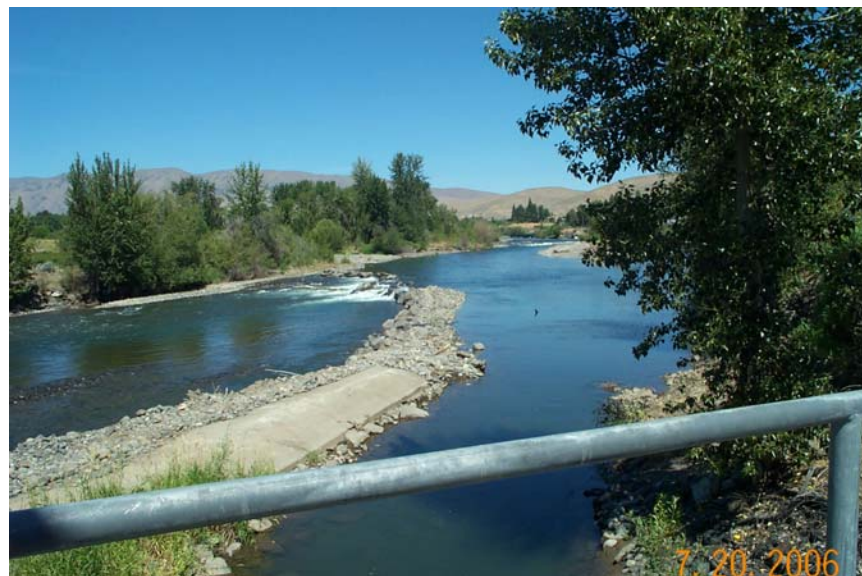
Figure 9. View Upstream from Glead of Concrete Arm and New Push-Up Dam that Form the Glead Diversion, July 2006
