**FIRST INTERIM STATUS REPORT: MODEL 9975 LIFE EXTENSION
PACKAGE TESTING**

Savannah River National Laboratory
Materials Science & Technology

Publication Date: December 2009

Document No. SRNL-TR-2009-00439

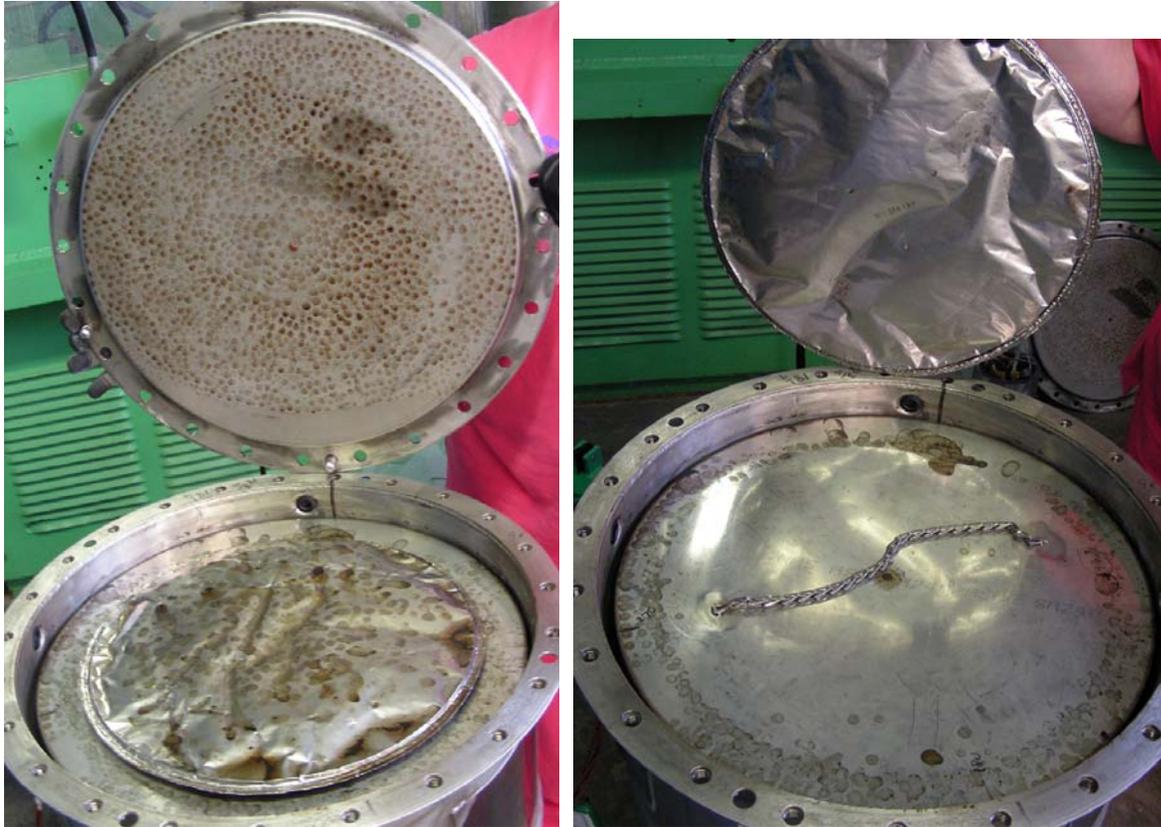
Figure 2. Stain on LE2 lid and other upper components from initial condensation activity.

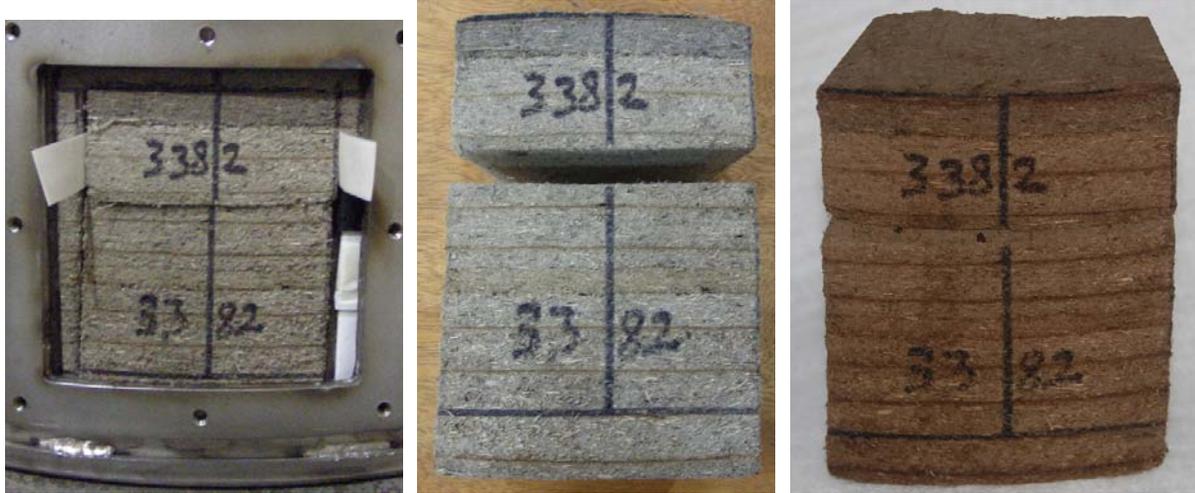
Photographs of the removable sections help to track fiberboard changes over time. Sequences of photographs for each package are shown in Figures 10-12. In test LE1, the appearance of the removable sections remains relatively uniform, although they darken somewhat over time. A strong odor was noted from the removable sections after 14 weeks at 142°F ambient, and continued during subsequent inspections. The peak moisture content of the removable sections ranged from 13 to 30 % WME through the first 57 weeks at 142°F ambient, and increased to 100% WME at week 63. At no time was mold observed on the LE1 fiberboard. The removable sections for LE1 would have been at a temperature close to the external environment (142°F).

(a) baseline (b) after 6 wks 90°F 95% RH (c) after 63wks 142°F, 30%RH
Figure 10. Sequence of photographs of small removable fiberboard sections from test LE1.

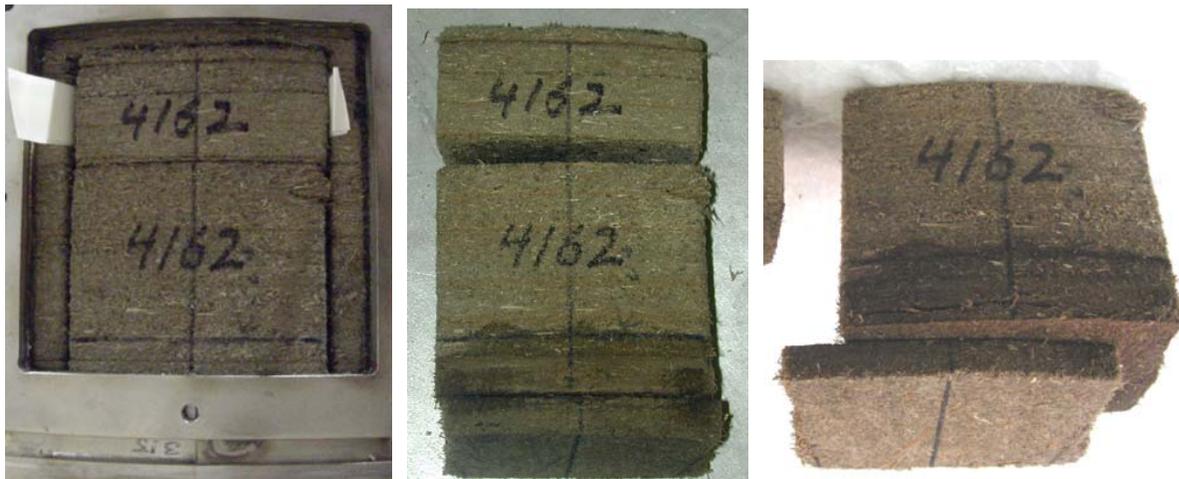
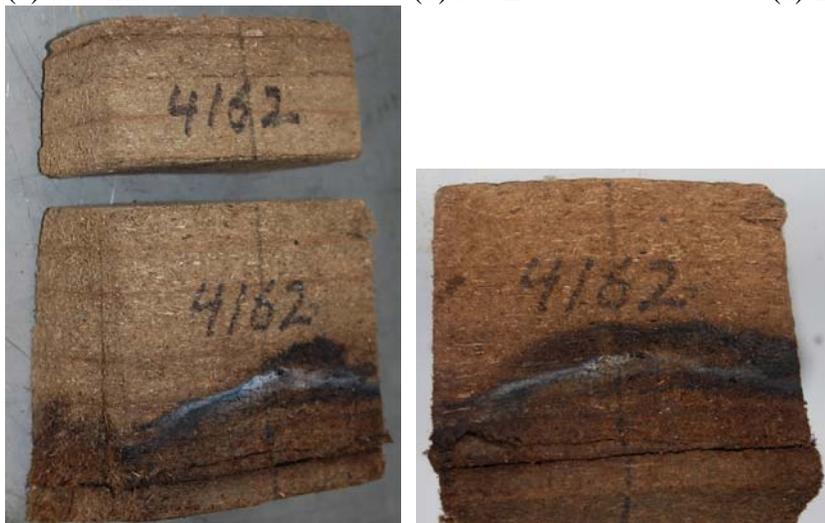
With tests LE2 and LE3, the bottom layers of the removable sections (as well as the rest of the lower fiberboard assembly) darkened significantly as they accumulated excess moisture. Some mold also grew in this region. In LE2, the bottom layers were observed to be saturated during the first inspection (after 3 weeks at temperature, 8 weeks total exposure), and a strong odor of decaying vegetation was noted after 19 weeks in test. Mold did not appear on the test 2 removable sections until 63 weeks exposure. A steep moisture gradient existed at the bottom of LE2; the saturated layers had a moisture content of 100 % WME, while approximately ½ inch above this region the moisture content was typically 17 % WME or less.

(d) 49 wk (e) 81 wk
Figure 11. Sequence of photographs of small removable fiberboard sections from test LE2.

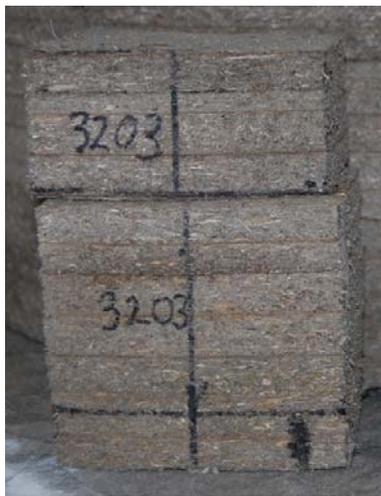
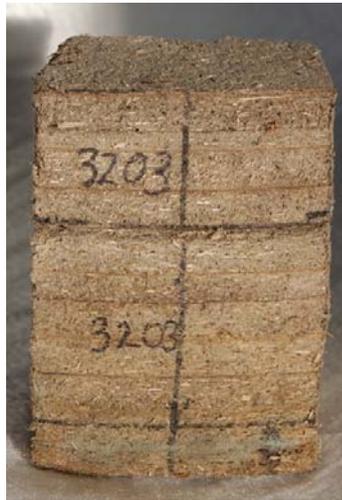
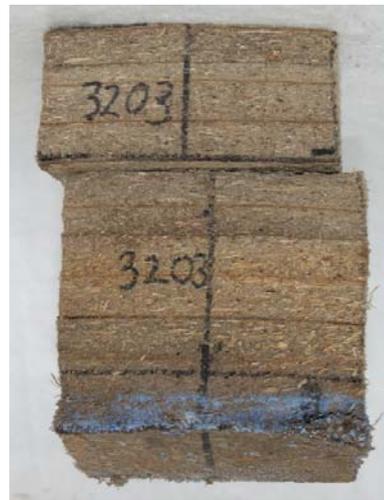
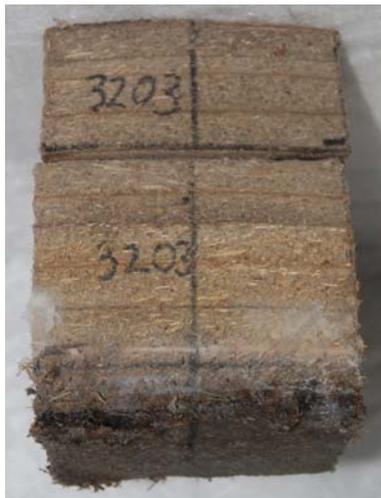
Figure 12. Sequence of photographs of small removable fiberboard sections from test LE3.

In LE3, mold was observed after 5 weeks exposure. At this time, the moisture content of the LE3 removable sections ranged from 67 % WME in the bottom layer to 12 % WME in the top layer. The moisture content of the bottom layer increased to 100 % WME at 15 weeks exposure. The mold continued to grow during subsequent exposure. During examination after 45 weeks exposure, the moisture content of the lower removable section at the maximum height of mold growth was 20 % WME. The temperature of the removable sections within the conditioning environment is unknown for test packages LE2 and LE3.

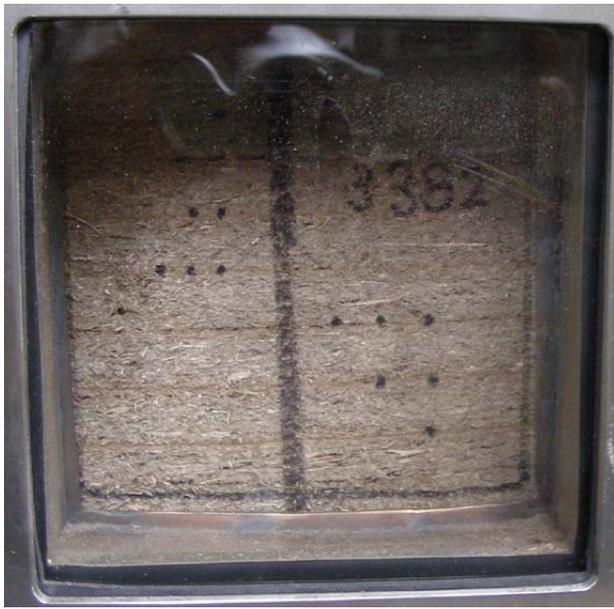
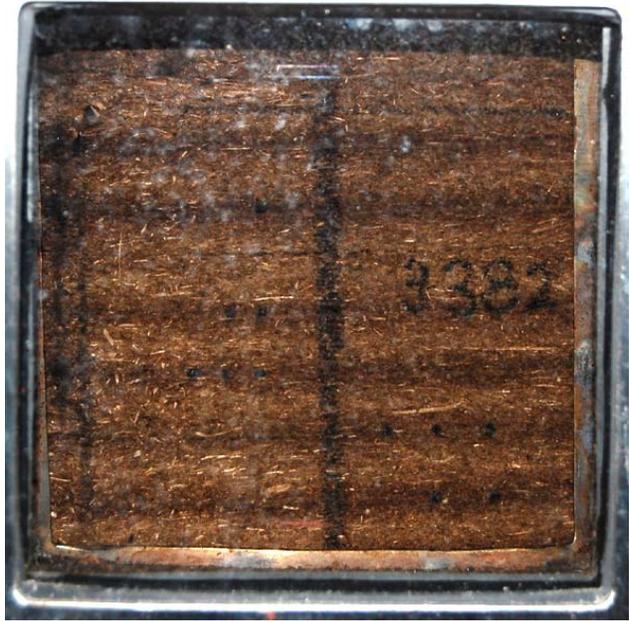
Figure 13. View of the side of test LE1 through the view port at time 0 (a) and after 53 weeks (b)

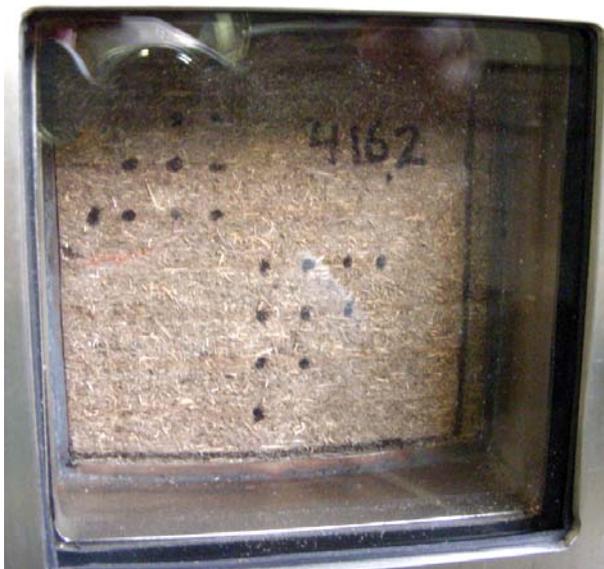
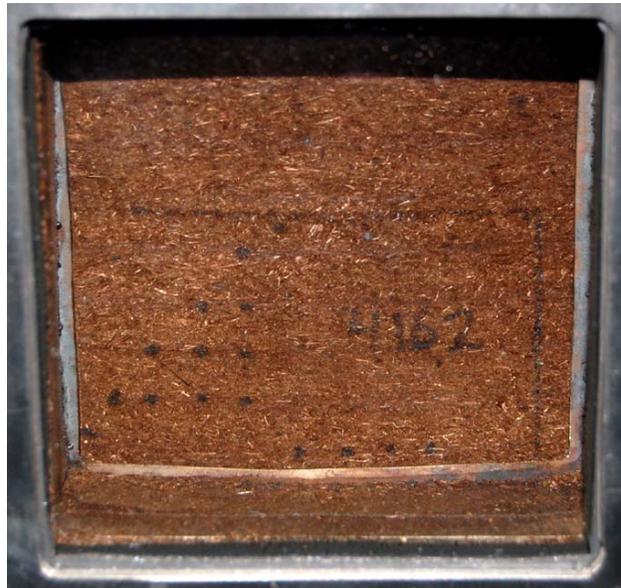
Figure 14. View of the side of test LE2 through the view port at time 0 (a) and after 81 weeks (b)

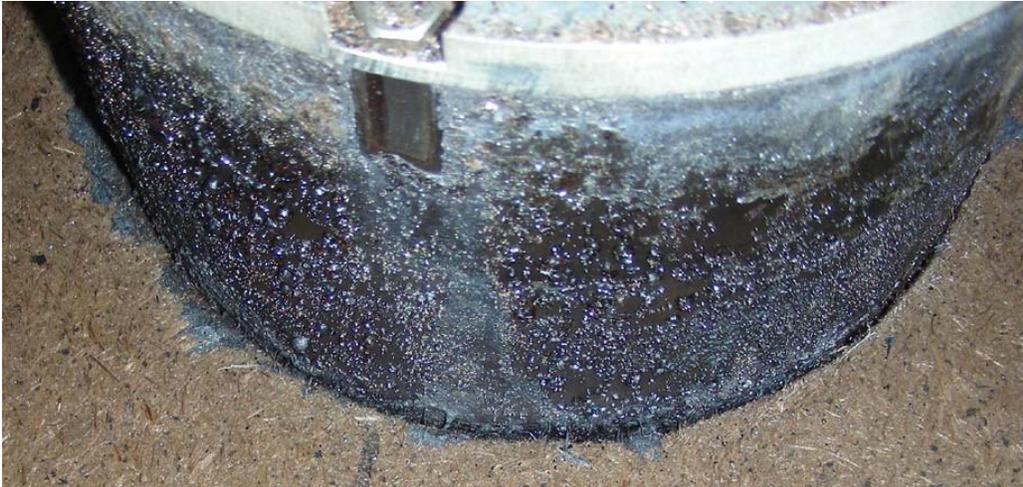
The corrosion of the lead shields is also of interest. In LE2, the corrosion product was observed during the first inspection, after 19 weeks in test, and was dark gray / black and nodular (Figure 17). Significant corrosion product was slower to develop on the LE1 shield, but was similar in appearance (Figure 18). In contrast, the corrosion product on LE3 remained white, but did develop occasional nodules (Figure 19). Of these three cases, the corrosion product on LE3 is the closest in appearance to that typically seen on 9975 packages (smooth white surface). Chemical analysis of corrosion product collected from LE2 showed that it was generally consistent with the lead carbonate seen on other packages.

Figure 17. Corrosion product on the LE2 shield, after 19 weeks in test.

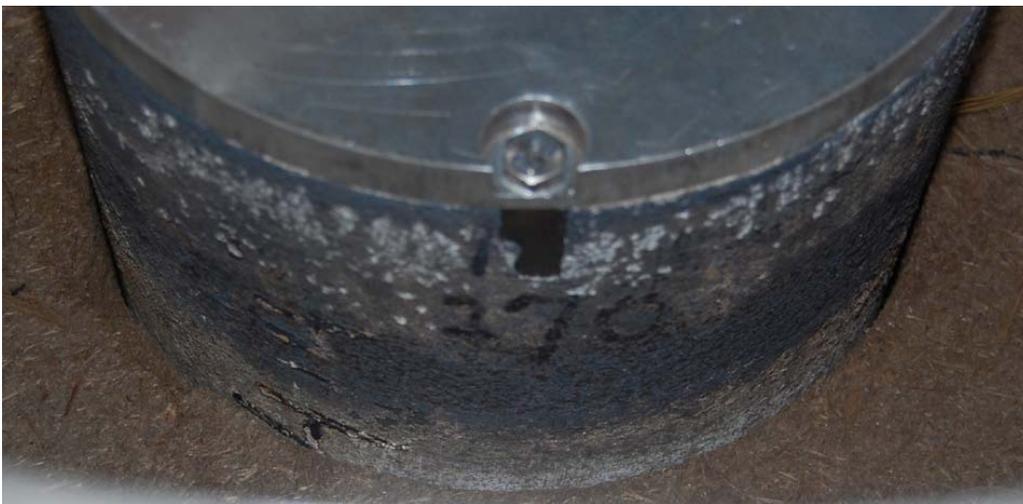
Figure 18. Corrosion product on the LE1 shield, after 63 weeks in test.

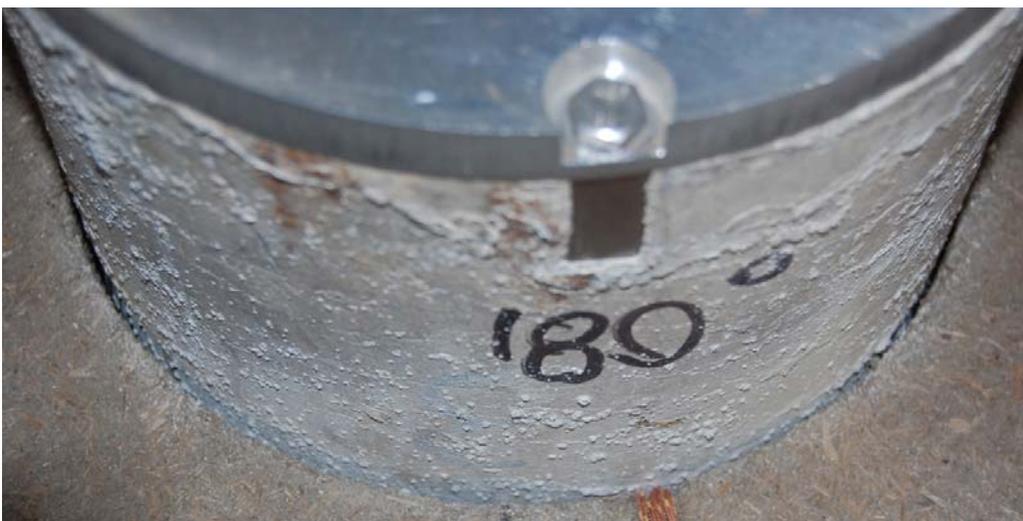
Figure 19. Corrosion product on the LE3 shield, after 45 weeks in test.
