# **Analysis of Failed and Nickel-Coated 3093 Beam Clamp Components at the East Tennessee Technology Park (ETTP)**

**ANALYSIS OF FAILED AND NICKEL-COATED 3093 BEAM  
CLAMP COMPONENTS AT THE EAST TENNESSEE  
TECHNOLOGY PARK (ETTP)**

**September 2010**

**Bechtel Jacobs Company, LLC  
Oak Ridge, TN**

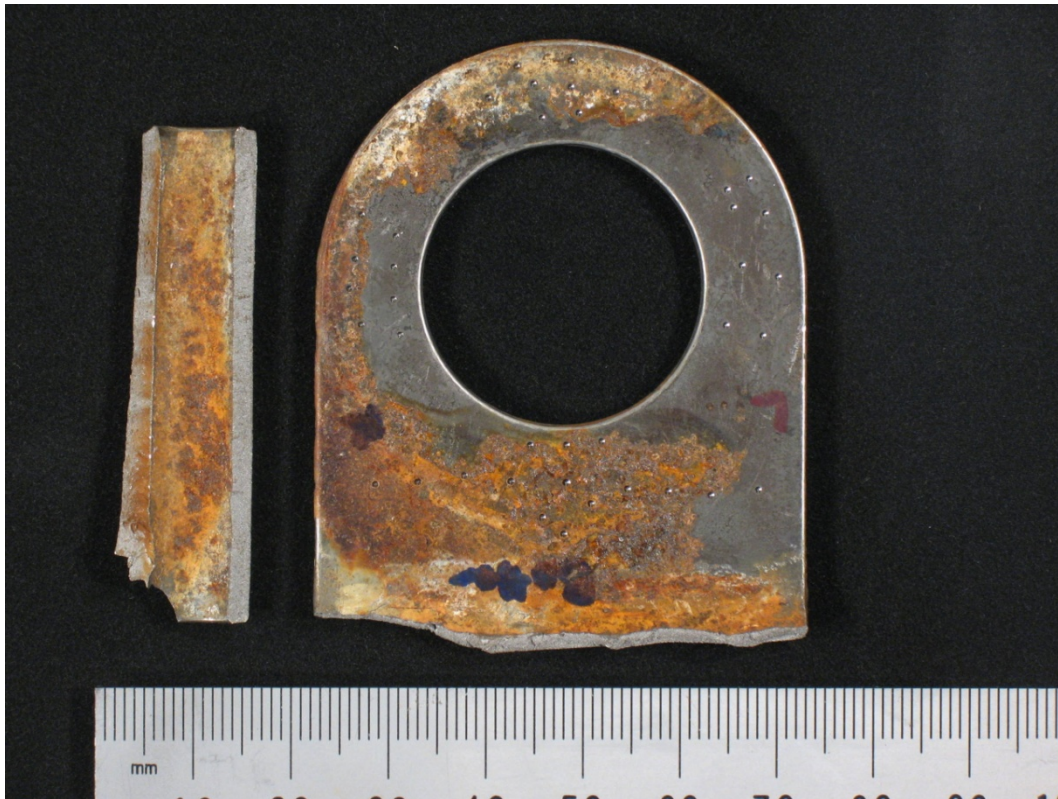
1. Two sets of corroded and failed yokes. Figures 1 and 2 show the failed yokes. For reference, these samples were labeled as 2YC and 6YC, and this identification is used for the rest of the report. Figure 3 shows a high magnification image of the corroded sample 6YC. Yoke samples are 420 stainless steel.

**FIGURE 1 Photograph of Corroded and Failed Yoke Sample #6YC.**

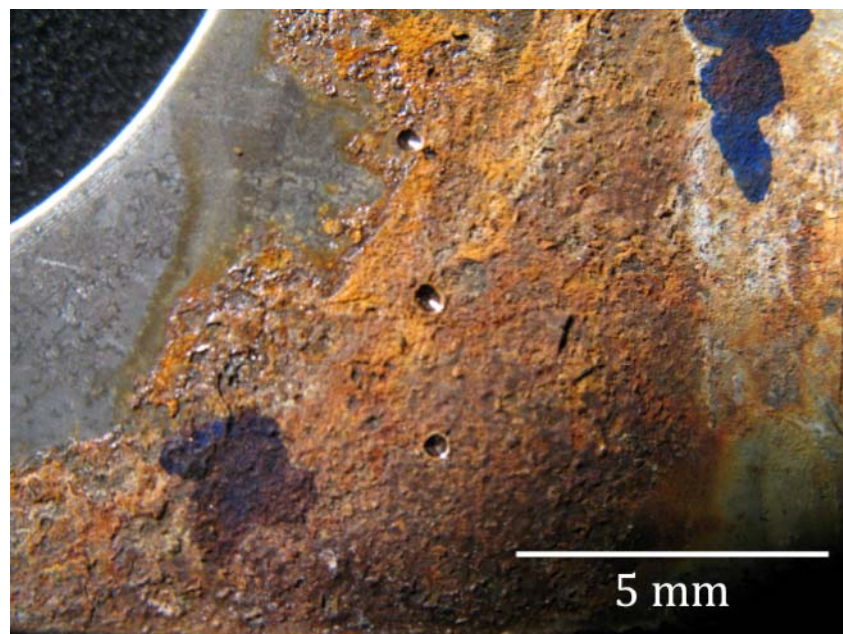
**FIGURE 2 Higher Magnification of the Corroded and Failed Yoke #6YC. Three indents seen in the photograph are from hardness tests.**

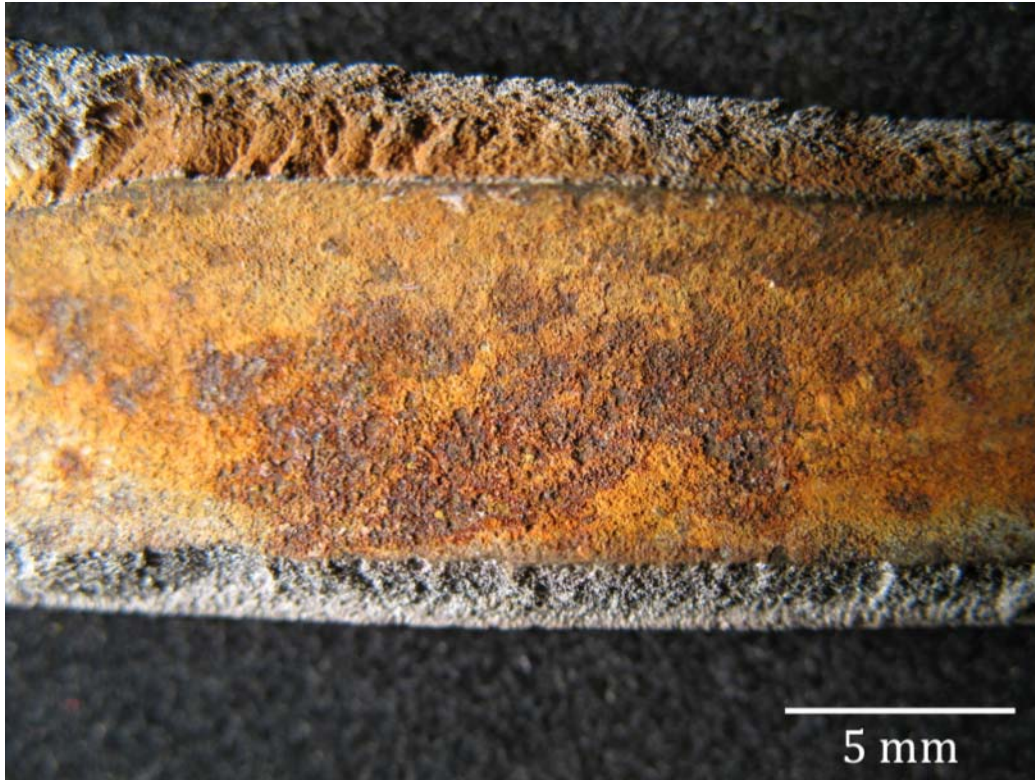
**FIGURE 3 High Magnification Picture of Fracture Surface of #6YC Sliver as shown in Figure 1.**

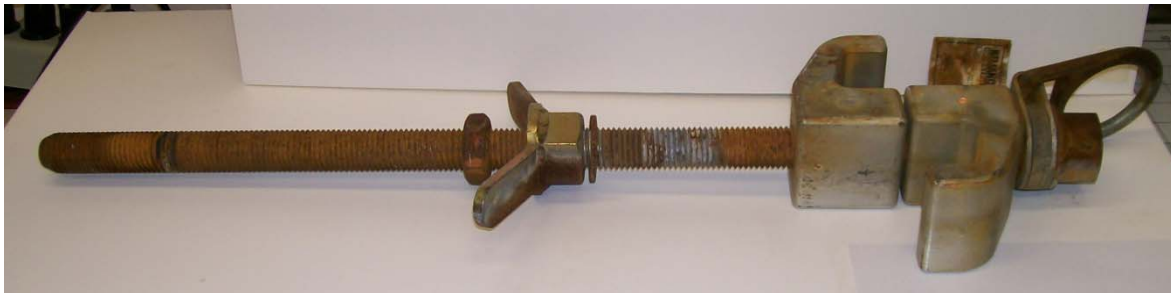
2. Five sets of used beam clamp assemblies. These samples showed varying degrees of corrosion. These samples were referred to as the “K25 five.” Figure 4 shows the entire beam clamp assembly for one of the five, which was numbered as #8. The D-rings were zinc plated. The D-ring samples are 4140 steel.

**FIGURE 4 One of “K25 five” Beam Clamp Assemblies Received by ANL. Labeled as Sample #8.**

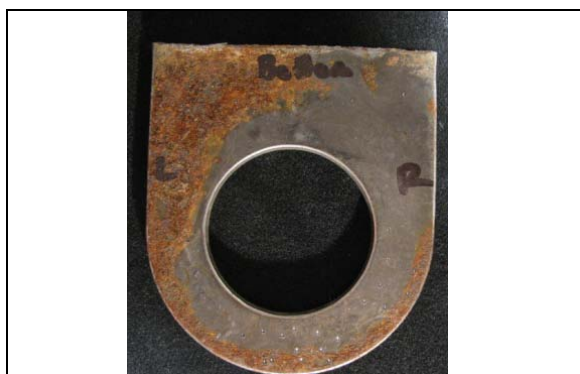
**FIGURE 10 Corroded Yoke Sample 2YC with Indents.**

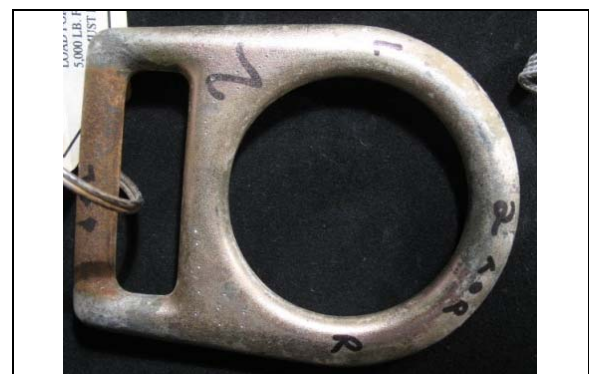
**FIGURE 11 Corroded D-ring Sample 2DRC with Indents.**

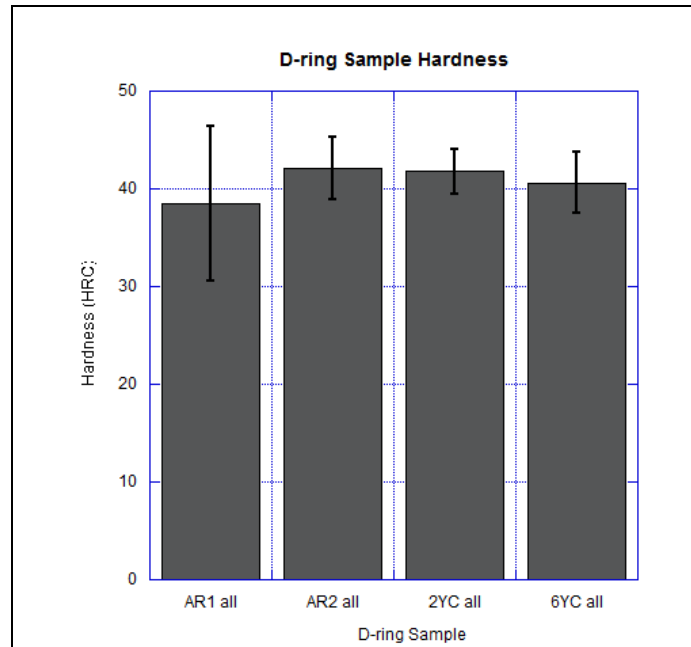
**FIGURE 12 Hardness Values of As-Received and Corroded D-rings.**

- The corroded yoke showed Rockwell C hardness values of  $R_c \sim 40-42$ .
- Corroded D-ring samples showed Rockwell C hardness values of  $R_c \sim 41-46$ .
- Annealing of the Ni-coated (5% P) yoke samples resulted in a decrease in hardness values to  $R_c \sim 25$ .

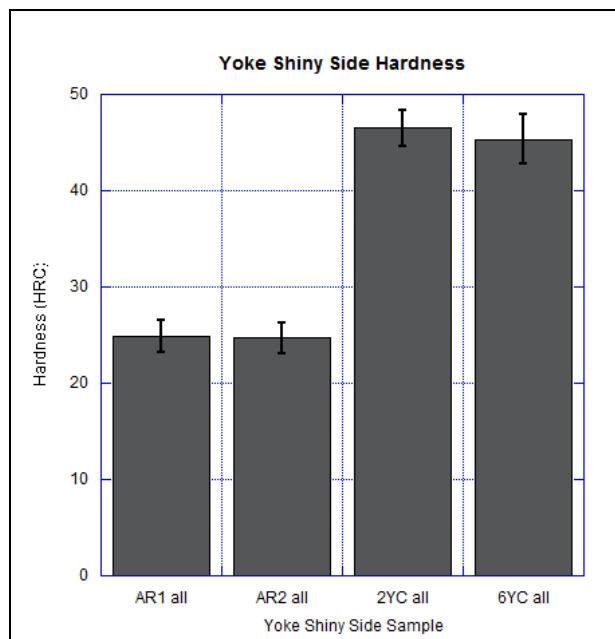
**FIGURE 13 Hardness Values of As-Received and Corroded Yokes on the Shiny Side.**

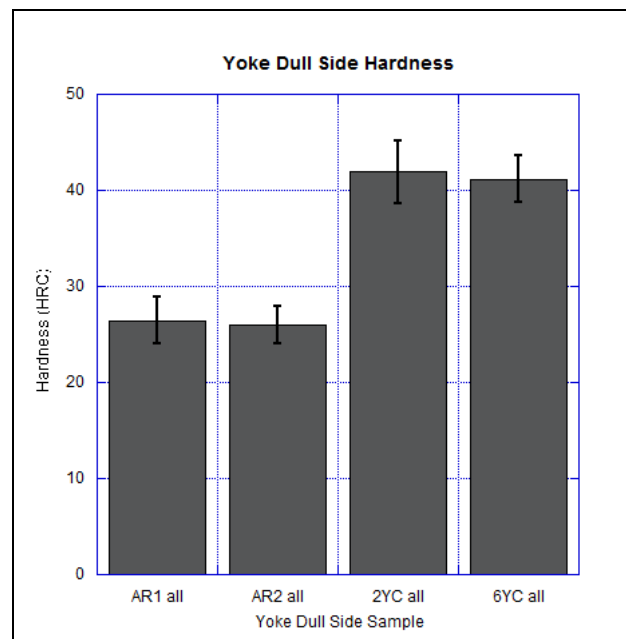
**FIGURE 14 Hardness Values of As-Received and Corroded Yokes on the Dull Side.**

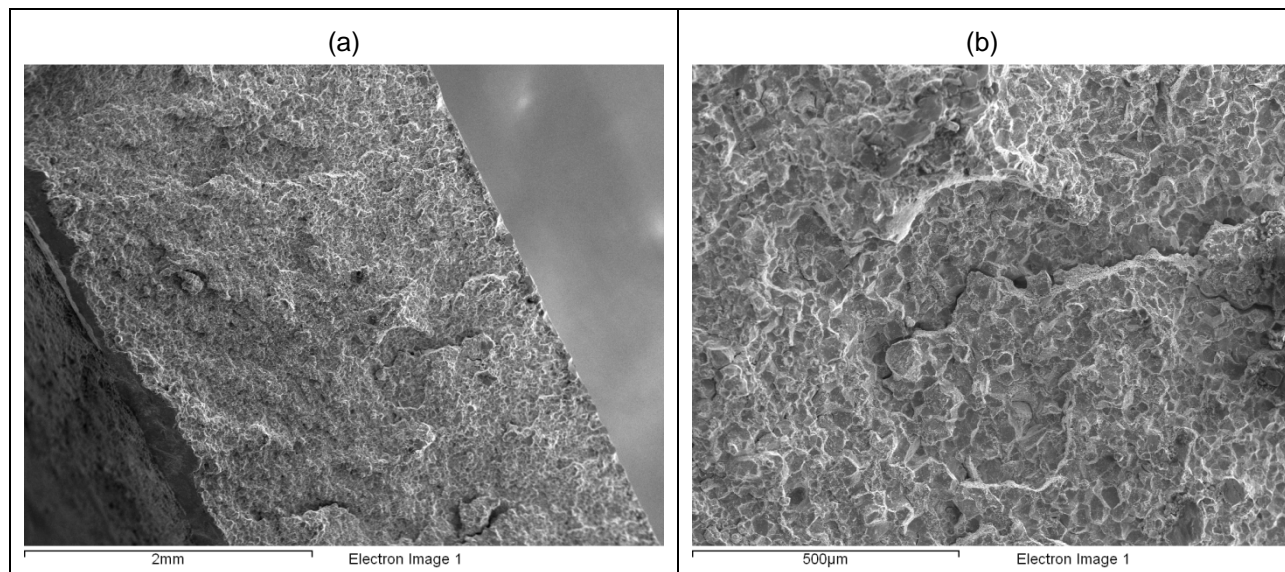
Figure 15(a) shows the fracture surface of the failed yoke (#2YC). There was no corrosion product observed in this region. Higher magnification shows intergranular fracture morphology normally associated with brittle failure. Figure 16(a) is a higher magnification of the same area as in Figure 15(b). Figure 16(b) shows the EDAX spectrum of the field of view of Figure 16(a). Clearly, the main components are detectable, such as iron and chromium.

**FIGURE 15(a) Fractured Edge from Small Piece of Steel. This was the cleanest fractured surface. There was no apparent presence of corrosion.**

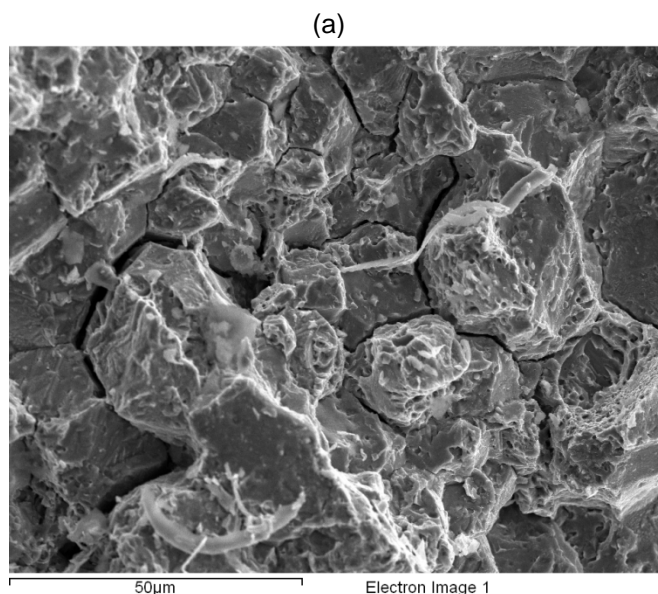
**FIGURE 16(a) Higher Magnification of Area in Figure 15(b).**

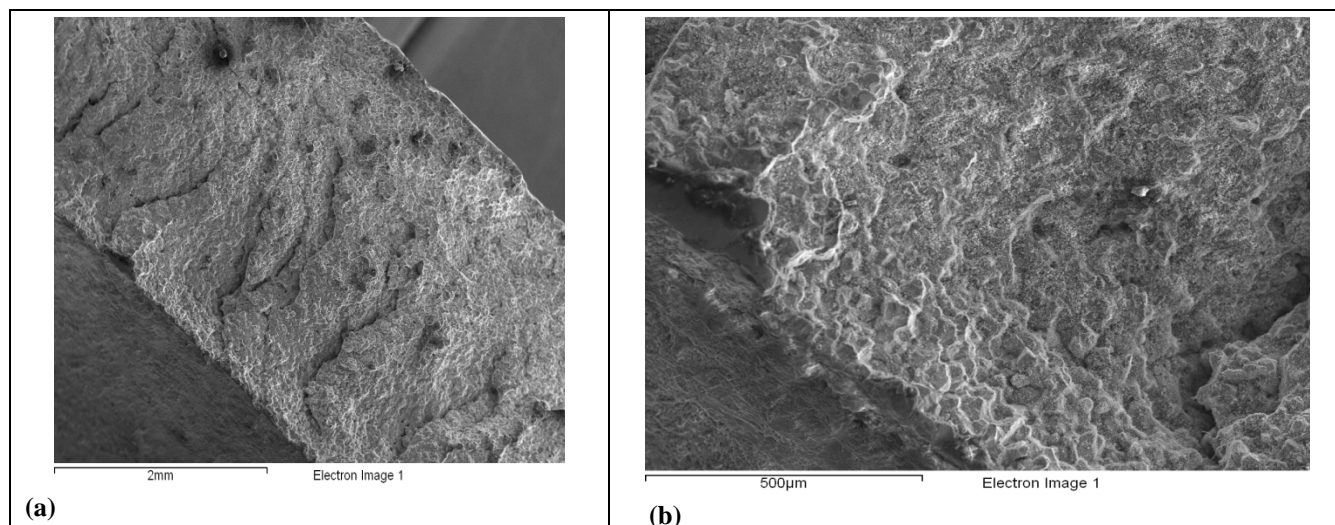
The next SEM image was taken from an area that had some corrosion products deposited on the fracture surface. Successive higher magnifications of the area are shown in Figures 17(a-c). Figure 17(c) clearly shows the corrosion products. The EDAX conducted on the area is shown in Figure 17(d). Apart from the steel constituents such as those observed in Figure 16(b), zinc and sulfur were detected as well. Zinc probably migrated from the galvanized components of the beam clamp assembly. Similar results indicating the presence of zinc and sulfur were also obtained in another area where corrosion product was present.

**FIGURE 17(a) Fracture Surface of 2YC, with Area of Corrosion.**

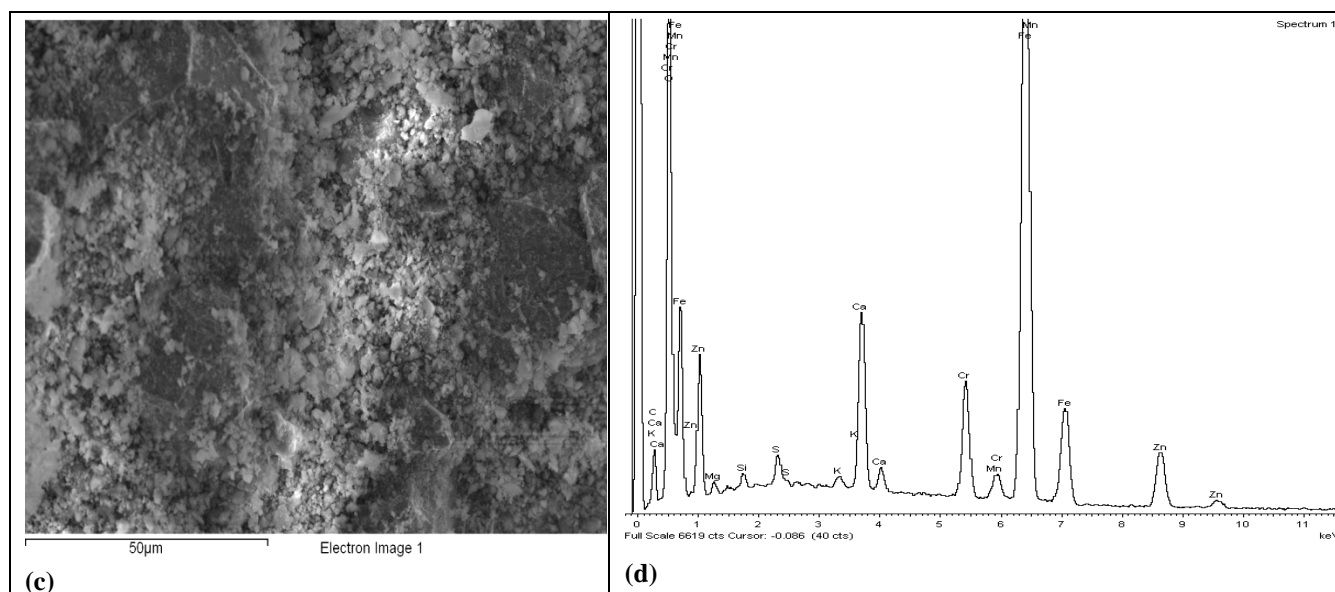
**FIGURE 17(c) Higher Magnification of the Image in Figure 17(b). Corrosion products can be clearly seen.**

**FIGURE 17(d) Presence of Zinc and Sulfur Detected in the EDAX Conducted on the Area of Corrosion Products.**

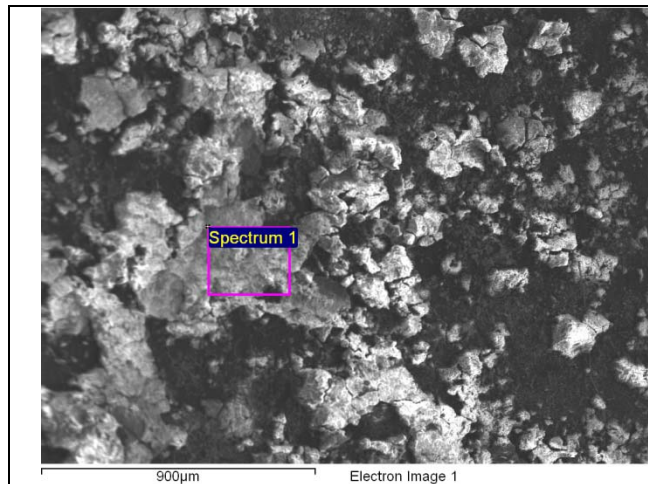
To ensure that zinc and sulfur were indeed in the corrosion products, some of the corrosion products were picked off the steel surface by using tape, and SEM was conducted. Results are shown in Figure 18(a) and Figure 18(b). Again, the EDAX spectrum indicates that the zinc and sulfur are in the corrosion products. Finally, a higher magnification of the corrosion products itself shows a needle-like structure, as evident in Figure 19 (top), and its corresponding EDAX spectrum is shown in Figure 19 (bottom). Bechtel Jacobs provided ANL with the analysis [2] of the rainwater from the K-25 building area, and the results showed high concentrations of sulfur (in sulfate form) and calcium. Bechtel Jacobs suggested that the calcium resulted from the gypsum board and concrete used in the building.

**FIGURE 18(a) Corrosion Products Lifted Off on a Carbon Tape and Imaged.**

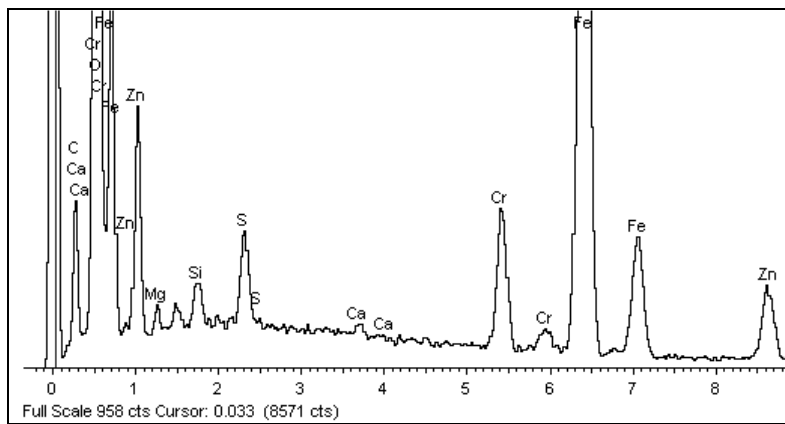
**FIGURE 18(b) EDAX of the corrosion products shown in Figure 18(a).**

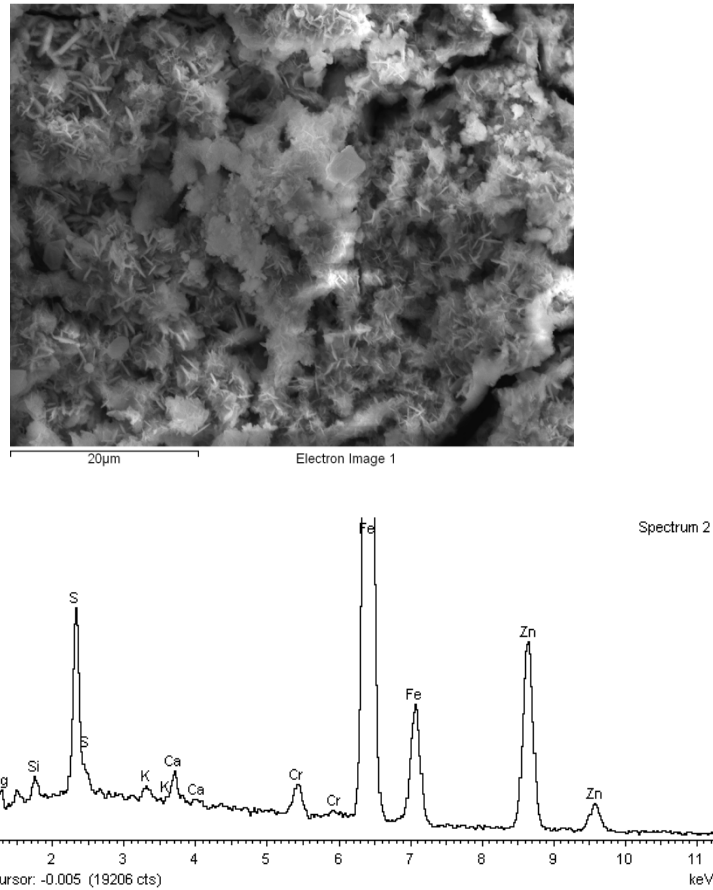
**FIGURE 19 High Magnification Photograph of the Corrosion Products and the Associated EDAX Pattern.**

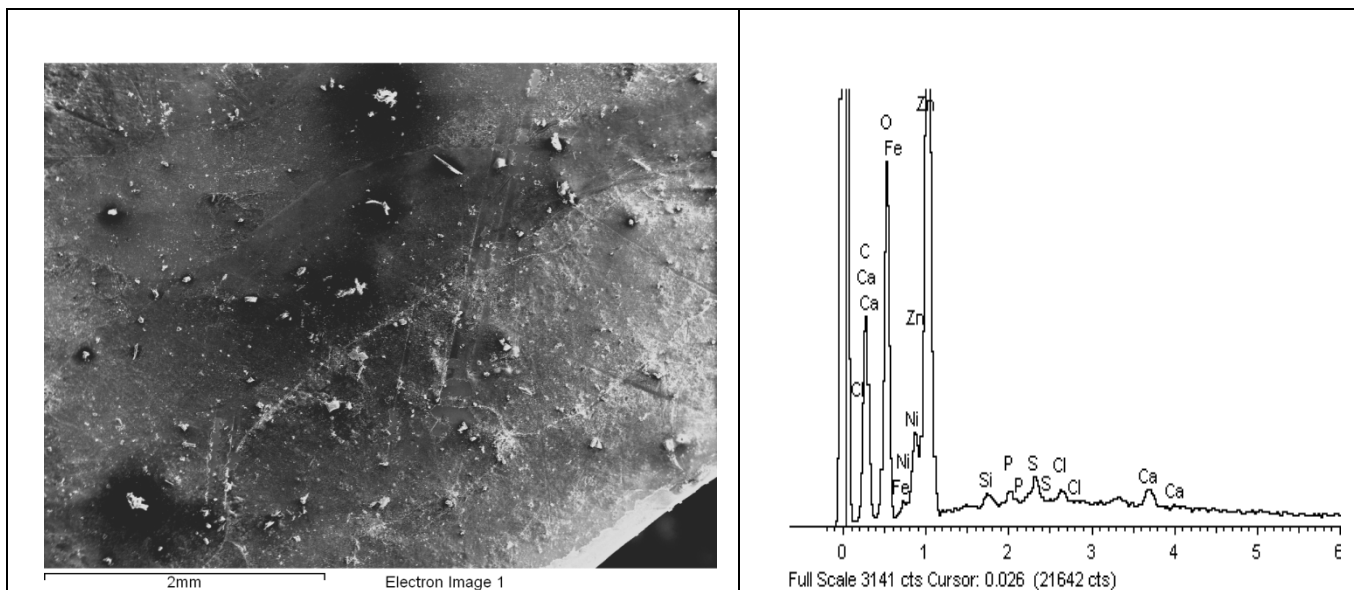
Figures 26(a) and 27(a) show low and high magnification photos of the white residue deposited on the yoke. The corresponding EDAX analyses (Figures 26(b) and 27(b)) showed that the prominent peaks are from zinc. In addition, there are smaller peaks of calcium, iron, sulfur, and nickel detected.

**FIGURE 26(a) Low Magnification Micrograph of the White Residue on the WA14 Yoke Sample.**

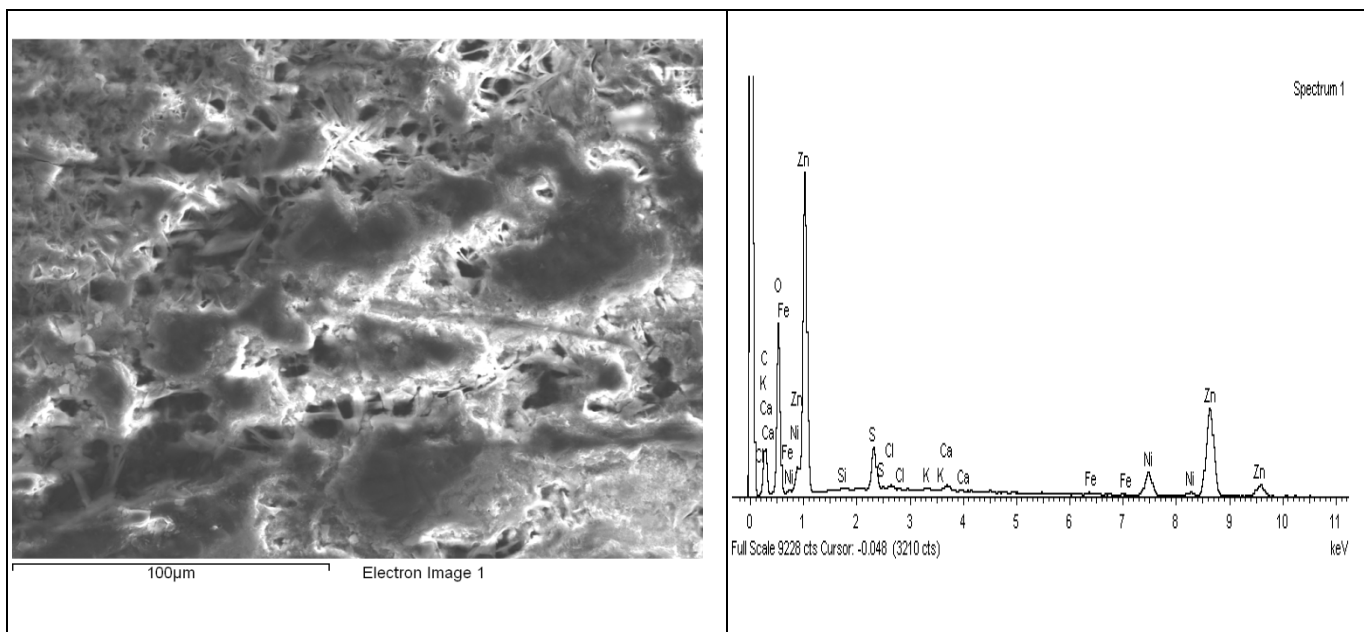
**FIGURE 27(a) High Magnification Micrograph of the White Residue on the WA14 Yoke Sample.**

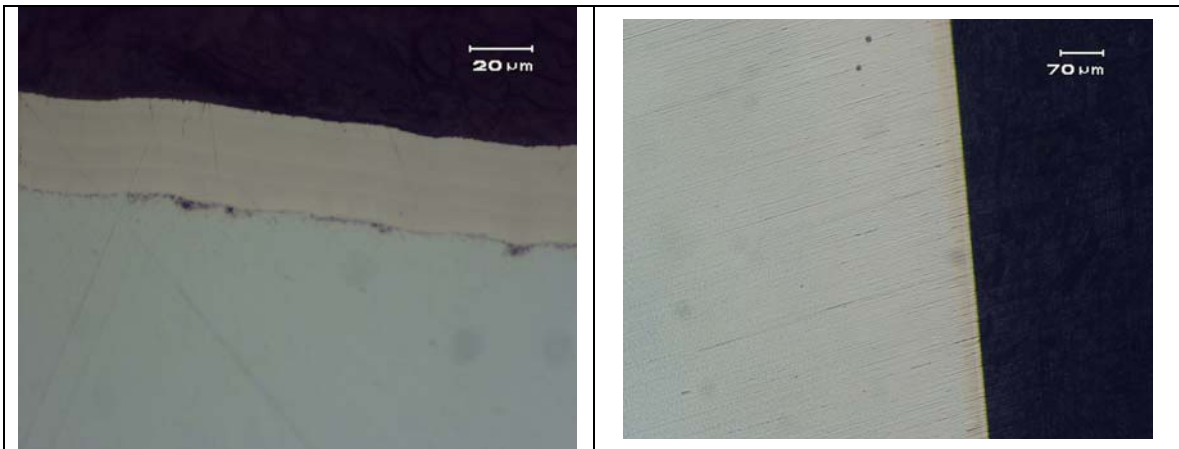
An interesting observation was made for the coating on the yoke sample. As shown in Figure 30, it appears that the coating was applied in multiple stages, as indicated by the two distinct layers of the coating.

**FIGURE 30 Coating of D-ring of Sample WA14.**

**FIGURE 31 Coating on Yoke of Sample WA14.**

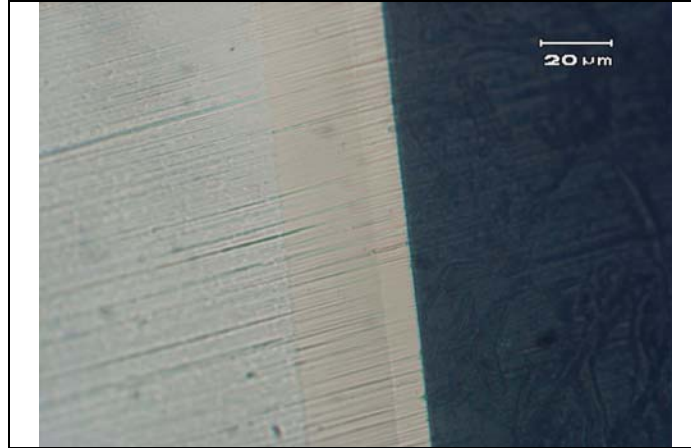
**FIGURE 32 Higher Magnification of Coating on WA14 Yoke. Notice the double layer in the coating.**

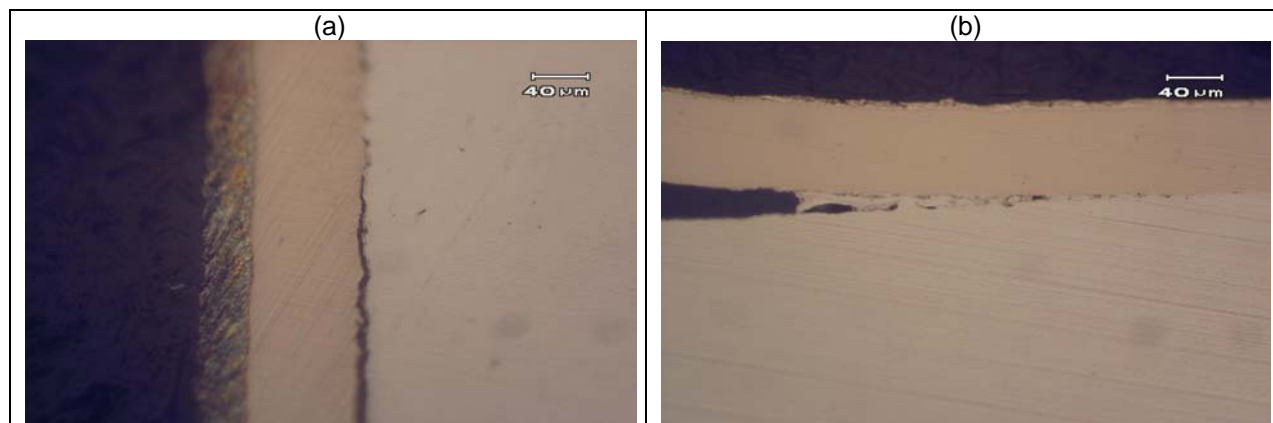
Polished cross sections were scanned to qualitatively determine the durability of the coating as a result of the slicing and subsequent polishing actions. For the most part, the coatings were intact in both the yoke and D-rings. However, in a few (<25% of the scanned) areas, part of the aluminum coating was missing, nickel coating had debonded, or both coatings disappeared, as shown in Figure 41. This effect is probably a result of the sample preparation, which involved cutting of the samples by using a band saw and polishing the cut surfaces.

**FIGURE 41 Damage Observed in the Coatings: (a) Delamination at the Nickel/Steel Interface and (b) Delamination at Nickel/Steel Interface and No Aluminum.**
