Impact of natural disasters on the western Hubei power grid and its anti-disaster enhancement measures

Abstract: The western mountain area of Hubei Province has obvious vertical climate and micro-climate features. It is a place where natural disasters occur frequently. The natural disasters have recently caused several large-scale and long-time power blackouts in the western mountain area of Hubei Province. This study analyses the damage to the power grid with voltage level from 220 to 10 kV in western Hubei Province caused by natural disasters from 2008 to 2016. The influence features of natural disasters on the western Hubei power grid are researched from four aspects, including natural disaster type, grid voltage level, occurrence time of natural disaster and line outage frequency. The causes of damage to the western Hubei power grid are studied from five aspects, including grid structure, design, equipment, construction, operation and maintenance. Also, the anti-disaster enhancement measures of the western Hubei power grid are proposed from the aspects of grid planning, design, equipment transformation, construction, operation and maintenance. The research results can provide

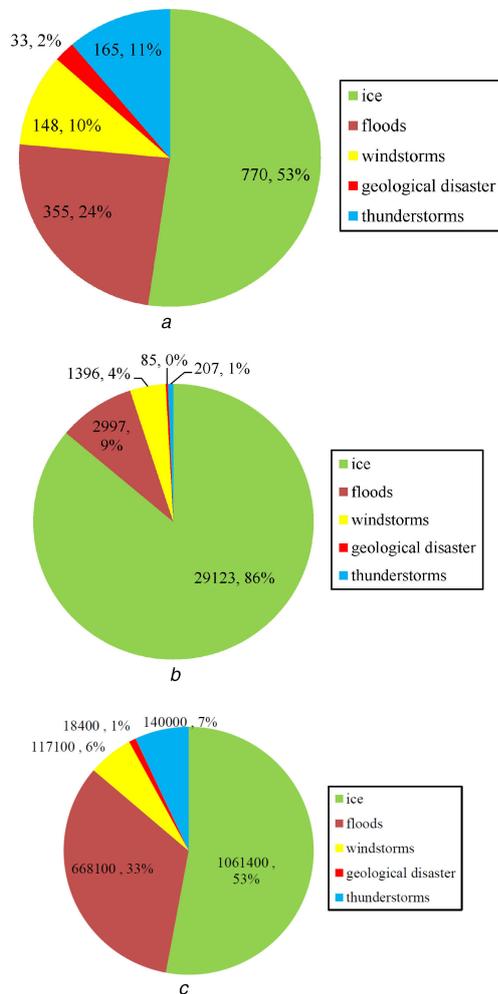
The influence of different natural disasters on line outage times, the number of inverted and broken tower, and family blackout is statistically analysed, as shown in Fig. 1. Among these natural disasters, ice disaster has the biggest impact on the western Hubei power grid, followed by floods. Among those natural disasters, ice disasters cause 53% of lines broken off, 86% of towers inverted and broken, and 53% of families powered off.

**Fig. 1** Influence of different natural disasters on the western Hubei power grid

(a) Line outage times, (b) Number of inverted and broken towers (base), (c) Family blackout

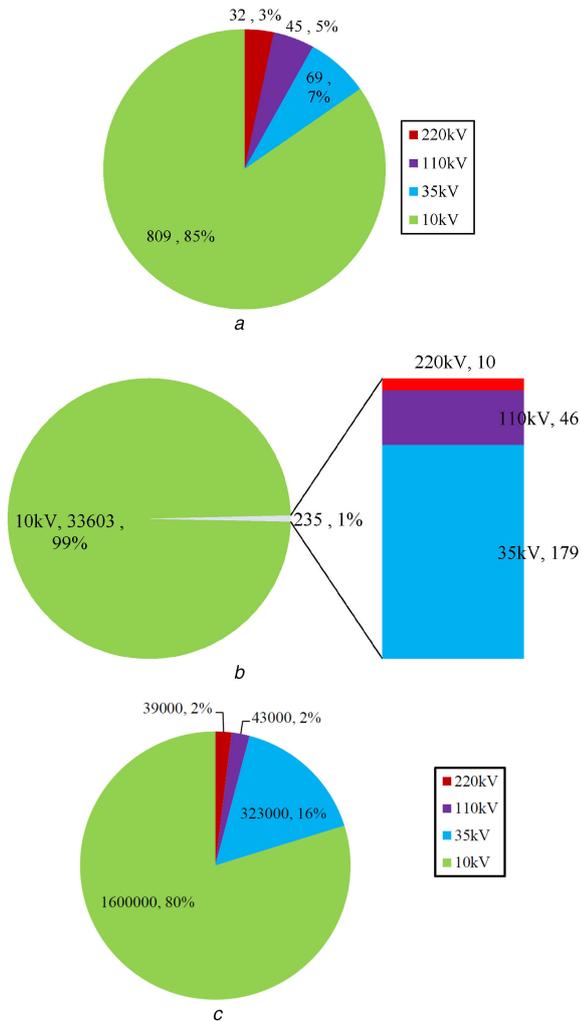
The influence of natural disasters on different voltage levels in the power grid is statistically analysed from the aspects of outage line number, number of inverted and broken tower and family blackout, as shown in Fig. 2. The ability for resisting natural disasters of 110 and 220 kV power grids is strong, and of 35 and 10 kV power grids is weak. In total, family blackout of 96% is mainly caused by 10 and 35 kV line outage due to natural disasters. 10 kV lines are seriously affected by natural disasters, accounting for 85% of line outage and 99% of inverted and broken tower.

Fig. 2 Influence of natural disasters on different voltage levels in the power grid
 (a) Outage line number, (b) Number of inverted and broken towers (base), (c) Family blackout

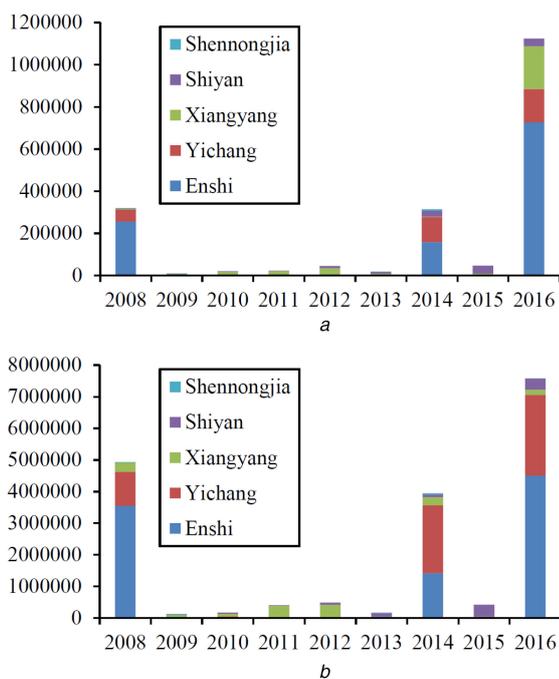
According to the time of occurrence of a natural disaster, family blackout and electricity loss caused by natural disasters are shown in Fig. 3. The power outage caused by natural disasters on the western Hubei power grid in 2016 is the most serious, followed by 2008 and 2014, because large-scale ice disaster occurred in western Hubei Province in these three years. The family blackout and electricity loss caused by natural disasters in Enshi is the most severe among the five cities.

Fig. 3 Damage to the western Hubei power grid caused by natural disasters
 (a) Family blackout, (b) Electricity loss

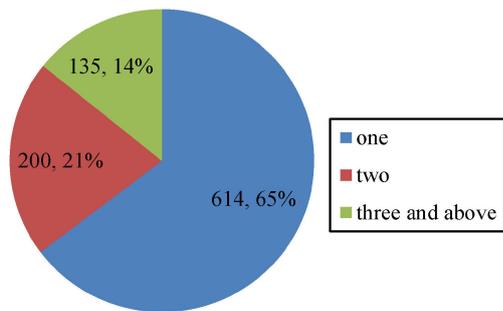
Line outage frequency is shown in Fig. 4. Fig. 5 shows the proportion of line outage frequency at different voltage levels. A total of 949 lines were out of service during the period from 2008 to 2016 due to natural disasters. Line outage of 65% only occurred one time, 14% of line outage occurred three times and above, and 38% of line outage on 10 kV power grid occurred two times and above.

Fig. 4 Line outage frequency

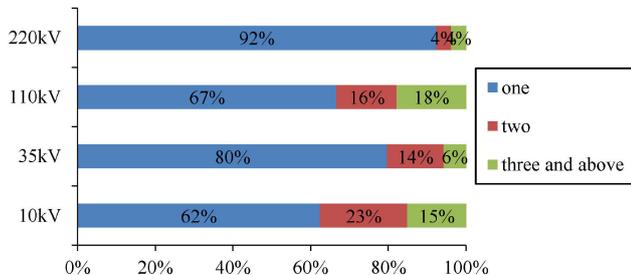
Fig. 5 Proportion of line outage frequency at different voltage levels
