Discussion on infrared accurate temperature-measuring technology of composite insulators for overhead lines

Rong Liu¹ ✉, Qinghe Shen¹, Hui Liu¹, Yubing Duan¹, Yang Zhang¹, Chao Zhou¹
¹State Grid Shandong Electric Power Research Institute, State Grid of China, Jinan, People's Republic of China

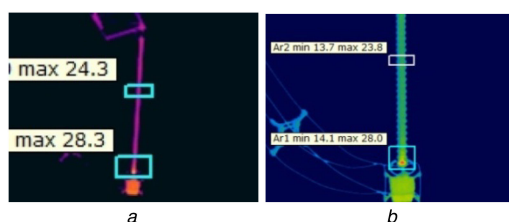
Requirements of infrared accurate temperature measurement of composite insulators on the device are mainly reflected in the spatial resolution. In the current local detection, two kinds of commonly used camera lens are 40 mm lens (0.65 mrad, view angle of 24×18 degrees) and 131 mm lens (0.2 mrad, view angle of 7×5.3 degrees). In order to compare the two kinds of lenses, they have been used to detect the same insulator which has overheated defects. The detection distance is 53 m, and the thermal image is shown in Fig. 1. As can be seen from the image, 40 and 131 mm lenses have little difference in temperature measurement, but the latter one's image is much clearer than the former, and the outline of the large umbrella skirts is clear and the hot spot can be learned from the image. The two kinds of lenses can be used to detect insulator insulation faults when the detection distance meets the requirements, but to determine the location of the hot spots, the use of 131 mm lens is better.

Fig. 1 Thermal images of overhead insulator using different lens

(a) Using 40 mm lens, (b) Using 131 mm lens

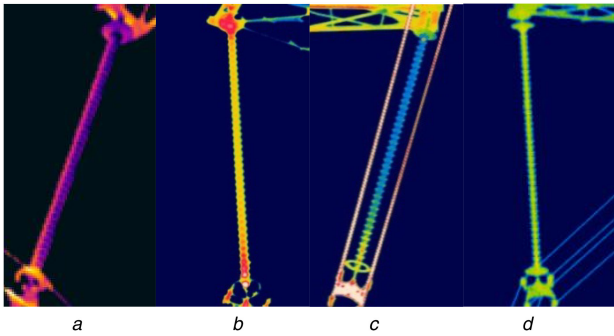
Fig. 2 Thermal images with different detected distances
(a) 32 m, (b) 40 m, (c) 80 m, (d) 125 m

As shown in Fig. 2a, when the 40 mm lens was used to detect with the distance of 32 m, it was difficult to distinguish the insulator's umbrella skirts in the thermal image. At the same time, by using a 131 mm lens, the image detected with three different distances was compared, as shown in Figs. 2b–d. When distance was 40 m, umbrella skirts overlapped seriously, the image was better when distance was 80 m, but when distance was 125 m, it could barely distinguish umbrella skirts.

Considering the height of 500 kV towers mostly about 50 m, the height of insulator is about 20–50 m. Combined analysis of the local detection image and infrared accurate temperature measurement should use 131 mm or larger focal length lenses, and detection distance should be in 50–100 m range.

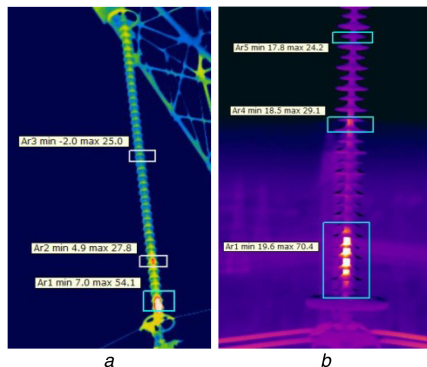
Fig. 3 Thermal images of the insulator on 500 kV line
(a) Ground temperature measurement, (b) On-tower temperature measurement

In the test on ground, one insulator on 500 kV line was found overheat serious, the wire side temperature of the insulator was 28 K higher than the adjacent phase insulator at the same position, thermal image as shown in Fig. 3. Fig. 3a shows the ground temperature measurement result, and the maximum temperature of the insulator was 54.1°C, which was 29.1 K higher than the normal position. Fig. 3b shows the on-tower temperature measurement result, and the maximum temperature of the insulator was 70.4°C, which was 46.2 K higher than the normal position. The temperature between the second and the sixth umbrella skirt was the highest, and there is also a hot spot between the sixteenth and seventeenth umbrella skirt.

After found the defect, professional personnel replaced the insulator immediately. It was found the sheath of the insulator heating part damaged, and mandrel exposed. The insulator has been degraded seriously because of the internal insulation defect, as shown in Fig. 4. It can be seen that infrared temperature measurement is very effective for detecting the insulation degradation defects and preventing the insulators from break, which may cause the wire dropping on the ground.

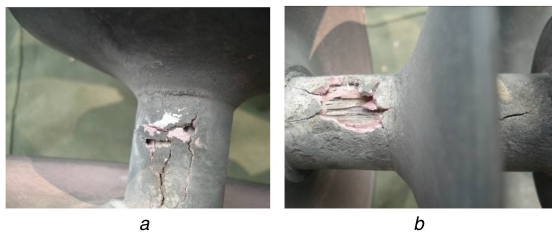
Fig. 4 Overheat insulator inspection
(a) Punch holes and cracks, (b) Sheath peeling

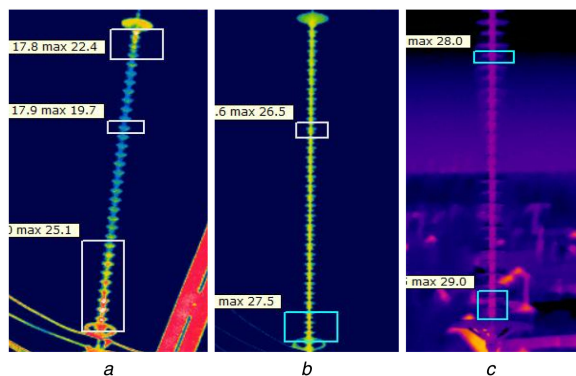
Fig. 5 Thermal images of normal insulator detected after rain
(a) Detected 4 h after rain, (b) Retested on ground under sunny weather, (c) Retested on tower under sunny weather

Fig. 5 shows thermal images of one insulator detected after rain. The maximum temperature of the insulator was 25.1°C when detected 4 h after rain, which was 5.4 K higher than the normal position, as shown in Fig. 5a. The maximum temperature of the insulator was 27.5°C when retested on ground under sunny weather, which was 1 K higher than the normal position, as shown in Fig. 5b. The maximum temperature of the insulator was 29°C when retested on tower under sunny weather, which was 1 K higher than the normal position, as shown in Fig. 5c.

The temperature difference was 5.4 K when the insulator was measured in cloudy day after rain. After one sunny day, the temperature difference was only 1 K when measured after sunset. The contamination on surface of the insulator has been accumulated for 10 years. In damp condition, partial insulation resistance on wire side of insulator was reduced, the leakage current increased, so the surface temperature rose. When the surface was dry, the surface heating phenomenon disappeared. It can be concluded that the insulation was in good condition, and the high temperature difference measured after rain was caused by damp contamination on the surface. This kind of heating can easily lead to the misjudgement of whether the insulator has an internal insulation defect.

Through the above analysis, it is considered that the infrared accurate temperature measurement of composite insulators shall not be carried out after rain, at least ensuring that the insulators have been exposed to the sun for one day and the surface of insulators has been dry.

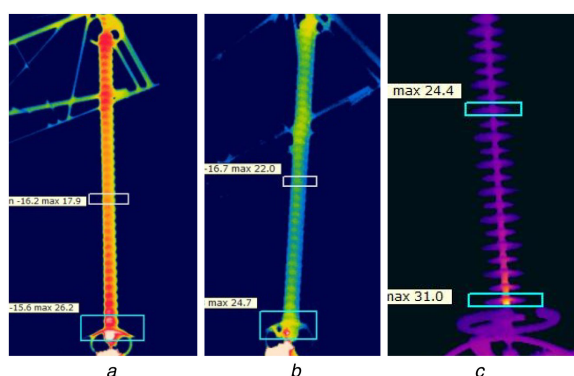
Fig. 6 Thermal images of overheated insulator detected after rain
(a) Detected 13 h after rain, (b) Retested on ground under sunny weather, (c) Retested on tower under sunny weather

Some insulators were found overheat when detected not too long after rain stopped, and the retest results were certainly abnormal when detected in a sunny day. Take insulator images in Fig. 6 as an example, when detected 13 h after rain, and the temperatures of insulator's wire side and normal position were 26.2°C and 17.9°C, respectively, while the temperature difference reached 8.3 K, but when detected in the second day under sunny weather, the temperatures of insulator's wire side and normal position were 24.7°C and 22°C, respectively, while the temperature difference was 2.7 K. Although the temperature difference was not too high, it can be seen from the thermal image that there was a hot spot at the end of wire side. Then power crews climbed up the tower and retested the insulator. The result showed that the temperature difference was 6.6 K, while the maximum temperature of the insulator's wire side was 31°C. Judging from the thermal image, it was obviously overheated, and the wire side mandrel of the insulator was defective. This paper suggests that the insulators' surface damp contamination aggravates the overheat caused by insulation defects, which lead to the high temperature difference when detected after rain.

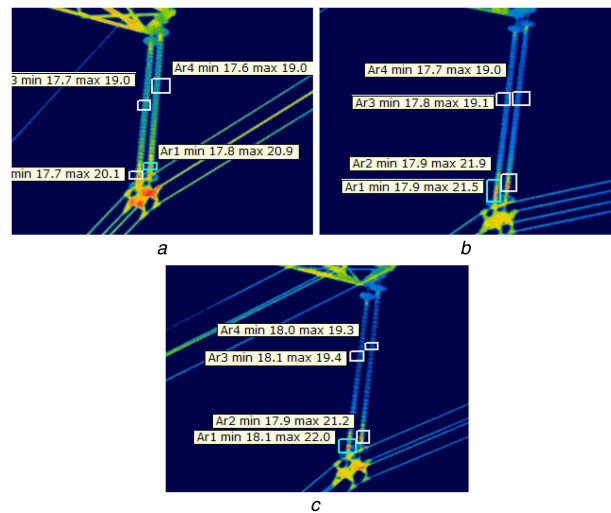
Fig. 7 shows thermal images of three-phase composite insulators on a 500 kV line tower designed with double strings.

Seen from the thermal images, all of the six composite insulators' wire side had abnormal hot spots, and the temperature difference between the highest temperature point and the ambient temperature was 2.6 K. Now make a similar comparison, the maximum temperatures were 20.1°C and 20.9°C on the two top-phase composite insulators, 21.5°C and 21.9°C on the two middle-phase insulators, and 21.2°C and 22°C on the two bottom-phase insulators. The temperature difference was 1.8 K between top phase and middle phase, and 0.5 K between bottom phase and middle phase, but compared with the two insulators on the same phase, the maximum temperature difference was only 0.8 K. In this case, it cannot be considered the composite insulators of bottom phase and middle phase were overheat, and the on-tower detection

Fig. 7 Thermal images of three-phase composite insulators
(a) Top phase, (b) Middle phase, (c) Bottom phase

result is necessary to confirm that. The different position of the composite insulators, the difference of the three-phase current, and the weather condition during the temperature measurement may cause this phenomenon, which may lead to miscarriage of justice.

First, according to the different temperatures displayed as different colours in thermal images, if no abnormal heating part exists, the equipment is normal. If there is abnormal heating, then we need to compare the temperature between the hottest point and lowest temperature point along the insulator. When the temperature difference is greater than 5 K, we can firmly believe that the insulator has insulation deficiencies. Otherwise, we have to make a similar temperature comparison between the corresponding parts of the three-phase insulators on the same tower, or the double insulators string on one phase. If the similar temperature difference is less than 1 K, the higher temperature insulator is normal, or we need to climb up the tower to confirm whether the insulator has insulation deficiencies.
