The possibility of extending work time of tribocouple welding improved stainless steel with improved carbon steel

Vlatko Marušić¹, Predrag Dašić², Ivan Opačak^{1*}

¹Mechanical Engineering Faculty in Slavonski Brod, Trg Ivane Brlic-Mazuranic 2, Croatia

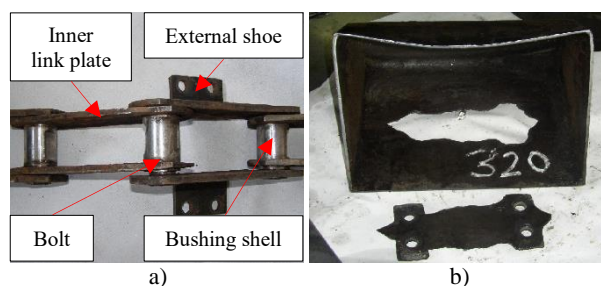
According to the original documentation: breaking force of elevator chain is about 2500 N and declared service life of a chain is two years. Figure 1 shows the parts of the original elevator chain after about six months of work.

Fig. 1. Appearance a damaged chain (a); buckets severed of link shoes (b).

Dimensional control measured: 1. wear of a bolt is ≈ 3 mm, only the surface of bolt in contact with capsule is worn; 2. only the surface of bolt in contact with capsule is worn; 3. wear of a shell on the outside is $\approx 2,2$ mm and on the inside to ≈ 1 mm, with emergence of upsetting compound shell/slice and increasing the gap at about 0,8 mm by an upsetted compound. Chain pitch is 160 mm. Wear of a tribocouple, which causes a change in chain pitch (slice, shell and bolt) is about 8 mm, and there is 6,25 tribocouples on meter of a chain. Conclusion can be that the chain extension, as a result of wear parts, can reach more than 50 mm per meter, resulting in overall chain elongation of 1,600 mm in total length chain of 32 m. Wear so big reflects to chain pitch, and this sometimes results in ripping buckets of link shoes.

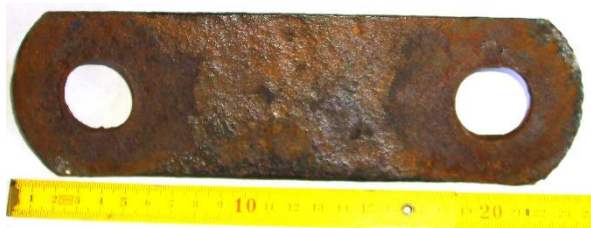
Chemical analysis showed that the slice and link shoes, are made of improved steel, C45E. The measured surface hardness of slices and link shoes, mean is about 210 HB. The thickness of these parts of the chain before the installation was 8 mm. Dimensional control was found that the corrosion caused local reducing of thickness on max. 6,8 mm. Metallographic search were carried out on a sample taken from a damaged external slice, Figure 2. In slice is pressed bolt Ø30 mm which is additionally welded to the outer side on the slice.

Fig. 2. Original damaged slice.

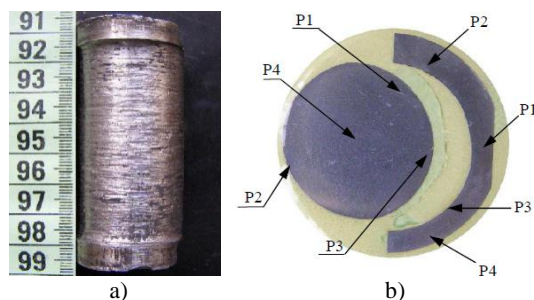
Chemical analysis showed that the bolts (Ø30 x 83 mm) and shells (Ø42/Ø30 x 65 mm) made of austenitic corrosion steel X5CrNiMo17-12-2 [5]. From damaged bolt Ø30 mm, shown in Figure 3.a, sample was cutted and control of hardness is performed. The cross-section of the test sample of damaged bolt is shown on Figure 3.b.

Fig. 3. The appearance of the original bolts in place „worn place“ (a); macro recording cross-sectional sample with marked positions of measuring the hardness of the bolt and the bushing shell (b).

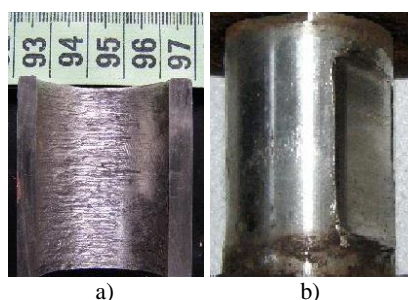
Test of shell is carried out on spot of damaging in towing part with the bolt, Figure 4.a, and in the outer side in contact with the sprocket, Figure 4.b.

Fig. 4. The appearance of the original bolt on spot „worn place“ (a); macro recording of cross-sectional sample with marked positions of measuring the hardness of the bolt and shell (b).

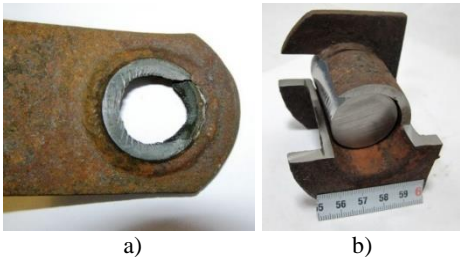
In order to verify welded compound bolt/slice were tested on the testing machine with static tensile tests. The load is added untill the termination of welded compound, and broken places served for metallographic examination and hardness control. The appearance of the welded compound slice/bolt after testing is showed on Figure 5.a. The cross-section of tribosystem shell/bolt/slice where will be performed metallographic examination and hardness measurement is shown in Figure 5.b.

Fig. 5. External slice after breaking bolt (a); the cross-section shell/bolt/slice (b).

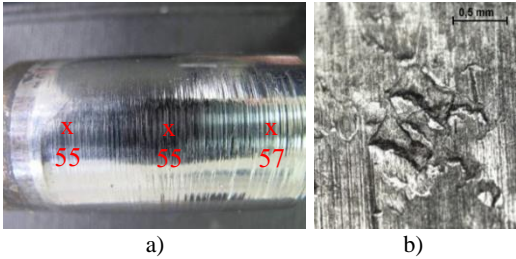
Characteristic traces of bolt wear are shown in Figure 6.a and 6.b.

Fig. 6. Characteristic wear traces of bolts, macro (a); micro (b).

Based on measurements on ten positions, conclusion was that on the most spend part diameter is 29,7mm, which is the higher for $\approx 0,3$ mm compared to the built measure of bolt. Traces of wear in the towing part of the stud characterize radial furrows caused by abrasive action of tiny particles of sunflower shell. These particles, during the work came in contact with bolt/shell, and considering the hardness of micro abrasives ≈ 6 Mohs [7] „furrows“ are interrupted at the point of encountering on harder carbides are logical look of traces of wear. Figure 9 shows the cross-section of the welded joint shell/slice and values of measured hardness HV1.

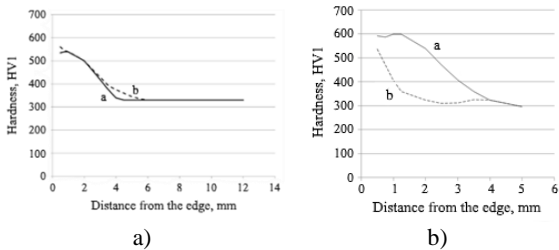
Diagram in Figure 7.a shows the flow of hardness HV1 from the edge to the core of the bolts on the unexhausted part (curve a) and on worn parts (curve b). Diagram in Figure 7.b shows the flow of hardness HV1 from the edge to the core of the shell after use.

Fig. 7. The flow of the hardness HV1 from the edge to the core after use of the bolts (a) and of the shell (b).

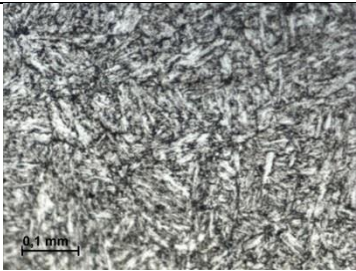
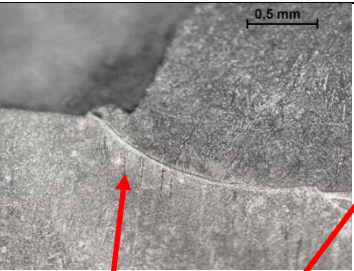
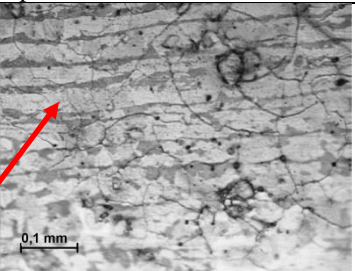
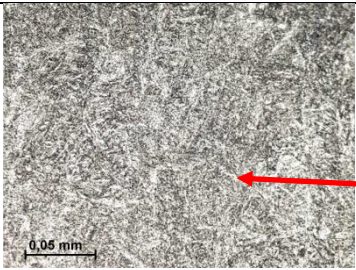
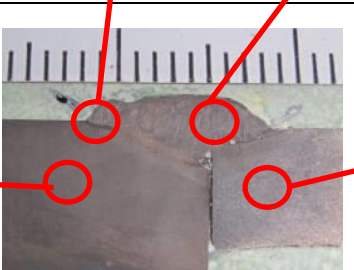
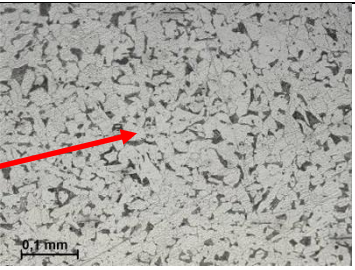
The edge zone of bolt, hardness ≈ 600 HV1 (unexpended part)	Hardness of clear weld are from 184 to 193 HV10	Hardnesses range from weld to HAZ on link plate side is 212 to 253 HV1

Adler		Nital
Hardness core of bolt is 330 HV1		Hardness core of slice is from 150 to 165 HV1

Fig. 8. Microstructure and hardness of bolt and slice.

Microstructure of bolt, slice, weld and HAZ are showed in Figure 8.

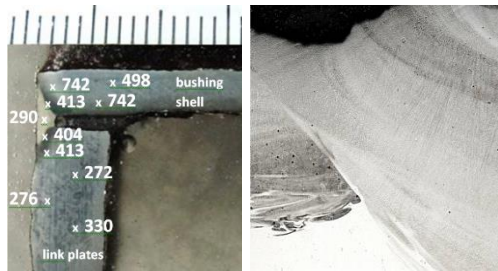
Fig. 9. Cross-section of welded compound link plate/bushing shell and values of measured hardness HV1.

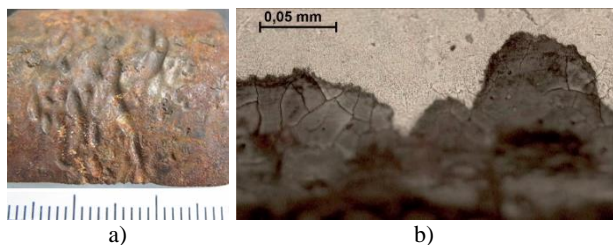
Figure 11.a shows characteristic traces of wear of external surface of shell, Figure 11.b shows traces of shell wear from the inside in contact with bolt.

Fig. 11. The typical wear traces of external carburized surface of bushing shell, the outer surface – macro (a); inner surface (b).

same as carburized shells in contact with bolt; 2. carburized shells are damaged by abrasion and corrosion due action of acid media which has pH value ≈ 5.2 ; 3. wear traces of external shell carburized surface with obvious local damage, suggest that dominant mechanism is abrasion; 4. maximum measured force at break of weld joint bolt/slice is higher than the budgetary breaking force of chain. The analysis results, search of structure and the measured hardness of triboelements show that the application of this approach to solving complex problems of wear elements of straight-chain transporter can achieve significant prolongation of life. Additionally, perhaps the most important, welding shells and bolt to appropriate slice avoid the risk of fracture. this is for all structures including tribosystem most important thing, because intensity of wear based on analyze of structure, hardness, traces of wear and middle media can predict. These results make conditions for possible continuation of research which will, except to increase the wear resistance of triboelements, could go in the direction of more detailed analysis of the impact of additional material for welding shells and bolts with slices so the choice of other parameters for welding process.
