Metallurgical Analysis of Surface Defect in Telescopic Front Fork

Souvik Das, Janak Lal, Arthita Dey, Goutam Mukhopadhyay, Sandip Bhattacharya

Keywords—Telescopic front fork, induction welding, hook crack, internal oxidation.

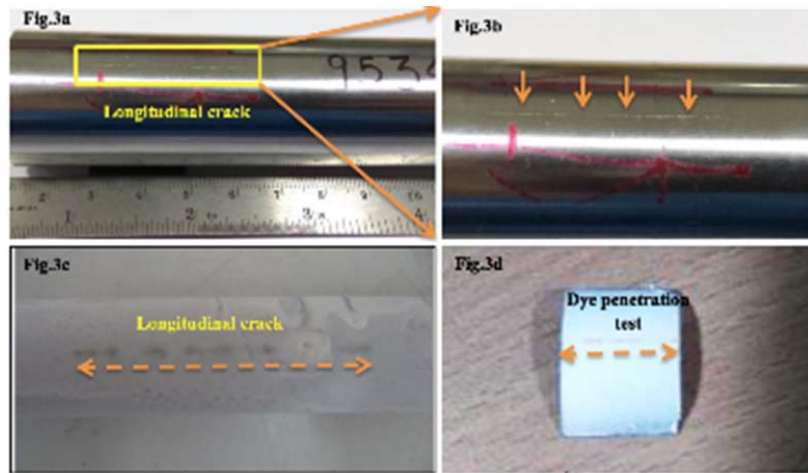
Sample #1: Visual observation of the failed fork showed small longitudinal crack along the length of the tube at the circumference close to the weld (Figs. 3 (a) and (b)). The crack was about 4 cm in length and very thin and difficult to detect easily. Crack was very shallow in depth and difficult to detect, so it was detected by dye penetration test (Figs. 3 (c) and (d)).

Fig. 3 (a) and (b) Longitudinal crack along the length of the tube, longitudinal crack was detected through dye penetration test

Sample #1: Visual observation of the failed fork tube showed presence of small cracks along the length of the tube at the circumference adjacent the weld flow lines. The crack was about 5 cm in length. The unetched microstructure of crack showed 'J' type hook crack [1], [2]. MnS inclusions were observed in the vicinity of the crack. The overall MnS inclusion was high as shown in Table III. Microstructural analysis further revealed that the hook of the crack was turning toward upward surface. The originator of hook crack is non-metallic inclusion primarily MnS stringers. These flattened non-metallic inclusions are formed during hot rolling of plate. They reduce the ductile toughness of the steel even in their normal position but do not affect the yield or tensile strength of the steel [3]. So, the mechanical properties of the tube under investigation were also satisfactory. Near bondline, these weak layers reorient themselves in such a way that they become subjected to tensile hoop stress when the pipe is pressurized [4] and a small crack originates. The slight upset of the metal at the weld acted to turn the ends of this usually very small subsurface crack in the direction of the upset. Because the metal flow during the upset is toward the both surfaces. The hook of the hook crack may turn toward either the outside or inside surface, depending on which the

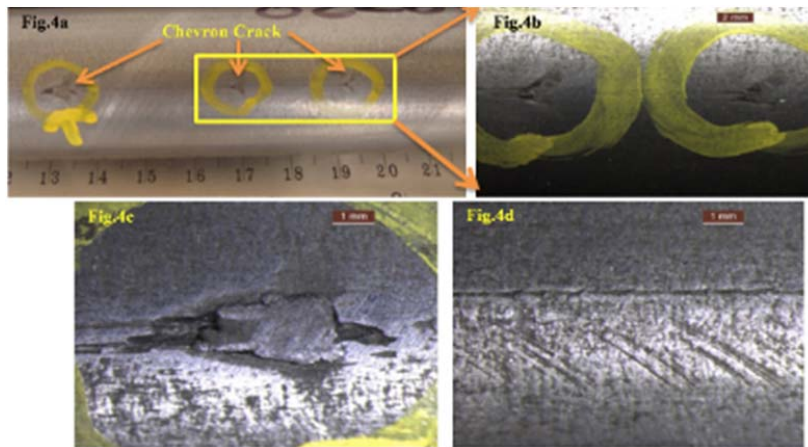
Sample #2: General view of the tube sample with defect is shown in Fig. 4 (a). Multiple chevron marks were observed on the surface of the tube. These chevron marks were found to form a single line (Figs. 4 (a) and (b)). Similar marks with less severity and a line mark running through centre of these defects were observed at 180-degree location (Fig. 4 (a)).

Fig. 4 (a)-(c) Chevron cracks on the surface of the tube, (d) Less severity defects were observed at 180-degree location of the chevron crack

Sample #2: Repeating chevron marks were observed to form a single line at certain interval on the tube surface. Similar marks with less severity and a line mark running through centre of these defects were observed at 180-degree location. Closer observation of the chevron marks in stereo microscope shows accumulation of material at centre of the chevron. Optical microscopy shows grain deformation at the defect contour indicating cold stage deformation. Based on the repetitive nature of the defect, it appears to be originating from the drawing stage itself and that too at exactly diametrically opposite locations of the tube. Decarburised grains along with internal oxidation associated with dark brown entrapment were observed along the cracks. Presence of mould powder entrapment inside the material indicates origin of the defect from slab stage. The morphology and location on the tube suggests that the steel defect got aggravated during drawing forming the chevron mark. Mold powder entrapment mainly occurs in the so-called “transient casting” periods, e.g. the time of casting start, casting end, ladle exchange, mold width change, SEN change, etc. During the unsteady casting periods, usually, the casting speed is largely varied, which disturbs the flow of the liquid steel in the mold and results in severe level fluctuation. Hence, mold powders are easy to be carried into the liquid steel, and some are entrapped by the solidified shell

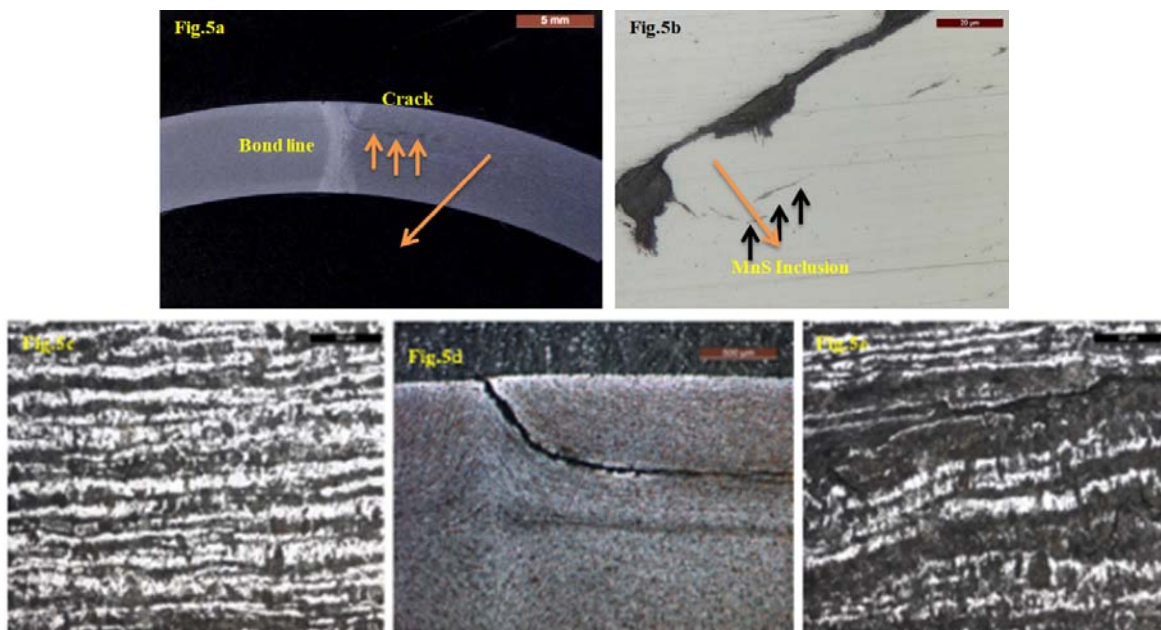
Fig. 5 (a) Chevron cracks on the surface of the tube, (b) Un-etched micro image of the defect location, (c)-(e): Etched micro image of the defect location at different magnifications

Sample #1: The un-etched microstructure showed a crack, 'J' type in shape and of 0.5 mm in depth (Fig. 5 (a)), typical to hook cracking [1]. Further the crack was found to be associated with some non-metallic manganese sulfide (MnS) inclusions (Fig. 5 (b)) which were further confirmed through EDS analysis. The macro dual zoom photograph of the micro sample revealed white bond line associated with the crack (Fig. 5 (c)). The 3% nital etched microstructure showed that the crack was slightly offset from the bond line of the Cold drawn Electric resistance Welding (CEW) seam (Fig. 5 (a)), but following the weld flow lines and opened up at the circumference. The hook of the crack turned toward upward, as shown in Fig. 5 (d). The weld flowline of the tubes was compatible to the cold drawn structure (Fig. 5 (d)), and the matrix revealed banded ferrite pearlite structure (Figs. 5 (c) and (e)) common to such high manganese structural steel

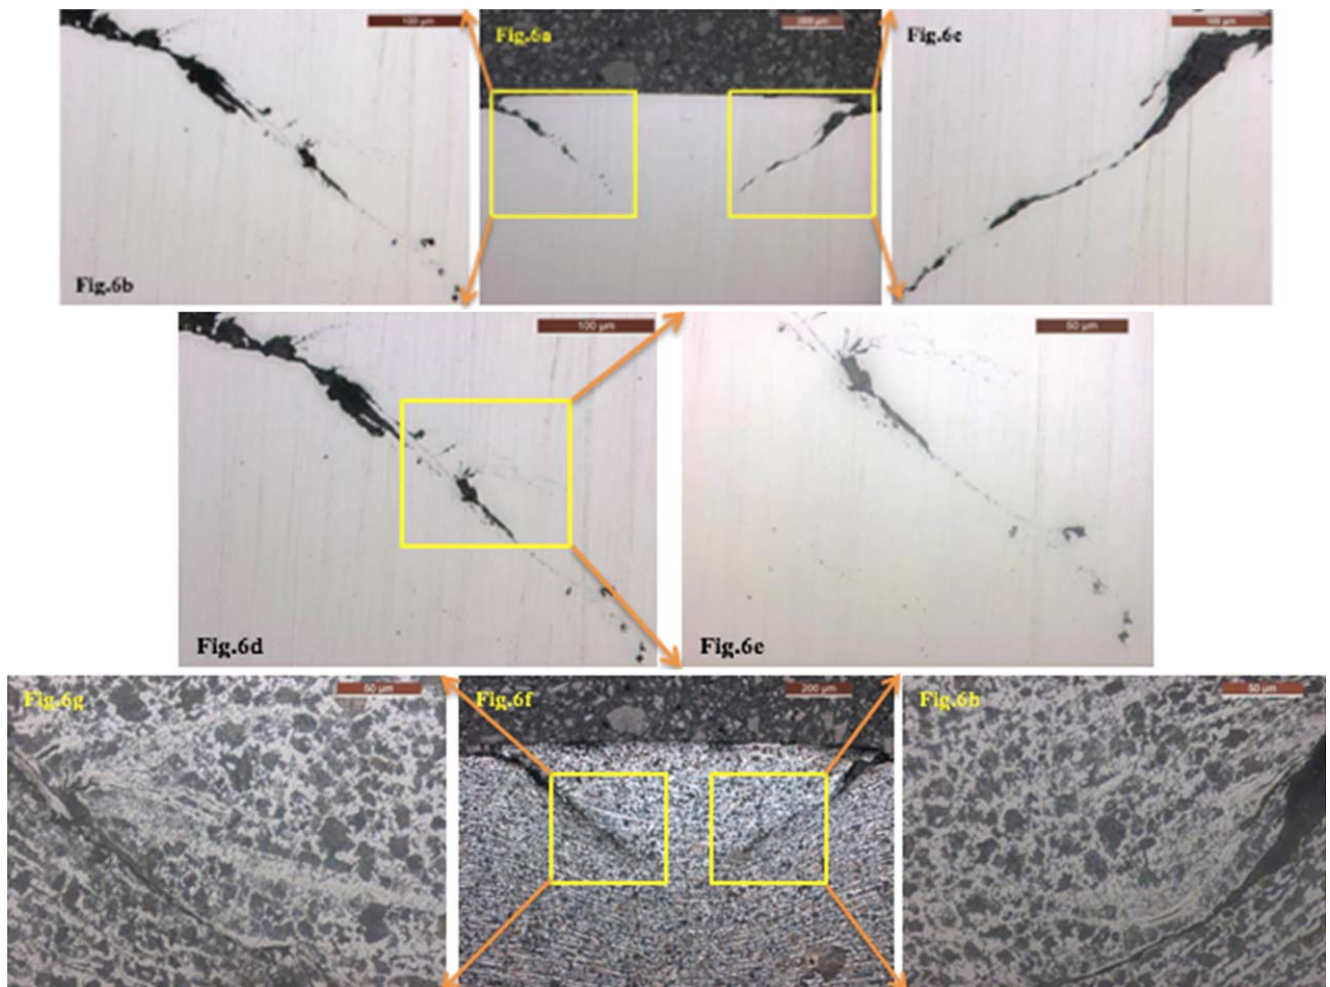
Sample #2: Un-etched micro image of the samples from defect area revealed bowl shaped defect. This was formed by chipped-off material as shown in Fig. 6 (a). Figs. 6 (b) and (c) show closer view of the cracks on both edges of the defect. It can be observed that the cracks contain some non-metallic entrapped in it. At higher magnification, as shown in Fig. 6 (e), suspected internal oxidation can be observed in chipped-off material.

The etched microstructure at the defect location is shown in Fig. 7 (a). Banded ferrite - pearlite structure was observed which followed the contours of the defect/chipped-off material. At higher magnification, decarburised grains were observed along the suspected internal oxidation. The chipped-off material does not show any banding or deformation. However, due to accumulation of this material, grains in the matrix below, it got deformed which is cold condition effect.

Fig. 6 (a)-(d) Un-etched micro image of the defect location at different magnifications, (e) Presence of dark brown entrainment along with internal oxidation (f)-(h) Etched micro image of the defect location at different magnifications

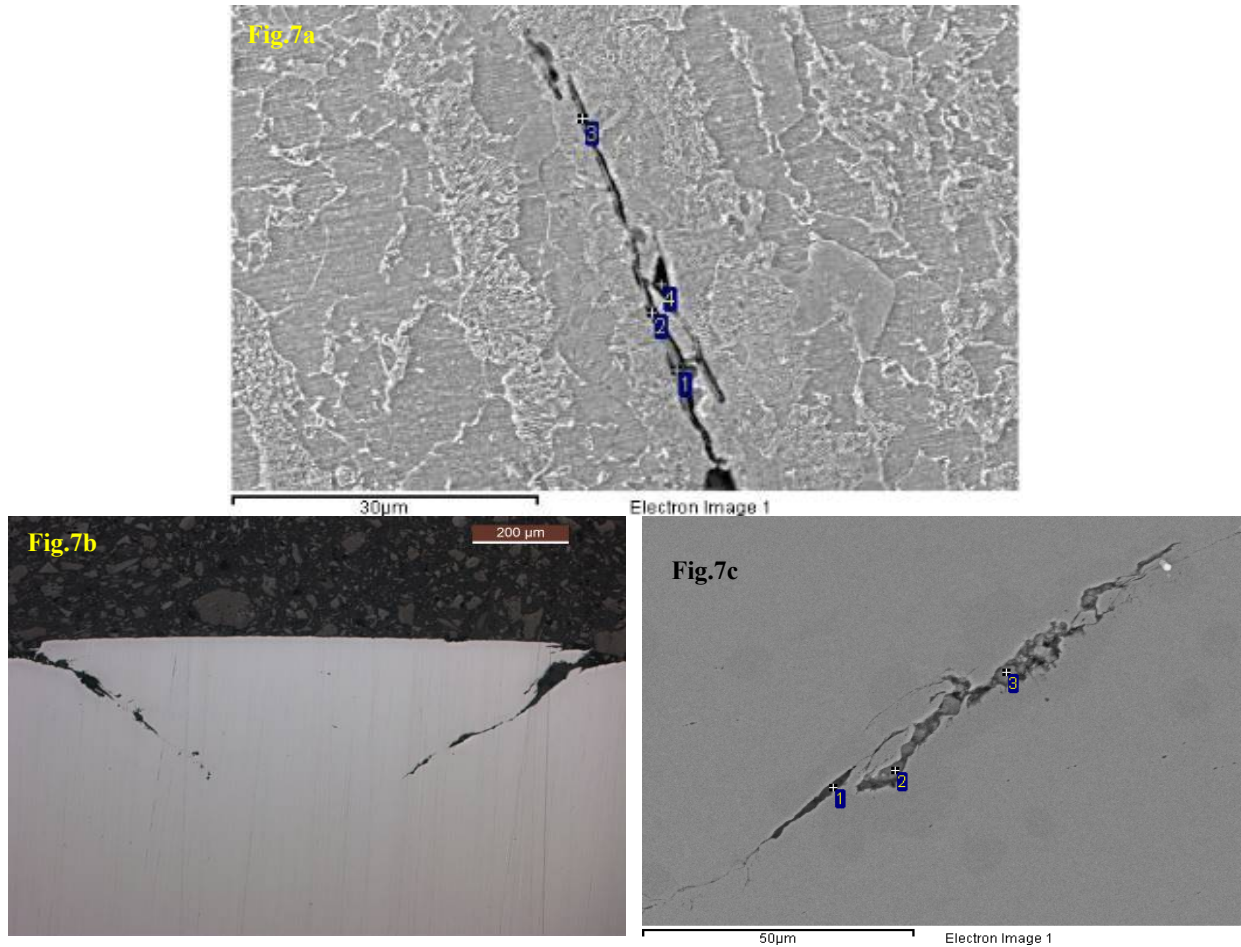
Sample #1: EDS analysis was carried out on non-metallic inclusion by Scanning Electron Microscope at an accelerating voltage of 15 kV. EDS analysis confirmed the inclusions as

MnS (Fig. 7 (a), Table II). Then, inclusion rating was also carried out by ASTM E 45 method to check overall cleanliness of the steel. The inclusion rating, shown in Table III, revealed higher MnS inclusions in steel.

Fig. 7 (a) EDS analysis of sample#1 at cracked location, (b) and (c) EDS analysis of sample#2 at defect location

Sample #2: EDS analysis of the dark brown entrapment revealed prominent peaks of Ca, Si, Al, Na, F and O which proves that crack has generated due to mould powder entrapment.

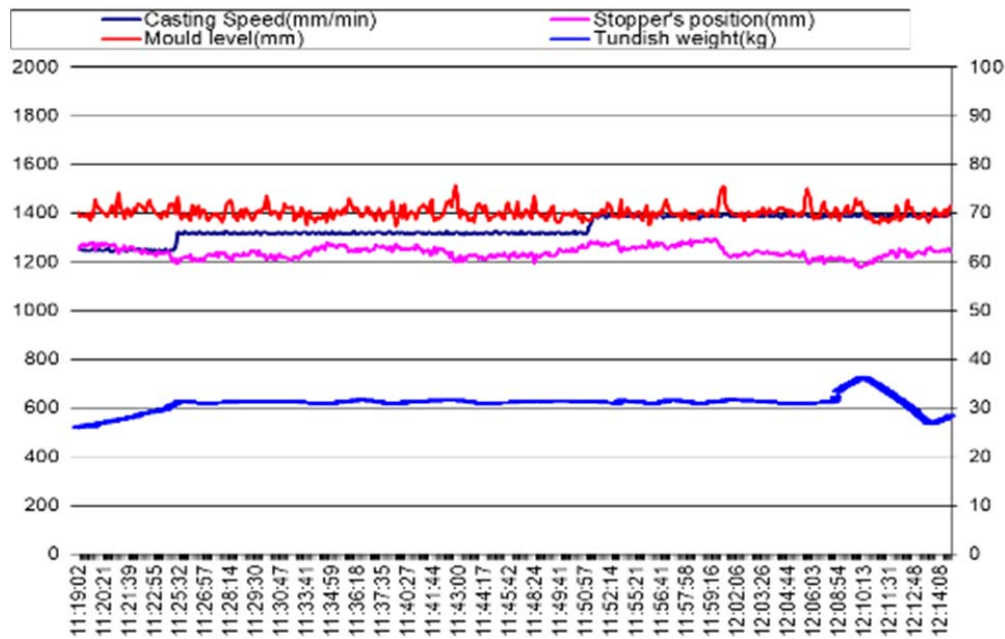
Fig. 8 Casting parameters for sample #2

and exist as non-metallic inclusions in slabs. If the interfacial velocity of steel melt which exceeds tear off velocity results in associated shear stress to become greater than the cohesion forces of the slag. Slag gets torn off and carried over in the form of droplets in the liquid metal. While a part of these droplets immediately floats back towards the meniscus, another part is transported by the metal flow and scattered in the liquid pool [7]. In case of sample #2, it has been observed that higher severity index in this coil is explained due to unstable stopper position shown in the caster (Fig. 8). As seen from the chart given for this slab, there are large fluctuations in casting speed along with large mold level fluctuations. Hence, changing stopper position causes unstable molten steel flow and so entrapment of mold powder.
