Fire Examination of Superhigh-Rise Apartment Building “Wooshin Golden Suites” in Busan, Korea

Young-sun Kim¹, Masayuki Mizuno¹ and Yoshifumi Ohmiya²

¹ Center for Fire Science & Technology, Research Institute for Science & Technology,
Tokyo University of Science, Japan

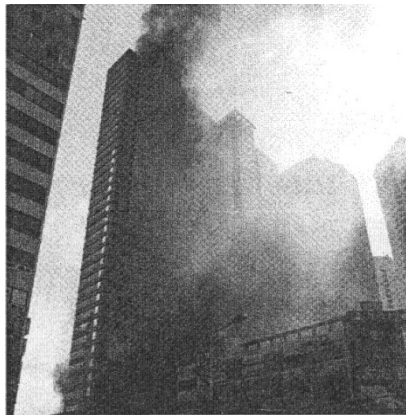
The fire broke out from the PIT level on the fourth floor which divided commercial area on lower levels and offices and residential units on upper levels. The cause of the fire is reported to be a spark generated around a socket near the door of men's dressing room for administrators of the building and the spark seemed to ignite nearby objects. Then as shown in *Figure 2*, the fire rapidly expanded rushing up along the outside wall and burnt the sky lounge and the penthouse on the top floor and some residential units on the 37th floor. *Image 3* presents the damaged building which faced to the coast taken from the back side at the time of the fire. The smoke generated on the coast side of the building rose from the upper levels as well as hang around lower levels on the opposite side of the beach. *Image 4* is the external appearance of the building after damaged by the fire. The image shows the finishing material of outside wall was burnt upward. The course of the fire announced by the South Korea fire department is briefly summarized in *Table 1*. Total floor area inside the building that was burnt down in the fire reached 1,134 m². In addition, exterior finishing material from 4th through 38th floors was also destroyed by the fire. Human damage was small as only four people slightly injured but financial damage amounted to more than 400 million yen.

Image 3 The fire scene of “Wooshin Golden Suites” [3]

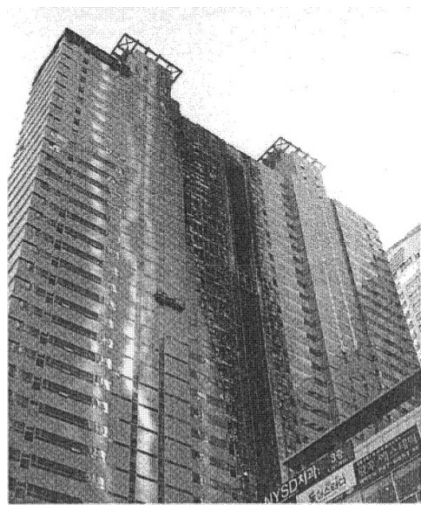
Image 4 External appearance of “Wooshin Golden Suites” after damaged in fire

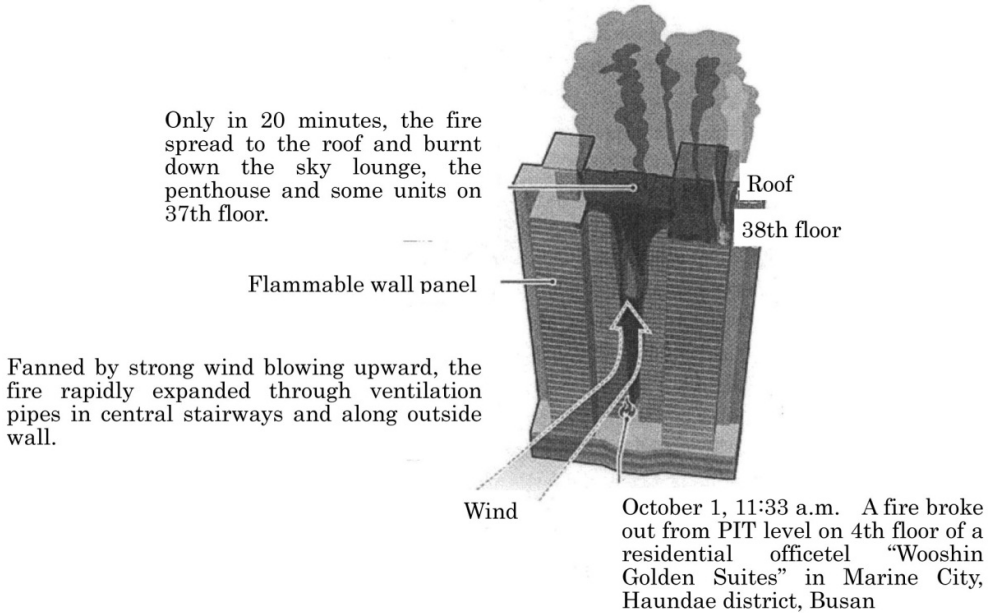
As stated above, the fire broke out from a spark of socket around 11:21 a.m. on October 1, 2010. Then the fire spread from inside of the building to outside wall as shown in *Figure 2*.

Figure 2 Description of the “Wooshin Golden Suites” fire [3]

The outside wall was made of aluminum composite panel and its core material was composed of polyethylene. As outside of the panel was exposed to hot current (including flame) ejected from an opening, the surface temperature rose and aluminum dissolved. In addition, combustible gas derived by thermal decomposition of the core material caught the fire and burnt the outside wall. Then the high-temperature gas rose along the wall to further accelerate dissolution of aluminum and combustion of polyethylene core material, and the damage spread upward. It is considered that the sequence of dissolution and combustion of the panel resulted in rapid and wider expansion of the fire upward along the wall. Accordingly, it only took about 20 minutes for the fire to burn from the fire source floor (4th floor) through 38th floor after the fire broke out. This indicates the spread of the fire was extremely rapid by burning the outside wall.

We can also point out that strong wind blowing from the sea and the surface shape of the wall created the complicated conditions and affected fire expansion. To be specific, the part of the outside wall where the fire spread was in the form of hollow. Therefore

when strong wind from the sea hit the hollow-shaped wall, the wind flew up along the wall and possibly fostered expansion of the fire. In addition, in a similar way as the ordinal surface or corners of wall, temperature decrease of thermal current moving upward along the U-shaped hollow is slower than in free space, and high temperature part tends to spread upward. Furthermore, walls facing to each other or being at right angle each other are prone to mutually transfer radiant heat. These conditions also seemed to encourage the fire to burn surface of the wall and expand upward.

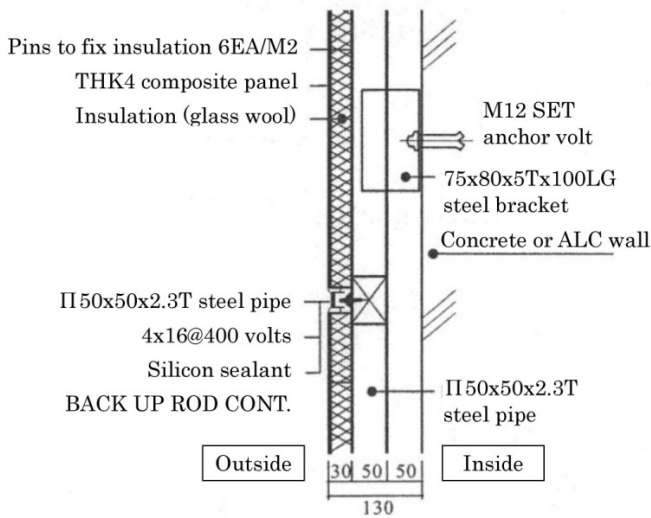
In South Korea, there is no regulation on the use of combustible external material. The biggest problems in “Wooshin Golden Suites” fire was that outside wall using combustible material burnt intensely and the fire rapidly spread upward due to the surface shape and strong wind at the time.

Exterior finishing material used in the outside wall is called aluminum composite panel with small load and high usability in construction, which is especially effective to decrease structural load and reduce construction cost of superhigh-rise buildings. As *Figure 3* explains, aluminum composite panel is connected to angles and then fixed to concrete wall.

Figure 3 Cross section of the outside wall structure

If incombustible material had been used in the outside wall, such a significant spread of fire could have been prevented. After “Wooshin Golden Suites” fire, the importance of fire-resistant capability of wall is recognized again in South Korea. On the contrary, since more than 80% of high-rise buildings in South Korea were built using combustible material, immediate response to this situation is strictly required.

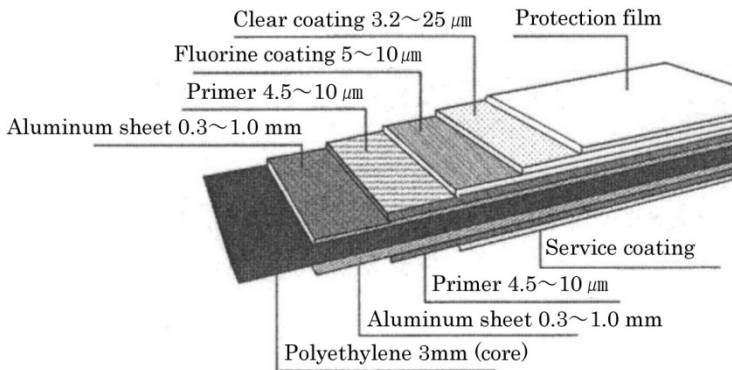
Figure 4 shows the pattern of aluminum composite panel. On the core material made of combustible polyethylene resin, aluminum sheet, some kinds of coating material and protection film are piled up to ensure beautiful surface appearance as well as strength and resistance. Coating material and aluminum sheets are very thin and not fire-resistant as the melting point of aluminum is at about 660°C. Also, considering that they have high thermal conduction rate and polyethylene ignite at 350 to 400°C, it is very likely that they easily ignite and burn when exposed to heat expected in case of fire.

Figure 4 Pattern of aluminum composite panel (the top faces to outside)
