GEOTECHNICAL ASPECTS OF THE SUMATRA EARTHQUAKE OF SEPTEMBER 30, 2009, INDONESIA

ABSTRACT

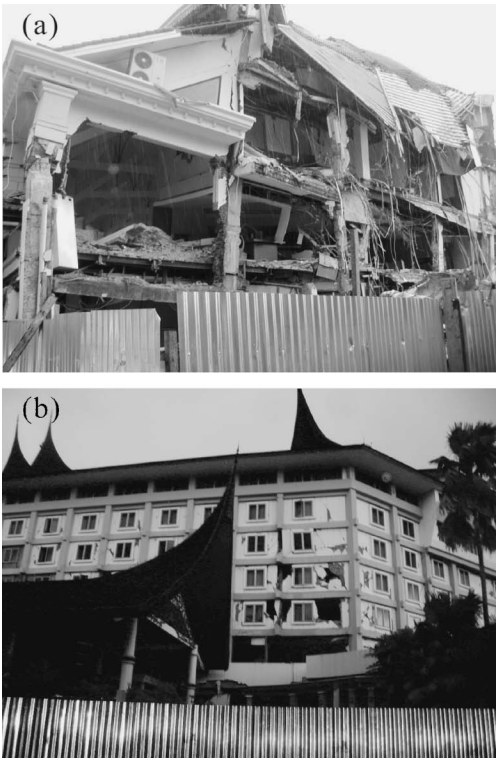
Fig. 2. A view of Ambacang hotel (a) and Buaminang hotel (b) that experienced considerable damage during the earthquake

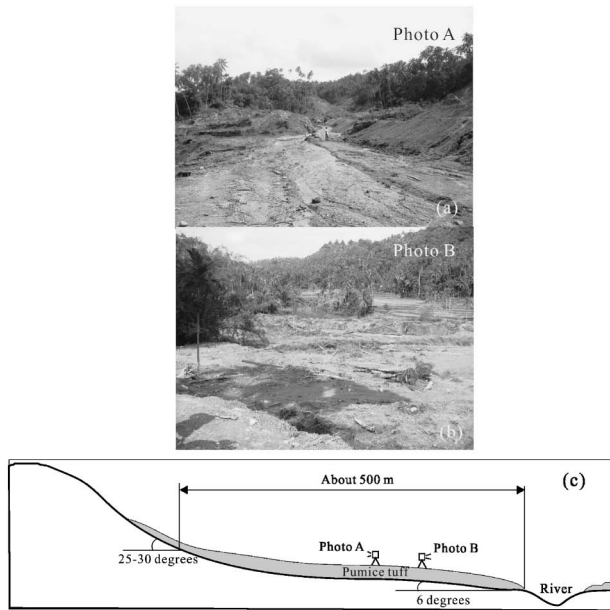
In Palokoto village, a large landslide destroyed a school, claiming 41 human lives (Fig. 5). The landslide mass, which consisted of volcanic material, mostly pumice tuff, traveled more than 500 m onto flatter areas with an inclination of 6–8 degrees, covering a territory of about 25,000 m². A Laser Rangefinder, a device that allows precise measurement of the degree of slope inclination, was used to evaluate a dip of the failure plane, which was found to be 25–30 degrees (Fig. 5(c)). The high velocity of the landslide and the considerable runout distance suggest that the sliding mass had a relatively low resistance to motion. The maximum thickness of debris

Fig. 5. A view of the large landslide in Palokoto: (a) the source area (Photo A), (b) the debris material at the toe (Photo B) and (c) schematic cross-section of the landslide site

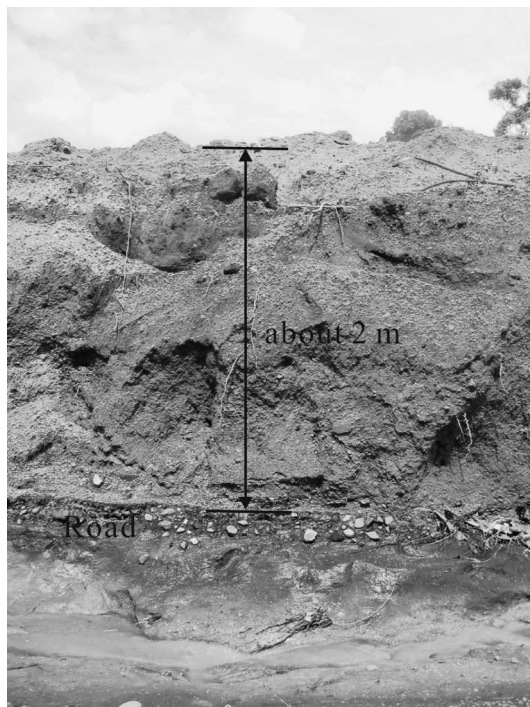
Fig. 6. The debris material at Palokoto village

material was estimated to be 2 m (Fig. 6). Smaller slides similar to the one shown in Fig. 7 occurred on the same and adjacent slopes, raising the total volume of debris material to about 40,000 m³. The survey showed that some parts of sliding mass and debris were still located on planes inclined in the range of 6–15 degrees, thus posing a continuing hazard to the local community. It is believed that such loose and disaggregated material can be easily and rapidly eroded during future intense, prolonged rain-

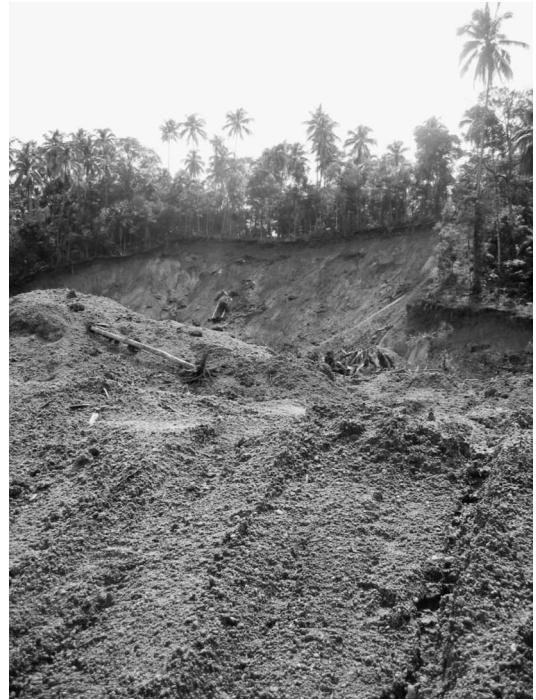
Fig. 7. A view of another slide at Palokoto that occurred about 300 m away from the main failure

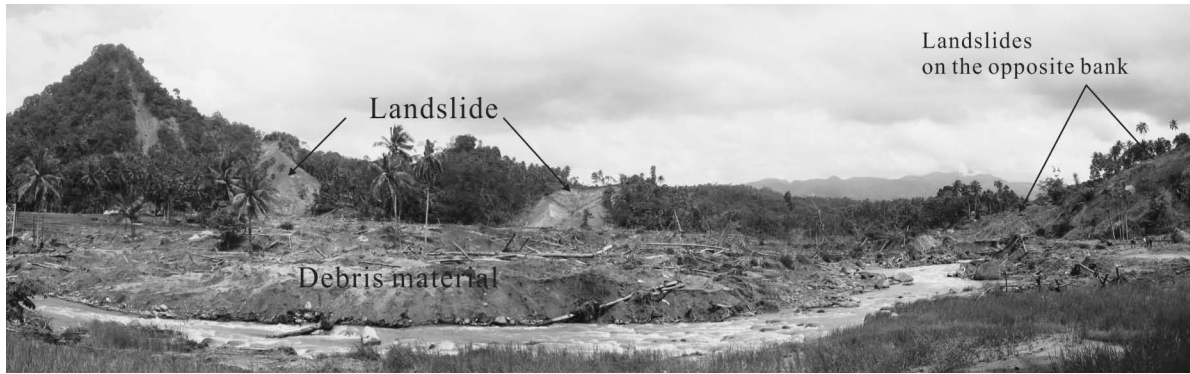
Two large slides also occurred on the opposite bank of the river (Fig. 8) where the landslide mass slid downward several meters. The failure appeared to be rotational in movement, with an inclination of the failure plane of 20–25 degrees. The material involved in sliding was highly weathered pumice tuff. The thickness of the sliding mass was estimated to be 5–10 m. A portable dynamic cone penetration test was performed near the scarp (Fig. 9) to obtain estimates of the strength of soil. Results of the test will be described in the following sections.

Fig. 8. A view of landslide sites and debris material at Lubuk Laweh (in this picture the river flows from the right to the left)

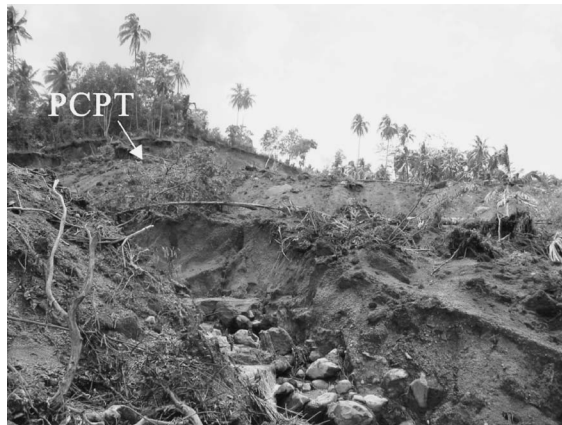
Fig. 9. A view of landslide that occurred on the opposite bank of the river at Lubuk Laweh. PCPT denotes the place where the portable cone penetration test was performed

A penetration test was conducted on the top of the sliding mass near the scarp area of the landslide shown in Fig. 9. Figure 15 shows the variation of measured N_d values with depth and the corresponding SPT N -values. From these data it can be inferred that the soil was weak: the N -values were typically in the range of 3 to 7. According to the Field Investigation Handbook of the Japanese Geotechnical Society (2004), granular soil with such penetration characteristics can be described as loose material with a friction angle of about 30 degrees.

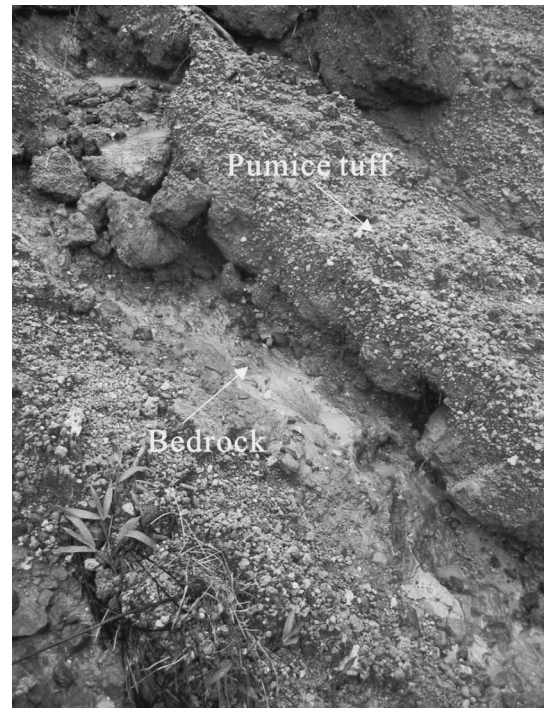
Fig. 11. A view of the failure plane of the Makalak landslide

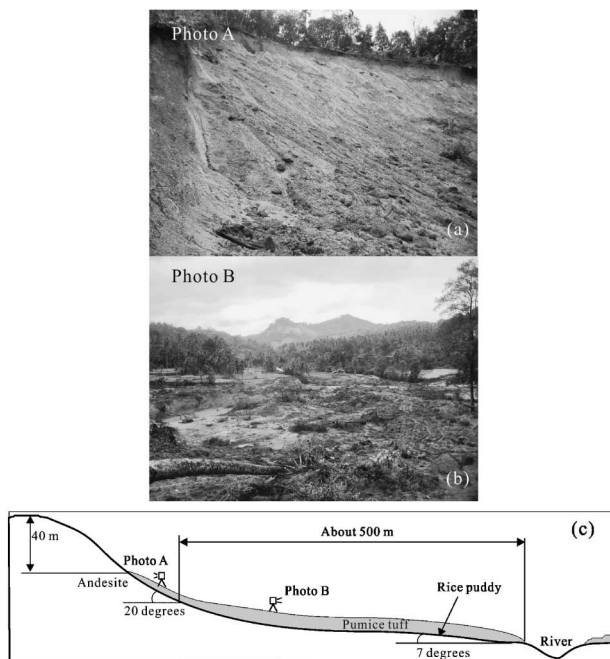
Fig. 10. A view of large landslide near Makalak village: (a) the source area (Photo A), (b) the debris material at the toe (Photo B) and (c) a schematic cross-section of the landslide site

A massive landslide with a volume of more than $200,000 \text{ m}^3$ was observed near Makalak village. Local people recalled that the slide was rapid in motion, resulting in the death of a family and a destroyed house. This landslide has a length of 500 m, a width of more than 100 m, and an estimated average thickness of 7 m (Fig. 10). The failure plane, which is inclined at about 20 degrees (Fig. 10(c)), developed along the boundary of highly weathered volcanic material with less weathered andesite (Fig. 11). It is noted that the sliding mass plunged onto a rice paddy, a fact that might have also contributed to the high velocity of the debris flow. It is believed that the saturated rice paddy served as a lubricated surface on which the sliding mass moved with little resistance to motion.

In case of the Makalak landslide (Fig. 10), the long distance and high velocity can also be attributed to the fact that the landslide slid on a rice paddy, which served as a lubricated surface on which the sliding mass moved with little resistance to motion.

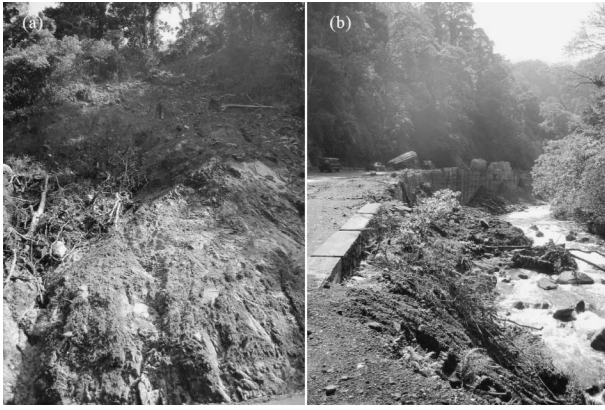
Fig. 12. A view of rock slide at Salaing: the unstable slope (a) and the debris material that plunged in the river (b)

earthquake were observed along the road connecting Pariaman with Padang Panjang (Fig. 1). Figure 12 shows a slope failure that blocked the road at a place called Salaing, suspending the traffic for 2 days. Huge rocks with a diameter of 3 m and weathered colluvium were the material that cascaded down the slope and plunged into the river (Fig. 12(b)). The slope inclination was measured to be about 45 degrees and the height was estimated to be approximately 70 m. The geologic characteristics of such rock slides can be described as follows: the top part of the slope is comprised of volcanic material (andesite or basalt) while the toe part is typically represented by metamorphic rocks (Fig. 13).

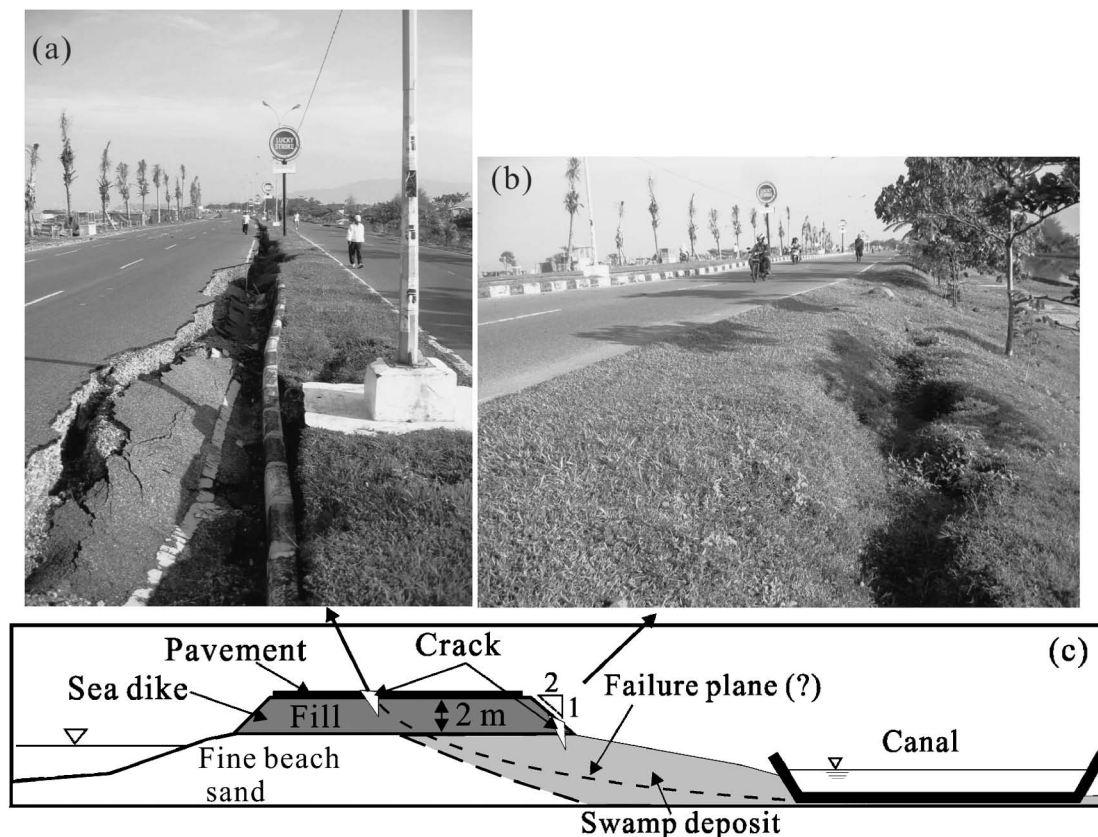
Fig. 16. Lateral spread observed at sea dike. The 1 m crack in the middle of the road (a), local failure of the road embankment (b) and schematic interpretation of the failure (c)

In addition to landslides, other geotechnical aspects of the damage caused by the earthquake were also assessed during the survey. Strong ground motion produced by the earthquake caused significant deformation of a sea dike in Padang (Fig. 16). Observations showed that a stretch of the road (about 200 m) was ruptured by numerous cracks, which appeared at several locations but primarily in the section of the road that was augmented five years ago to permit more traffic. Unlike the original part of the embankment that stood on fine beach sand, the new lane was placed on the “swamp” deposits as schematically shown in Fig. 16(c). It appears that during the earthquake, the soft swamp soil experienced significantly larger deformations than the fine sand, resulting in the formation of several big cracks and local failures.

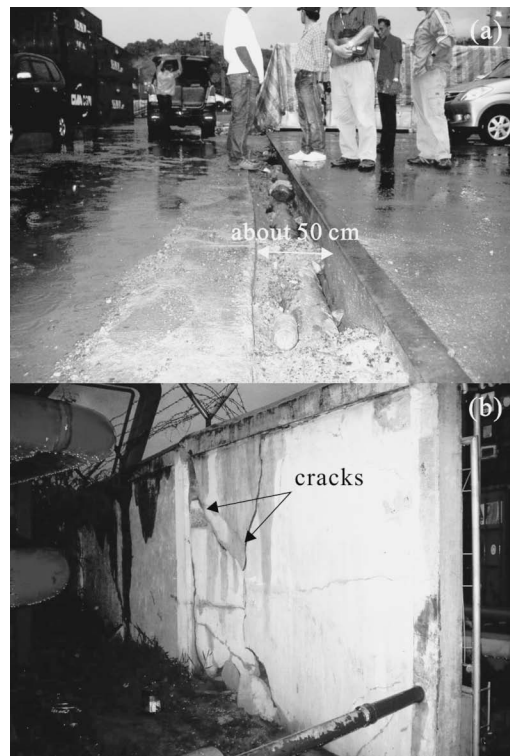
Fig. 18. Minor damage was observed at the Padang Harbor: (a) lateral deformation of the platform and (b) cracks on the wall

Minor damage was also observed at the Padang Harbor, which is located in the south part of the city (Fig. 17). Ground shaking produced a 50 cm gap between the platform that stood on piles and the filling (Fig. 18(a)). A few cracks also appeared on the wall that separated the platform from the piers (Fig. 18(b)).
