## FAILURE OF REINFORCED EARTH AS ATTACKED BY TYPHOON NO. 23 IN 2004

In October 2004, Typhoon No. 23 attacked western part of Japan, causing severe damage to infrastructures over a wide area in Kansai. In the early morning on 21st October, failure of a large Reinforced Earth wall with the maximum height of about 23 m took place in a mountainous area in Yabu city, Hyogo Prefecture. The debris flow from the reinforced embankment attacked a warehouse at the foot of the mountain, however, no casualties were reported. Immediately after the incident, an investigation committee was set up with missions to investigate the causes of this catastrophic embankment failure and also to examine any possible occurrence of further slope disasters in this region. In this paper, the failure mechanism by considering causes of the slope failure is discussed based on the results of stability analysis performed using laboratory and field data, coupled with topological information and the rainfall data. Some lessons learnt from this unique case study are described with reference to the design and construction of Reinforced Earth wall in rainy mountainous areas, in particular.

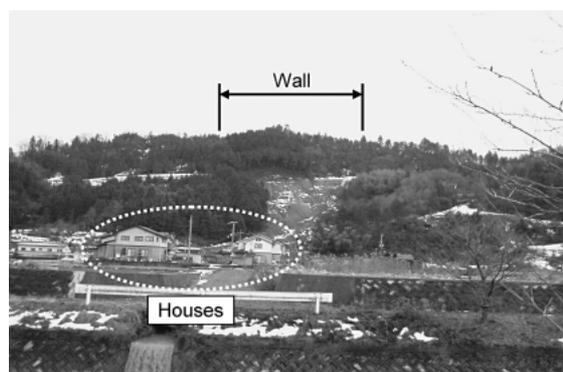
Fig. 1. Site after the collapse of Reinforced Earth wall

Yabu city in northern part of Hyogo Prefecture in west Japan. The time of occurrence of the incident was quite exact by the record of an emergency phone call from a local resident to Yabu local government office. Figure 1 shows a picture of the wall failure that was taken a few months after the incident.

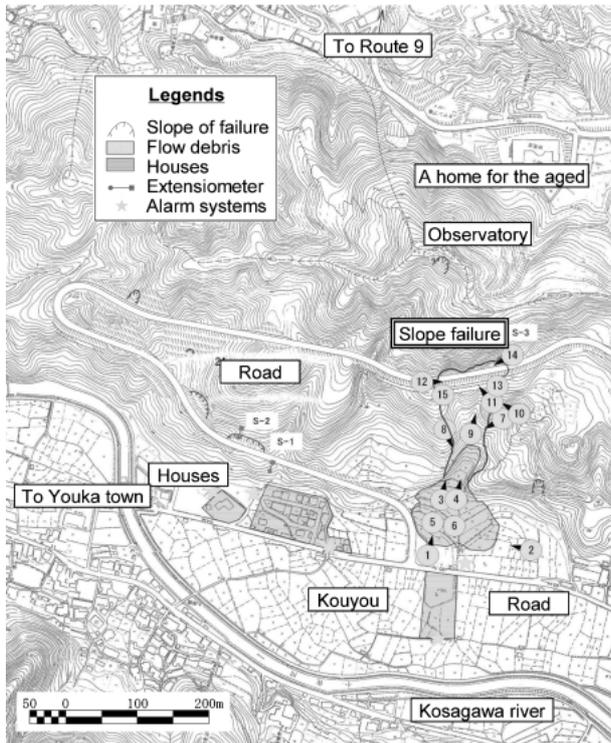
Fig. 2. Topographical map of the site immediately after the incident

The construction of the reinforced wall was completed in the year of 2000, i.e., four years before the incident. Figure 2 shows a topographical map of the site showing the condition immediately after the failure of the wall. The numbers shown in this figure refer to spots from where some pictures immediately after the incident were taken in order to obtain any clues into the failure mechanism (Shibuya and Kawaguchi, 2006). The landslide took place over a length of about 150 m along the slope involved with the collapse of the wall over 80 m length along the road. It was obvious in the map that the slope over which the wall failure occurred consisted of a couple of small valleys. Moreover, the road was inclined about 7% from West (right hand side in Fig. 2) to East (left hand side in Fig. 2). These topographical surroundings would have brought about some concentration of surface/ground water into the collapsed portion of the road during the heavy rainfall.

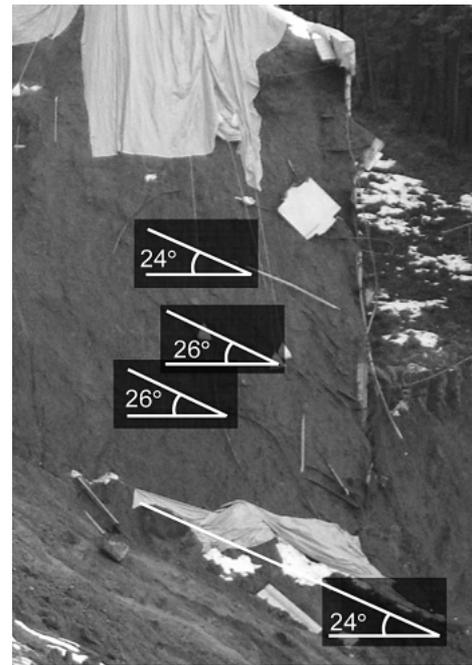
Fig. 3. Cross section of the remainder of the wall

- i) Parts of the wall (i.e., concrete skins and metal strips) reached to the end of debris flow,
- ii) Neither damage of metal skins nor breakage of metal strip/concrete skin joints was found,
- iii) The remainder of the wall stood in good shape,
- iv) The metal strips remaining on the side wall of wall were all inclined at an angle of 24–26 degrees from the horizontal that was equal to the supposed slip surface angle on the foundation (Fig. 3), and
- v) Rainfall water poured into the collapsed area during rainfall.

Regarding the remark iv), it was observed that the metal strips in the remained wall aligned horizontally just like the arrangement when the wall was constructed. It should be mentioned that the collapsed wall was as high as 23 m. To the authors' best knowledge, such a huge collapse as that of Reinforced Earth wall has not been reported in the literature.

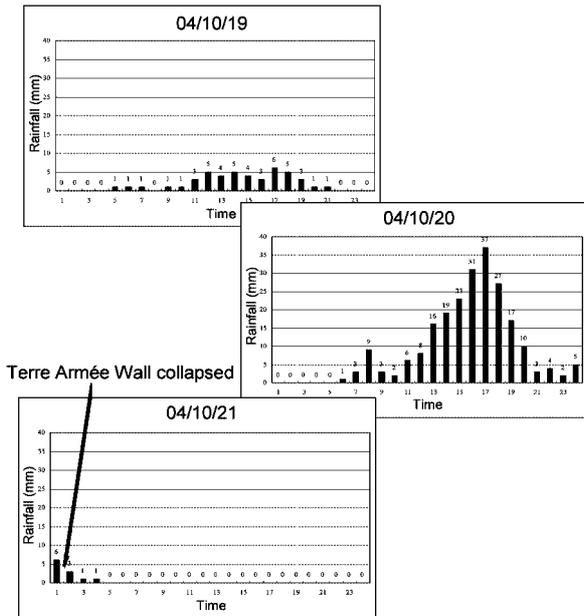
As mentioned earlier, the incident took place at 1:40 am on 21st October in 2004. Figure 4 shows the intensity of rainfall with time over three days before and after the incident. It should be mentioned that the data was recorded at an observatory very close to the site. Heavy rain with the intensity in excess of 10 mm per hour continued over eight hours (1 pm–8 pm) on 20th October. Note that the amount of 226 mm of rainfall was certainly the peak record over the past eight years in this region. It may well be postulated that this heavy rainfall was the trigger of the disaster.

Fig. 4. Rainfall data

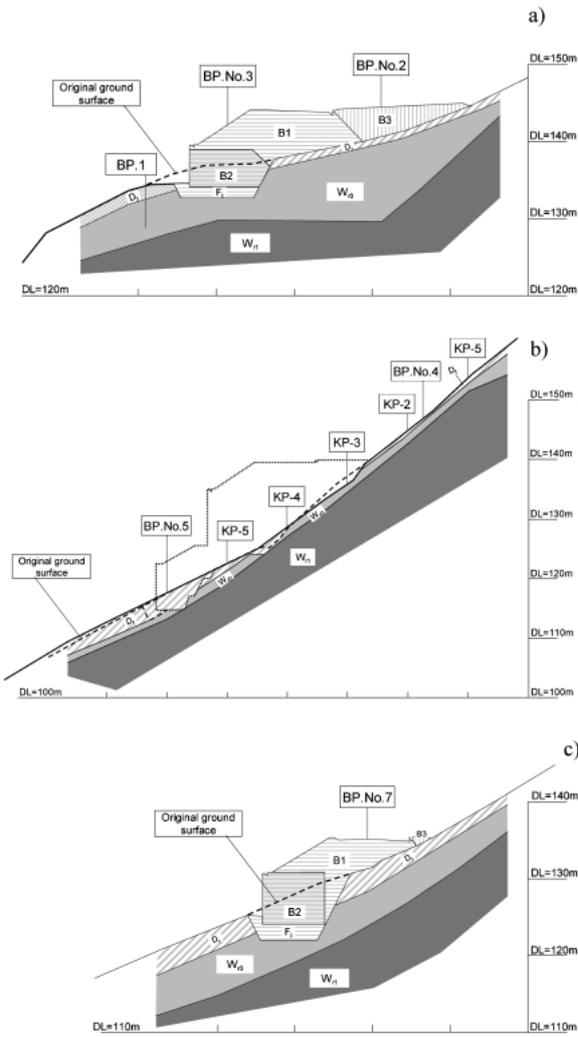
Cross sections of the wall depicted from these geotechnical investigations are shown in Fig. 8. As seen in Fig. 8, the subsoils may be conveniently characterized into seven layers as described below:

Fig. 8. Cross section of the wall: a) west line, b) central line and c) east line

It is to be noted that the wall rests on  $W_{r0}$ -layer with  $N$ -value of 22 on average. It should also be mentioned that the permeability from in-situ test was in the order of  $10^{-5}$  (m/s) for weathered rock layer ( $W_{r0}$ -layer), whereas it was smaller by one order of magnitude in the road embankment (i.e., B1, B2 and B3 layers).

- i) Concentration of in-soil seepage and surface water flow into the collapsed area,
- ii) Relatively low permeability of embankment (B1, B2 and B3 layers) as compared to the weathered rock foundation ( $W_{r0}$ -layer) (see Fig. 8),
- iii) Poor drain system behind the wall in particular,
- iv) Low bearing capacity of the foundation, and
- v) Softening characteristic of the foundation soil as sheared undrained (see Figs. 13 and 14).

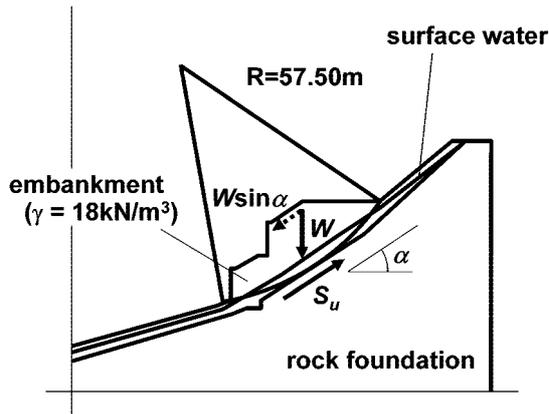
Fig. 16. Short-term stability analysis

surface was carried out by using the strength parameters from triaxial UU test and constant-volume direct shear test. Figure 16 shows the short-term stability analysis performed at the central portion of the collapsed wall (see Fig. 8(b)). The surface water level was postulated based on in-situ measurement that was made immediately after the incident. The results of back-analysis are shown in Fig. 17, in which the back-calculated factor of safety,  $F_s$ , is plotted against the total stress strength parameter,  $S_u / \sigma_{vc}$ . Note that  $F_s$  is close to unity (i.e.,  $F_s = 1.1$ ) when the  $S_u / \sigma_{vc}$  value of 0.70 is employed, whereas  $F_s$  was far less than unity when  $S_u / \sigma_{vc}$  of 0.34 from conventional direct shear test is used for the calculation. The result strongly suggests that we should use soil strength from direct shear box test in which the magnitude as well as history of initial stress conditions on the supposed slip surface are closely simulated in the laboratory. In the stability analysis performed, it was assumed that the soil behind the wall was saturated as a consequence of heavy rainfall over a short period of time. The effect of concentrated rainfall on the wall stability was manifested in the fact that the  $F_s$  value with dry soil (i.e.,  $S_r = 0\%$ ) behind the wall was far greater than unity.

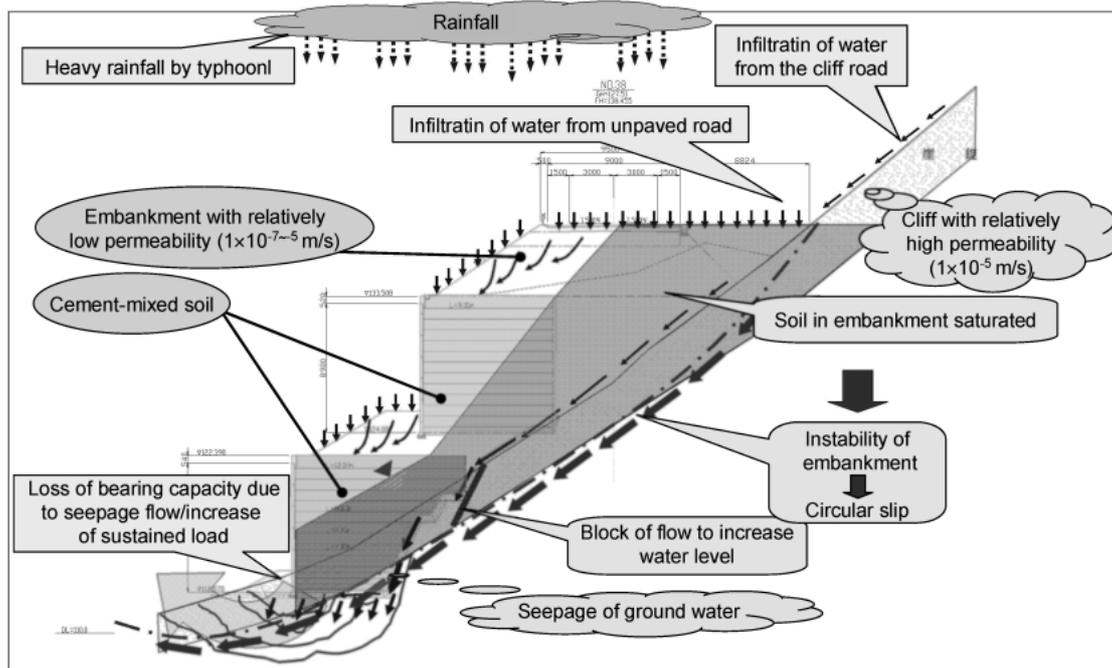
Regarding the sketch shown in Fig. 18, the scenario of the wall failure could be described as:

- i) A great deal of in-soil and surface water poured into the collapsed area over a short period of time,
- ii) The water infiltrated into the embankment and gradually stored behind the wall since the permeability of the wall was relatively small,
- iii) Total load increased due to the water infiltration,
- iv) Seepage water pressure in the weathered rock foundation having relatively high permeability increased gradually,
- v) The overall stability of the embankment reduced substantially due to the water storage in and behind the wall, together with possible development of seepage pressure in the foundation soil,
- vi) The localized failure on the foot of the wall may have occurred due to the lack of bearing capacity, and
- vii) A type of circular slip occurred across the foundation.

The wall failure as such could be described simply as “the undrained shear failure of foundation since the wall acted as if a reservoir dam in the event of heavy rainfall”. Finally, it is strongly recommended that the design and construction manual should be revised properly so as to prevent any future occurrence of this type of failure. The case study described in this paper also suggests the strong need for co-operation between structural engineers and geotechnical engineers.

Fig. 18. Scenario of the wall failure

- i) Drainage system should take care not only the wall but also the embankment behind the wall,
- ii) The wall should be placed on rock foundation with SPT  $N$ -value more than 50,
- iii) The surface of the road should be temporarily paved even in the course of construction by which infiltration of surface water into the surroundings of the wall may be grossly lessened, and
- iv) In short-term stability analysis of the wall involving the case of rainfall attacks, it is promising to employ soil strength from direct shear box test, in which the magnitude as well as history of initial stress conditions on the supposed slip surface are closely
