# INVESTIGATION OF DESTROYED STRUCTURES AND THE RECONSTRUCTION PROGRAM; ISE-WAN TYPHOON

Senri Tsuruta

Director, Harbour Hydraulics Division, Transportation,  
Technical Research Institute,  
Ministry of Transportation

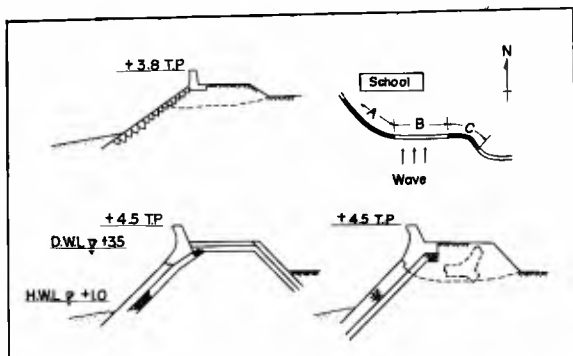
Fig. 2-2 C-collapsed from line of juncture due to scouring of back-filling as the back slope was not covered with concrete slabs. B-seen in foreground.

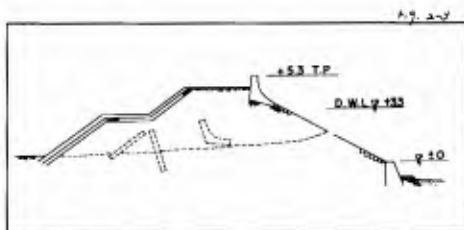
Fig. 2-4 Total collapse of structure due to scouring of back slope by overflowing of sea water as pavement of crown was unfinished.

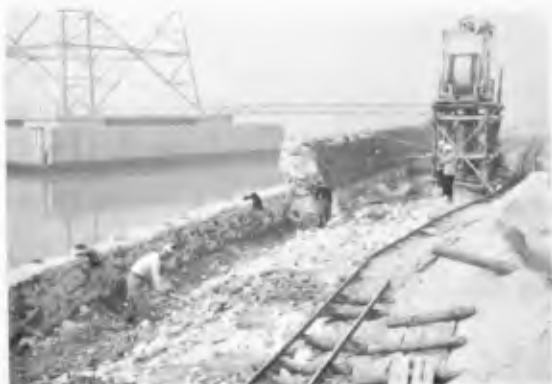
Fig. 2-5 Wall behind power transmitting tower remained in a little damage. (Port of Nagoya)

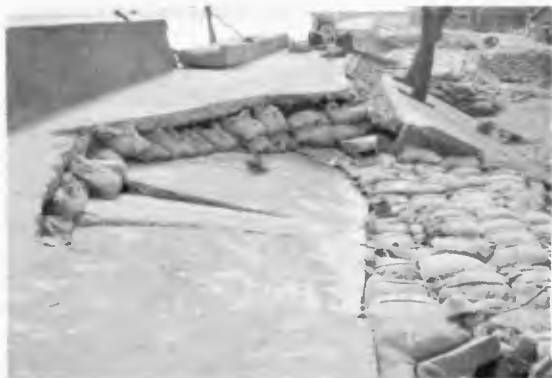
Fig. 2-6 Wall smashed by waves as interior was in a hollow state from settling of sand filling. (Yokkaichi City)

pavement at certain intervals for the replacement of the filling when necessary; to construct partition walls mentioned in the following paragraph; and to prevent the leak of the sand filling through the stone works by providing a complete cut-off and applying a mortar mixture in laying the stones.

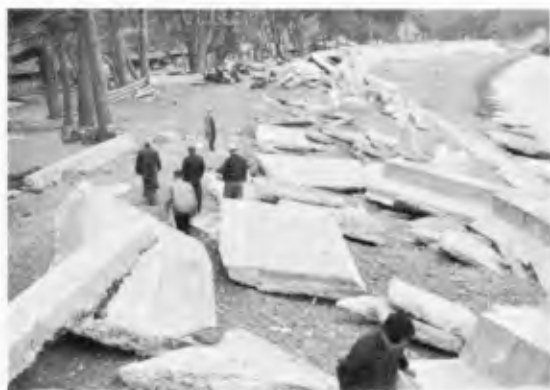
Fig. 2-7 Completely covered structure collapsed from settling of sand filling for a length of over 100m as partition wall was lacking. (Port of Nagashima)

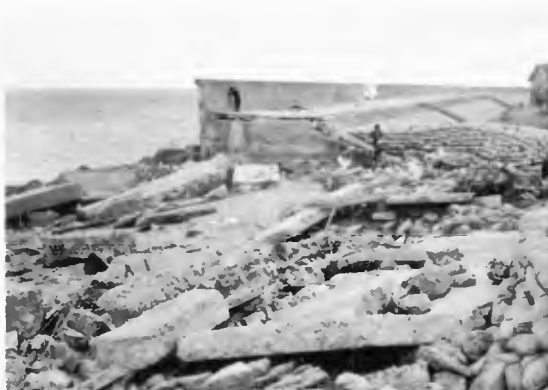
Fig. 2-8 Right side of the wall was saved by partition wall. (Yokkaichi City)

In coastal embankments protecting low areas, especially dikes enclosing reclaimed land, disruption in one section will provoke numerous breaks along the entire length of the structure in a short period of time as dashing current of sea water will penetrate through the interior from the opening and wash out the sand filling, while strong waves will hit the surface of the structure from the exterior. Examples of such destruction over a distance of several hundred meters were to be found in many location (Fig. 2-7), as in embankments enclosing the reclaimed areas of Nabeta near Nagoya and Kinuura and Hekinan facing the Chita Bay. If the embankment had been provided with partition walls at intervals of twenty to thirty meters, destruction would not have extended over such length of the embankment (Fig. 2-8).

The body should be of a self-supporting structure as far as possible. Partition walls at intervals of about 30m would serve to prevent a failure in one section from affecting other sections of the embankment.
