COMPARISON OF HURRICANE SANDY IMPACTS IN THREE NEW JERSEY COASTAL COMMUNITIES

Katlin Walling¹, Jon K. Miller¹, Thomas O. Herrington¹, and Anthony Eble¹

Keywords: Hurricane Sandy; watermarks; storm surge

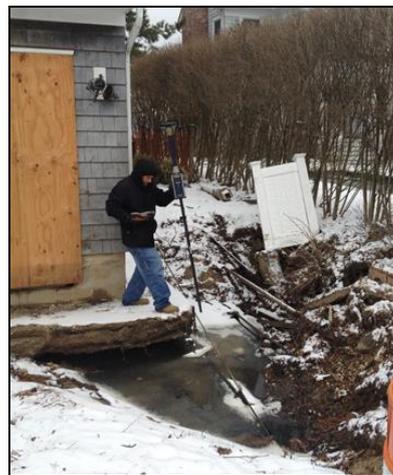
Figure 4: Field crew documenting severe scour found around a

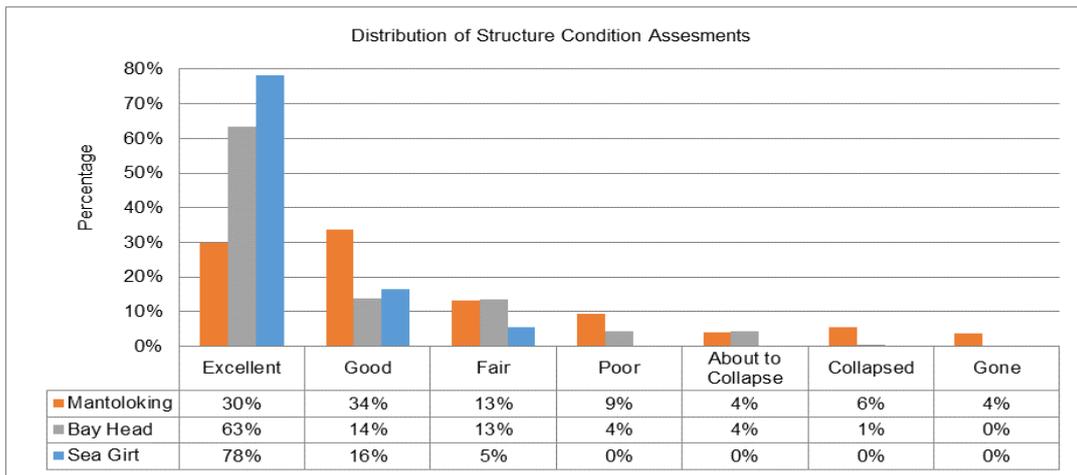
After organizing the data from the Hurricane Damage Assessment forms, an analysis of the 'Structure Condition' ratings was made and a comparison among the three communities was conducted. Of the 55 structures surveyed in Sea Girt, none received a damage rating worse than 'fair'. The 186 structures surveyed in Bay Head received ratings between 'excellent' and 'about to collapse'; however, none received a 'collapsed' or 'removed' rating. The 412 structures surveyed in Mantoloking received damage ratings ranging from 'excellent' to 'removed'. Figures 5 and 6 graphically present the quantification of 'Structure Condition' ratings for each surveyed structure (recall only damaged portions of Bay Head and Sea Girt were surveyed) in each town, where the distribution of structure condition ratings and the cumulative distribution is shown, respectively. In Sea Girt, 78% percent of the surveyed structures showed no visible damage and the remaining 22% were determined to be in 'good' to 'fair' condition. In Bay Head, 63% of the surveyed structures showed no visible damage, 27% were determined to be in 'good' to 'fair' condition, and 9% of the surveyed structures were significantly damaged. In Mantoloking, only 30% of the surveyed structures showed no visible damage and 47% were in 'good' to 'fair' condition. The remaining 23% of structures surveyed were significantly damaged.

Figure 5: 'Structure Condition' percentages for each of the three communities displayed as a histogram.

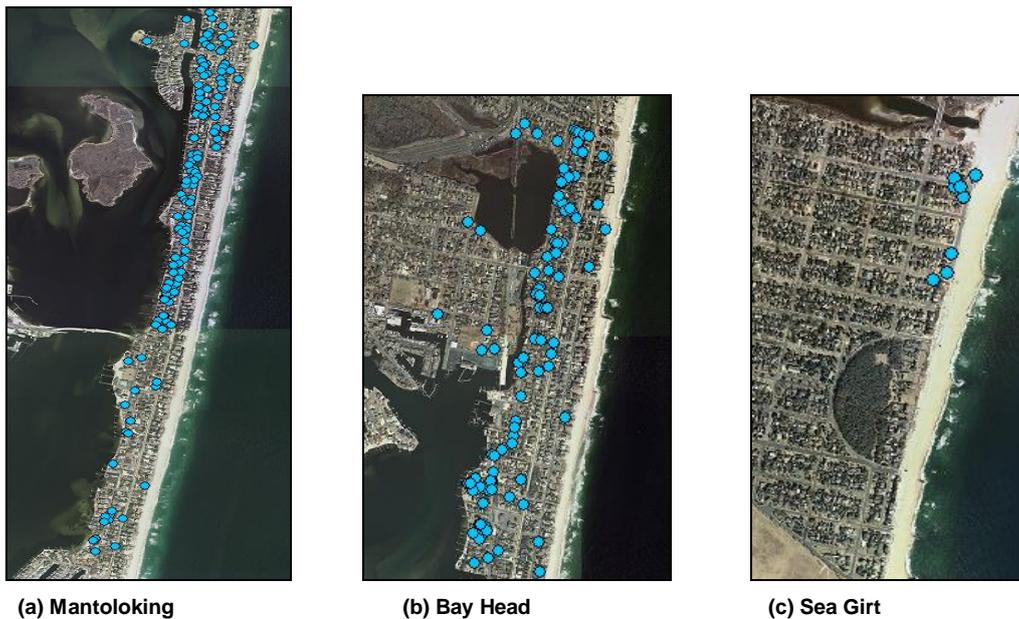
The spatial distribution of the measured watermarks in (a) Mantoloking, (b) Bay Head, and (c) Sea Girt is shown in Figure 7. The data are displayed in an ArcGIS format that was generated from the Microsoft Access database. Note that most of the watermarks were found on the bayside of Mantoloking and Bay Head. This is primarily because the water was mostly ‘calm’ in this area; it slowly rose and fell, leaving obvious marks. On the ocean side, however, the rough wave action and high velocity surge flow was rarely steady enough to leave clear marks. In the three communities, the watermarks were most commonly found on garage doors, glass doors, windows, fence posts, columns, light-colored siding, and flag poles.

Figure 7: ArcGIS map displaying watermarks revisited with the RTK GPS in (a) Mantoloking, (b) Bay Head, and (c) Sea Girt. Each light blue dot represents an individual watermark.

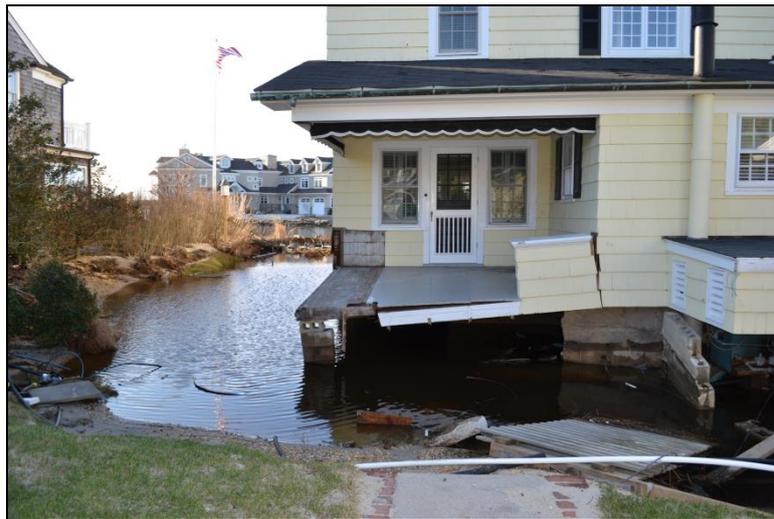
Of the total structures located along the bayside in Mantoloking, 13% received 'Structure Condition' ratings of 'poor' or worse. Of these, 100% of the structures had documented scour in the immediate vicinity. Through the course of the surveys, it became evident that severe scour was the primary cause of foundation failure, and often, near collapse for houses located directly adjacent to the bay in Mantoloking. In Bay Head, all of the bayside structures received 'Structure Condition' ratings of 'excellent'; only one of these structures had evidence of scour nearby. The Borough of Sea Girt, which is only located along the oceanfront and is not adjacent to a bay, did not have any failed structures associated with the presence of scour. Scour depressions are caused by concentrated, fast moving fluid flow, thus indicating that high velocity flow was present more throughout the Borough of Mantoloking than in either of the other communities. The data collected in these three communities is being used in several ongoing studies focused on understanding storm surge propagation through developed areas including the development of scour.

Figure 8: Foundation failure of a house on the bayside of Mantoloking due to severe scour.

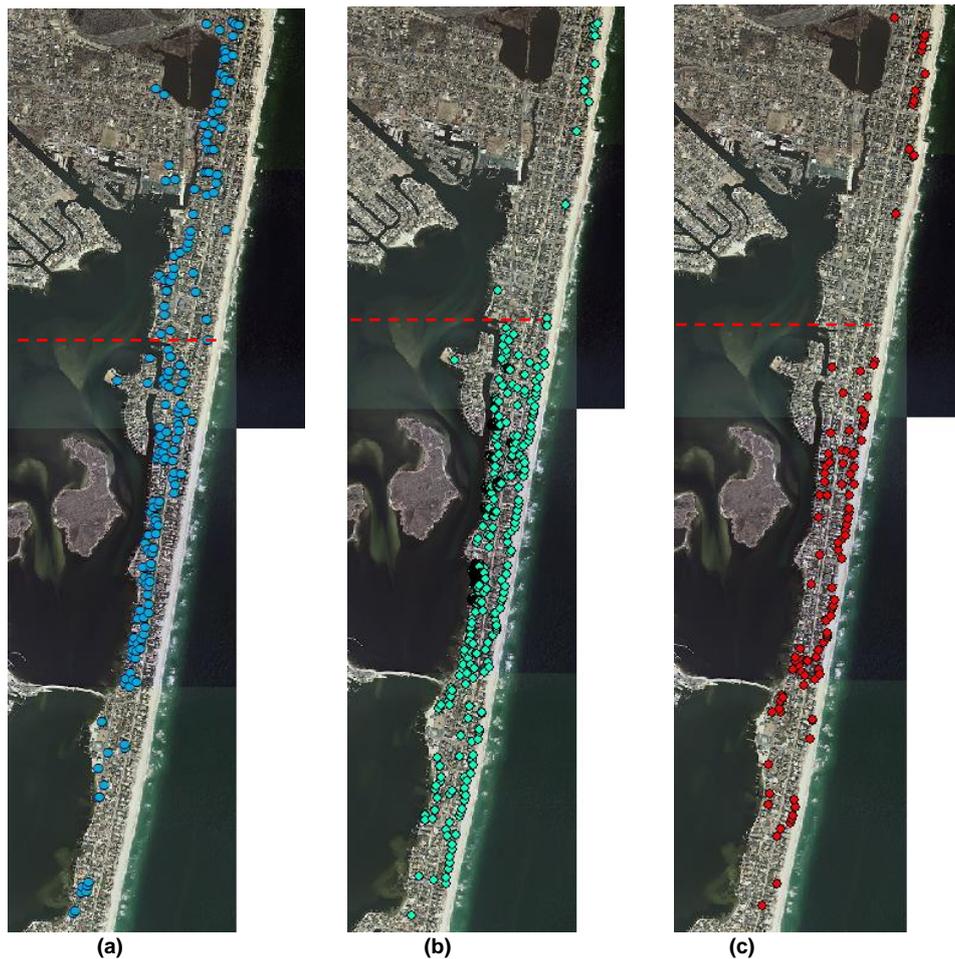
Figure 9: ArcGIS map of the Boroughs of Mantoloking and Bay Head (red dashed line indicates the boundary between Boroughs) displaying documented (a) watermarks, (b) property with scour, and (c) structures in a condition of 'poor' or worse. There were no recorded scour marks or heavily damage structures in Sea Girt; for a map of watermarks found in Sea Girt, see Figure 7c.

Of the houses that received 'Structure Condition' ratings of 'poor' or worse, the majority, 63% were located along the oceanfront in Bay Head and Mantoloking (see Figure 9c). This is primarily because once the dunes had eroded, these houses became exposed to strong wave action and channelized flow; they remained in this vulnerable state throughout the duration of the storm, resulting in severe structural damage. The oceanfront structures and property experienced damage from not only the wave action, but also from the inundation flow. From modeling the area in XBeach, Nederhoff (2014) concluded that most of the erosion occurred during Sandy's 10 hour storm peak. During the following 20 hour period, the barrier spit was exposed to a strong water level gradient flowing from the bay to the ocean. Therefore, any initial weak spots created during the peak hours, were then subjected to continual strong fluid flow, resulting in more erosion and greater damage.

From Figure 8c, it is evident that the oceanfront houses in Mantoloking were more heavily exposed to strong wave impact than the oceanfront homes in Bay Head. This is the result of wave energy dissipation provided by the existing rock seawall in Bay Head which was buried under the dune line and provided a secondary level of protection from direct wave attack and storm surge propagation. Irish (2013) examined the seawall's performance during Hurricane Sandy, and concluded that without the seawall's presence, the oceanfront homes in Bay Head would have experienced wave-averaged forces twice as large, and as a result, would have experienced significantly more damage. In contrast, the Borough of Mantoloking did not have a secondary layer of protection landward of the beach and dune to prevent direct wave attack and the formation of channelized flow.

along the bayside. In comparing panels b and c in Figure 9, it is evident that these structures are concentrated in areas where intense scour was also observed. It was hypothesized that scour caused by high velocity flow was the primary cause of foundation failure in the mid spit and bayside houses.
