Field evidences of secondary surface ruptures occurred during the 20 February 1956 Eskişehir earthquake in the NW Anatolia

FARUK OCAKOĞLU* and SANEM AÇIKALIN

Eskişehir Osmangazi University, Department of Geological Engineering, Eskişehir, Turkey.

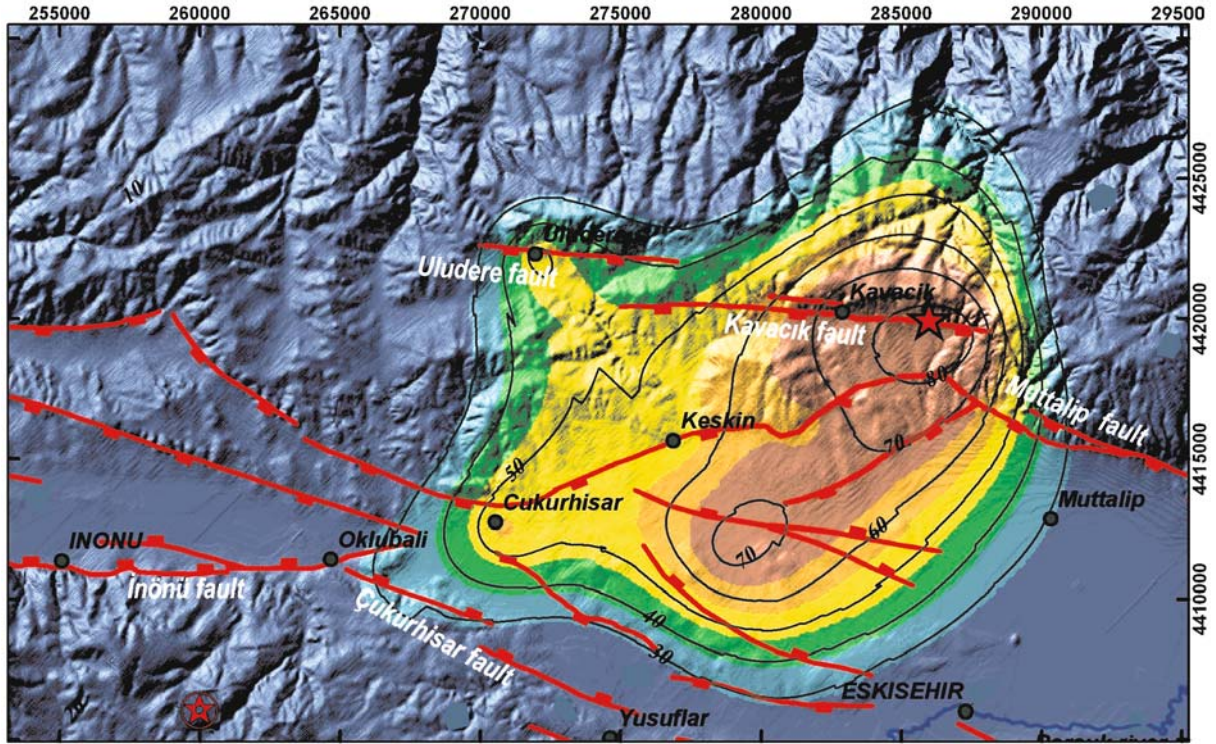
Figure 3. Distribution of damage pattern (heavy + moderate/total) of buildings related to 1956 Eskişehir earthquake (data from Öcal 1959 and Ocakoğlu *et al* 2006). The intensity scale used is Mercalli-Cancani-Sieberg. Digital shaded base map is produced from 1/25.000 scale topographic map of 10m resolution. Note that the maximum damage occurs very close to epicenter located to the north of the graben. SW epicenter belongs to the biggest aftershock.

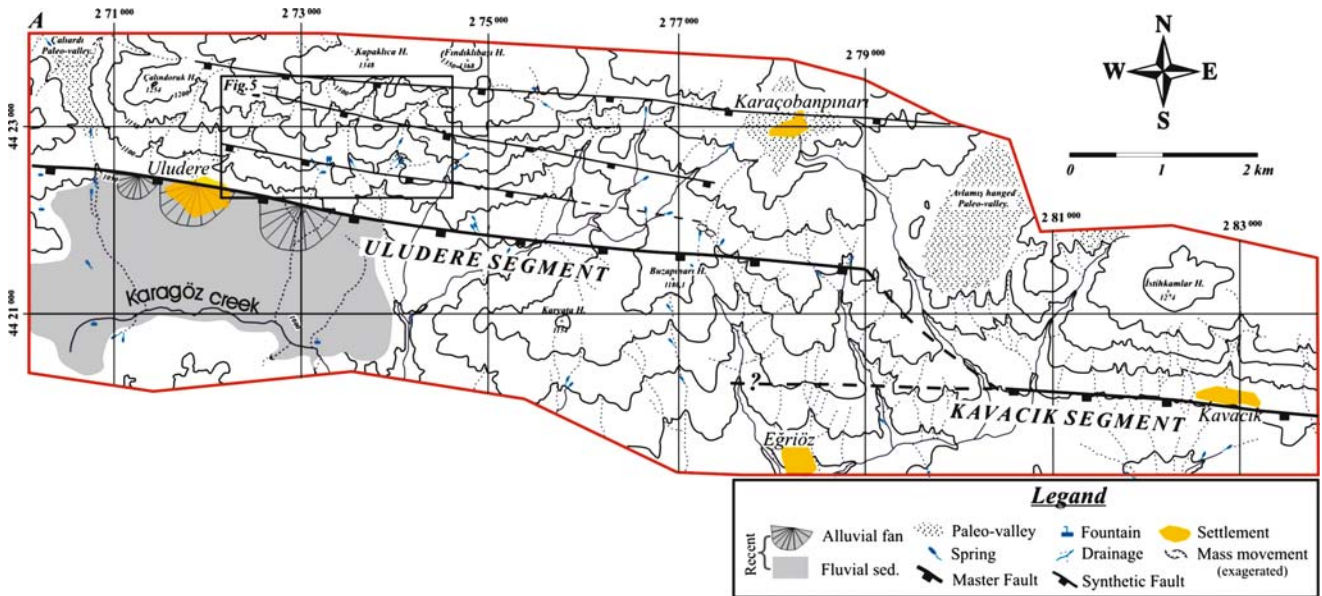
Figure 4. Morphotectonic map of the Kavacık and Uludere faults (landslides exaggerated about 5 times). Note similarly trending secondary synthetic faults to the north of Uludere segment where surface rupture is observed. Note also oblique bounding fault between Uludere and Kavacık segments.

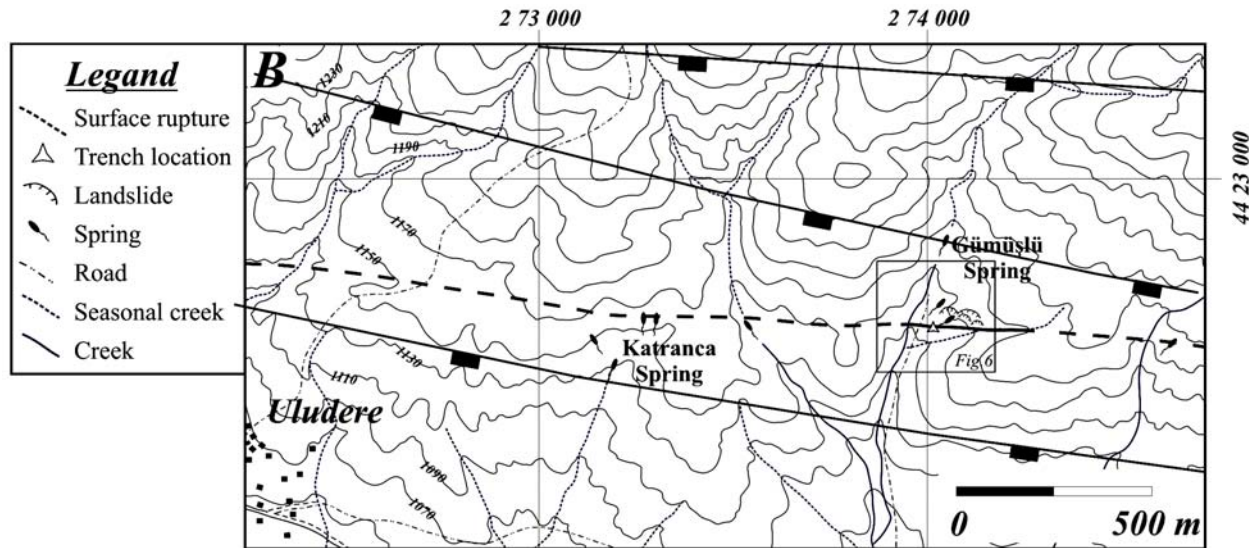
Figure 5. Detailed morphology of the Gümüşlü valley and vicinity. Note that WNW-running synthetic faults define morphology, and surface rupture is grossly parallel to them.

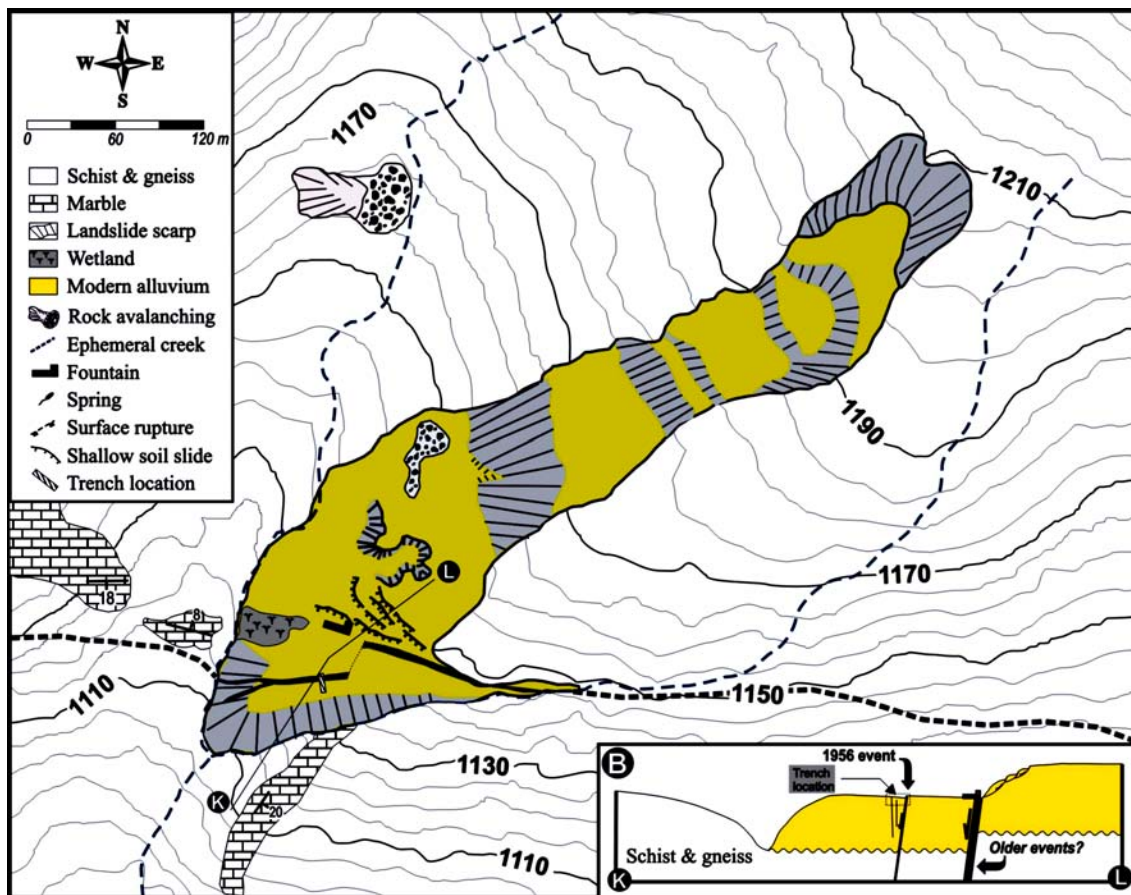
The surface rupture of the Eskişehir earthquake crosses the eastern tilted terrace throughout for more than 100 m (figure 6A). It forms a 2.5 m wide trough that strikes $N80^\circ E$. The height of the rupture's scarp attains 20 cm. This fault break depression is in fact a small half graben that presumably related with a south-dipping discontinuity (figure 6B). Near the western edge of the terrace, surface rupture bifurcates, but only one branch can be traceable down the base of western slope of the terrace (figure 6A). The fault break is indistinct on the flank of western strath terrace where the slope gradients are visibly decreased (figure 6A). However, tilted marble foliations as well as collapsed blocks in thin alluvium strongly suggest that it probably extends farther west in the metamorphic basement. Towards the opposite direction (east), the surface break shows a ca. 20 m right-stepping and later can be faintly traceable till the metamorphic basement (figure 6A).

Figure 6. (A) Morphological map of the Gümüşlü valley (reproduced after 1/25.000 sheet) showing the surface rupture and older and contemporaneous landslides. (B) K-L profile across the surface rupture. Height of the slided scarp is about 3 m.

In addition to these fresh mass failures, eastern side of the Gümüşlü valley hosts another huge, multistoried and inactive landslide (figure 6A). It was originated at 1210 m altitude and moved downward for 350 m towards SW. Internally, six reactivation surfaces ranging in height from 2 to 10 m were mapped.

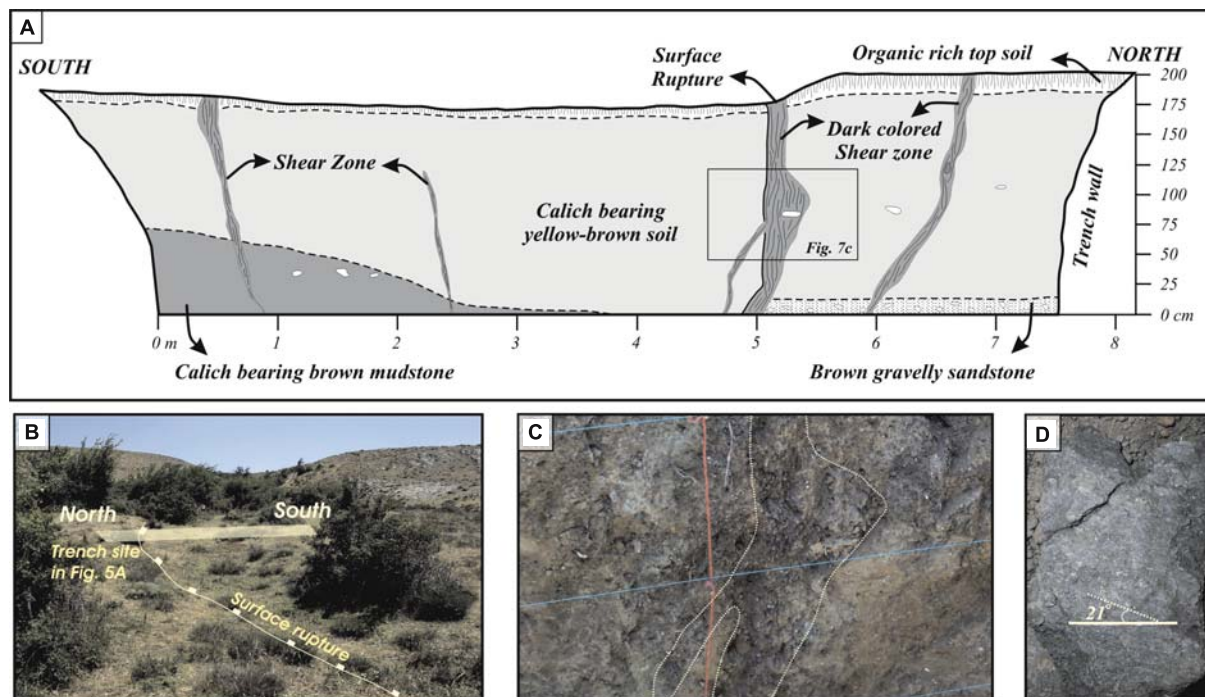
A trench (8 m long and 2 m wide) dug perpendicular to the surface rupture of the 1956 Eskişehir earthquake displays many breaks that cut the thick brownish soil and reach the surface (figure 7A, 7B).

Figure 7. (A) Trench log showing the western wall of the Gümüşlü trench (width and length of the trench is about 1.5 m and 7.5 m, respectively), (B) surface rupture near the trench site, (C) shear zone in the trench, and (D) slickenlines on the sheared muds in (C) (removed sample).

The main branch that causes the depression on the surface is a south-dipping, carbonaceous zone about 15–20 cm wide (figure 7C). This zone displays faint shears here and there, but is limited by a clear fault from the south. Many slickensides on this fault and on secondary shear surfaces consistently indicate a trend of N80°E/30°NE. Together with the surface rupture geometry (i.e., southern block down and northern block up), the orientation of slickenside clearly indicates a left lateral oblique-slip movement (rake = -30°) (figure 7D). A parallel secondary shear-zone without any apparent surface offset is also evident, one meter to the north (figure 7A). In the south of the trench, two less distinct north-dipping shear-zones occur as well. These antithetic faults did not apparently cause any displacement on the ground surface.

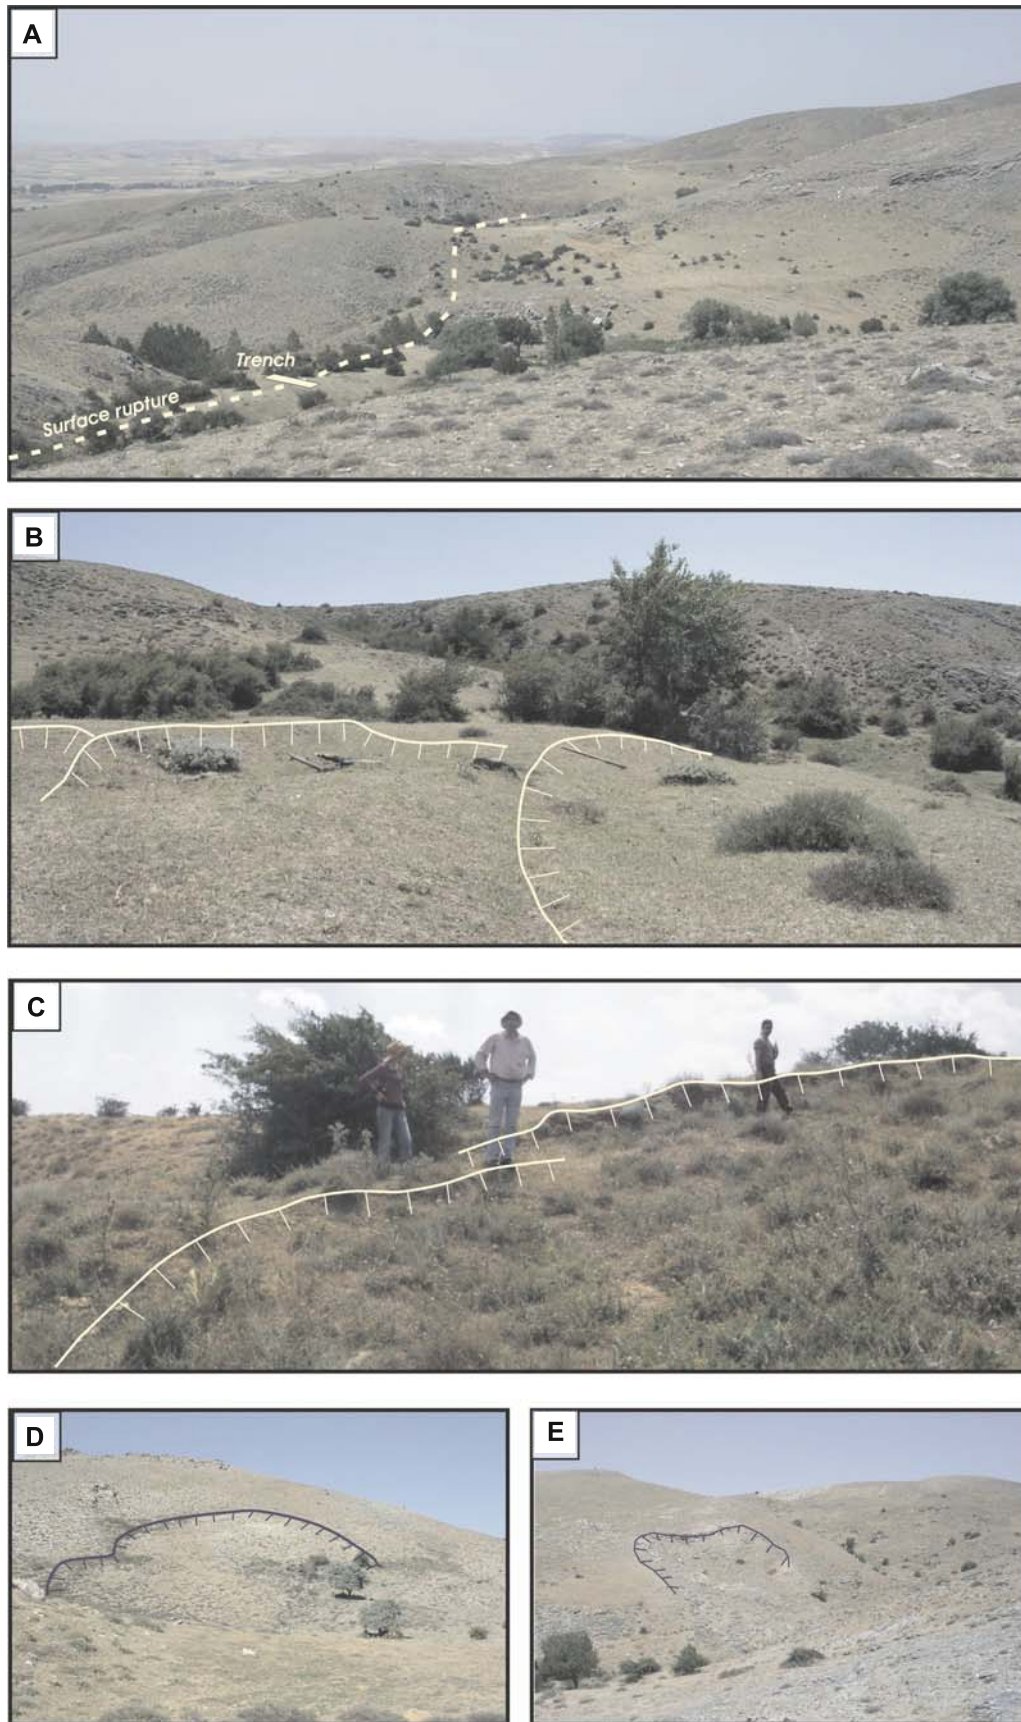
Figure 8. (A) Distant view of the Gümüşlü valley. Note well-developed fault terrace. (B) Small landslides to the north of trench site at Gümüşlü valley. (C) Larger landslides at the north of Buzapınar hill (see figure 4). (D) A rockslide developed in gneisses in 2 km east of the Gümüşlü valley. (E) Another rockslide in steep slopes in gneisses very close to surface rupture.

We observed several landslides and rockslides throughout the Uludere and Kavacık fault scarps and some of which were recognized by nearby residents just after the Eskişehir earthquake. Mass failures (meters-sized landslides) in the Gümüşlü valley follow the relatively steep scarp between tilted and horizontal terraces, and occurred as three or four stepping curvilinear lines (figures 6B, 7B, 8B). Vertical offset on the small crowns of these failures is more than 1.5 m. Another landslide belt follows the stream-eroded northern edge of the horizontal terrace. A trench at the western limit of this zone (figure 6A) did not yield any ground penetrating linear feature. For this reason we prefer a shallow landslide origin instead of surface rupture for this feature. To the 1.7 km southwest of Karaçobanpınarı village (figure 4) several springs form a wetland that accumulated several meters thick loose material. Slide scars (often <1 m high) in these sediments are recent and may be comparable to the Gümüşlü valley failures, and occur for about tens of meters in WNW–ESE direction (figure 8C). One km east of the Gümüşlü landslides, a mappable rockslide is developed on a steep scarp of a fault terrace (figure 8D). Similarly, 250 m to the north of the surface rupture, another significant rockslide occurs on the steep slopes in the metamorphic rocks (figure 8E). Fresh appearance of both failures again suggests a possible connection with the 1956 Eskişehir earthquake. Lastly, 600 m to the northeast of Kavacık village where the damage rate was maximum (figure 3), local people reported a series of fractures on thin soil on the huge Kavacık fault scarp that would correspond to anastomosing ruptures if not shallow slides. All
