## Variant Concept of Elevation of a Steel Grid Tower

Janusz Krentowski <sup>1</sup>, Sandra Mlonek <sup>1</sup>, Kamil Ziminski <sup>1</sup>, Piotr Knyziak <sup>2</sup>

**Abstract.** The article presents the stages of analysis of an existing steel structure of a 35m-high lattice tower, located in a woodland. The assessment of the condition of the tower's structural elements and connections was made in the aspect of plans for its elevation, in order to install an observation camera warning against fire hazard. The tower up to 30 m was made of five segments with a square section, with decreasing width from 4.86 m to 2.05 m. The last segment, 5m high, was made as a cuboid. Truss walls and horizontal truss membranes were used. Technical platforms were installed inside the shaft. Rolled sections of St3S steel with a yield point  $f_d = 215$  MPa were used as structural elements. The tower was erected on concrete spot footing. Static and strength analyses of the existing structure were carried out, taking into account the actual condition of materials and connections in the aspect of the planned modernization. The influence of wind gusts and the load from ice were taken into account.

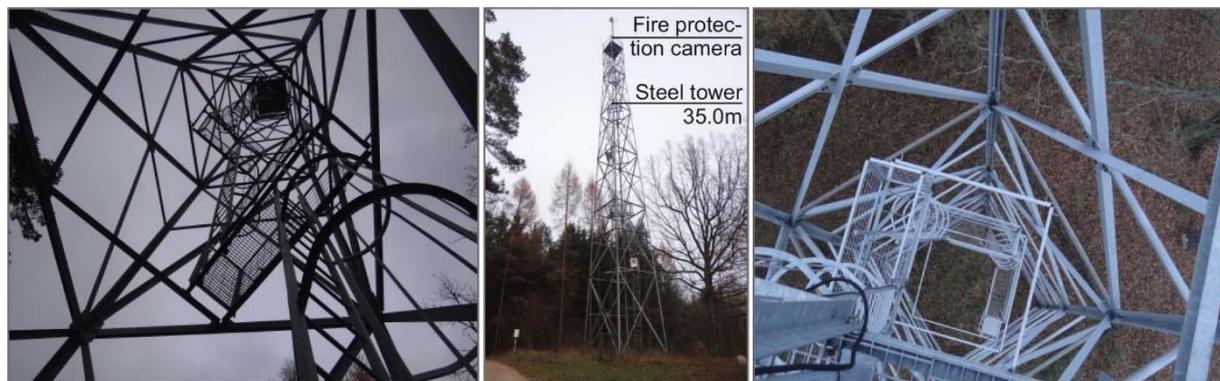
**Figure 1.** Overview and structural details of the lookout tower

An example of a 35 m lookout tower furnished with an additional six-meter steel mast is illustrated in Figure 1.

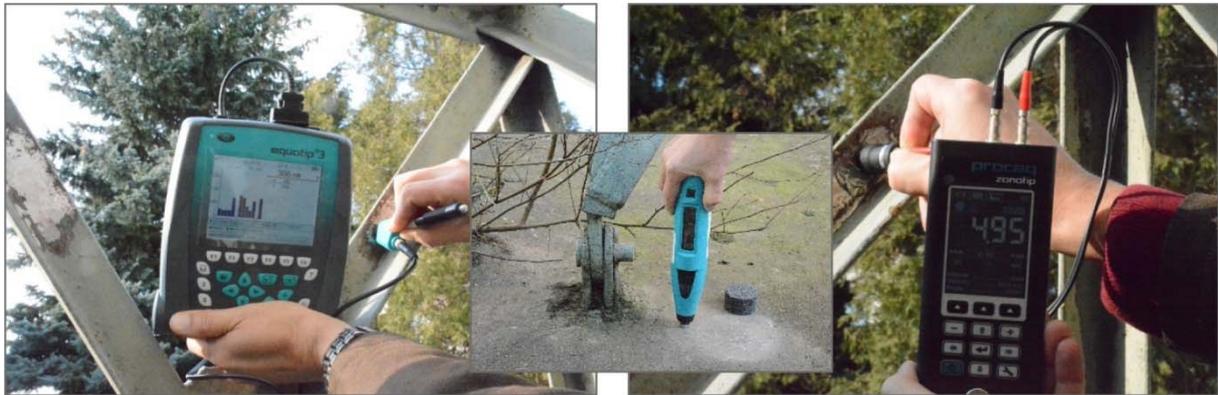
**Figure 2.** Documentation of non-destructive tests of steel and concrete carried out "in situ"

Due to the lack of detailed design documentation, a range of visual examinations and non-destructive tests using specialised ultrasound devices (Figure 2), as well as strength tests (Figure 3), were performed, [5]. Before the measurements were made, the surface of steel elements where the material was measured for thickness and hardness was locally cleaned. Samples were taken and tested in a universal testing machine with a maximum load of 100 kN, [6]. The measurements indicated that the hardness of steel sampled from the steel structure tested experimentally corresponds to St3S standard, and the strength of screws conforms with the 8.8 design class. Some screws were locally identified to correspond to the 4.8 strength class. The condition of the protective coating was assessed as correct, as no concentrations of corrosive processes were observed on a structure operating in an aggressive environment, in the vicinity of industrial plants.

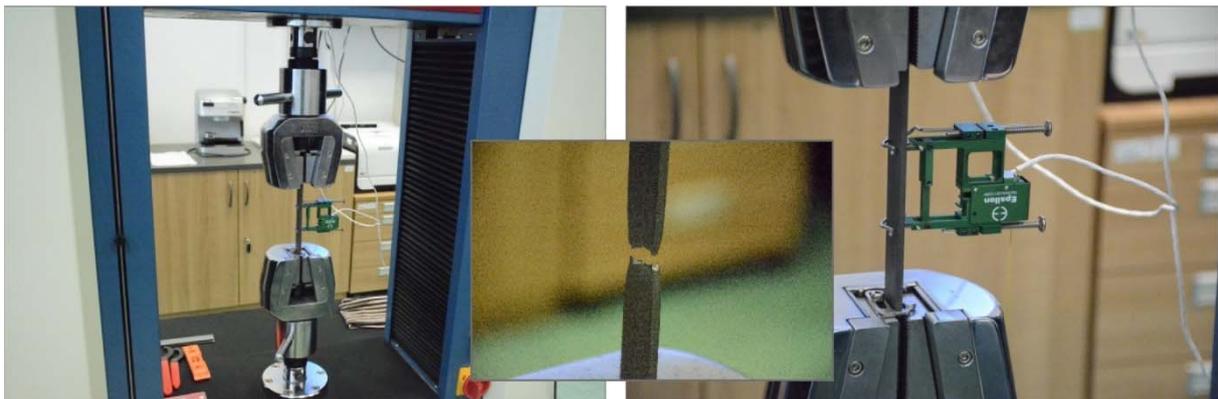
**Figure 3.** Examples of laboratory strength tests of steel samples

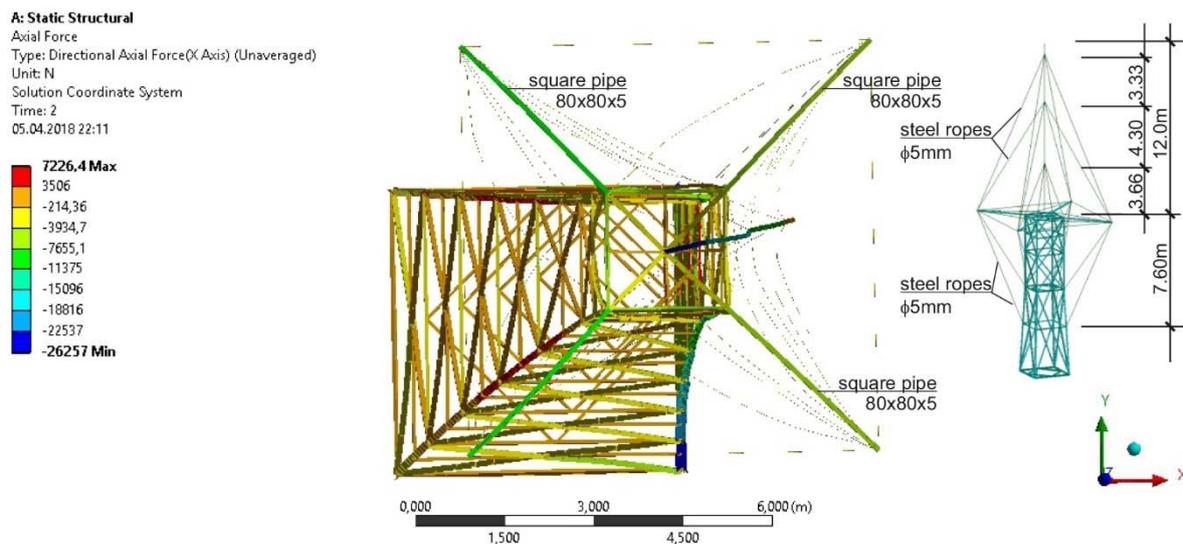
**Figure 4.** The newly designed structure based on the truss tower

The construction details of the analysed approach are presented in Figure 4.

It was assumed that a 12 m pylon would be installed on the +35 m level. A system of steel wire rope lashing was supposed to stabilise the pylon from excessive deformation and vibration. In order to obtain the necessary inclination of the lashing in relation to the vertical axis of the pylon, additional braces made from 60x4 square pipes, stiffened in the horizontal plane with taut steel ropes, were planned. The calculations assumed that the pylon would be a truss structure, resting on the top platform using hinges. The pylon would be stabilised with three rows of lashing. At each level, four lashings would be set at a 90° angle towards each other in the vertical plane. All of the ropes, the lashing and the ropes stabilising the braces, were designed as Ø5 mm with 2.0 kN tension.

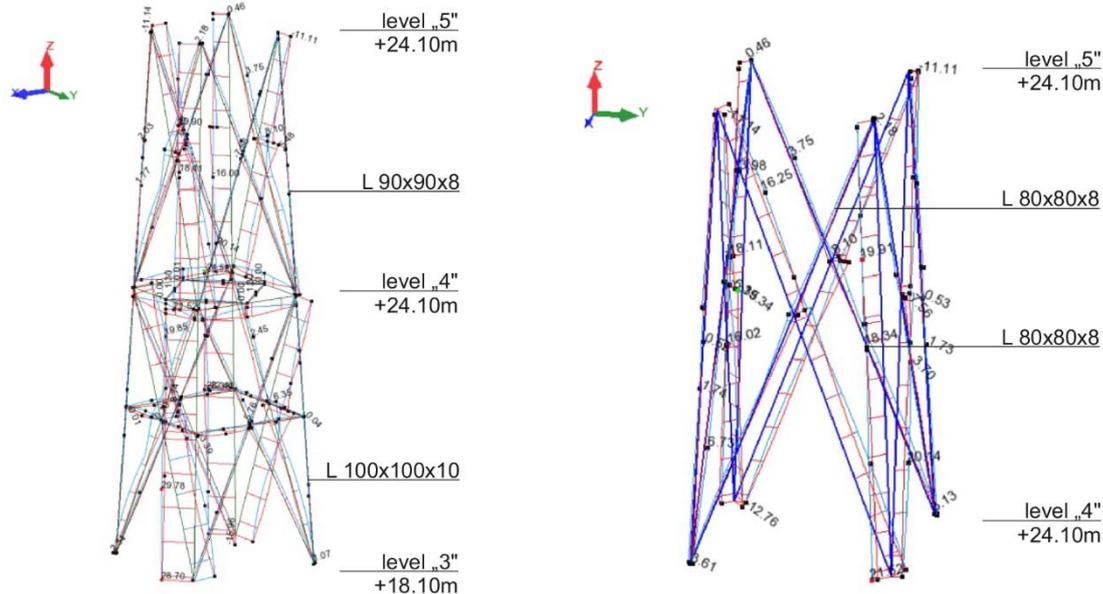
**Figure 5.** The state of effort of the structural elements of the tower at the mast superstructure stage of 12 m

During the modernisation process, special attention must be paid to the limit states in relation to the tightened truss bars (Figure 5). At the first level, the lattice is made from LR100x8 even angles. The

length of the bar is 7.52 m. In the parallel plane to the lattice, the buckling length of the bar is 3.99 m. In the perpendicular plane to the lattice, the buckling length of the bar is 7.52 m, with  $\lambda_y=246$  slenderness. According to [8], the coefficient of effective slenderness of bars connected to the junction with two screws may be calculated using the following formula: in the axis v-v:  $k=0.7+(0.35/\lambda_v)$ , in the axis y-y:  $k=0.7+(0.40/\lambda_v)$ .

The relative slenderness of the lattice bar is 2.65, and upon application of the coefficient of effective slenderness, it equals 2.25. This makes the buckling coefficient  $\chi$  more favourable, equalling to 0.17, which has a positive effect on the ultimate limit state. This approach proved that the ultimate limit state was not exceeded and was at  $N_{sd}/N_{Rd}=0,90$ . A similar situation occurs in lattice bars at higher levels.

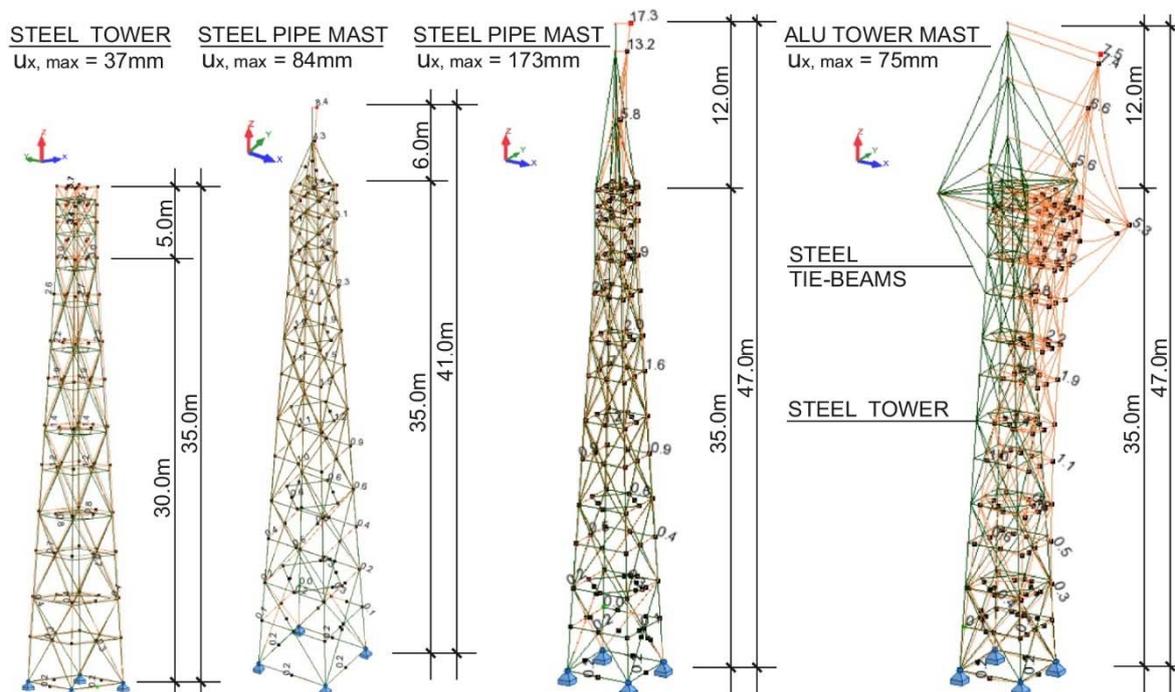
**Figure 6.** Horizontal deformations during subsequent stages of the modernisation of the observation tower

Type of mast	Construction height [m]	Limit deflection EC L/300 [mm]	Limit deflection EC L/500 [mm]	Calculation deflection [mm]
lattice tower	35	117	70	37
tower + mast 6m	41	137	82	84
tower + mast 12m	47	157	94	173
tower + lattice mast	47	157	94	75

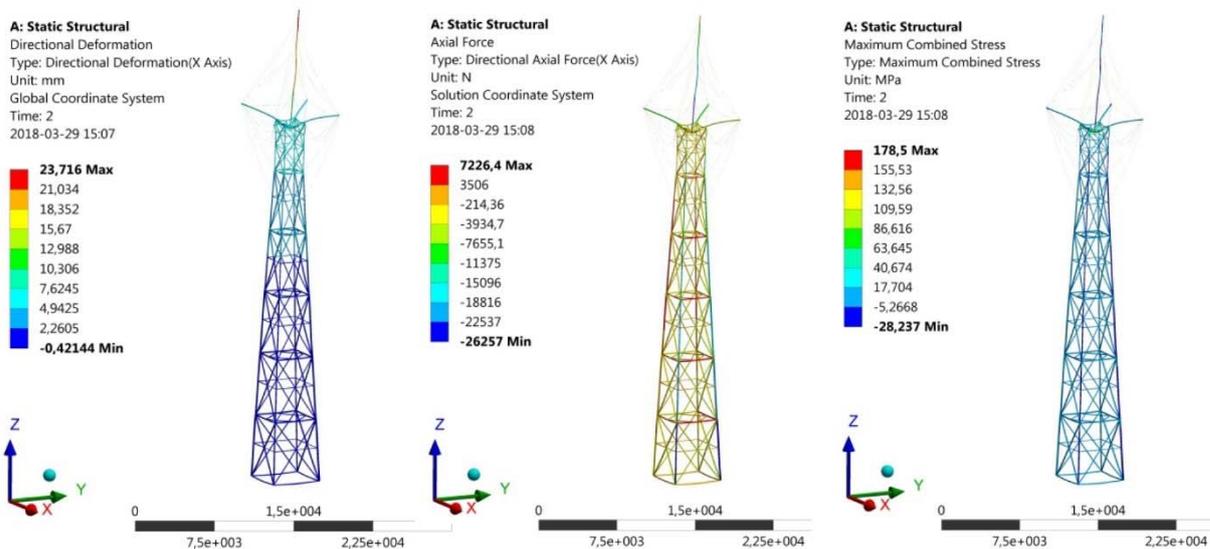
Additional control calculations were conducted in Ansys, a computer simulations platform popular among engineers. The tower was remodelled as a 3D bar structure made from rolled steel sections, whose diameters were determined in “in situ” tests. The limit conditions were modelled as hardening at the ends of the lowest vertical bars. The structure proposed to be built at the top of the platform (35 m) constitutes of four bars on the extension of the platform’s diagonals. In the calculation software, these form a rigid bar with the diagonal of the platform. Also, steel ropes are used for tightening the proposed structure. The ropes were introduced as cables for transferring only the axial force. The structure was loaded with its own load and wind pressure, as this load option was chosen upon earlier verification of the most unfavourable combination of loads, using Robot (Figure 7).

**Figure 7.** Numerical analysis of the final concept of the superstructure of the observation tower
