# Moving and Straightening the Building Segment

Krzysztof Gromysz<sup>1</sup>

<sup>1</sup> Silesian University of Technology, ul. Akademicka 5, 44-100 Gliwice, Poland

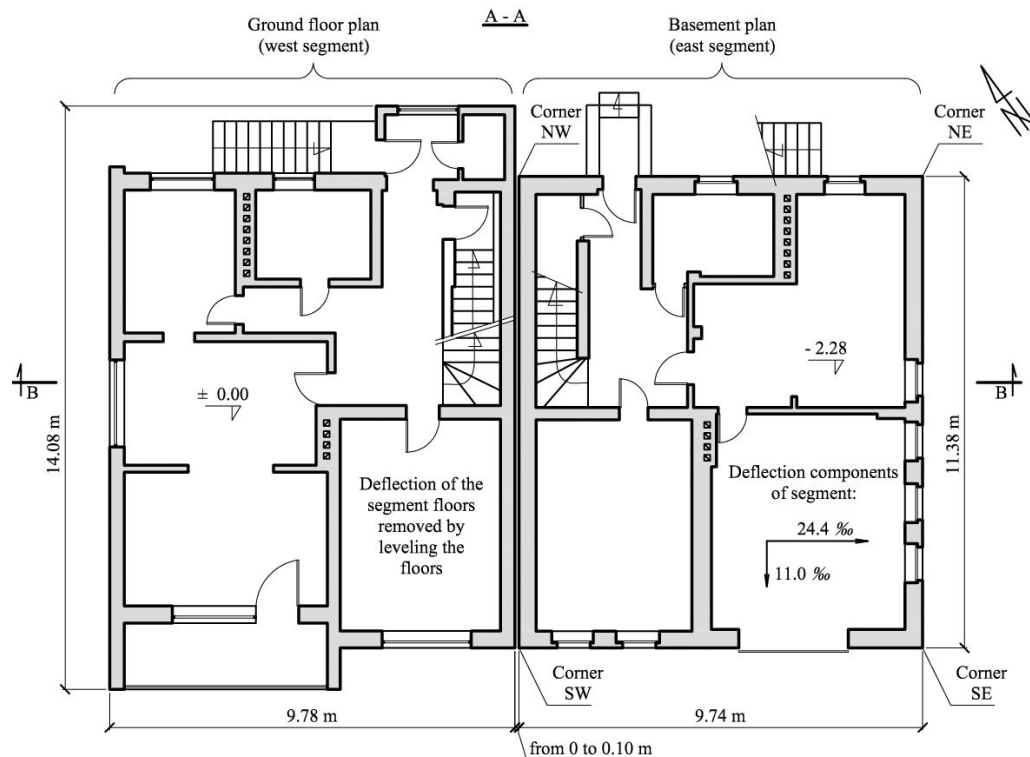
The building consists of two segments provided with a full basement: the eastern and western segment (Figure 2). The structure features two aboveground floors and is used for residential and office purposes. The basement plan of each segment is rectangular, with the dimensions of 9.74 m  $\times$  11.38 m, and the ground floor and first floor plan can be inscribed into a rectangle with the side length of 9.78 m and 14.08 m. The building height, counting from the ground level to the roof edge, is 8.79 m (Figure 3). The structure is founded 1.15 m below the ground level on reinforced concrete foundation footings with a height of 0.35 m and a width of 0.40 m to 0.60 m. The bearing walls of the segments, with a thickness of 0.25 m to 0.38 m, are made of full brick on cement and lime mortar. The ceilings of the both segments are made of 0.14 m thick reinforced concrete monolithic slabs, rested on the walls through ring beams with the section of 0.25 m  $\times$  0.25 m. The flat roof is not ventilated, with a slag insulation layer provided on the ceiling over the first floor, onto which a concrete screed was laid, covered with roofing paper. The maximum expansion joint width between the segments was 100 mm on the basement flooring level. However, the working range of the expansion joint on the ceiling level over the ground floor was exhausted and the segments were directly interacting (the compressions of the segments in the expansion joint – Figure 3). In addition, due to uneven subsidence of mining area, the structure became vertically deflected. The following are the measured deflection components of the eastern segment: 24.4 mm/m

towards a shorter side of the segment and 11.0 mm/m towards a longer side (Figure 2). The value of the resultant segment deflection was hence  $(24.4^2 + 11^2)^{0.5} = 26.8$  mm/m. The deflection was burdensome [4] and it was decided to remove it by the uneven raising of the eastern segment [5]. The western segment was also vertically deflected but the flooring sloping had already been removed earlier by levelling the floors. The plans of the building segments are shown in Figure 2, where the basement plan for the eastern segment is shown, and the ground floor plan for the western segment.

**Figure 2.** Plan of residential building consisting of two twin segments

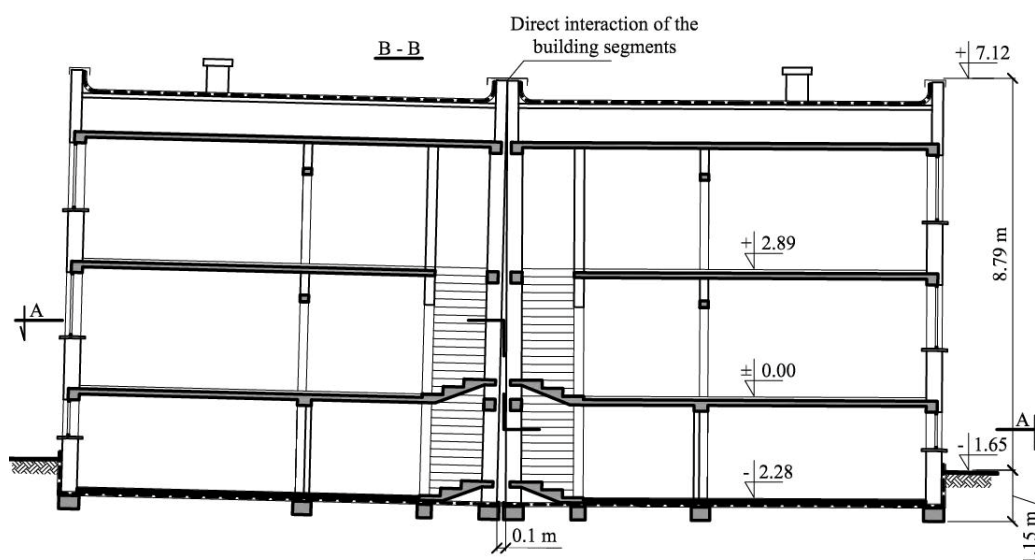
**Figure 3.** Cross-section of building with the marked area of direct interaction of segments in the expansion joint

As shown above, the eastern segment was deflected vertically in the south-east direction (Figure 2). Moreover, the eastern and western segment were in contact on the ceiling level over the first floor (direct interaction of segments in the expansion joint – Figure 3). The relative position of the structures did not allow, therefore, to straighten the eastern segment without moving it in prior. The following sequence of works was programmed for this reason. It was planned to first move the eastern segment towards the shorter side of its plan, and then to straighten it.

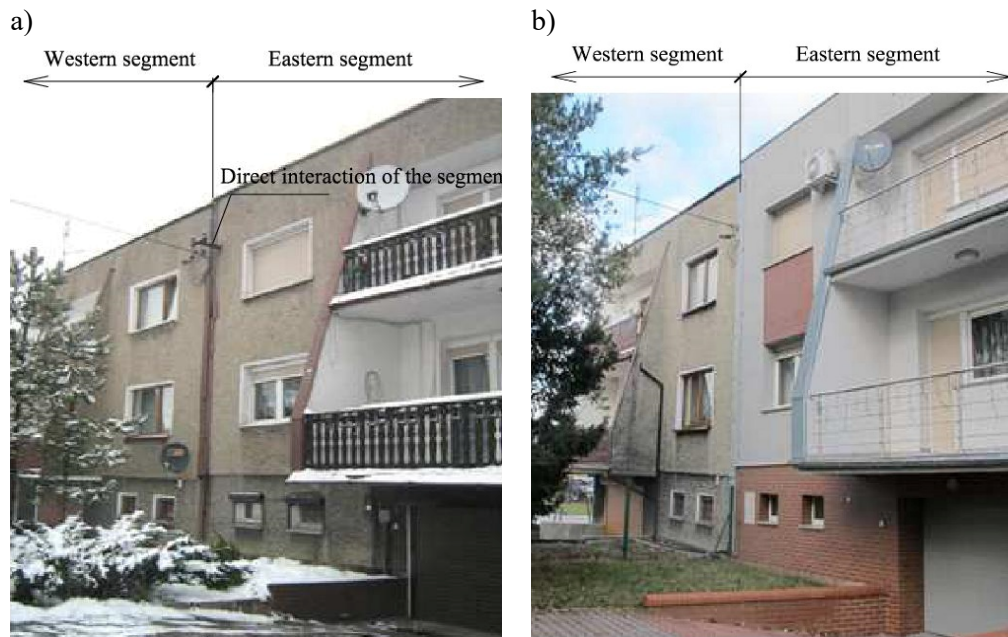
**Figure 4.** Residential building consisting of two segments - view from the south: a) eastern segment before displacement, b) eastern segment after displacement and completed renovation

Figure 4a shows a building plan before displacing the eastern segment and Figure 4b a building plan after displacing the segment and after the completed renovation.

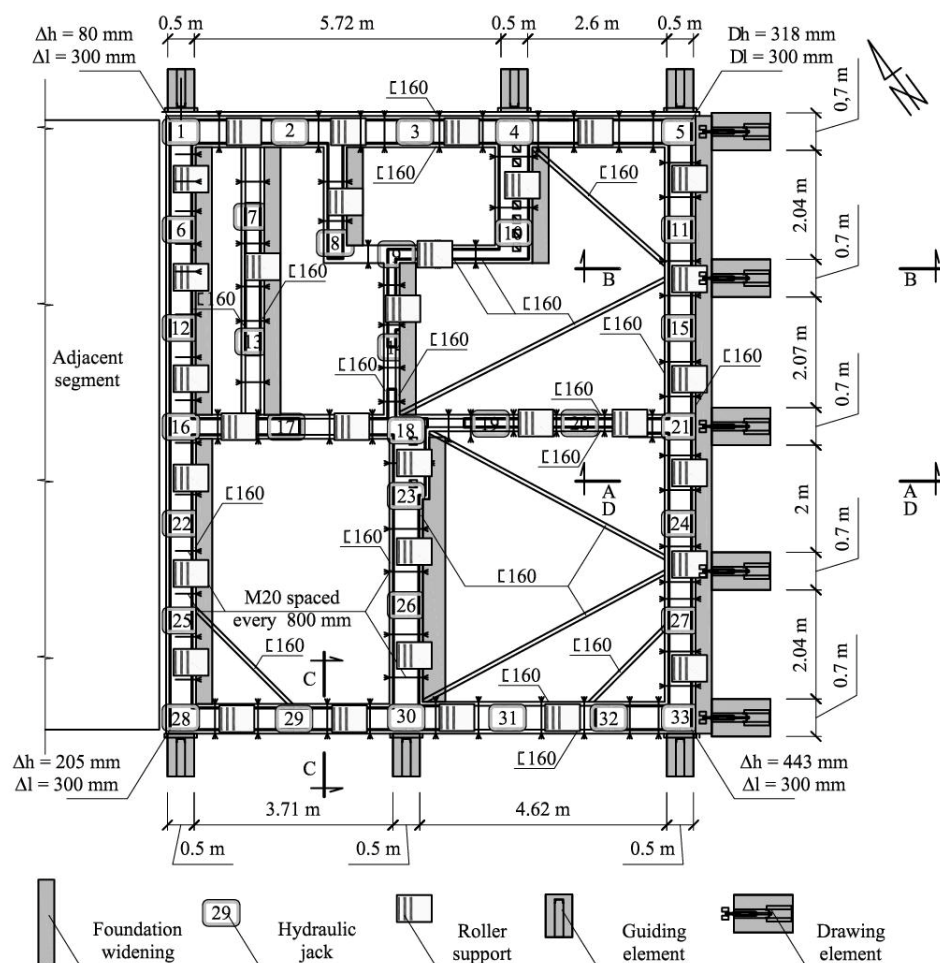
**Figure 5.** Plan of reinforced walls of the eastern segment;  $\Delta l$  – horizontal displacement of the building,  $\Delta h$  – total vertical displacement of corners; sections A – A, B – B, C – C and D – D are given in Figures 6 – 9

The building basement walls were detached in the first phase on the 0.35 m level over the basement flooring, and then the building part situated over the detachment plane was evenly raised by  $\Delta h_I = 180$  mm upwards. Mobile supports could have been mounted into the so formed space in the walls. Then, in the second phase, the aboveground part of the segment was lowered by 100 mm ( $\Delta h_{II} = -100$  mm) and rested on the mobile supports. In the third phase, the segment was moved evenly horizontally by 300 mm ( $\Delta l = 300$  mm). In the last, fourth phase (phase IV), the segment was raised unevenly in such a way that the structure has reached its vertical position. Each corner of the segment was therefore displaced by a different value. The height of uneven raising of the structure corners resulted from the direction and value of structure deflection. As a consequence, the following are the raising height values of the individual corners (see Figure 2) in this phase: NW corner –  $\Delta h_{IV} = 0$ , NE corner –  $\Delta h_{IV} = 24.4 \cdot 9.4 = 238$  mm, SW corner –  $\Delta h_{IV} = 11.04 \cdot 11.8 = 125$  mm, SE corner –  $\Delta h_{IV} = 24.4 \cdot 9.74 + 11.04 \cdot 11.8 = 363$  mm. Table 1 lists the designed vertical and horizontal displacements of four segment corners in particular phases. In addition, total displacements in vertical ( $\Delta h$ ) and horizontal ( $\Delta l$ ) direction are shown in the table 1 and in Figure 5.

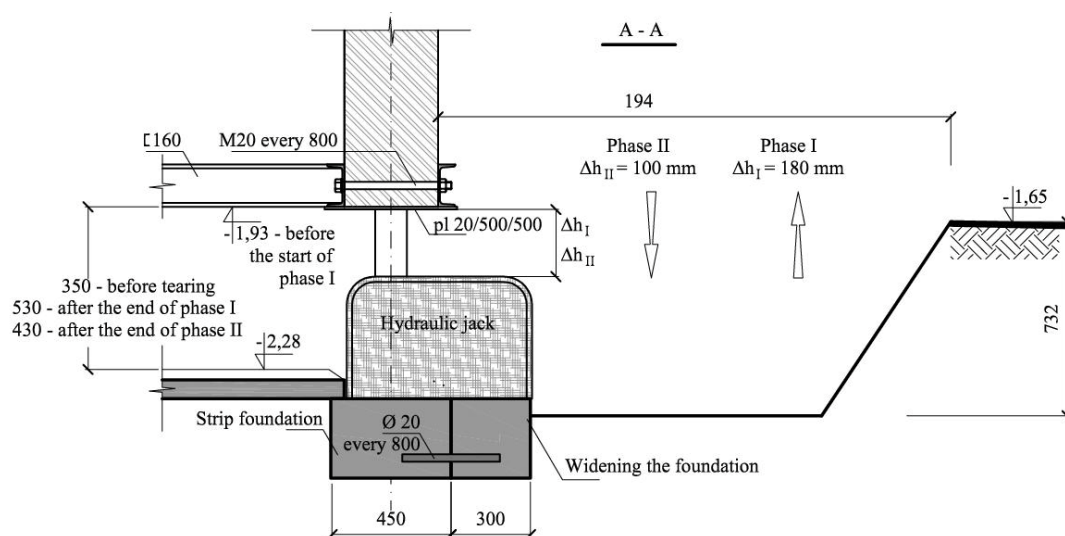
**Figure 6.** Hydraulic jack installed in the building wall during even raising of the building (phase I,  $\Delta hI = 180$  mm) and during lowering (phase II,  $\Delta hII = -100$  mm); location of A – A section is shown in Figure 5

After providing a steel reinforcement over the designed detachment plane of the segment, foundation walls of the building - running in the direction perpendicular to the direction of the designed structure displacement - were widened. The widening was performed by adding concrete footings with the width of 300 mm and height of 350 mm to the existing foundations. The added concrete strip foundations were joined with the existing ones with bars with a diameter of 20 mm bonded every 800 mm to the existing foundations, and then the bars were concreted in the widening (Figure 6). Drawing elements were

provided in the next step outside the building from the eastern side (Figure 7), and guiding elements were provided from the northern and southern side (Figure 8). Each of the five drawing elements consisted of a concrete foundation, with the cross-section of 300/700 mm and a length of 1100 mm, and of a steel construction made of  $\angle 160$  sections anchored in the concrete foundation. Turnbuckles were fitted to the steel construction, using which a horizontal force was generated, transmitted from the drawing elements to the steel reinforcement and to the building. Six guiding elements were mounted on the both sides of the building – three along the northern wall and three along the southern wall (Figure 5). The elements consisted of a concrete foundation with the cross-section of 300/500 mm and a length of 800 mm, and of an anchored steel construction forming a triangle (Figure 8). The purpose of such elements was to ensure horizontal movement of the building along a straight line. 33 hydraulic jacks were then installed in the building basement walls. 33 openings, with the dimensions of 600 mm  $\times$  500 mm, were driven through the walls under the reinforcement. The 20/500/500 plates were mounted in the openings (Figure 6), by joining them by welding with the reinforcement running along the walls, and then hydraulic jacks with the piston diameter of 120 mm were placed on the foundations. The structure was detached by generating a pressure of 10 MPa to 16 MPa, and the detachment plane was running on the level of the lower foot of the reinforcement. The building was then raised by  $\Delta h_1 = 180$  mm (Figure 6), which was achieved by applying the same displacement value in all the jacks.

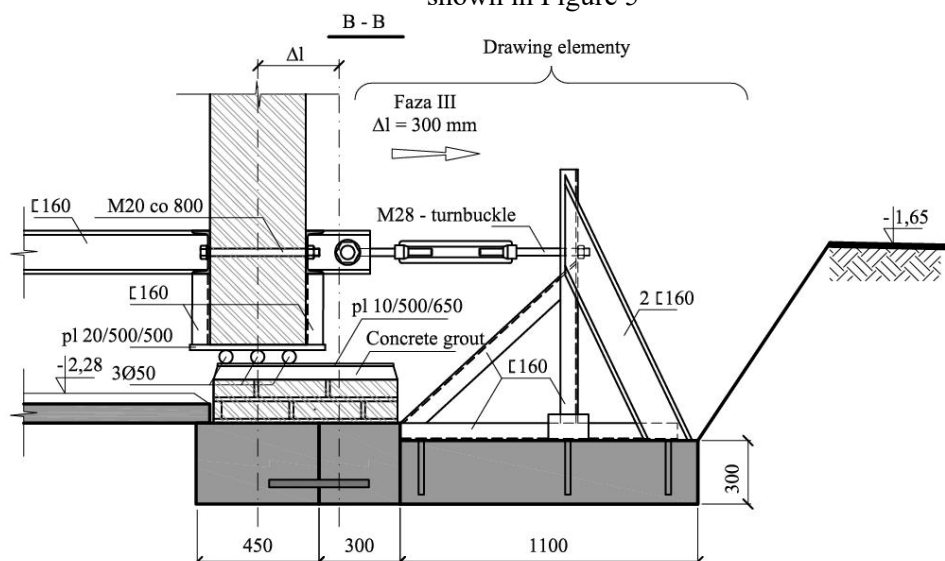
**Figure 7.** Drawing element during building displacement in horizontal direction (phase III,  $\Delta l = 300$  mm); location of section B – B shown in Figure 5

Building movement in the horizontal direction by the value  $\Delta l = 300$  mm was forced by generating forces in five turnbuckles at the same time. When the segment was placed in a new location over the widened foundation, the structure was stabilised by blocking its movement in the supports and 33 hydraulic jacks were started to be installed again. The jacks were installed in the same places where they stayed during even raising of the building, except that they were shifted by 300 mm in relation to the building part (Figure 9).

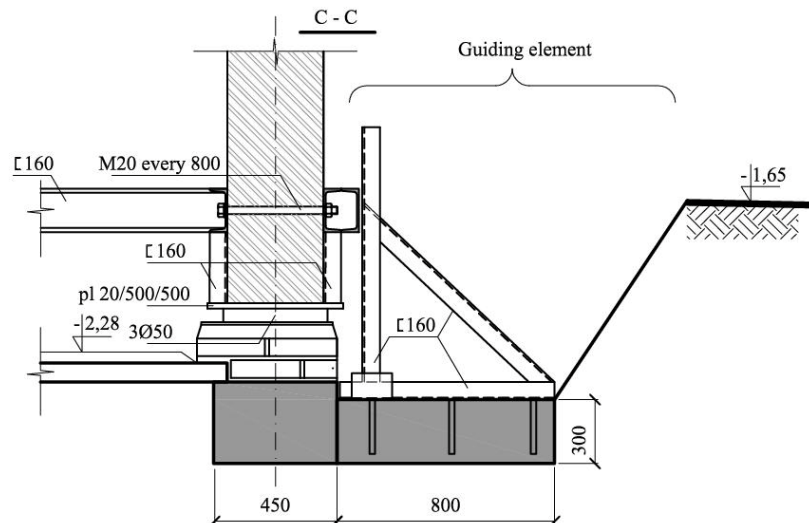
**Figure 8** Guiding element; location of section C - C is shown in Figure 5

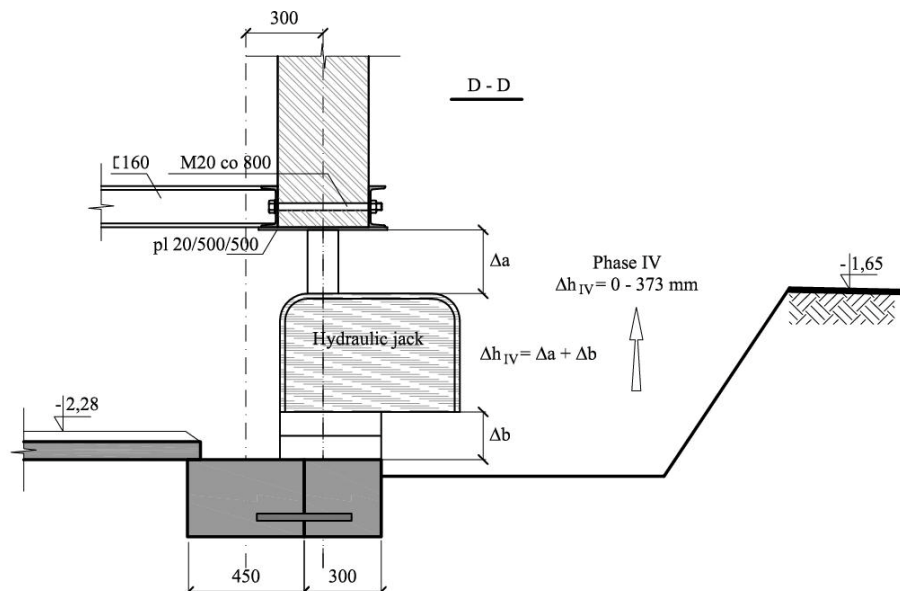
**Figure 9.** Hydraulic jack installed in the building wall during uneven raising of the building (phase IV,  $\Delta h_{IV}$ , of 0 to 363 mm); location of section D – D is shown in Figure 5

The structure was lifted unevenly after installing the jacks. A different displacement value  $\Delta h_{IV}$  was applied in each jack, from zero for jack number 1 to 363 mm for jack number 33. Building deflection was removed this way, with the resultant of 26.8 mm/m. The building position was stabilised with mechanical interlocks of the jacks and with additional supports made of hard wood. Figure 10 shows: a

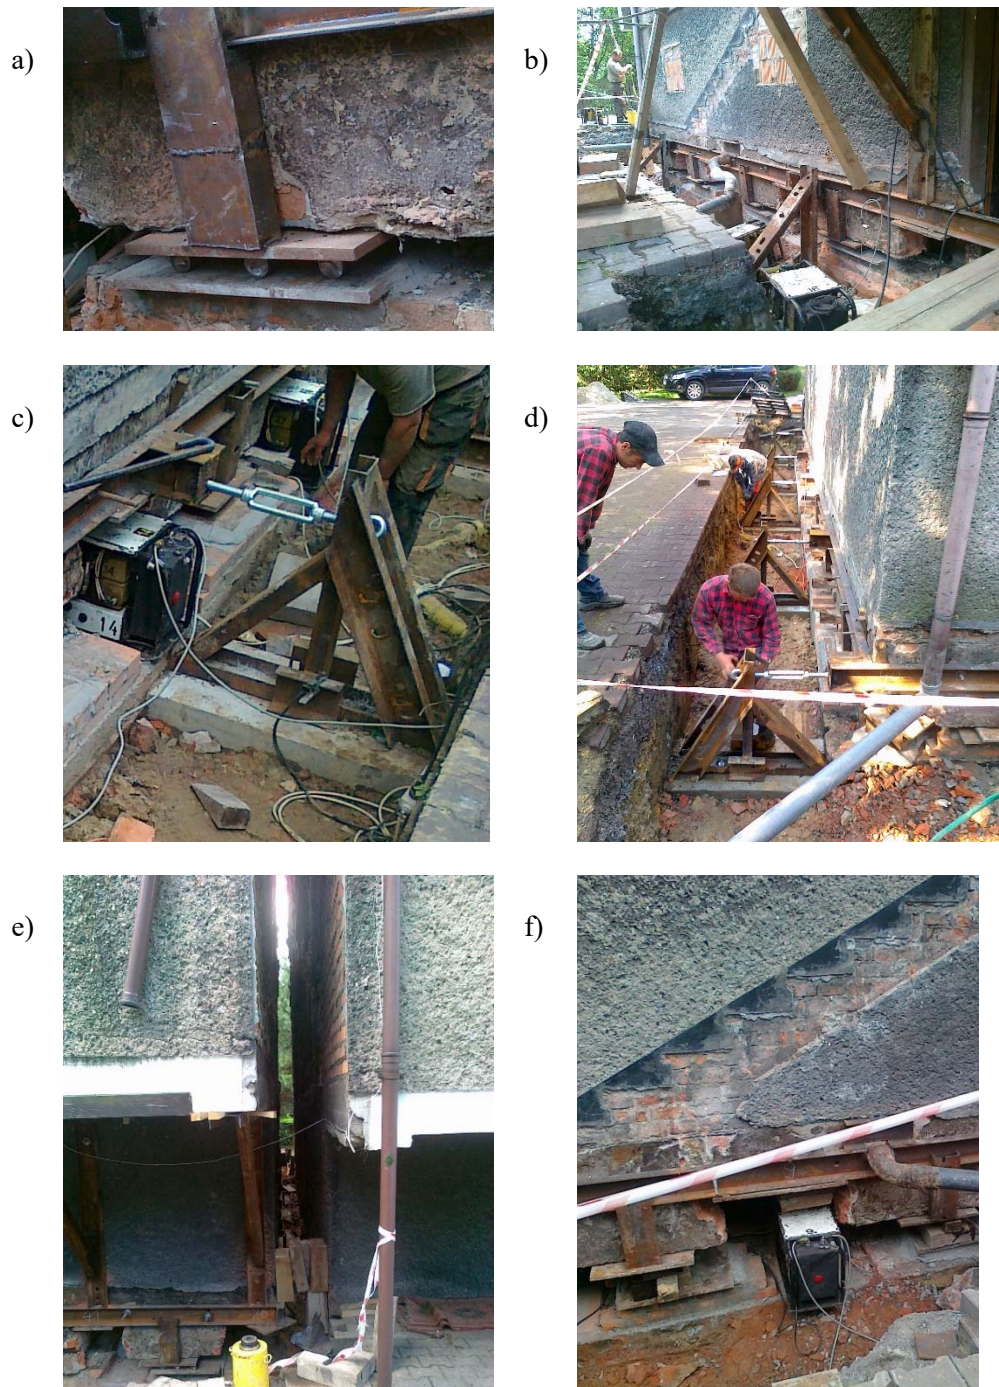
**Figure 10.** Works in the building: a) roller support, b) guiding element, c), d) drawing elements, e) expansion joint in segment displacement in horizontal direction, f) hydraulic jack during uneven lifting

guiding element, drawing elements, the expansion joint after segment displacement in the horizontal direction and a hydraulic jack during uneven lifting. Restoration works of walls were started after completing structure displacement works. First, the remaining bearing walls of the structure situated below the reinforcement were demolished, and then were rebuilt in the new location of the segment. Reconstruction was carried out in two stages. The fragments of the walls between the jacks were constructed in the first stage.
