# Applications of Thermal Visual Measurements in Light of Toughened Up Legislation

**Abstract.** The purpose of research was to verify the impact of thermal modernization of existing buildings on their energy performance in light of toughened up legislation. The paper answers the question - how thermo-modernization can affect the reduction of its needs for the building and contribute to the reduction of dust emitted, when heating is based on solid fuels. Some houses of similar typical construction which was very popular in Poland in 70', were tested. In one of them, doors and windows were replaced, but its elevation was left without insulation, while in another one, the thermal insulation was made, but old wooden door and window framing has been left. The research carried out with the thermovision camera allows a qualitative estimation of heat leakage from buildings. The test results were developed in detail in the Flir Tools software and the value of the building's heat demand was estimated before and after the thermo-modernization of the building or replacement of framing. On the basis of the conducted research, it is justified that even very high quality framing not accompanied

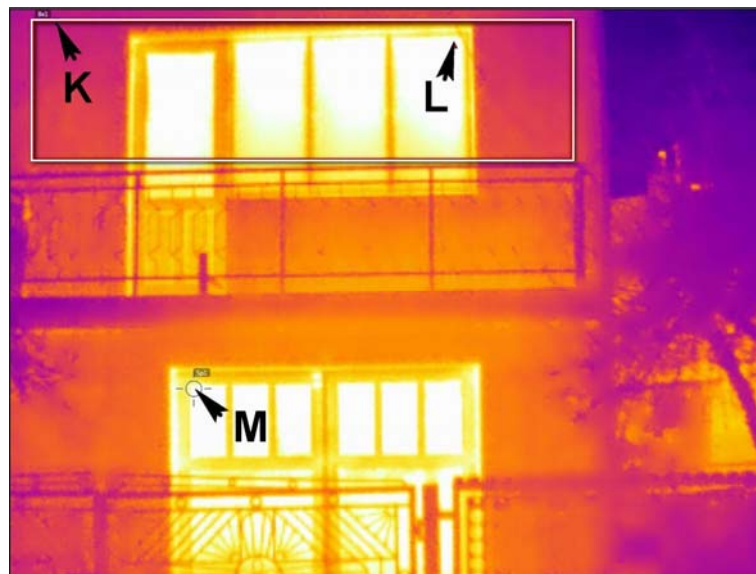
**Figure 4.** Thermovision image of the west elevation of the 1<sup>st</sup> building [authors resources]

In the thermovision pictures of the 1<sup>st</sup> building, shows clearly the heat loss through the wooden door and window framing, which has not been replaced, since the construction of the building. In the corners of windows and balcony doors on the 1<sup>st</sup> floor, heat losses are comparatively large. In figure 4, in the area marked with a white rectangle, the temperature extremes can be read: for the L point the maximum is 0,8°C, while in the K point the minimum is -4,6°C. So the values difference between the points separated from each other by only 2,7m points is 5,4°C. The highest temperature value on the whole analysed elevation, was recorded in the corner of the garage gates, at the M point and amounted to 1,3°C. Considering that, the ambient temperature during the measurements was -4.9°C, the amplitude value was 6.2°C. Such large heat leakage is a very unfavorable phenomenon, causing cooling of rooms and leading to destructive action of the weather conditions [10]. Moreover, in the connect area between the balcony slab and the wall, some increase in the temperature value is visible. The reason for the occurrence of this phenomenon is the incorrect construction of the supporting structure of the balcony slab and insufficient thermal insulation of its passage through the building's wall. This is a common

phenomenon and often occurs in residential buildings, constructed in old technologies. In addition, badly performed drainage of water and residual snow from the balcony, causes the accumulation of moisture around the passage through the wall and intensifies the phenomenon of heat transport. The remaining surface of the elevation is characterized by steady temperature distribution, without clearly marked thermal bridges. Therefore, it can be concluded that the thermal insulation was done correctly. A frequently occurring mistake, which in this case was avoided, is heat transport through improperly insulated anchors for the installation of expanded polystyrene boards.

Despite the fact that the 1<sup>st</sup> building is characterized by good thermal insulation properties of the partitions, it is recommended to replace the door and window framing in order to minimize heat losses. In the 2<sup>nd</sup> building, it is necessary to make thermal insulation of elevation, taking into account the research results presented in the article. They indicate that the parameters of the thermal insulation of 1<sup>st</sup> building were insufficient to avoid local heat losses - figure 8.1. The research carried out at the same time indicates that even small building with proper maintenance and conservation, with single-layer walls, erected in the 70' and 80' of the last century, require a comprehensive thermo-modernization, simultaneous exchange of framing on energy-efficient, and insulation of external partitions. Only this approach allows to reduce heat loss, increase thermal efficiency of buildings and ensure thermal comfort, positively affecting the health and safety of users.

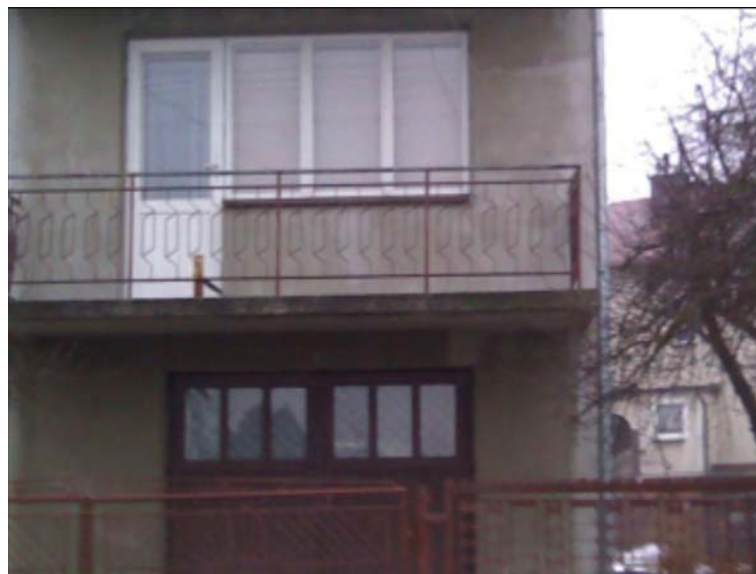
**Figure 5.** Digital photo of the west elevation of the 1<sup>st</sup> building [authors resources]

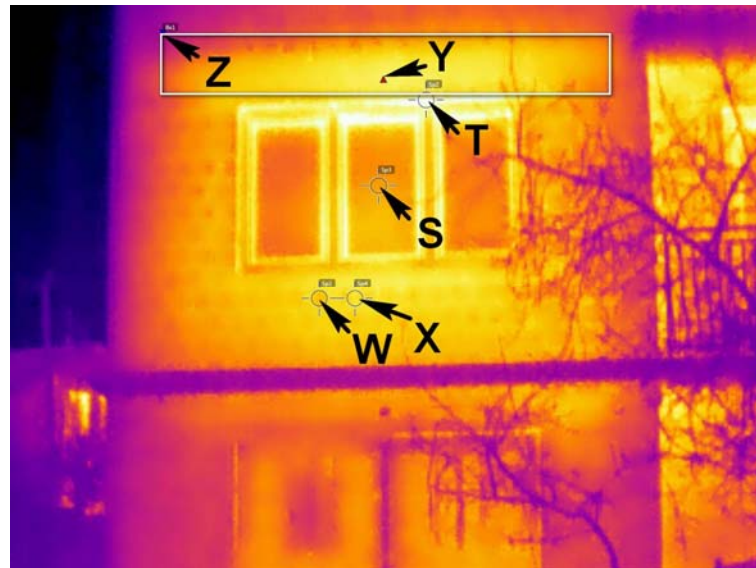
**Figure 6.** Thermographic picture of the west elevation of the 2<sup>nd</sup> building [authors resources]

On the elevation of 2<sup>nd</sup> building, thermal insulation wasn't applied, but window and door framing has been replaced on the first floor. During the measurements, only the rooms of this storey were heated, which can also be seen on the basis of the colour distribution on the elevation, reflecting the temperature values. On the obtained thermogram of the analyzed eastern wall, construction errors are visible:

- a wide yellow band over the window (the area marked with a white rectangle) is the place of heat leakage from the building. The probable cause of this unfavourable phenomenon is improper, or lack of

thermal insulation of the window lintels. In the construction of this type of objects a beam, reinforced with double-T bar was used. Incorrectly insulated metal element forms a big thermal bridge. The temperature difference in this area between Z and Y points is  $2.7^{\circ}\text{C}$ ;

- on the thermogram, contours of uncovered welds between the ceramic bricks are distinctly outlined, absorbing humidity from the environment, in greater extent than ceramic blocks. This is a very disadvantageous phenomenon occurring in monolayer walls, unadapted to the atmospheric conditions prevailing in Poland in the third climatic zone. Measurement of the temperature value between the points X - weld, and point W - the surface of the block, showed a difference of  $0.5^{\circ}\text{C}$ ;

- despite the fact that the new, replaced PVC framing has a low heat transfer coefficient ( $U=0,15\text{W/m}^2\text{K}$ ), around the window frame - a special one in its upper part, there is a large loss of heat. In the middle part of the window glazing - point S, a temperature of  $-1.2^{\circ}\text{C}$  was noted, whereas at the point T  $=1.4^{\circ}\text{C}$ . This unfavourable phenomenon arises due to incorrect installation of the framing [10]. The most common mistakes are: incorrect positioning of the window, incorrectly selected window sizes, poor window positioning in the wall, badly prepared reveals, incorrect fixing of the framing, leaks around the windows, installation without supporting blocks - preventing the filling of the void with the mounting foam. In passive and low energy buildings, it is common to place the framing in the insulation layer.

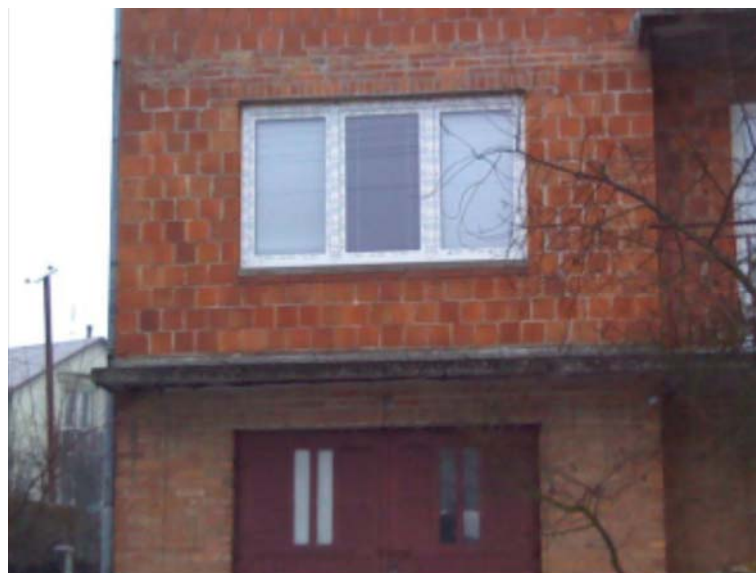
**Figure 7.** Digital photo of the west elevation of the 2<sup>nd</sup> building [authors resources]

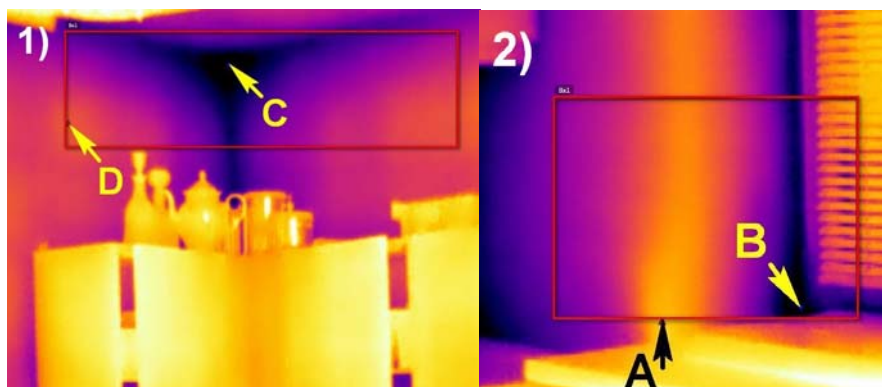
**Figure 8.** Thermograph of a wall corner inside the 1<sup>st</sup> building, Figure 8.2. Thermograph of window corners of the interior of the 2<sup>nd</sup> building [authors resources]

It is very important for the correct analysis of the obtained results, to carry out thermovision research outside and inside the facility. Figure 8 shows thermal images taken inside and outside the rooms of the analyzed building. Figure 8.2 shows the lower left window corner of the 2<sup>nd</sup> building, in which the old wooden framing was replaced. The temperature values were measured in a marked rectangular area (red line). At point A, the temperature is  $13.9^{\circ}\text{C}$ , while at B it is only  $7.7^{\circ}\text{C}$ . The reason for such a large difference in value is improperly made installation of window frames. Figure 8.1 shows the wall corner in 1<sup>st</sup> building. The temperature difference between points C and D is  $3.9^{\circ}\text{C}$ . In spite of the fact that thermal insulation was made on the elevation of the building, due to its poorly selected parameters, the corner of the building is still the place of heat migration.
