Damage investigation of pre-stressed cables in segmental box girder concrete bridge ev. No. 324-018 in Pardubice, Czech Republic

S Rehacek*, D Citek, P Bouska and J Kolisko

Klokner Institute, Czech Technical University in Prague, Solinova 7, Prague 6, Czech Republic

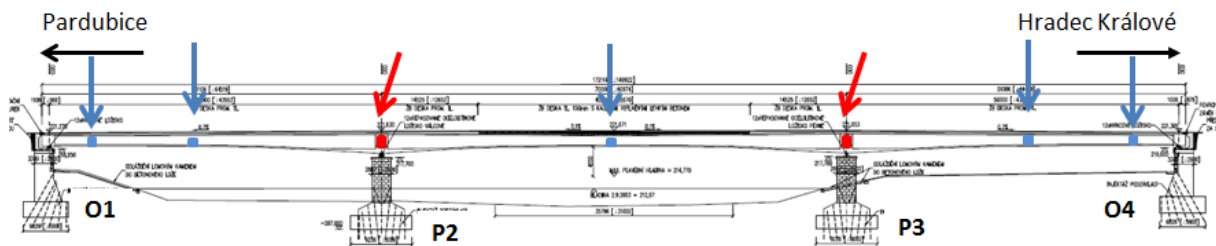
Figure 1. Chart of the placement of deviators

The deviators in the place above pillars P2 and P3 were not anchored to the crossbeams in any way, and therefore they may have deviated from their original condition. According to the data provided, this deviation was not discovered during the previous regular inspections.

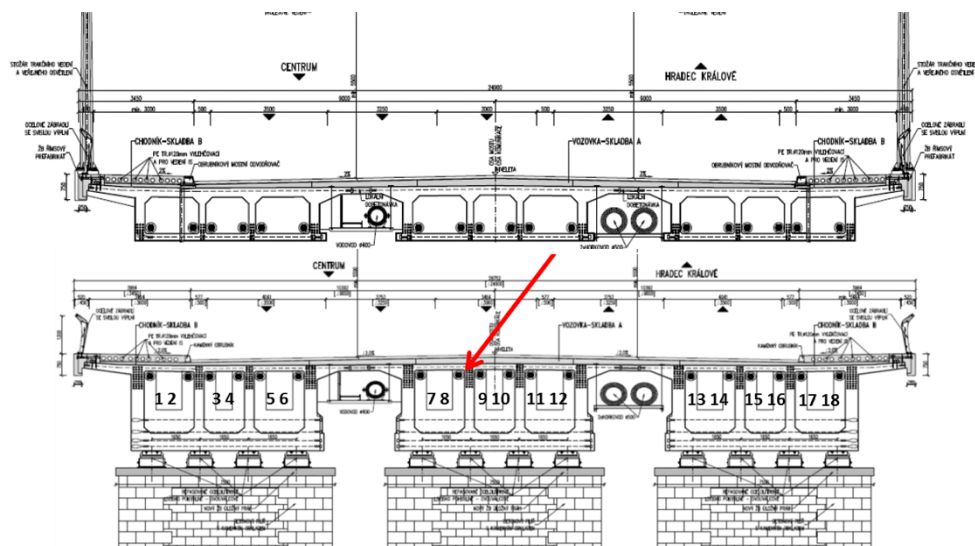
Figure 2. Cross-sections in the bearing structure with numerical marking of the cables: a view from the stationing direction. Stress deviators inclined to the right (Hradec Kralove) side of the bridge are marked by the red arrow.

Some rope strands of cable No. 8 are partly or entirely released. This finding was confirmed by the tapping with a hammer on the strand. At damaged and undamaged strands, different acoustic responses are apparent. A logical explanation of this fact is that a partial or complete failure of this cable has occurred.

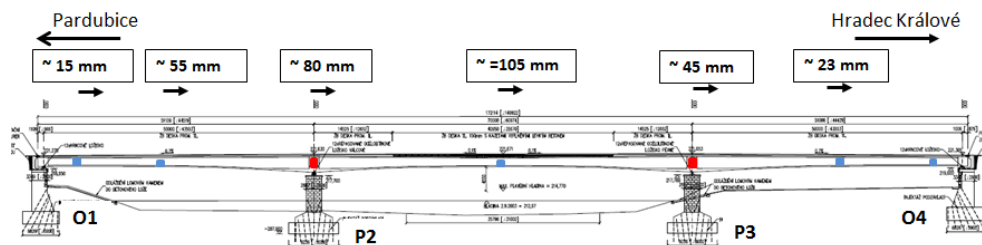
The edge of the cross-beam above the P2 pillar was damaged, it was broken off in a width of approx. 80 mm under the shifted block of deviators, figure 3.

From the above-stated findings, it is possible to conclude that the cable failure probably occurred in the first bridge span.

Figure 3. The approximate shift of the cable found out in the direction against the stationing
