Root cause failure analysis of reducer weld-joint leakage for liquid outlet of slug catcher

R A T Gurning, D Priadi, D Ferdian, and Suryadi

Department of Metallurgy and Materials Engineering, Faculty of Engineering, University of Indonesia

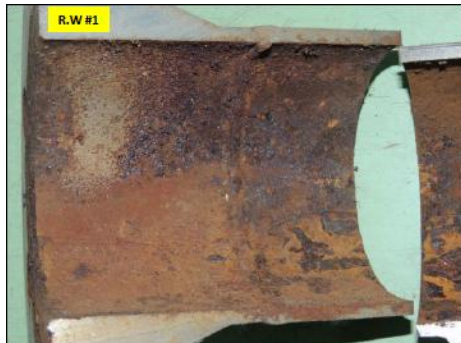
Based on internal view of the spool reducer R.W #1 and R.W#2, they were suggested that the corrosion product found on the top surface area. The color was nearly dark brown, very crumble and also easily wiped away. However, generally the layer of scale and corrosion product was mainly found on the bottom surface of reducer. The combination of color was dark brown and earth yellow. The corrosion product was very hard and sticks onto the steel surface. The erosion marks are not observable in the internal of reducer and on the both flange mouth, inlet and outlet mouth.

Figure 1. Internal view of R.W #1

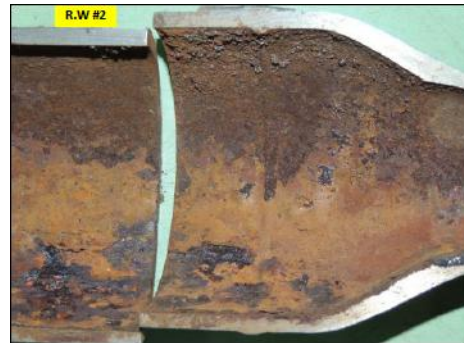
Figure 2. Internal view of R.W #2

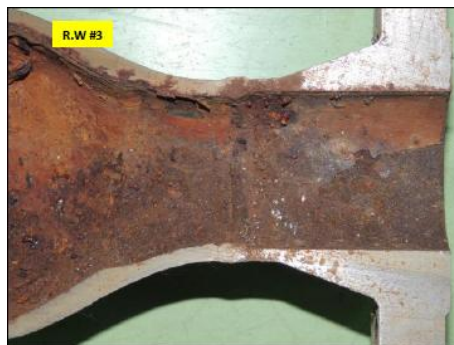
Figure 3. Internal view of R.W #3

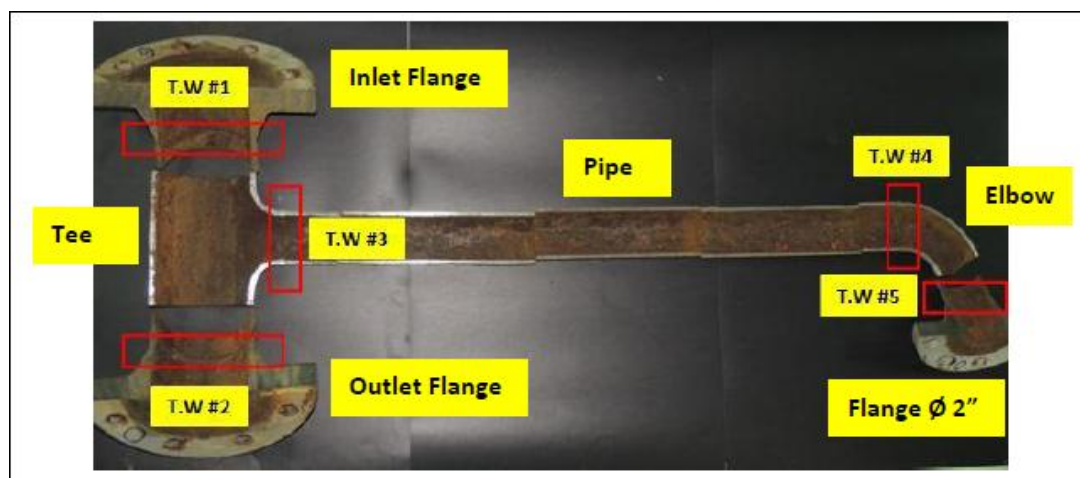
Visual examination also performed on Tee-Weld 4" spool. The internal view of tee-weld 4" may be shown in Figure 4. The appearance of corrosion product and layer of scale were found on the bottom surface of tee. The characteristic and combination color were similar with layer found in the reducer

Figure 4. Internal view of Tee 4"

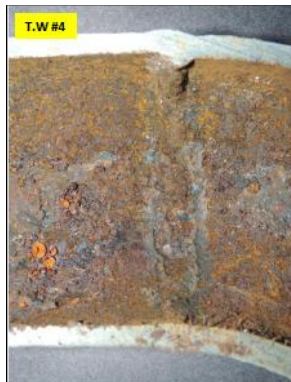
Figure 5 and 6 shows that there were weld root degradation indications on weld joint of T.W#4 and T.W#5. The weld root degradation may be resulted either from improper of welding technique or improper instant repair. This weld root degradation may cause the turbulent flow of fluid in the weld-joint pipe and also may cause the root weld more anodic and vulnerable to corrosion. However, the corrosion product were found on the 2" straight pipe with dark brown of its color. Based on its fluid service and the visual result, the corrosion product may be siderite (FeCO_3). XRD analysis may show the dominant corrosion product in the straight pipe.

Figure 5. Internal view of T.W#4

In order to minimize the inconsistency of weld joint quality and the improper of welding process, it is recommended to check the remaining weld joint and replace any joint with improper weld profile which may affect the flow pattern and threats such as flow accelerated corrosion.

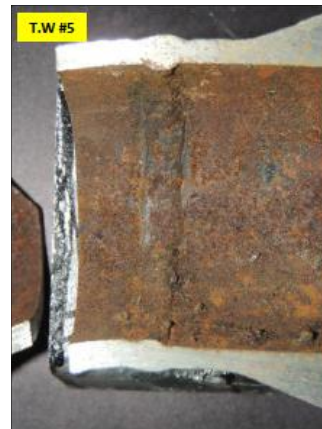
Figure 6. Internal view of T.W#5

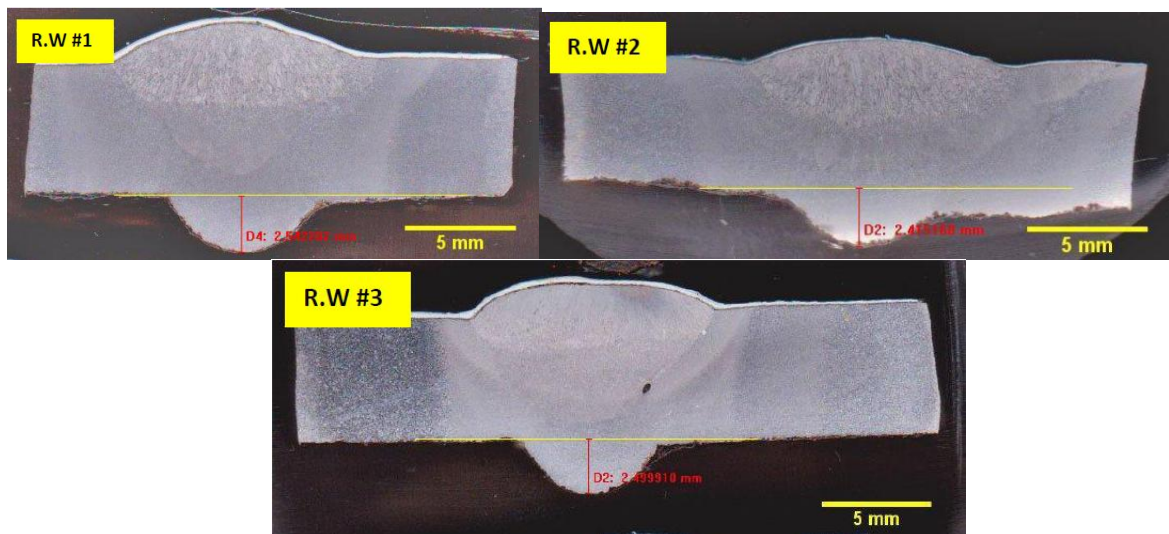
Macrophotography test was conducted on the weld joint spool. Samples are cut from spool material. Its cross section is prepared with the following steps such as grinding, polishing and etching. Figure 7 shows macrophotograph result of weld joints on reducer 4"x2". Based on Figure 7, there is no abnormal weld root on weld joint reducer 4"x2". The weld root height was found about 2.5 mm on each sample. However, Figure 8 shows the excessive weld root on T.W#2. The excessive root of T.W#2 may be caused by the improper instant repair. This excessive weld root may disrupt the fluid flow inside the pipe and increasing the preferential weld corrosion occurred. The preferential weld corrosion may be influenced by several parameters including flow conditions, scaling effects, the environment, steel composition and also welding procedure [5].

**Figure 7.** Macrophotograph of weld joints on reducer 4'' x 2''

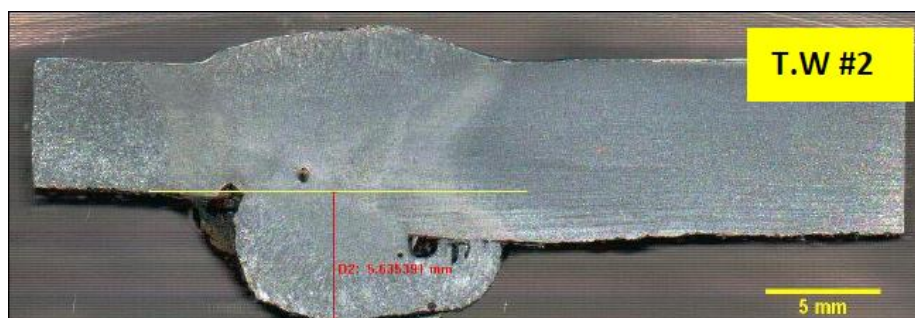
**Figure 8.** Macrophotograph of tee weld joints on spool 4'' x 2''

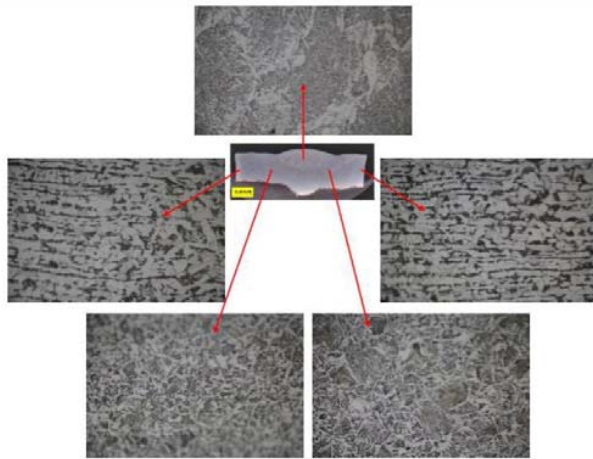
Figure 9. Microphotograph of weld joint R.W#2

Figure 9 shows the macrophotograph of weld joint R.W#2. The microstructure analysis was taken on HAZ area. There was no abnormal microstructure on R.W#2. The combination of ferrite and pearlite was found normal on each sampling analysis. The excessive root sampling of T.W#2 was also observed on Figure 10. However, the microstructure was also found normal and there was no detrimental microstructure. Therefore, failure due to microstructure may be negligible.

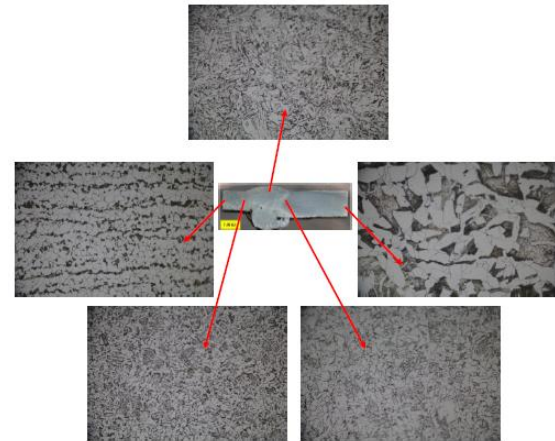
Figure 10. Microphotograph of weld joint T.W#2

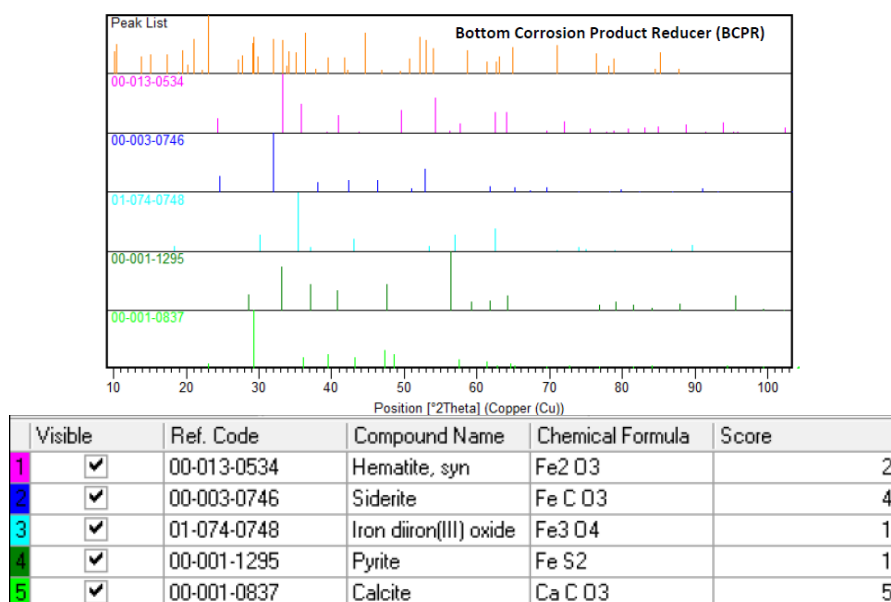
Figure 11. XRD of BCPR

Corrosion products may be shown from Figure 11 to Figure 14. Table 6 shows summary of XRD test of BCPR, TCPR, BCPR, and TCPR. Generally, corrosion products that occurred based on XRD tests may be caused by carbonate scale, bacterial corrosion, sweet corrosion and corrosion of steel by water. There was also presence of pyrite (FeS₂) in the corrosion product. However, it may not be considered due to the reading from XRD spectrum showed “unmatched strong”. Therefore, FeS₂ may not exist in the corrosion product.

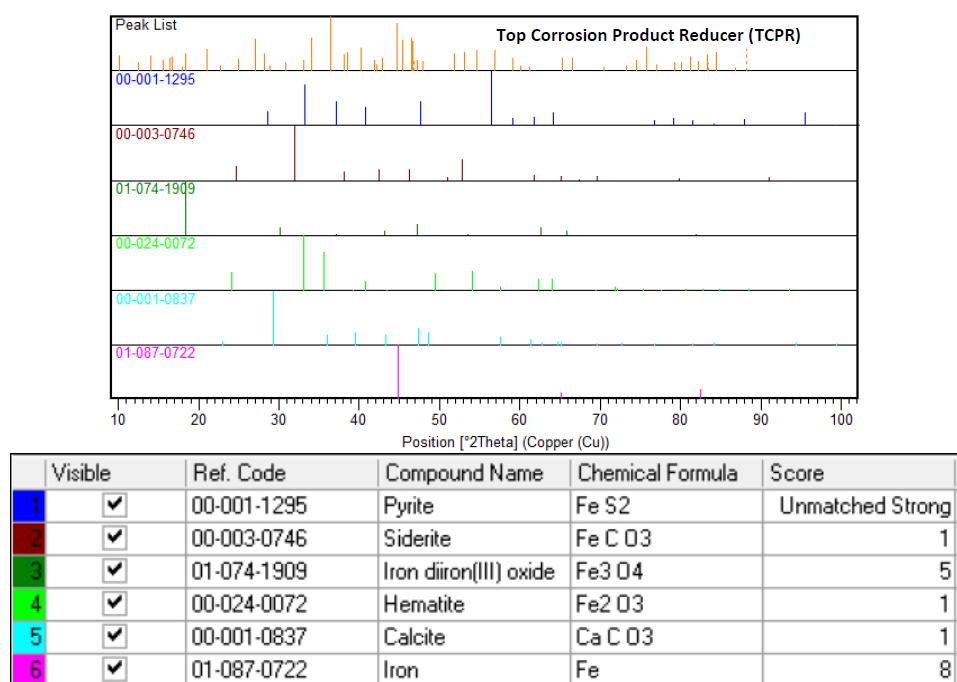
Figure 12. XRD of TCPR

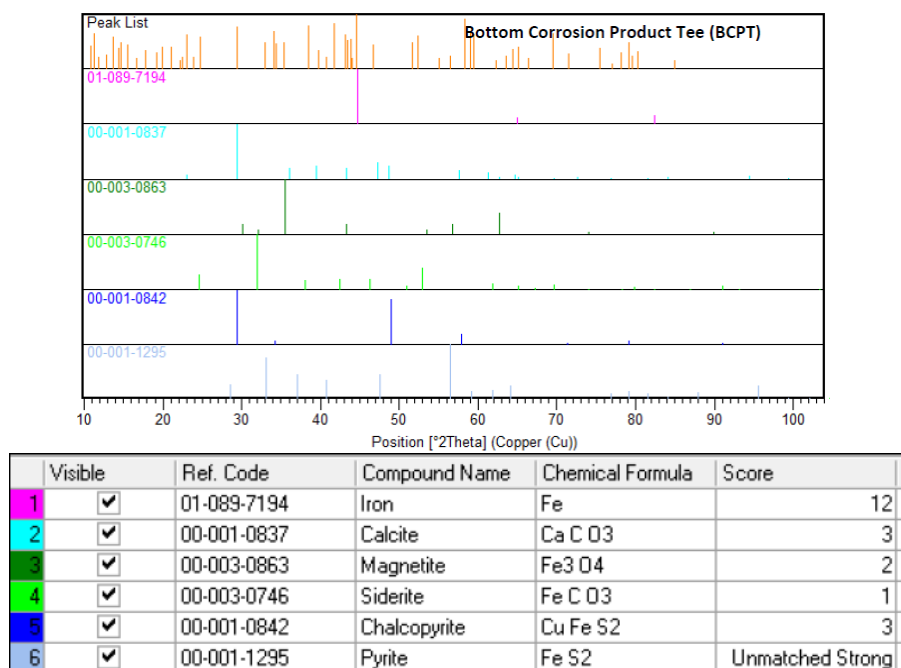
Figure 13. XRD of BCPT

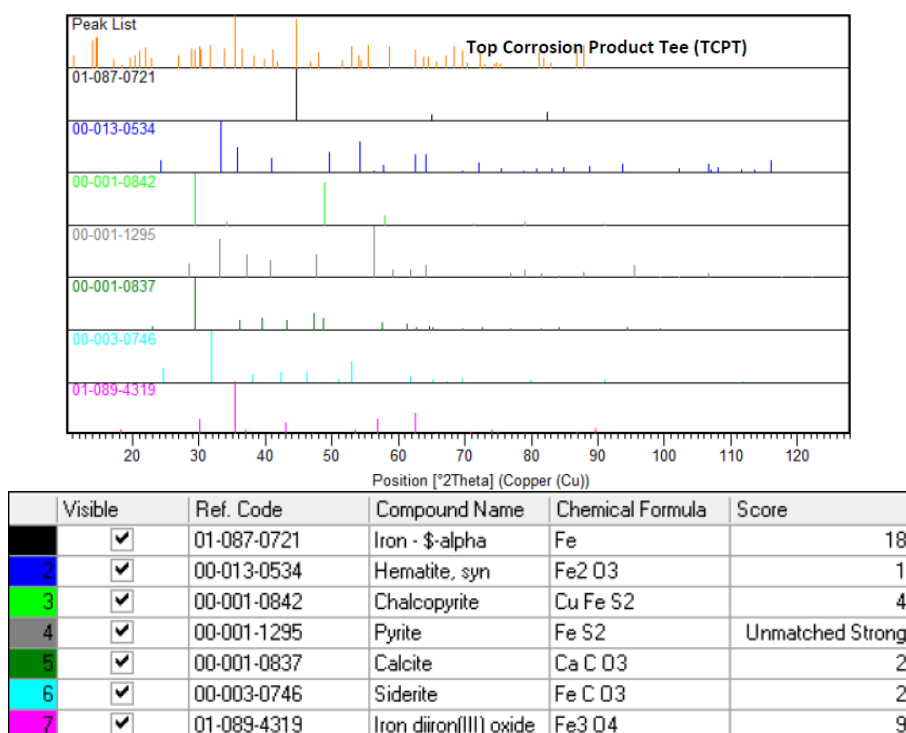
Figure 14. XRD of TCPT
