Experience of using the ultrasonic low-frequency tomograph for inspection of reinforced concrete structures

To cite this article: M S Kuznetsov *et al* 2019 *IOP Conf. Ser.: Mater. Sci. Eng.* **481** 012047

M S Kuznetsov¹, O V Maltseva,² A S Noskov,³ A S Kuznetsov⁴

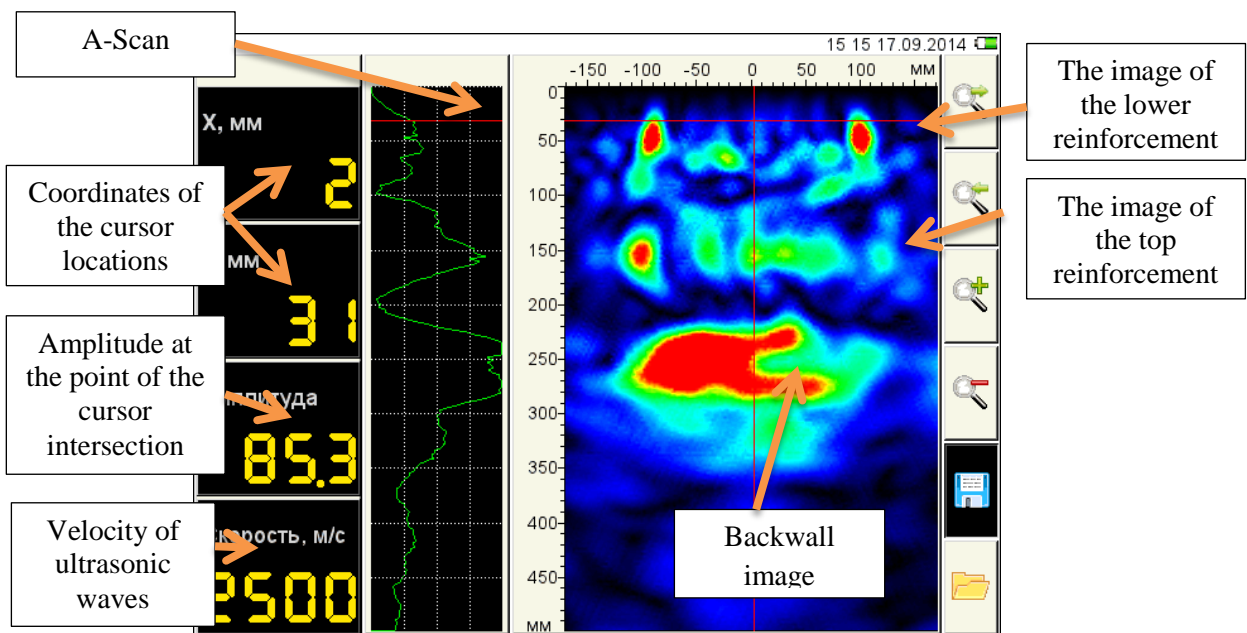
Figure 3 shows a B-scan of the flooring where some images are visible due to the difference in their color. The position of the images in the section of the structure can be judged by from the axes of the coordinates, X and Z . The horizontal axis X origin is at the center of the antenna array and rubs along the longitudinal side of the device. The vertical axis Z origin is on the surface of the structure to which the device is applied, and shows the location of the images along the thickness of the structure. The coordinates of the image of interest on the B-scan are identified by moving the horizontal and vertical cursor on the screen. Further, the A-scan on the instrument's screen shows a graph of the images echoing property. The images which are lined up horizontally along the X axis, at a distance of

about 50 mm from the structure's surface where the device is located, show the bottom reinforcement mesh of the flooring. The top reinforcement mesh, judging by the scan, is located about 150 mm from the floor surface. The ultrasonic waves are echoed from the bottom surface of the flooring at the interface between concrete and air (by reference to the device location), which is seen on the scan as a large image with Z coordinates equal to 250 mm, or the so-called backwall image. Its location confirms the thickness of the flooring being tested. The B-scan shows no images other than those which belong to the design elements. Thus, there are no structural flaws (discontinuities) of concrete on the scanned area of the floor structure detected.

Figure 3. Scan of the 250-mm flooring with images of the nearby and distant rebars and the backwall image.

The scan shows no extraneous images, thus, there are no defects in the structure (discontinuities) of the concrete.

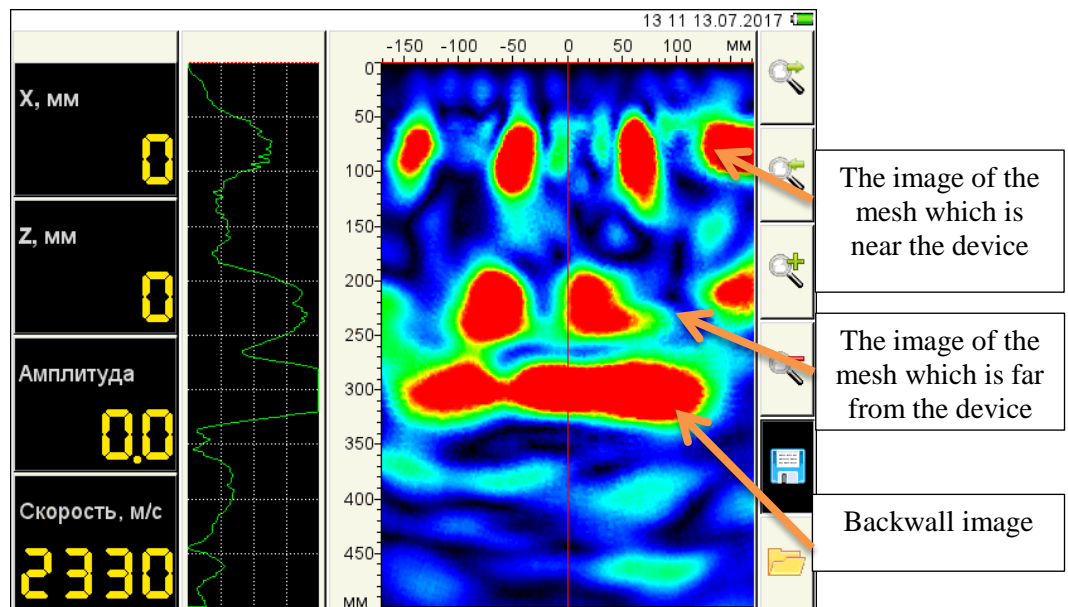
The tomography at Figure 5 clearly shows the images of two layers of reinforcement (two meshes) which are located at about 70 mm from the surfaces of the structure (protective layer of concrete). The backwall image of the structure is clearly visible at a distance of 300 mm. The interface between concrete and air shows the thickness of the structure. The scan shows no extraneous images, no structural flaws (discontinuities) of concrete in this area.

Figure 5. The tank wall scan with the reinforcement images and the backwall image.

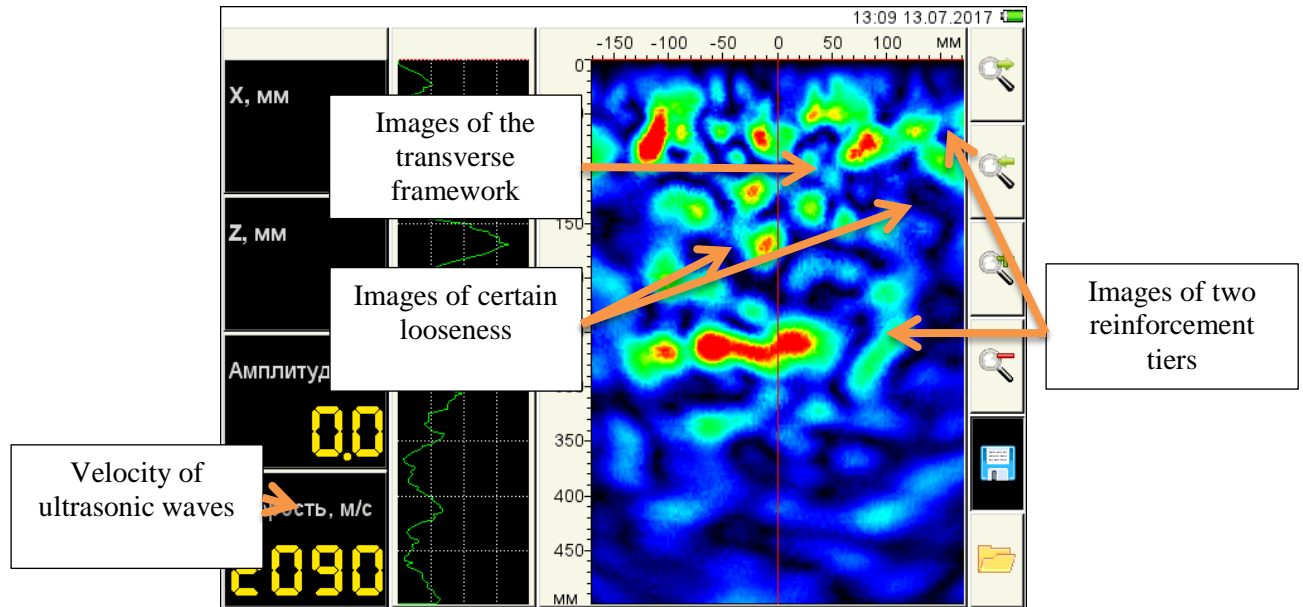
A scan (Figure 6) with additional images lined up between two tiers of the mesh images was made at another area of the same tank wall. The transverse frame which connects the reinforcement meshes is obviously located here. A small number of additional images are seen at the location of the

reinforcement. Obviously, the concrete is not dense enough in the area of the reinforcing cage. Therefore, the ultrasound velocity goes down.

Figure 6. The tank wall scan with images of the transverse reinforcing cage between the near and distant meshes and the unexpected images of some loose concrete.

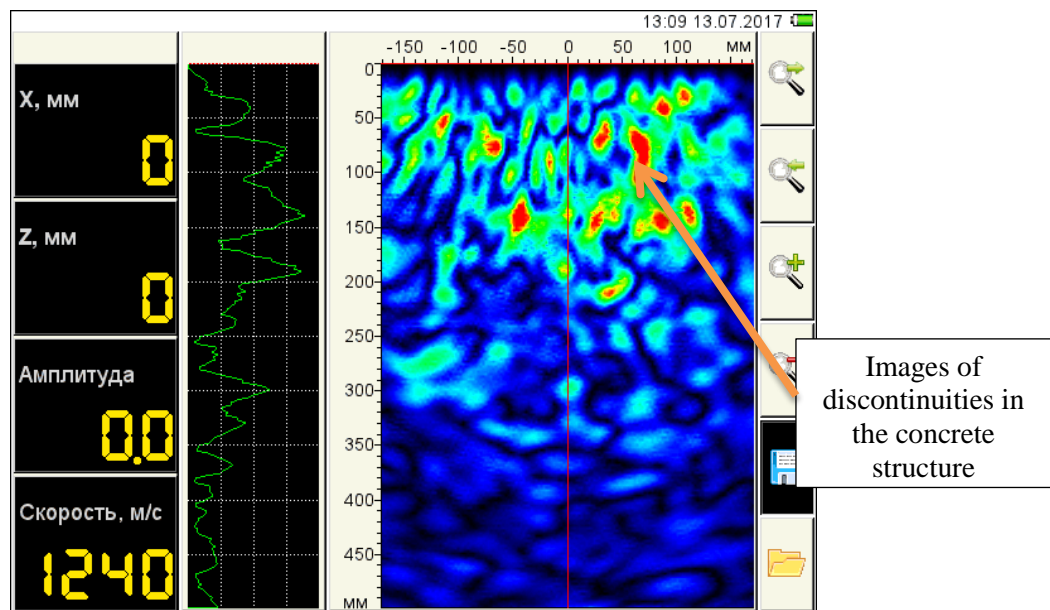
The same tank wall was further scanned in the loose concrete areas (Figure 7). The ultrasonic waves velocity here is lower than that in dense concrete. A large number of foreign images indicates a lack of consolidation of concrete to the depth equal to 250 mm of the structure thickness. The waves stop short of the backwall of the structure and are echoed from the indications. Consequently, the backwall image is not seen on the scan.

Figure 7. The scan of tank wall in the area of loose concrete.

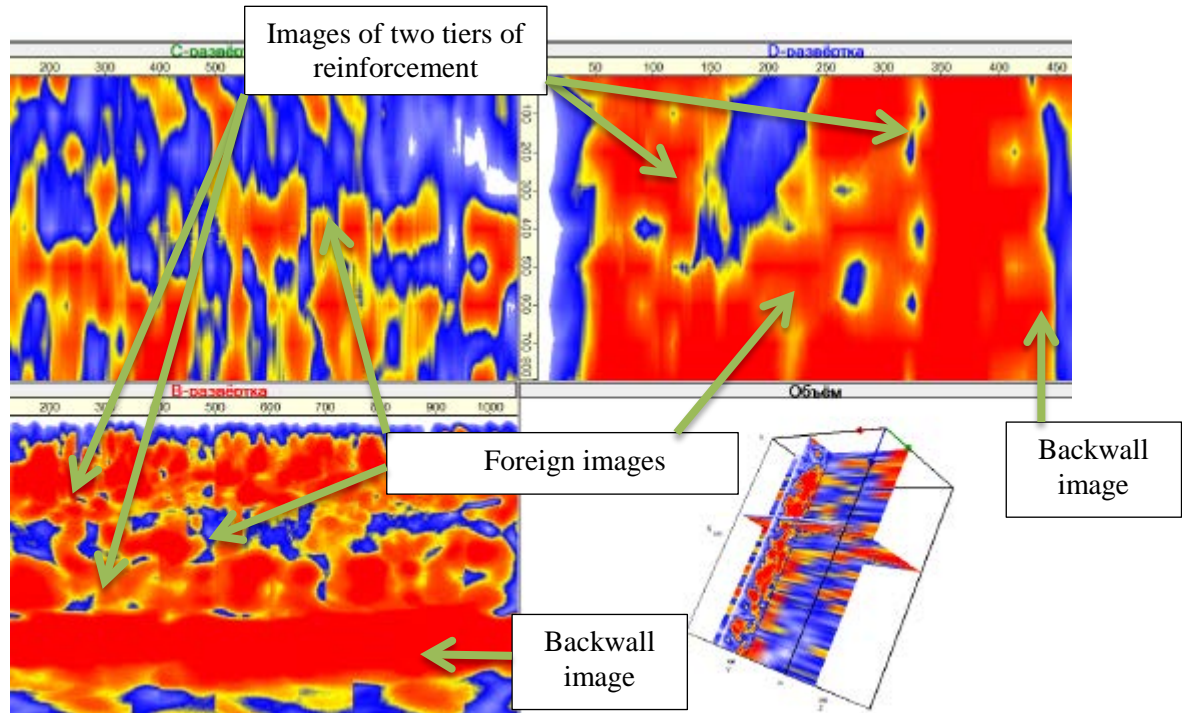
See Figure 8 for a screenshot of the plane scans of the tested area. The B-scan shows extra images undesigned between two reinforcement tiers, which may prove to be foreign matter or most probably cavities resulted from loose concrete. The C- and D-scans are shown along the secant planes of the body at the place where they run through the foreign images.

Figure 8. Screenshot of the plane scans at the tank wall area with echoes from the two tiers of reinforcement, the backwall and foreign images.

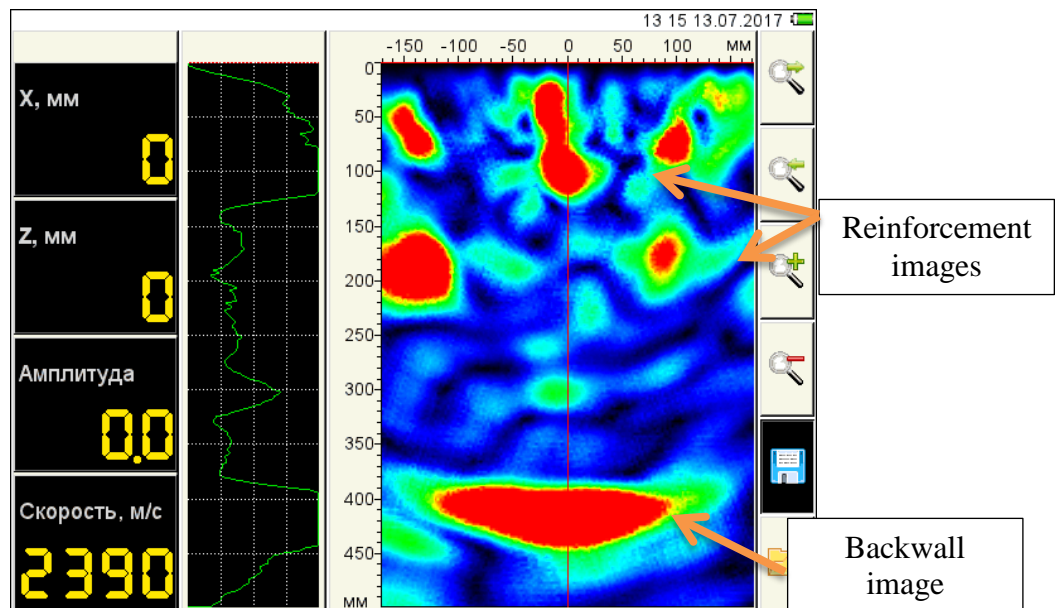
Here the wall thickness is increased to 400 mm. The scan performed on a dense area of concrete is shown in Figure 9. It clearly shows the images of the reinforcement and the backwall image of the structure at a distance of 400 mm.

Figure 9. The tank wall scan at the pier location.

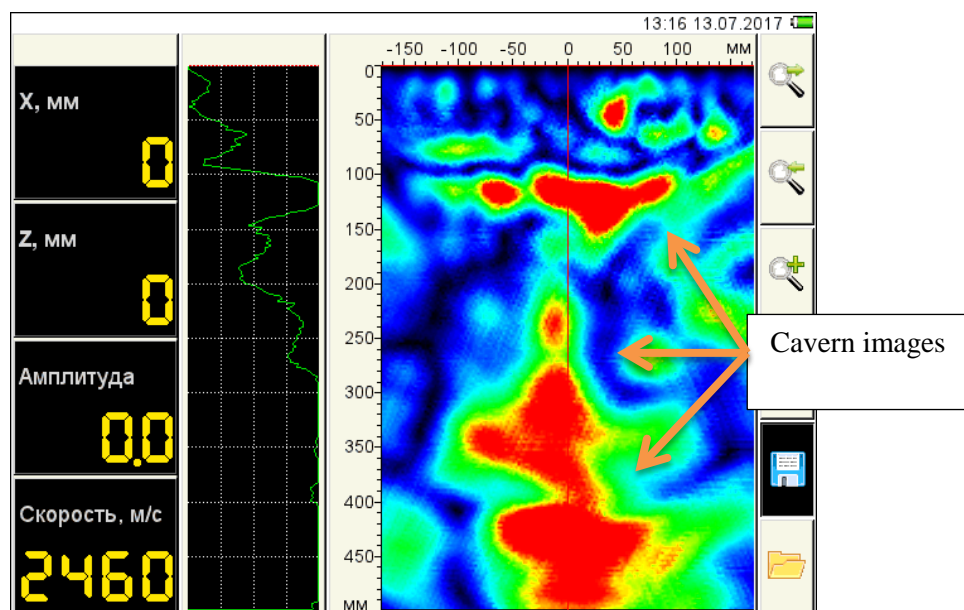
One of the piers showed a centerline defect seen as a long narrow cavity running deep into the body of the structure. At this area, the scan shown at Figure 10 has been made. As can be seen from the scan, the cavity runs deep inside and transforms into a large cavern which opens onto the opposite surface of the structure. The defect echoes the waves, the backwall image is missing.

Figure 10. The tank wall image at the pier location with a large cavern image in the center of the pier.

- “heal” the structure with special repair mixes as deep as the defect runs;
- reinforce structures with metal yokes and carbon reinforcement systems from outside;
- dismantle the structure.

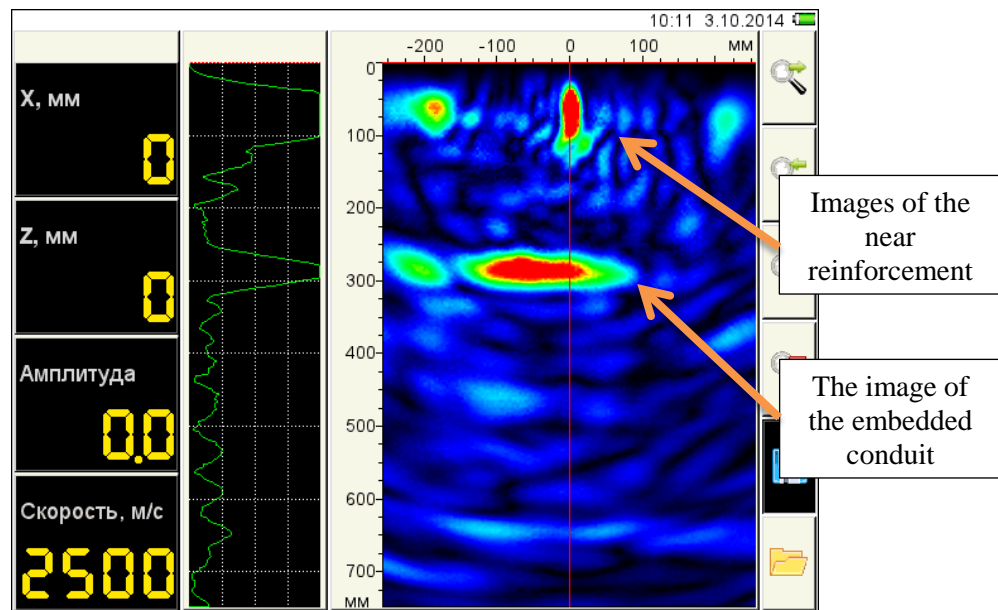
To acquire the experience a 600-mm column was scanned in situ with a conduit in the center (figure 11). The scan clearly shows the images of the near reinforcement and those of the embedded part. The backwall image is missing since the waves won't go beyond the conduit and are reflected by it.

Figure 11. Scanning of the column with the embedded pipe at a distance of 300 mm from the surface.

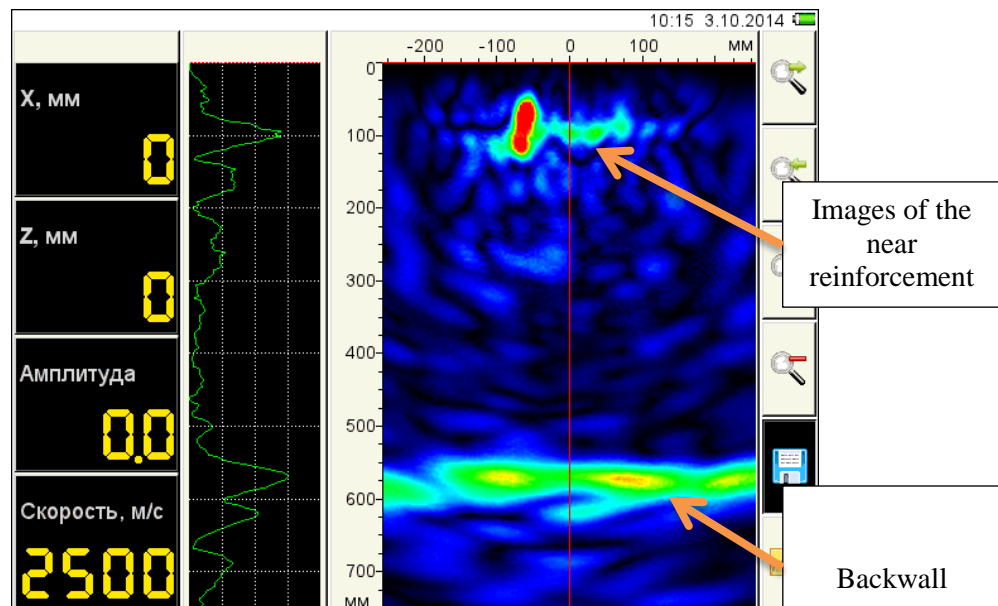
Figure 12 shows a scan of the same column at the conduit free area. The images of the near reinforcement and the backwall image of the structure are clearly visible at a distance of 600 mm which is the section size of the column.

Figure 12. The column scan at the conduit free area.
