Fracture failure analysis on ultra supercritical turbine bolts

Central Laboratory, Central Iron and Steel Research Institute, Beijing, China

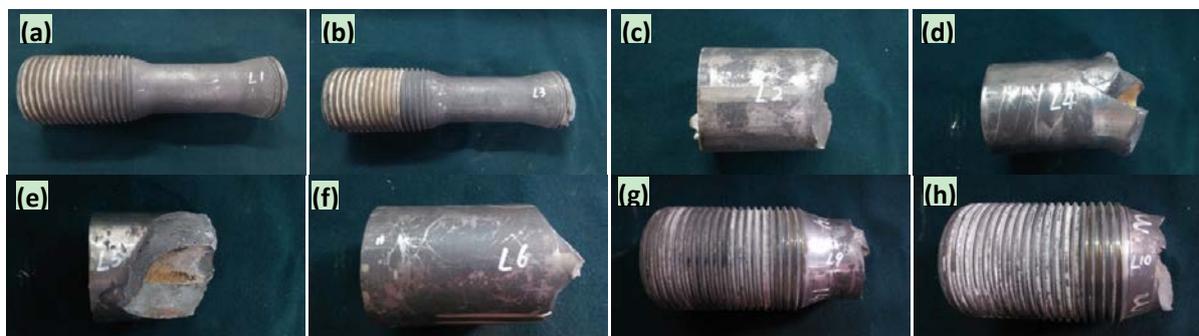
Figure 1. Fracture macro-profile of the bolts.

The photographs of the two kinds of bolts are given in fig.1. It can be seen that the control valve bolts are crack from the screw thread position. And the main throttle valve bolts are crack from the rod.

There has no obvious plastic deformation around each fracture.

(a)(b) control value bolts; (c)-(h) main throttle valve bolts.

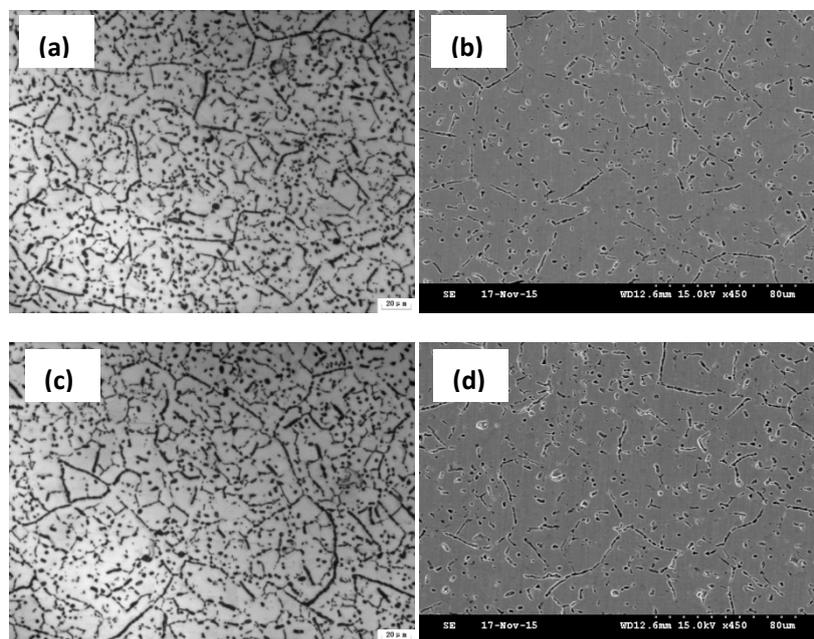
**Figure 2.** Microstructures of the bolts.

The normal position structures of the bolts are austenite + β phase as given in fig.2. The structures are homogeneous with no other abnormal structures.

(a)(b) control value bolts; (c)(d) main throttle valve bolts.

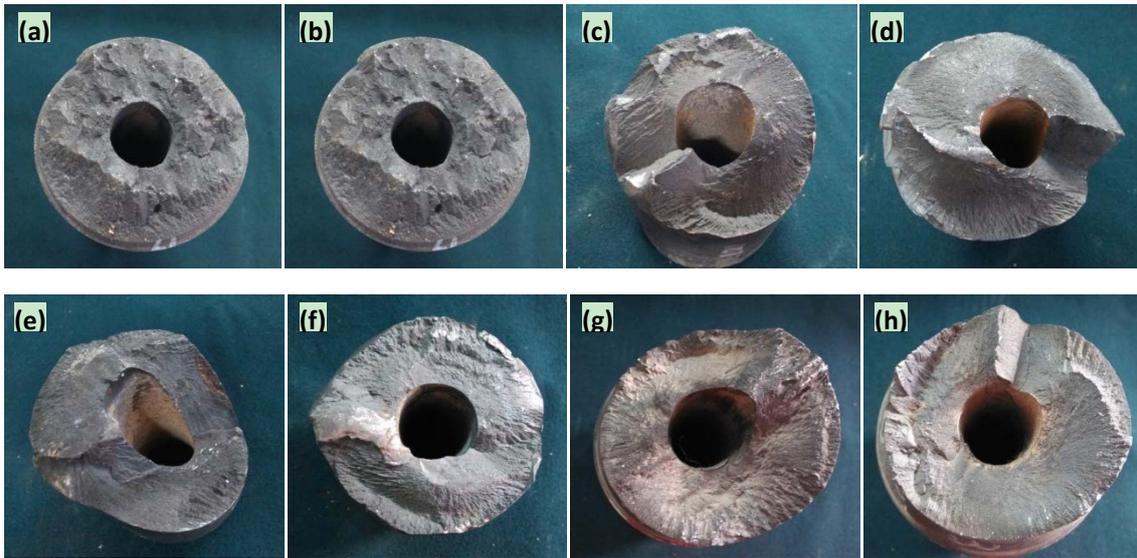
Figure 3. Fracture macro-profiles of the bolts.

It can be seen from fig.3 that the fractures are black because of the severe oxidation at high temperature, which indicate that the bolts have fractured for a long time. The cracks initiated from the inner wall surface according to the radial stripes. The main fractures are perpendicular to the axial direction. Compared with the main throttle value bolts, the fracture surfaces of control value bolts are blunter. It can be speculated that the control value bolts fractured earlier and had been oxidized more severely. The fracture micro-morphology of the bolts is given in fig.4. It is very hard to get rid of the high-temperature oxidation layers. However intergranular fracture can still be seen after derusting treatment. Mean while, some cracks which are not perpendicular to the bolt axial direction have been found near the main fractures as given in fig.5. The cracks are 45° in direction of the bolt axis, with the features being arborization, intergranular and severe oxidation as shown in fig.6.

(a) (b) control value bolts; (c)-(h) main throttle valve bolts.

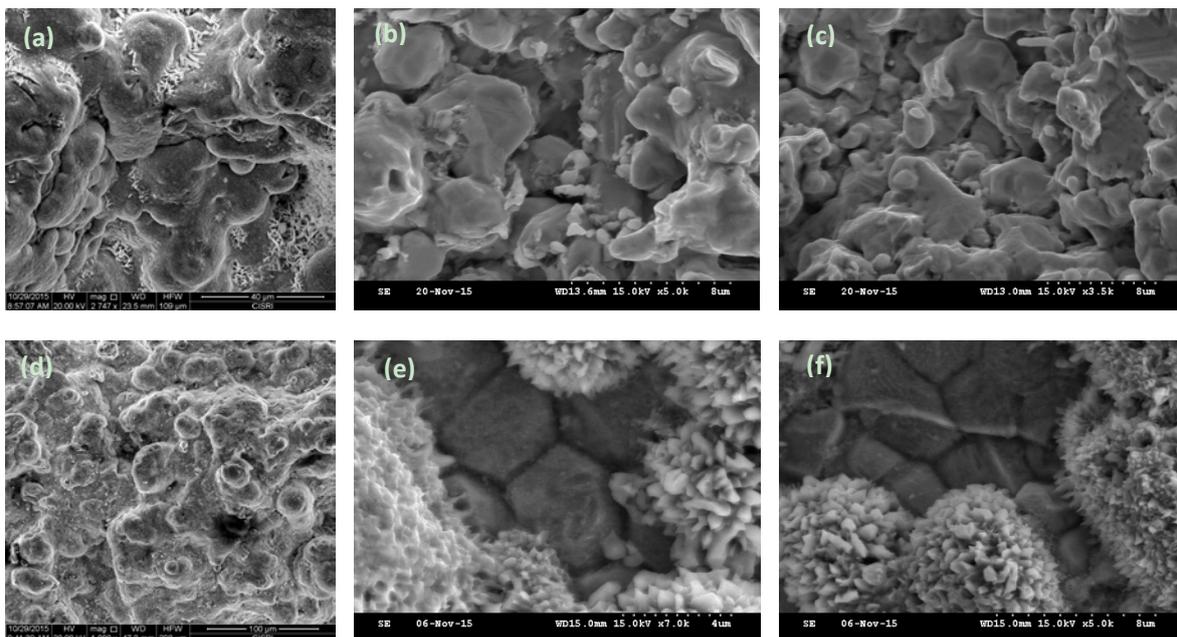
Figure 4. Fracture micro-morphology of the bolts.

(a) control value bolt origin surface; (b)(c) control value bolt derusting surface; (d) main throttle valve bolt origin surface; (e)(f) main throttle valve bolt derusting surface

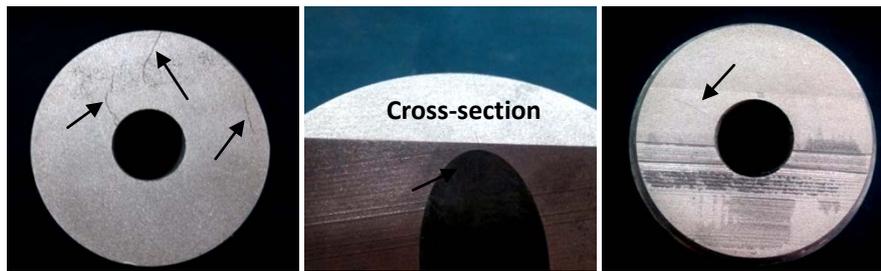
Figure 5. Cracks near the main fracture

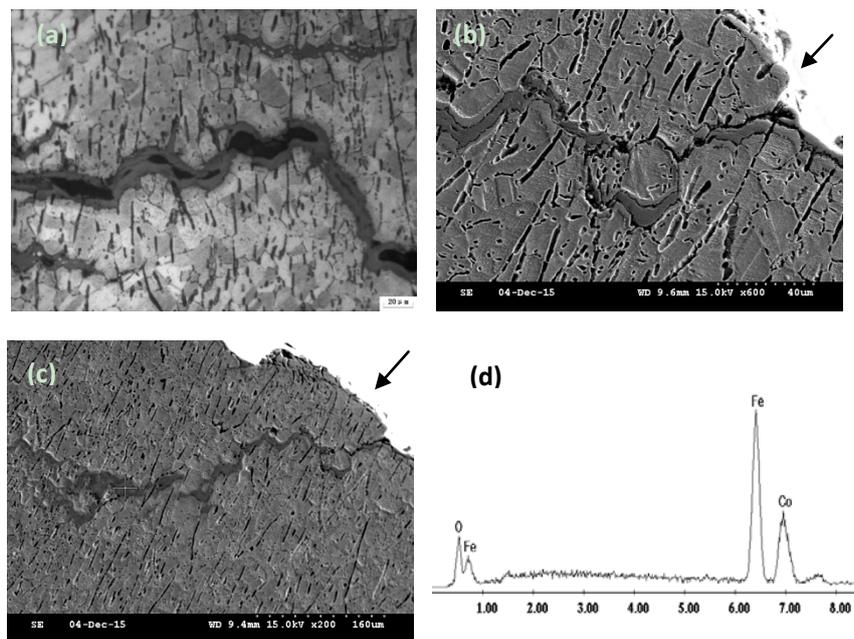
Figure 6. Cracks near the main fracture (where the arrows point are origin fractures).

(a) metallograph of the crack; (b)(c)SEM micrograph; (d) energy spectrum of position marked in (c).

The fractured bolts have serviced about 8 years at 600 °C, and the main fractures are severely oxidized, intergranular and has no plastic deformation. The cracks near the fracture are dendritic, intergranular and also have been oxidized severely. All the features indicate that the bolts are high temperature stress-rupture fracture, and the stress accelerated grain boundary oxidative played an important role during the crack growth. Meanwhile, the cracks which are 45° in direction of the axis indicate that there must be some abnormal torsion stress on the bolts. It is known from the user that all the fractured bolts are installed on the same ultra supercritical turbine. And the bolts installed on another turbine at the same time are still used well. It can be deduced that the fractured bolts were improper assembled, which result in higher pretightening stress and abnormal torsion stress. After a long time service at high temperature, the bolts stress-rupture fracture.
