## Fatigue failure of an idle gear shaft of a gearbox

Charnont Moolwan<sup>1\*</sup> and Samroeng Netpu<sup>2</sup>

**Abstract** This paper reports the results of failure analysis of an idle gear shaft of a gearbox in a hot re-rolling steel mill in Thailand. The shaft failed prematurely after only about 6,000 hours of service which was very much lower than the expected working life of 40,000-50,000 hours. The results showed that the shaft failed by fatigue fracture. Beach marks on the fracture surface were clearly visible. Fatigue cracks were initiated at two corners of the keyway of the shaft. Relatively large final fracture area of the fracture surface indicated that the shaft was under a very high stress at the time of failure. The root cause of the fracture is poor design and poor machining of the keyway. Too small fillet radii at the bottom of the keyway gave rise to stress concentration resulting in excessive stresses at the keyway corners. These high stresses led to fatigue crack initiation at the keyway corners followed by crack growth, and final fracture.

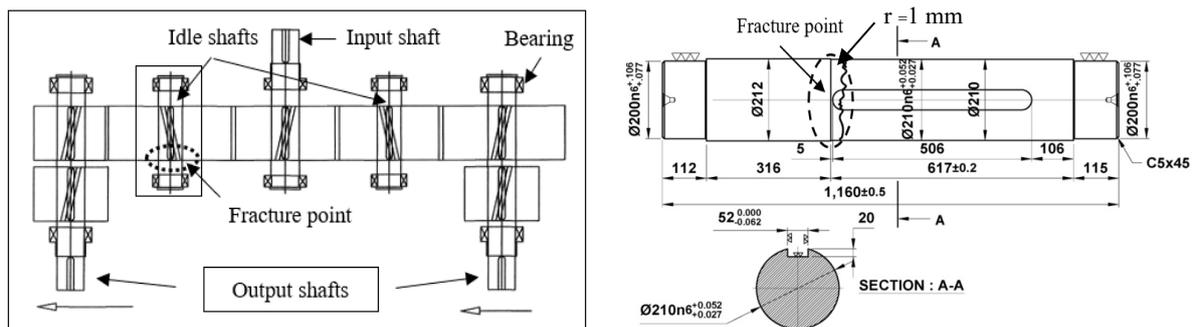
Details of the gearbox assembly showing the failed shaft and the location of the fracture are as shown in Figure 1a, and key dimensions of the failed shaft are shown in Figure 1b.

Fig. 1. (a) The gearbox layout showing failed shaft and fracture position (b) Key dimensions of the failed shaft

A detail drawing of fillet radii of the keyway in drawing as shown in Figure 1 did not specify the value of fillet radii of the keyway. The shaft manufacturer cannot be blamed for machining the keyway with sharp corners. Inadequate fillet radii of the keyway resulted from poor design in detail design phase.

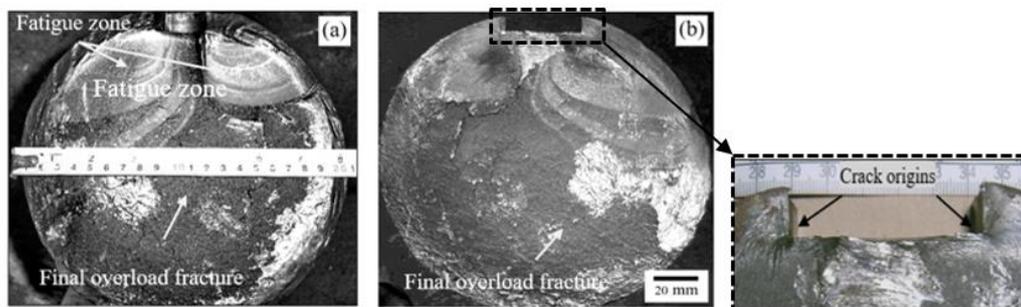
The fracture surface of the failed shaft has two distinct portions both of which are rather flat as shown in Figure 2. Beach marks are clearly visible in one zone of the fracture surface. Such fracture surface appearance indicates that the shaft most likely failed by fatigue fracture. The final fracture surface area is approximately 80% of total fracture surface indicating that the stress in the shaft, hence the loads, must have been very high. Fracture surface appearance, as shown in Figure 2b, also indicates the crack most likely initiated at two corners of the keyway of the shaft. Ratchet marks in the fracture surface suggest further that the fracture is fatigue fracture.

The overall fracture surface was rather flat indicating that the final fracture was brittle by nature and that the shaft was subjected to very high triaxial stress before failure.

Fig. 2. The failed shaft the fracture surfaces

It can be seen in Figure 2 that the final fracture area is relatively large covering about 80% of the fracture surface. The large final fracture area indicated that the failed shaft was heavily stressed (workpiece of steel bar too low temperature) at the time of final fracture. The fatigue cracks initiated at both corners of the keyway and ratchet marks between two cracks can be readily observed. The results indicated the stresses at the corners of the keyway were very high which was confirmed by the calculation in the previous section. The result is agreement with that of other investigators [22].

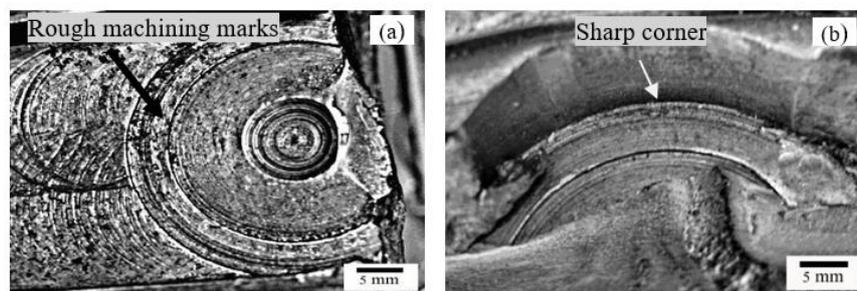
The keyway of the failed shaft was examined in more detail to identify characteristics and features of the keyway that could lead to crack initiation. It was observed that the keyway surface had distinctive rough machining marks as shown in Figure 3a. The keyway corners are quite sharp as shown in Figure 3b. Rough surface and sharp corners of the keyway are possible causes for the failure of the shaft as such features could lead to stress concentration and crack initiation.

Fig. 3. Keyway (a) machining marks on surface (b) sharp corners

The keyway surface contained distinctive very rough machining marks as shown in Figure 3. This is the result of poor milling of the keyway. Poor design and poor milling, resulting in low values of fillet radii and rough surface, are potential stress raisers that could lead to high stress concentration being created at the keyway corners which eventually lead to the initiation of the fatigue crack.

1. The idle gear shaft of a gearbox under this investigation failed by fatigue fracture.
2. The fatigue cracks initiated at both corners of the keyway and propagated inwards until final fracture occurred.
3. Excessive stress combined with poor machining and inadequate fillet radii at the keyway corner, which gave rise to high stress concentration, are the main causes of the fracture.
4. It is recommended that extreme care must be taken in detail design phase of critical component such as detail specification of fillet radii of keyway corners and generous fillet radii should be provided. Machining must also be done with great care avoiding sharp corners and too rough surfaces.

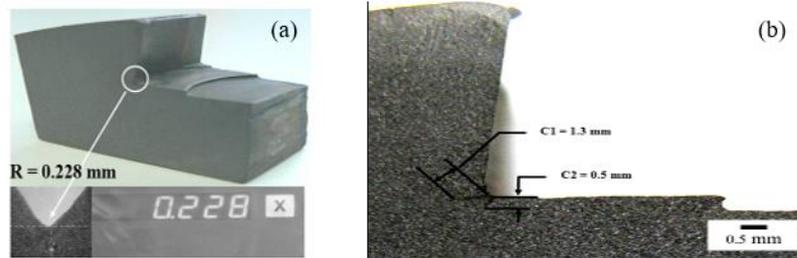
A sample from the material in vicinity of the keyway corner was cut, polished and examined to look for any abnormalities. The fillet radius of the keyway edge was found to be 0.228 mm as shown in Figure 4a which is much smaller than the recommended value of between 0.7-1.0 mm [14]. Two cracks at a

keyway corners were found as shown in Figure 4b. This demonstrates clearly that the crack did indeed start at the keyway corners.

Fig. 4. Section the keyway showing (a) fillet radius (b) cracks at a keyway corner

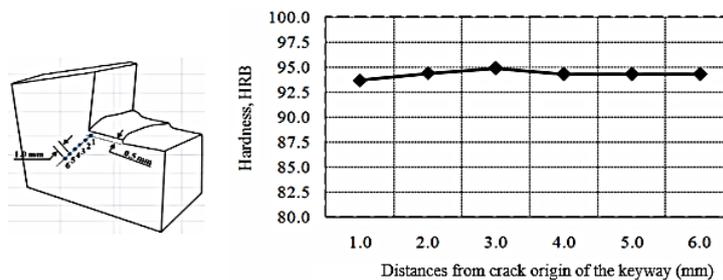
The hardness values measured at various distances from the crack region of the corner of the keyway are as shown in Figure 5. The hardness values were found to be between 92.7-94.9 HRB (195-210 HB) which were within specified limits of commercial machinery steels [15]. The hardness values indicated shaft material was in annealed condition to improve machinability. The result indicated that correct material was selected.

Fig. 5. Hardness values of the failed shaft

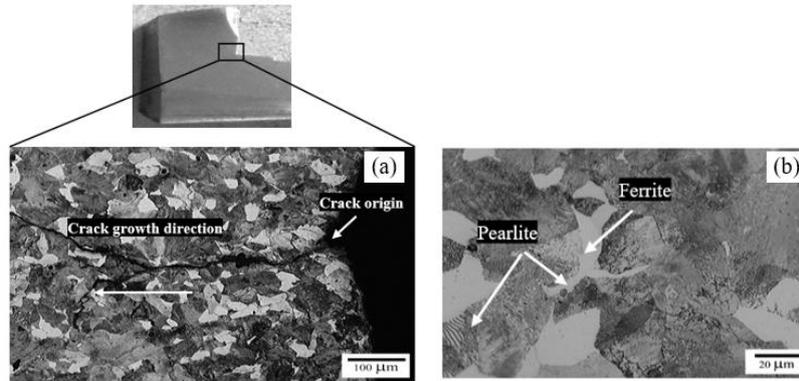
Examination of the polished and etched example from the shaft material in the vicinity of a keyway corner revealed that there was a crack which extended from the keyway corner through the sample as shown in Figure 6a. This indicated that the crack started at the keyway corner then propagated towards the center of the shaft.

The microstructure of the failed shaft was a mixture of pearlite and ferrite as shown in Figure 6b. The structure of the shaft is typical structure for low alloy medium carbon steel in an annealed condition [18].

Fig. 6. The microstructure (a) crack growth direction and crack origin (b) (high magnitude)

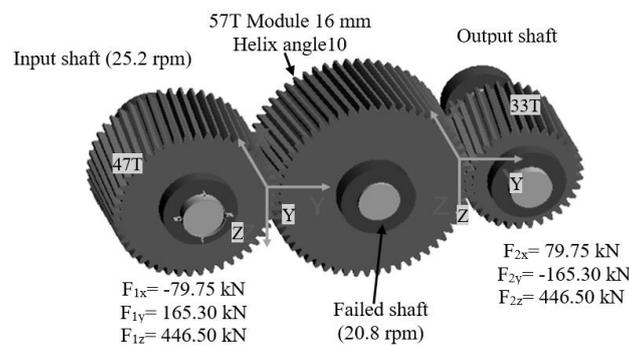
In the present case the power of electric motor is 900 kW and the rotational speed of input shaft is 25.2 rpm. The transmitted torque carried by each shaft is 50% of the value in equation 1 as there are two output shafts in the gearbox. The forces on the shafts were calculated using bearinX software of Schaeffer (FAG) Company. The calculated values of F<sub>1x</sub>, F<sub>2y</sub> and F<sub>1z</sub> are -79.75 kN, 165.30 kN, 446.50 kN, respectively, as shown in Figure 7.

Fig. 7. Force analysis on the gear

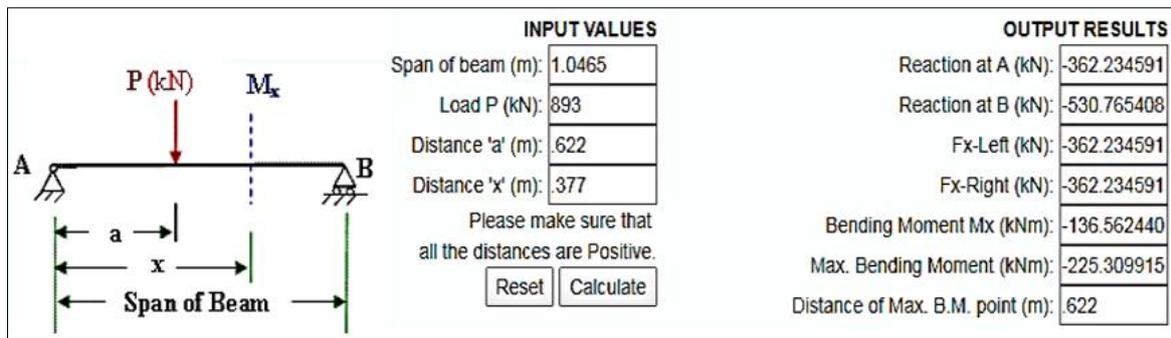
The shaft under consideration is being subjected to bending force. So as the shaft rotates there is a fluctuation of stress, the point which is subjected to bending moment value is found and shown in Figure 8. Bending stress ( $\sigma_b$ ) at the keyway corner of failed shaft is found and shows in Table 2.

Fig. 8. Bending moment of the shaft
