Failure analysis of high pressure fuel pump on piston aircraft engine

B Jiang¹, Y P Feng² and X D Yu¹

Abstract. High Pressure Pump (HPP) failure leads to a sudden fuel cut off, during the training flight. To investigate the root cause of HPP failure, two more aged fuel pump (TSN 600h), from the same flight academy, was received. The failed pump and aged pumps were disassembled and analyzed by optical microscope (OM), scanning electron microscope (SEM) and metallographic analysis. Results showed that the metallographic technology of the three pumps were the same. Foreign debris found in the failed fuel pump stuck one plunger. At next revolution the rotor was pushing hard against the follower plate causing a sheared plunger and cylinder. Subsequent fragments leads to the other two plungers' failure. Due to more and more debris, other parts of the pump fail as a secondary failure. Friction or stuck marks in the failed pump and the other two aged pumps indicated that it is more likely to have axial scratches in operation base Z. This operation base is close to desert.

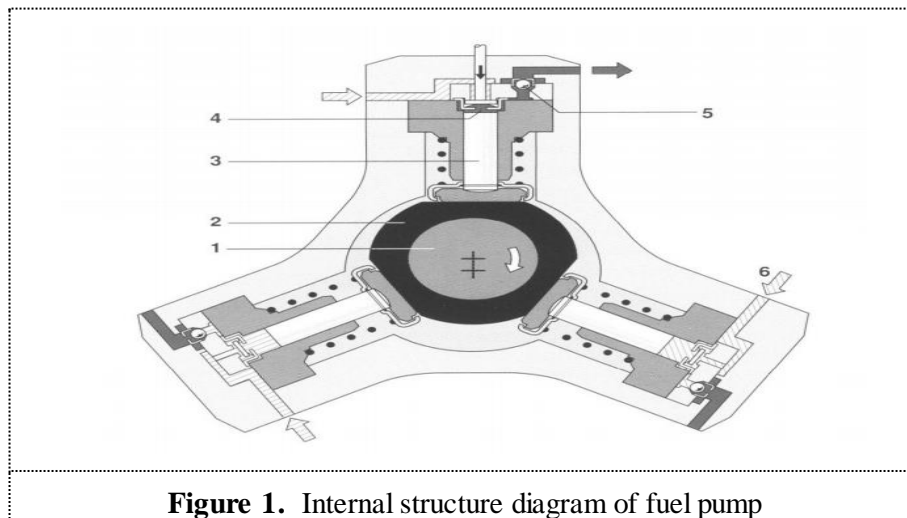
Figure 1. Internal structure diagram of fuel pump

The schematic diagram of inner structure was shown in Figure 1. The three plungers are driven by a rotor shaft. The cycle of fuel absorption and discharge is completed in one rotation. The failed pump block had an obvious damage area, as shown in Figure 1 (red arrow). Obvious bulge and deformation can be seen in the other two corresponding position (blue arrow). Internal damages were shown in Figure 2b. The plunger plate and the metal clamp ring (metal ring), can't be found in the failed pump. In addition, all the plungers were stuck in the cylinders. Lots of crushed metal particles were found inside the block.

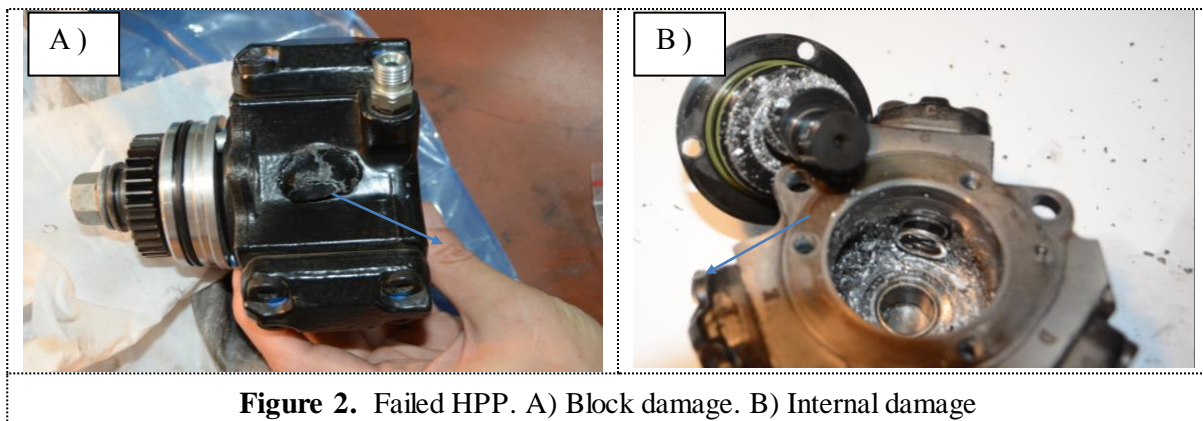
Figure 2. Failed HPP. A) Block damage. B) Internal damage

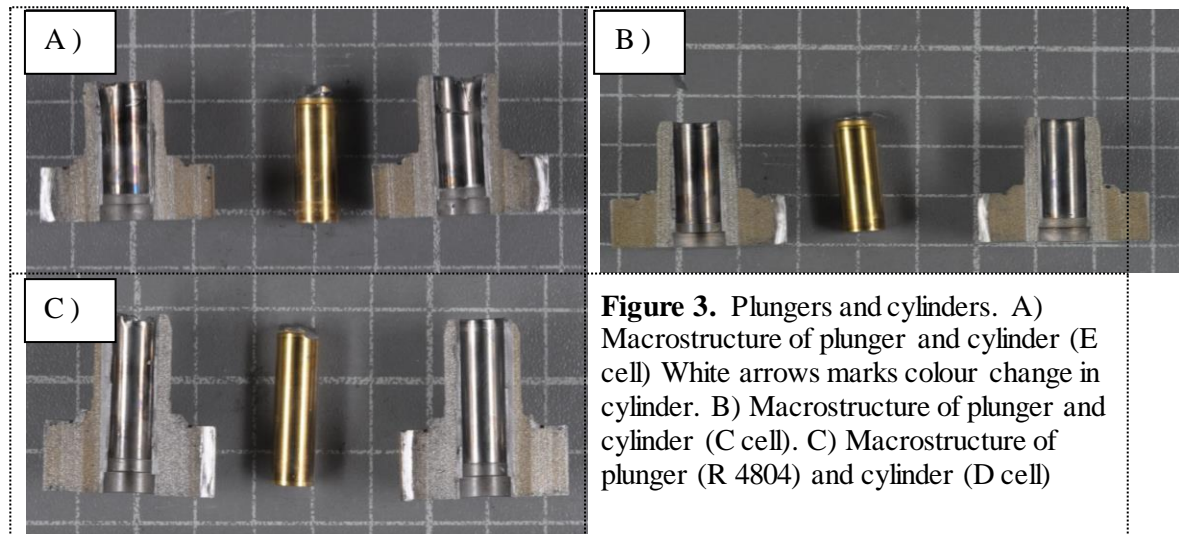
Plunger units (including plunger and cylinder) were cut along cross section, as shown in Figure 3. Side wall surfaces of cylinders have obvious blue color area, indicating high temperature process occurred in this area.

Figure 3. Plungers and cylinders. A) Macrostructure of plunger and cylinder (E cell) White arrows marks colour change in cylinder. B) Macrostructure of plunger and cylinder (C cell). C) Macrostructure of plunger (R 4804) and cylinder (D cell)

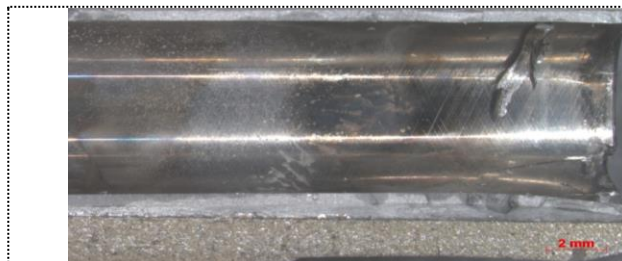
Figure 4. Surface macrostructure of cylinder

Microstructure of one cylinder was shown in Figure 4. Scratches and particles can be seen on the side wall surface. Using Scanning Electron Microscopy (SEM) to observe the scratches and particles' morphology, as shown in Figure 5. As the energy spectrum curve of the substrate material of cylinder shown in Figure 5, the main chemical elements were Cr 3.7(wt %), Mn 0.8 (wt %) and balanced by Fe. Surface layer of cylinder may treated by carburizing process.

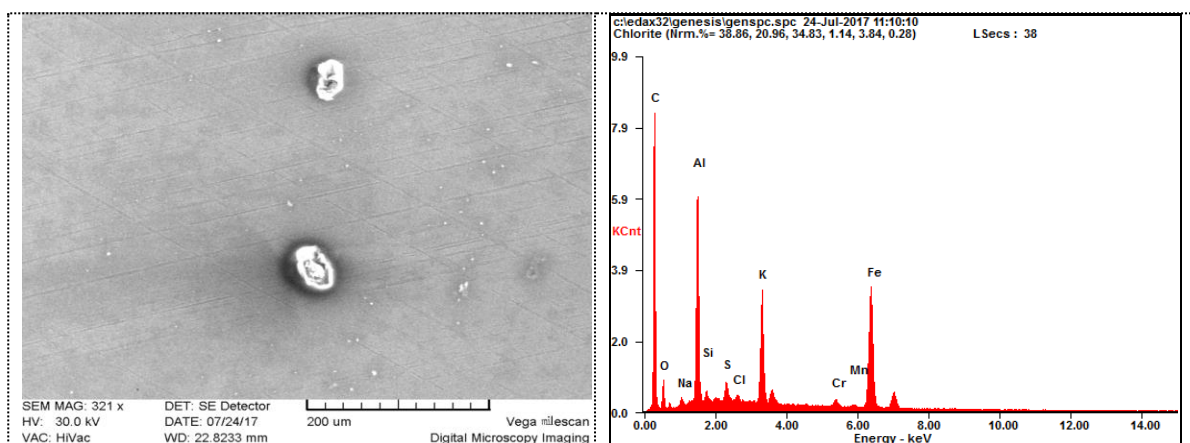
Particles on cylinder wall have two kinds of morphological characteristics, one was pits (fewer), energy spectrum analysis shows that the center of the pits include elements Al, Si and K. Another was particles, most of particles with chemical elements close to substrate material of cylinder, while few particles with chemical elements Al, Si and Ca. The micro topography of plunger was investigated too. The energy spectrum analysis shown that the main chemical composition of the plunger surface are Ti and N, which means Ti-N wear-resistant coating [5].

Figure 5. Surface microstructure of cylinder and energy spectrum of some particles

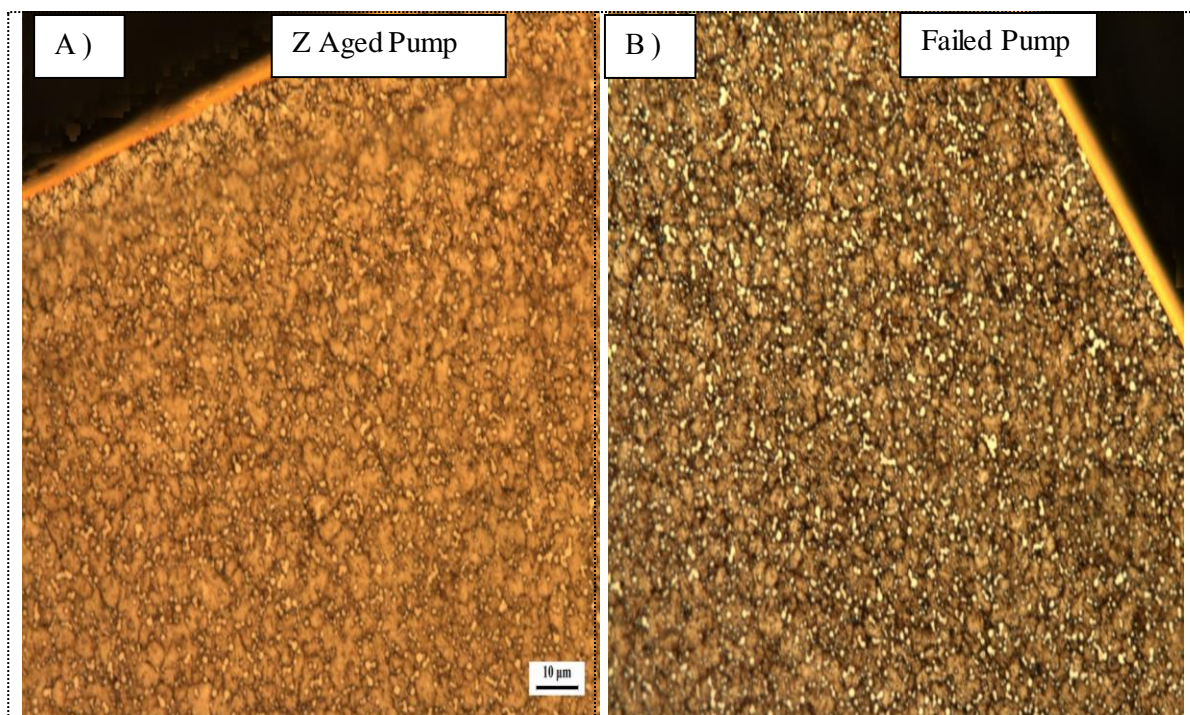
As shown in Figure 6, metallographic microstructures of plunger of Aged Pump Z and Failed Pump were the same with fine ferrite and cementite grain, the microstructure is very uniform and fine. Distribution of cementite was alone ferrite grain boundary location with scale of 2 ~ 5 microns. Metallographic organization of cylinder wall was shown Figure 6, the surface layer was carburized. The thickness of carburized layer is uniform, the white stripe within the carburizing layer is decarbonization organization. Existing research show that the white decarburization organization can gradually formation and evolution, with the extension of service life or load cycle. Its morphology has nothing to do with the treating process but with the service life and load cycle. Part of the surface appears light white, high temperature decarburization organization, which was caused by poor lubrication condition. Matrix organization are composited by martensitic, residual austenite and a small amount of cementite. Metallographic figure's difference in brightness mainly caused by corrosion, which has nothing to do with the material composition. So for material's microstructure, there are not deviations for failed pump and aged pump Z.

Figure 6. Metallographic structural comparison of plunger for HPP between Aged Pump Z and failed pump

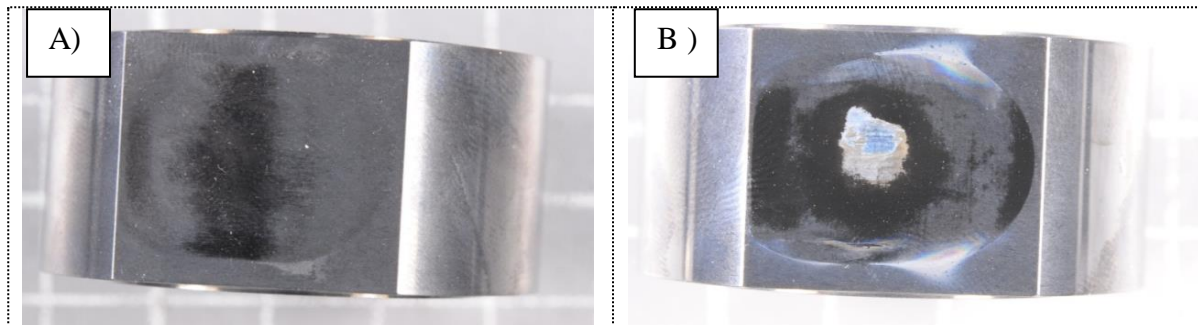
Obvious impact marks or even falling coating, were found on the surface of rotor in Aged Pump Z, but were not found in Aged Pump Y, as shown in Figure 8. Blue color, over heat aero, can be found on the surface of plunger and cylinders in both failed pump and two aged pumps. Metallographic results show that these color change areas corresponding to the carburized layer suffering high temperature decarburization process in poor lubrication. The above results shown that the color change area related to the local high temperature. The color change area is associated with poor lubrication condition, but not the root case for a stuck pump.

Figure 8. Rotor of camshaft of Aged Pump Y (a) and Aged Pump Z (b)

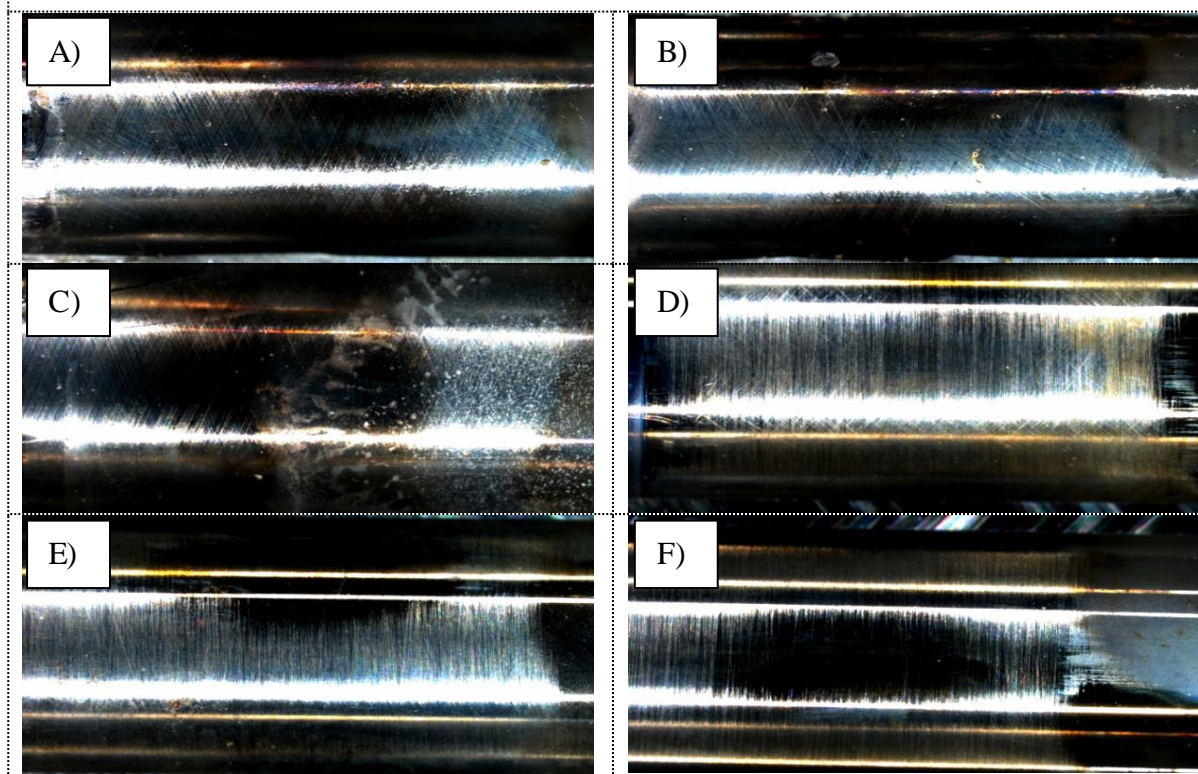
Compare the traces of wear on the cylinder surface of failed pump and aged pumps as shown in Figure 9. Aged pump had circumferential distribution scratches, but the cylinder surface of failed pump contains a large number of axial distribution scratches. Circumferential scratches may be caused by the plunger's rotation. Axial and deflection axial scratches may be caused by particles blocking the plunger's movement. And some particles may break apart by the rotation of the plunger.

Figure 9. Comparison of wear track for Aged Pump Z and failed pump
