# Failure analysis of the fracture surface of the crankshaft of a vehicle

**Abstract.** The purpose of this study was to determine the cause of a fracture in the crankshaft of a 1000 cc gasoline engine. On the broken surface, it could be seen that the cracks started from the direction of the oil hole. A visual examination revealed that there were beach marks on the surface of the fracture, which is usually common in fatigue failure due to a dynamic load. From the test for the chemical composition, it was found that the material was classified as alloy steel. The Rockwell-based material hardness values were different. The highest hardness value of 102.2 HR<sub>B</sub> was on the outer shell portion of the crankshaft on the *x* and *y* axes at points 1 and 14. Finally, it was concluded that the reason for the fracture in the crankshaft was fatigue failure, the material hardness that did not match that of the standard, as well as the initial crack contained within the radius of crank pin number 1.

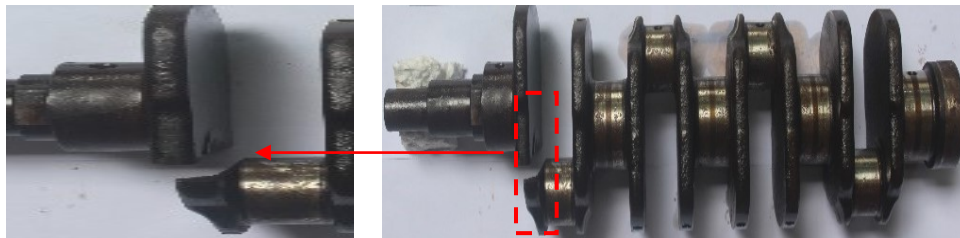
In this study, the material used was taken from the crankshaft of a car. First, observations were made to determine the mechanical properties of the material. The visual inspection showed a crack on the crankshaft with an engine rotation speed of 5500 RPM. The crankshaft was broken at crank pin number 1, as shown in figure 2. The visual inspection showed beach marks on the fault surface, as shown in Figure 3, characterizing the cause of the failure.

**Figure 2.** Failure of the crankshaft.

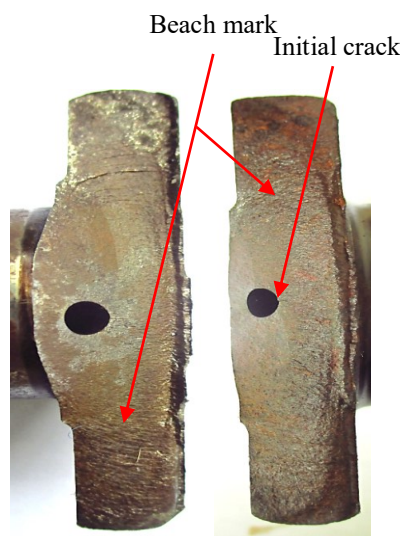
**Figure 3.** Failure surface of the crankshaft.

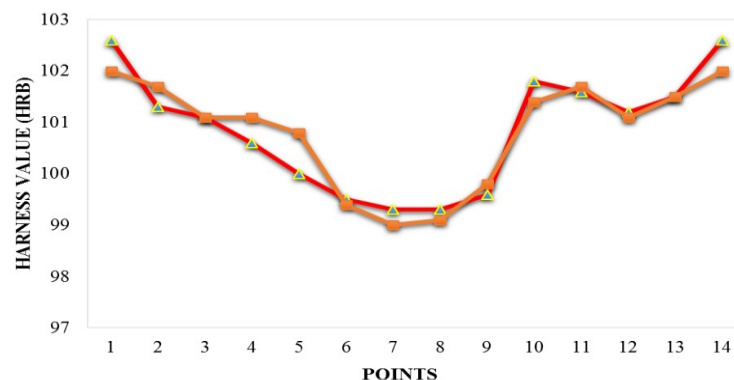
From the hardness test results, it was found that the highest hardness value of 102.2 HR<sub>B</sub> was on the outer shell portion of the crankshaft on the  $x$  and  $y$  axes at points 1 and 14. The hardness testing point can be seen in Figure 5. The hardness of the shaft on the outer shell was greater than at the centre to avoid defects and rapid wear during work. The hardness reached 13 mm from the outer surface of the crankshaft. Due to the unsuitable heat treatment process, the crankshaft was harder than the standard AISI 1060 material, which was 94 HR<sub>B</sub>, while the average hardness of the crankshaft material that was tested was 100,83 HR<sub>B</sub>. Therefore, the crankshaft, which was too hard to overheat up to a depth 13 mm from the outer surface, was prone to failure.

**Figure 5.** Graph of the hardness values (red is  $x$ -axis and orange is  $y$ -axis).

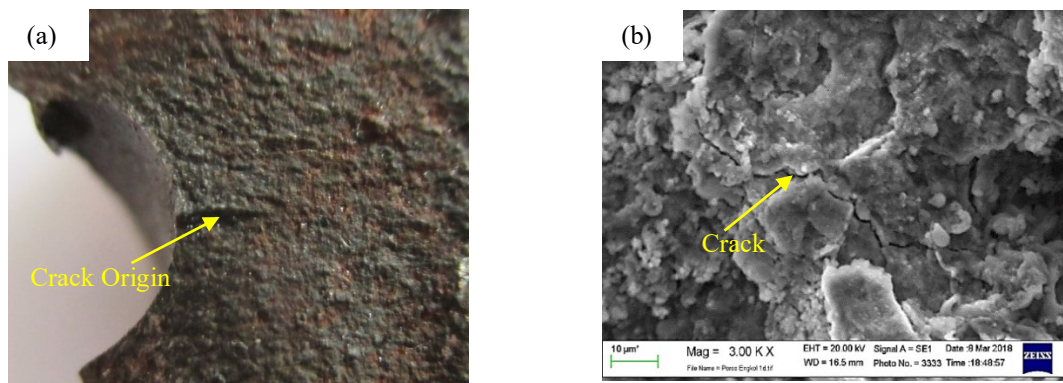
From the SEM test result, a defect around the oil hole was seen at a magnification of 3000 times using an EVO MA10 SEM. Due to maintenance errors and negligence in the installation process, there was a scratch with a sharp object resulting in the defect. The defect can be seen in Figure 6.

After observation of the factography by SEM, the existence of a crack was discovered. The result of a simulation using the finite element analysis revealed that the stress intensity factor was 2.42 MPa√m, which was smaller than the fracture toughness of 50 MPa√m of the material. Therefore, it could be concluded that the crack here did not spread. However, the crankshaft experienced fatigue failure here, as characterized by the beach marks on the crack surface of the crankshaft, as shown in Figure 3 [12]. Another cause was the material hardness that was up to a depth of 13 mm from the outer surface of the crankshaft. As such, the crankshaft was too hard and prone to fracture.

**Figure 6.** (a) Visual observation results and (b) result of the observation of the broken surface at a magnification of 3000 times.

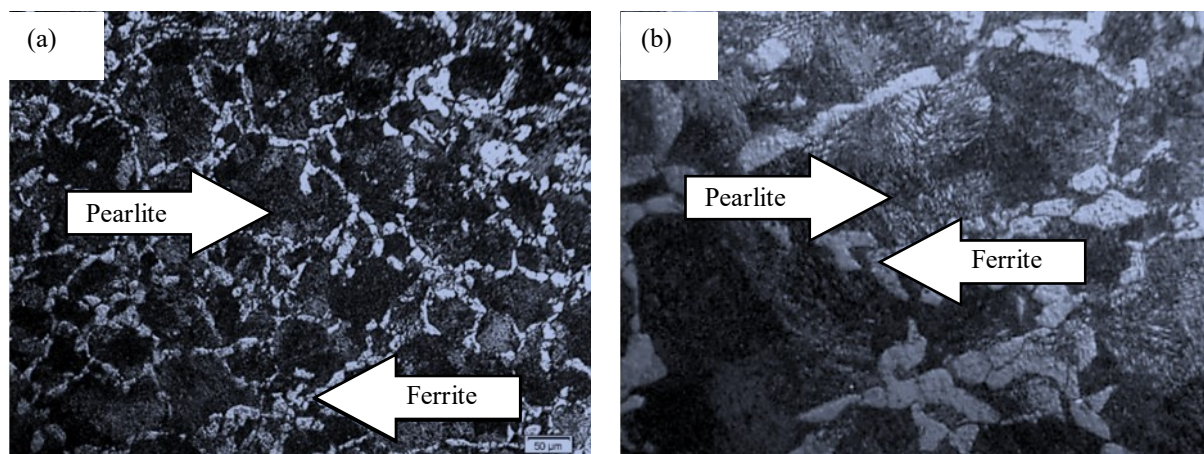
The results of the microstructural test revealed that the matrix was ferrite and pearlite [13] with a mean hardness value of 100.83 HR<sub>B</sub> on the x-axis and 100.85 HR<sub>B</sub> on the y-axis. This showed that this material was hypereutectoid steel, which is steel with a carbon content of between 0.02-0.76%. Figure 7 shows the results of the microstructural test with magnifications of 20 and 50 times.

**Figure 7.** (a) Results of microstructural testing with 50x magnification and (b) results of microstructural testing with 20x magnification.
