Load-deformation analysis on a slope at Gunung Pulai water treatment plant, Sultan Ibrahim Reservoir

K Azman*, M Mushairry¹, A R Ahmad Safuan¹, O Mohd Hanim¹, I Izni Syahrizal¹, V Mohammadreza¹, C A Sophia¹, M A Mohd Azreen¹, A Rini Asnida¹, S Radzuan¹, H Muhammad Azril¹, A Mohd Nur Asmawisham¹, M A Mohd For¹, T Sahrul Nizam¹, A R Afif¹, K Kamrul Zaman¹, H Hairul Hairi¹, A W Zulkifly¹, D S A Ismail¹ and M A R Muhammad Fateh¹

¹School of Civil Engineering, Faculty of Engineering, Universiti Teknologi Malaysia 81310 Johor Bahru, Johor, Malaysia

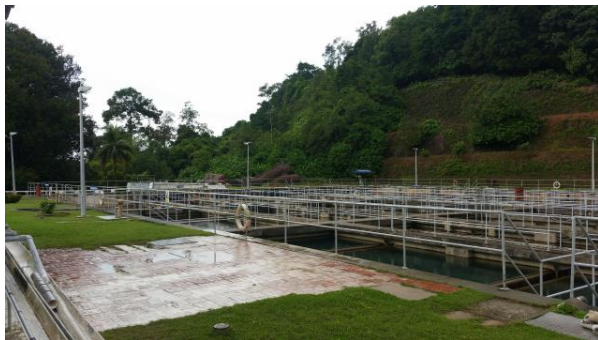
Figure 1. Water sedimentation plant.

State government under new management of the Syarikat Air Johor (SAJ). However, the integrity of the water treatment structure should be checked due to the structure was built over more than 90 years, and moreover after a several cracks was recently observed at Water Sedimentation Plant as shown in Figure 1 and Figure 2.

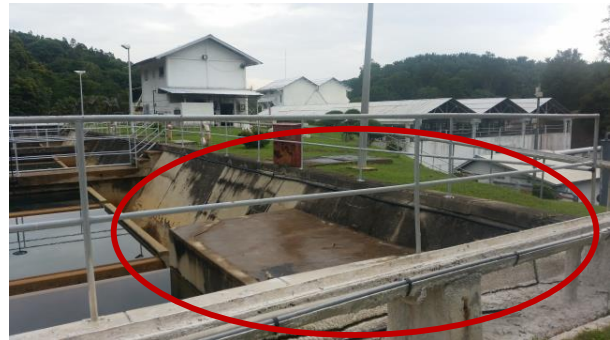
Two (2) possibilities could have contributed to the cracks which are the effect from vibration due to blasting activities from the nearby quarry and/or the movement of present retaining wall or sloping area nearby the treatment plant. To measure and quantify the vibration, real time monitoring is conducted in order to understand on the vibration effect toward the treatment plant structure. The implementation of slope monitoring program and installation of vibration monitoring devices at Gunung Pulai Water Treatment Plant (GPWTP) that include designing, setting-up and installing multiple monitoring systems with the aim of identifying contributed factors to the problem of crack on water treatment structures, i.e. Water Sedimentation Plant (Kassim *et. al.*, 2018a).

Figure 2. A structural crack was observed on the Water Sedimentation Plant storage tanks.

Therefore, it is strongly recommended that slope remedial works (designing and constructing stable slope) together with in depth investigation on crack of sedimentation concrete structure (repairing and monitoring of crack propagation) should be carried out in very near future. The most importantly, the slope at corner area should be reinstated to strengthen gabion wall before the cracks on that particular location of Water Sedimentation Plant are repaired.

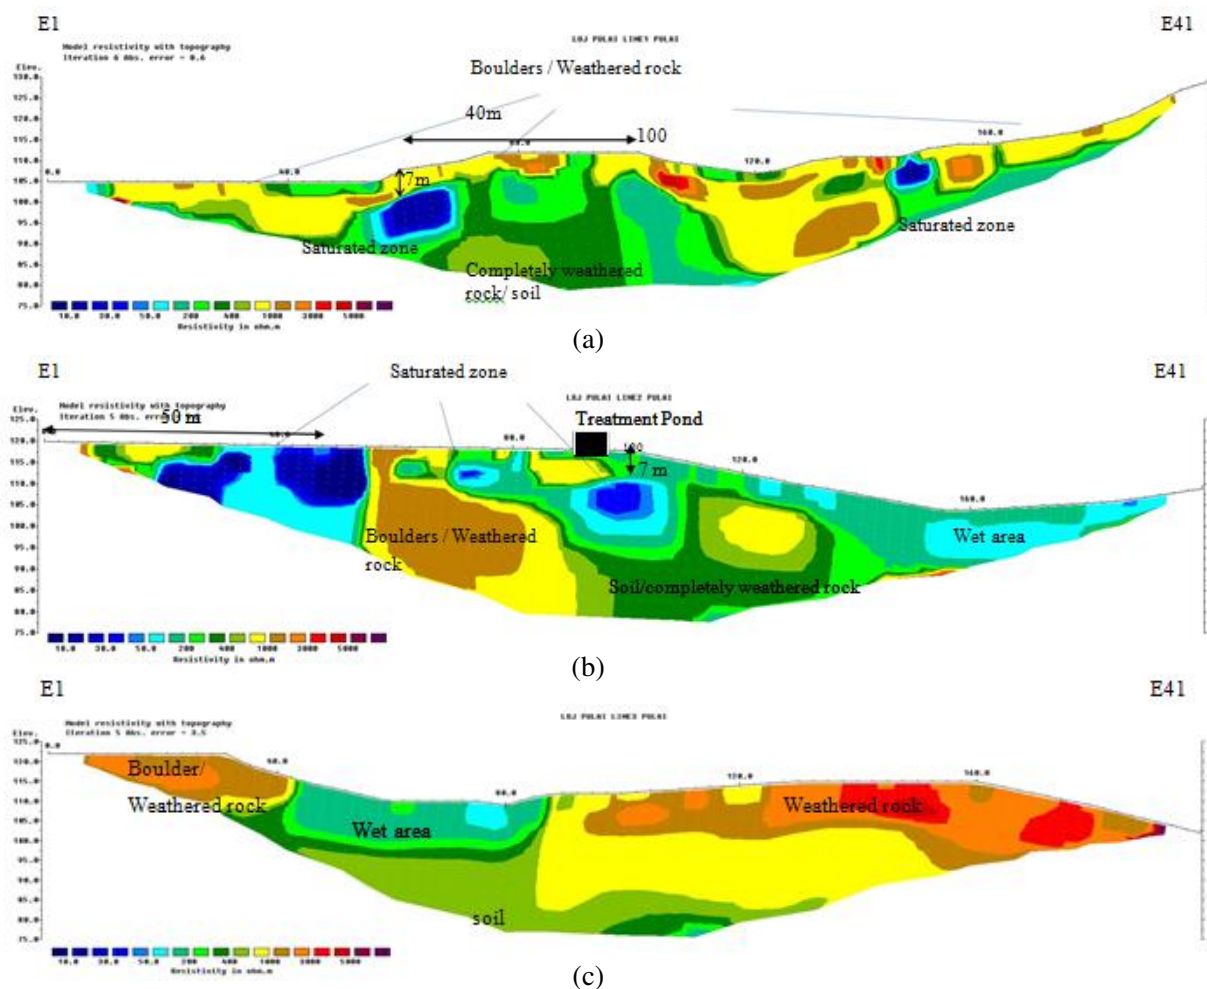
Figure 4. Resistivity image of Line 1 (a), Line 2 (b) and Line 3 (c) (Kassim *et. al.*, 2018b).

The resistivity images in Figure 4 show a subsurface profile along 200m of resistivity Line 1, Line 2 and Line 3. The images show that the subsurface material of Line 1 is dominantly underlain by resistivity

value less than $500\Omega\text{m}$ around the centre of the line that can be interpreted as completely weathered rock or soil. Significant low resistivity zone (less than $50\Omega\text{m}$) was identified at 40m (60m from E1) from the center of the Line 1 that interpreted as saturated zone. The depth of saturated zone is estimated 7m from the surface. The image also shows that the subsurface material of resistivity value ranging above $1000\Omega\text{m}$ can be interpreted as hard layer of weathered rock or boulders. The hard layer is shown overlain the area.

Line 2 is dominantly covered by low resistivity value material which is less than $400\Omega\text{m}$ interpreted as soil or completely weathered rock. The significant very low resistivity (less than $50\Omega\text{m}$) was found 50m from E1 considered as saturated zone where consider as soil with high water content. The saturated area is believed to be confined by the hard material (boulders). Saturated zone was also detected at the center of survey line which is next to the water treatment pond. And lastly, Line 3 shows that subsurface material is dominantly underlain by high resistivity material (more than $1000\Omega\text{m}$) that can be interpreted as hard and

weathered rocks. It is believed that there is soil layer underlain the boulders. It can be observed at the upper part of subsurface profile at the distance of 45m to 90m from E1 there is a location of low resistivity area which considered as wet area where it is considered high water content in the soil here.

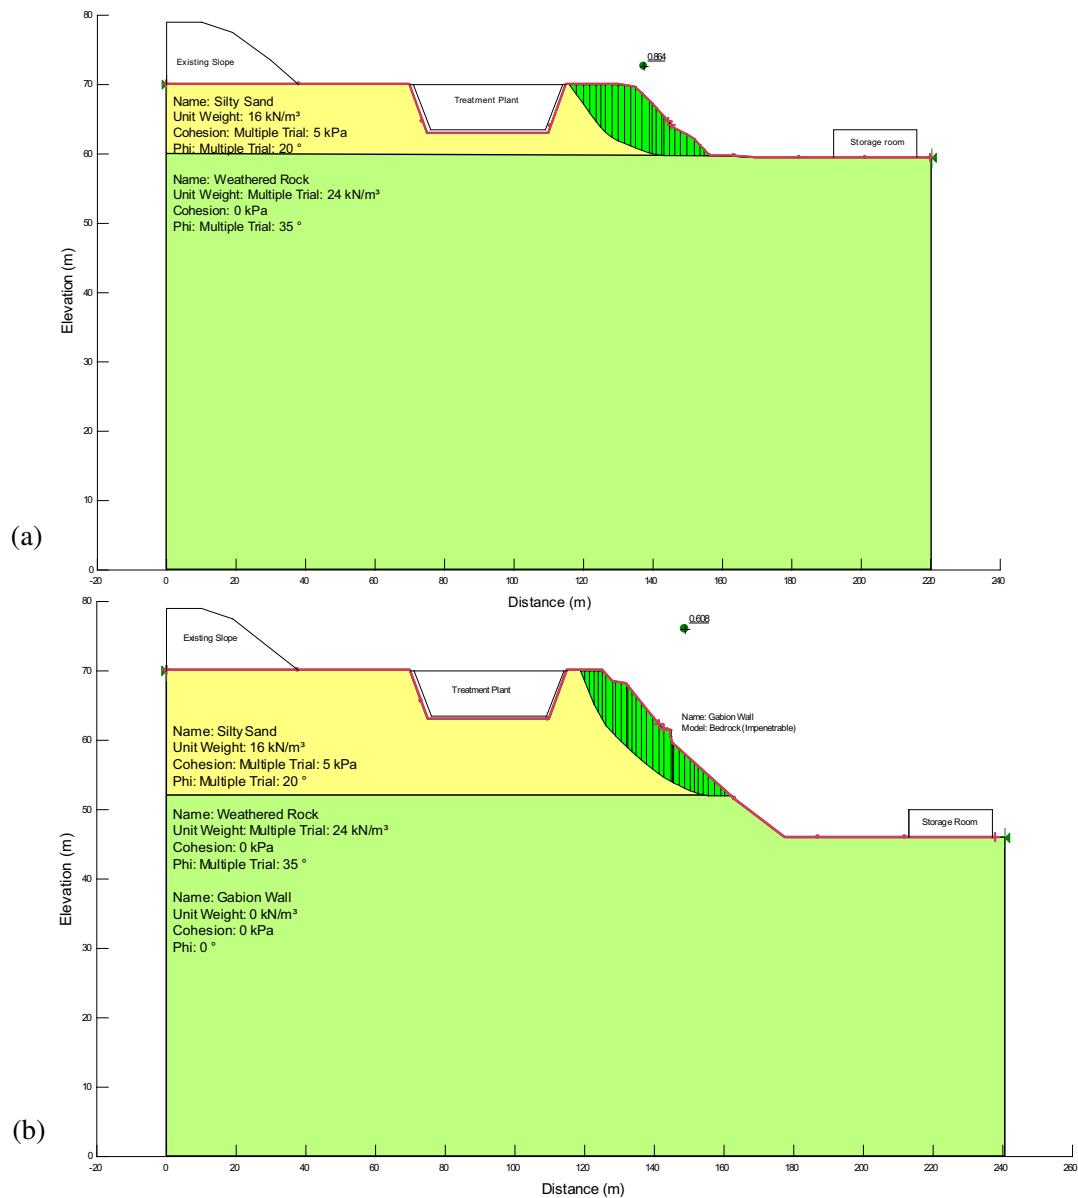
Figure 6. Slope stability analysis on C1(a) and C2(b).

Figure 6(a) and (b) shows the calculated Factor of Safety (FOS) for cross section C1 and C2. The slope stability analysis show the failure feature for cross section C1 is likely global and deep seated with the FOS = 0.864 via sensitivity analysis. The FOS = 1 (stable condition) with sensitivity of k_h , ϕ' and c' at 0.21g, 24° and 10kN/m³, respectively on top soil (Silty SAND) but FOS is not sensitive to bottom soil (Weathered Rock) as shown in Figure 7. The results for cross section C1 indicate any decrease in ϕ' and c' (during wetting/saturated condition) or increase in k_h will cause instability on slope (FOS is less than 1).

Also, the failure feature for cross section C2 is likely global and deep seated with the FOS = 0.608 via sensitivity analysis. Figure 7 shows the FOS < 1 for all k_h , ϕ' and c' values to show original slope at cross section C2 is unstable. However, the sensitivity trends are similar to cross section C1 where it is sensitive to top soil but FOS is not sensitive to bottom soil. The results indicate the slope at C2 is likely to fail to compare to FOS for C1 = 0.864.

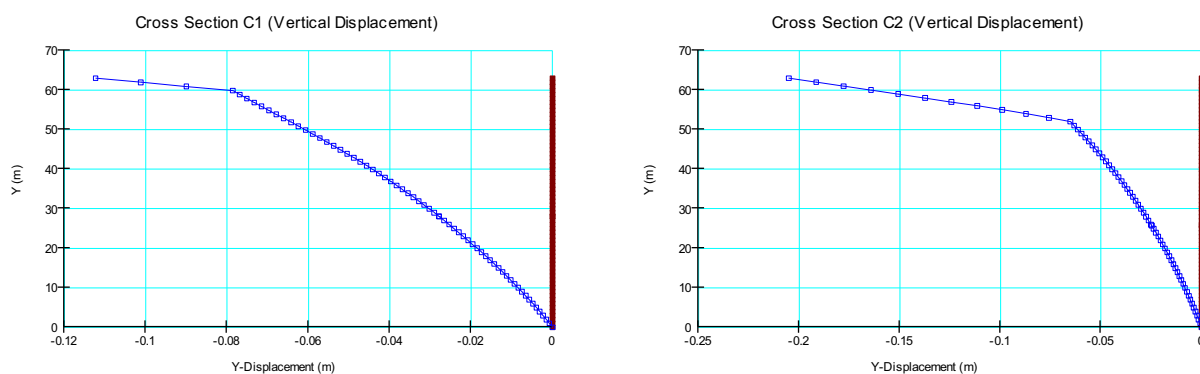
Figure 8. Vertical displacement on C1 and C2.

Figure 8 to 10 shows the results of Load-Deformation analysis on cross section C1 and C2. The results of analysis show the vertical displacement on cross section C1 is maximum on the bottom of treatment plant (Y-displacement = 110mm) but decreasing to 0mm at Reference Level of 0m. The horizontal displacement, X-displacement = 10mm to 60mm on cross section C1. The results for cross section C1 indicate applied load significantly affect deformation at both vertical and horizontal directions which could have contributed to FOS < 1 in slope stability analysis. For cross section C2, the maximum vertical displacement (Y-displacement) = 200mm is larger than found on C1 (Y-displacement = 110mm). The horizontal displacement on C2, X-displacement = 60mm to 150mm as shown in Figure 10. The results indicate deformation due to applied load is more critical at cross section C2 to compare to cross section C1.

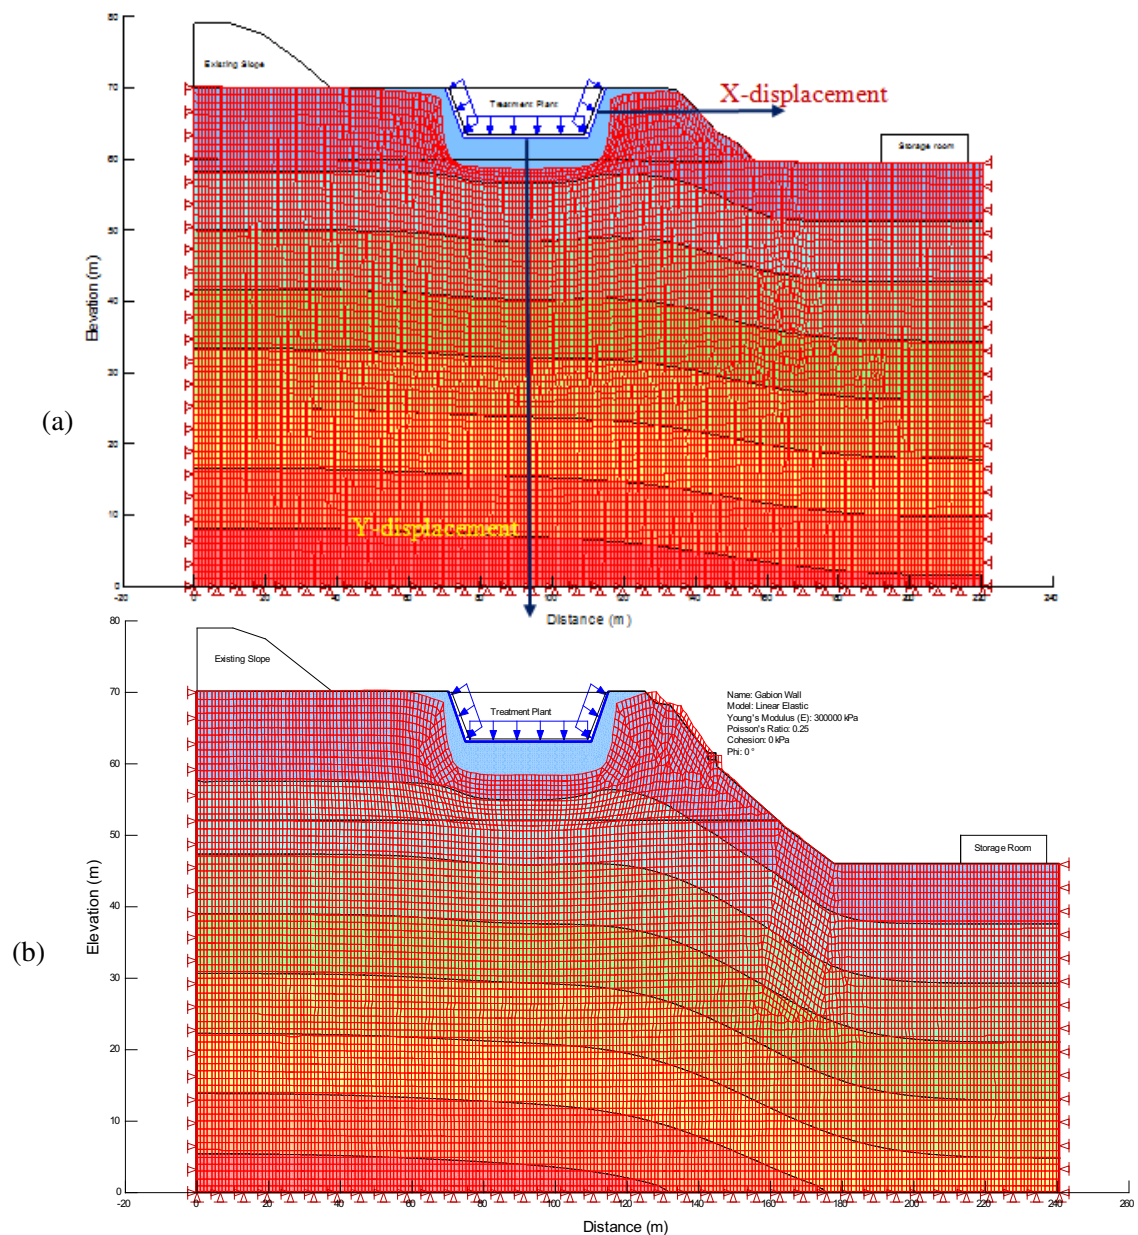
Figure 9. Load-Deformation analysis on cross section on C1(a) and C2(b).

applied structural and water loads significantly affect deformation at both vertical and horizontal directions which could have contributed to $FOS < 1$ in slope stability analysis. It is also shown that deformation due to applied loads is more critical at cross section C2 (near corner area of Water Sedimentation Plant) to compare to cross section C1.

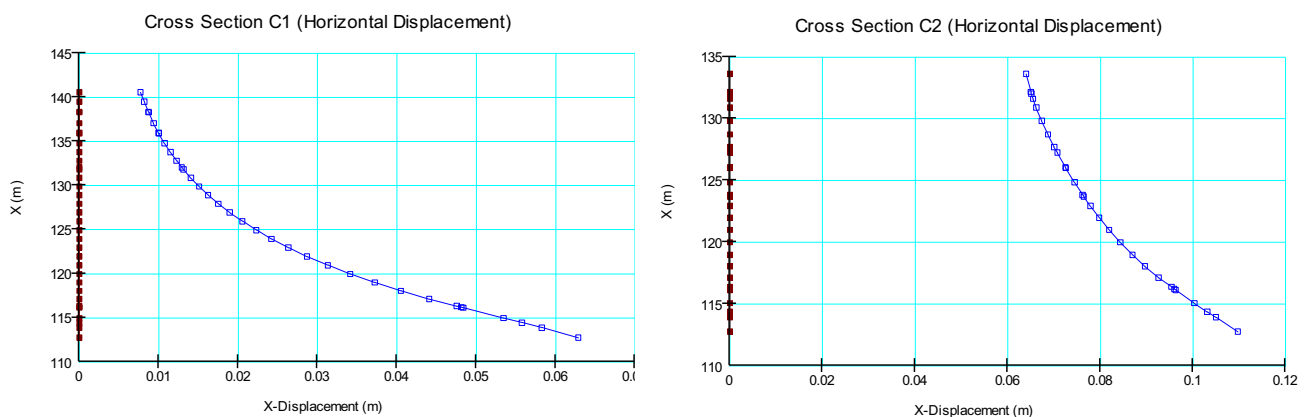
Figure 10. Horizontal displacement on C1 and C2

The calculated Factor of Safety (FOS) via sensitivity analysis for cross sections of original slope shows the failure feature is likely global and deep seated with sensitivity analysis results indicate any decrease in ϕ' and c' during wetting/saturated condition and/or increase in k_h will further cause instability on slope. The results of Load-Deformation analysis on cross sections of original slope also show maximum vertical displacement on the bottom of treatment plant but decreasing to 0mm at Reference Level of 0m, and horizontal displacement is also decreasing from 150mm to 10mm toward the slope. The results indicate
