## Study of leaf spring fracture behavior used in the suspension systems in the diesel truck vehicles

To cite this article: Husaini *et al* 2019 *IOP Conf. Ser.: Mater. Sci. Eng.* **541** 012046

# Study of leaf spring fracture behavior used in the suspension systems in the diesel truck vehicles

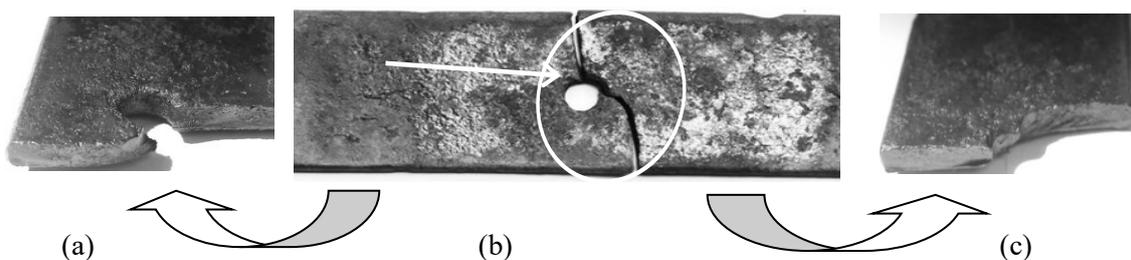
The object research used in this study is the leaf fracture spring used in colt diesel trucks. Leaf springs experience fracture after the vehicle runs up to a distance of about 572 km. Broken leaf spring as shown in Figure 1. This material was obtained from a mechanical workshop, and then identified the type of vehicle and the allowable load capacity. The fracture that occurs in the leaf spring is near the bolt hole as indicated by the arrow.

**Figure 1.** (a) Broken leaf springs on the left side of Fig. 1(b). (b) Broken leaf spring for research object. (c) Broken leaf springs on the right side of Fig. 1(b).

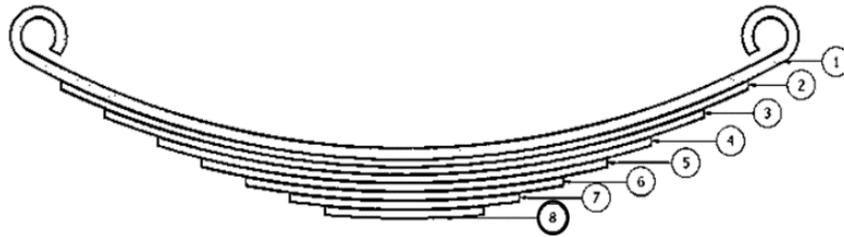
Figure 2 shows a schematic drawing that explains the arrangement of springs from number 1 to number 8. In this case the broken one is spring number 8 as shown in Figure 2.

**Figure 2.** Schematic drawing of the arrangement of the leaf springs from No. 1 to No. 8 (broken spring).

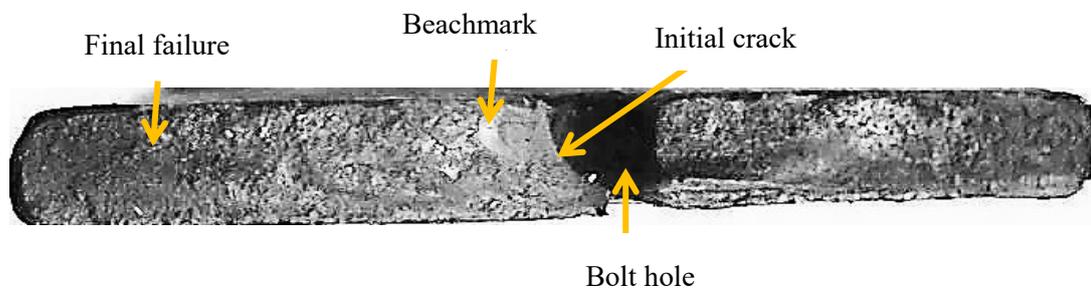
Visual observations on the fracture surface of leaf spring evaluated were around the bolt hole area. From visual observation, it was found that there was an initial crack on the side of the bolt hole as shown in Figure 3. Furthermore, the beach mark can be seen on the fracture surface. This finding indicates that the spring has experienced fatigue fracture [8].

**Figure 3.** Picture of the fracture surface of the leaf spring of number 8.

Fracture surfaces of leaf springs (Figure 3 and 4) show that fatigue crack propagation has occurred which starts from the initial crack, then crack propagation occurs in line with increasing dynamic load so that the final fracture is split in two parts [8][9].

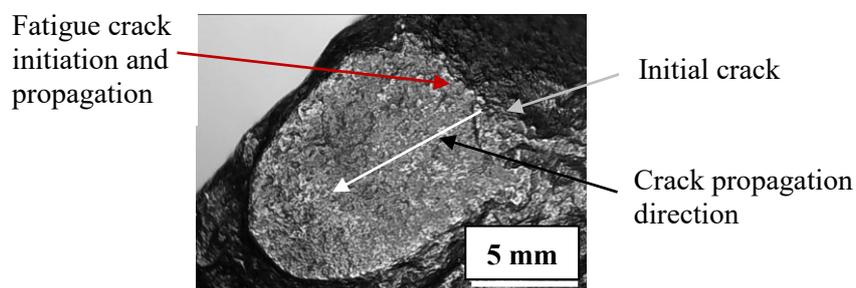
Figure 4 shows that the image taken from initial crack tip area as shown in Figure 3. It can be seen that the crack initiation occurred here which is characterized by relatively smooth fracture surfaces which indicates that fatigue cracking has occurred.

**Figure 4.** Fracture surface image taken from initial crack tip area of Figure 3.

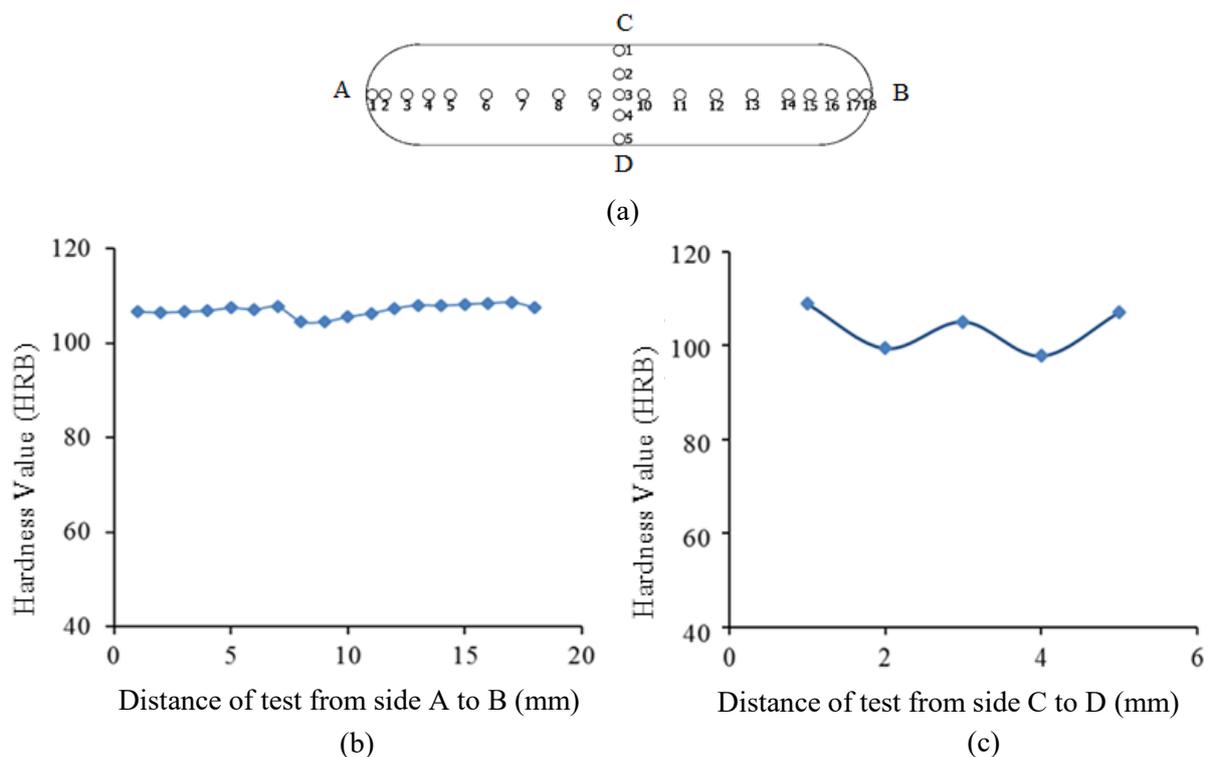
The hardness test results in the horizontal direction from point A to B and the vertical direction from point C to D as shown in Figure 7. The distance between test points is approximately 2 to 5 mm (see Figure 6.a). Hardness in the area close to the bolt hole or at the core is lower than the hardness value in the part close to the side of the spring surface. It shows that the toughness of the material in the center of the leaf spring is higher than the part on the outer side of the spring. Therefore this spring is very susceptible to fracture. This result is in accordance with the results reported by previous researchers [2][7].

**Figure 6.** Curve of hardness on the Leaf Spring. (a) Hardness test point at the spring. (b) Curve of hardness in the inner section in the direction from A to B (see Figure 6 (a)). (c) Curve of hardness in the inner section in the direction from C to D (see Figure 6 (a)).

The leaf spring cross section hardness yields different values between the center and the edge side. Hardness test results show that, in the horizontal directions from A to B are 104.6 HRB for minimum value and 108.5 HRB for the maximum value. The difference in hardness value is insignificant only 3.6%. The same results are encountered in directions from C to D are 97.8 HRB minimum and 107.1 HRB maximum where the results remain under 10% namely 8.7%. The mean hardness was 106.5

HRB in the A to B direction and 102.5 HRB for the C side to D direction. The mean of the overall hardness value is 104.5 HRB. It can be concluded that there is no hardening that cause the leaf springs damaged. This matter as seen from hardness value is not significantly different between the points around the fracture and at the point on the edge.

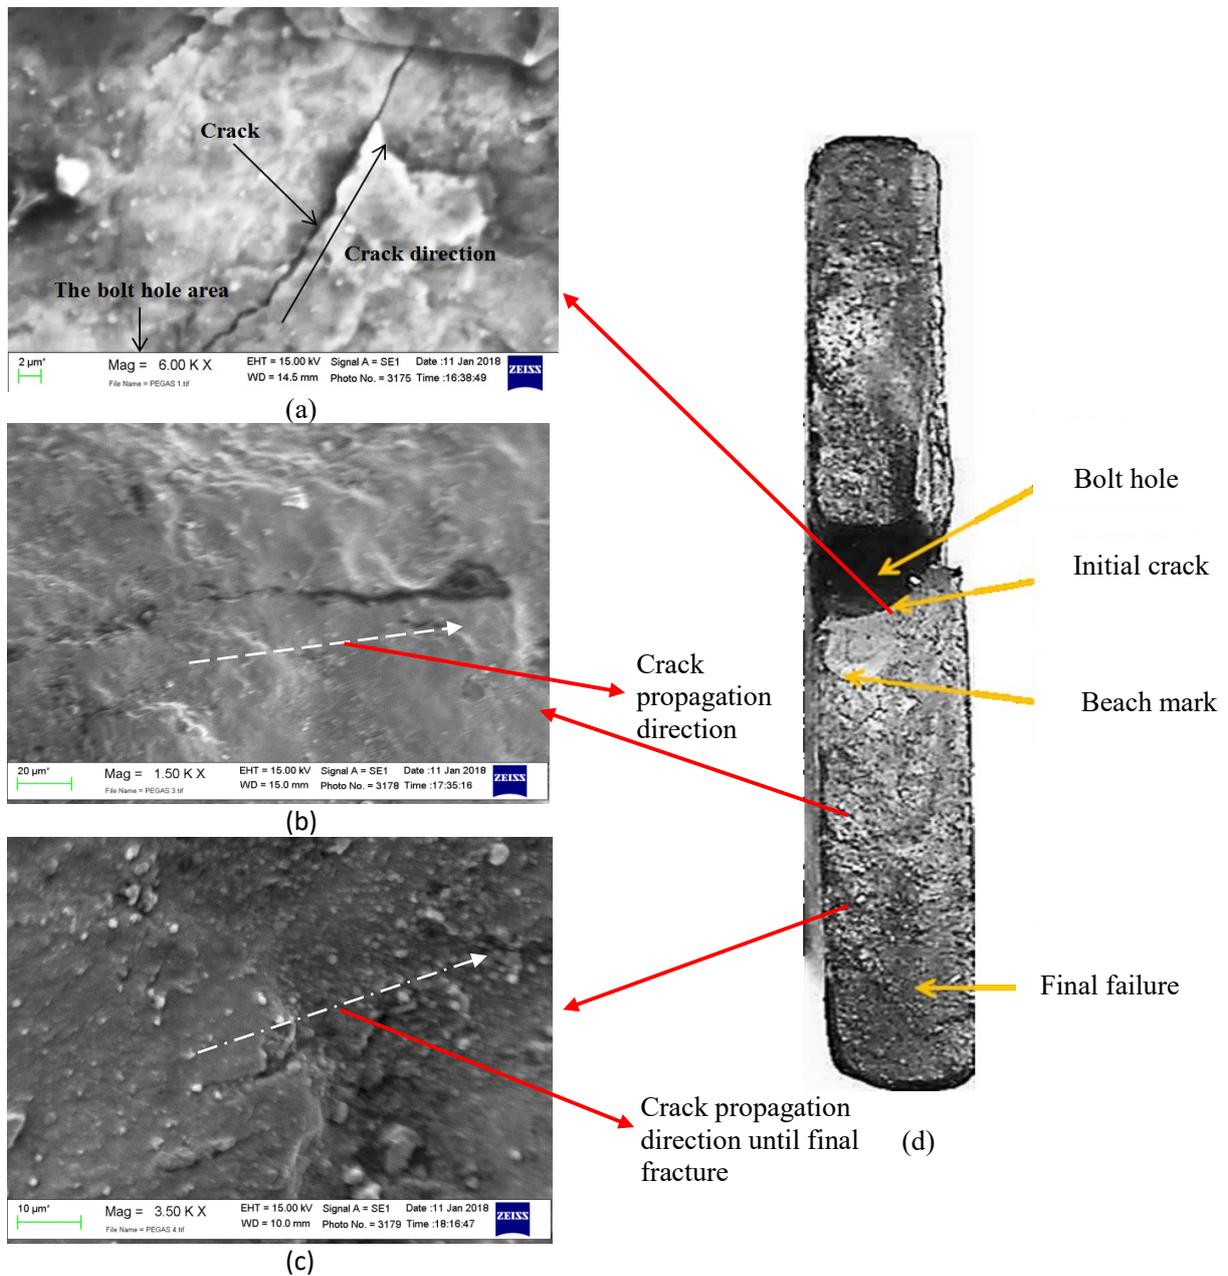
In reality, leaf springs as a suspension system in vehicles always receives dynamic loads and sometimes until they experience failure of fatigue fractures. Therefore, the fracture surface was necessary to investigated using scanning electron microscope (SEM) [14]. Microscopic observations with magnitudes of 6000 on the fracture surface of the spring identified that the crack occur around the bolt hole. The crack starts on the bolt portion then propagate to the cross section of the spring. Furthermore it can be explained as in Figure 7. Where, Figure 7 shows a series of SEM images taken at the crack surface (Figure 7 (d)). The initial crack and the direction of crack propagation as shown in Figure 7 (a), then crack propagation occurred (Figure 7 (b)), until the end final fracture occurred as shown in Figure 7 (c).

**Figure 7.** A series of SEM images taken at the crack surface. (a) The initial crack and the direction of crack propagation. (b) Crack propagation occurred. (c) Final fracture occurred. (d) Leaf spring fracture surface.

1. From SEM observation, it was found that on the fracture surface of the spring identified the initial crack occur around the bolt hole. The crack extension starts on the bolt part then propagate to the cross section of the spring until final failure.
2. The value of stress intensity factor  $K_I$  is higher than the value of fracture toughness  $K_{IC}$  of AISI 5150 material. This result indicated that crack propagation occurred and this fact also indicated that this is one of the causes of leaf spring failure.
3. Fracture of the spring was also induced by fatigue fracture that characterized by existing the beach mark on the fracture surface.
