## Influence of thermal insulation from PUR foam to improve thermo-technical parameters of building envelope for broiler housing

To cite this article: T Szabóová and M Balková 2019 *IOP Conf. Ser.: Mater. Sci. Eng.* **549** 012005

**T Szabóová<sup>1</sup> and M Balková<sup>1</sup>**

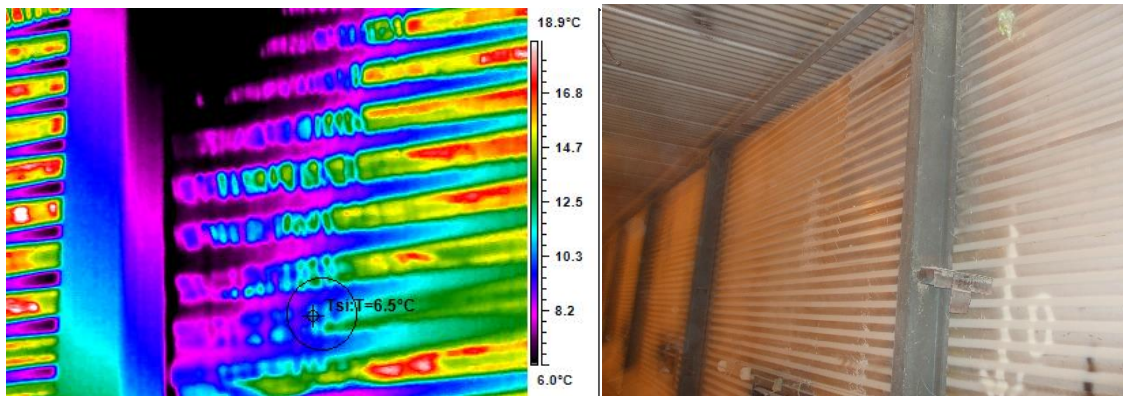
- critical surface temperature for mold formation [4]  $\theta_{si,80} = 9.79^\circ\text{C}$
- dew point temperature [4]  $\theta_{dp} = 6.51^\circ\text{C}$
- safety surcharge for intermittent heating of stables with a drop in the internal air temperature  $\theta_i$  up to 5 K [5]:  $\Delta\theta_{dp} = 0.2\text{ K}$
- safety surcharge for intermittent heating with a drop in the internal air temperature  $\theta_i$  up to 5 K [6]:  $\Delta\theta_{si} = 0.5\text{ K}$
- surface temperature of uninsulated wall (Figure 1)  $\theta_{si} = 6.5^\circ\text{C}$

$$6.5^\circ\text{C} < 10.29^\circ\text{C} \rightarrow \text{The wall doesn't meet the standard requirement}$$

$$6.5^\circ\text{C} < 6.71^\circ\text{C} \rightarrow \text{The wall doesn't meet the standard requirement}$$

**Figure 1.** Thermogram of non-insulated internal wall.

The surface temperature of the non-insulated peripheral wall of the hall building  $\theta_{si}$  was only  $6.5^{\circ}\text{C}$  (Figure 1). Assessing the wall from the hygienic point of view, it was found that the monitored wall doesn't meet the standard requirements.

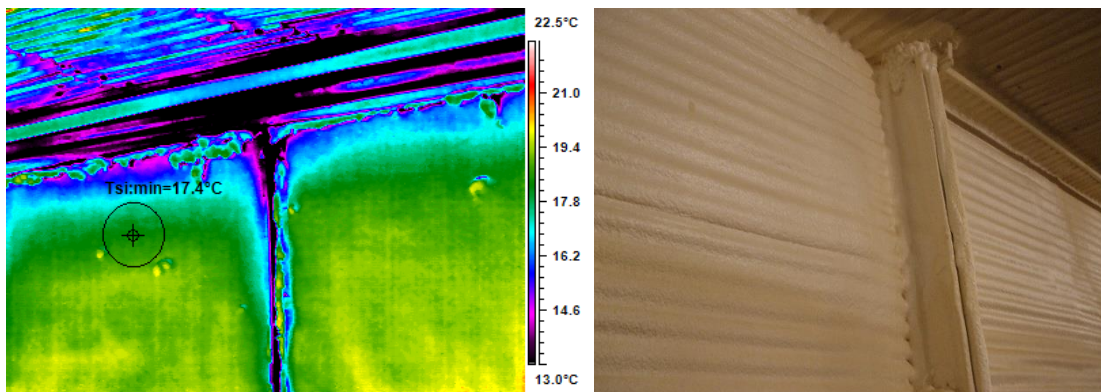
$\theta_i = 18^\circ\text{C}$ ,  $\theta_e = -3.5^\circ\text{C}$ ,  $\Delta\theta_{ie} = 21.5^\circ\text{C}$ ,  $\phi_i = 54\%$ ,  $\phi_e = 39\%$ ,  $\theta_{si,80} = 12^\circ\text{C}$ ,  $\theta_{dp} = 9^\circ\text{C}$ ,  $\Delta\theta_{dp} = 0.2\text{ K}$ ,  $\Delta\theta_{si} = 0.5\text{ K}$ ,  $\theta_{si} = 17.4^\circ\text{C}$  (the surface temperature of the insulated wall of Figure 2).

$$17.4^\circ\text{C} \geq 12.5^\circ\text{C} \rightarrow \text{The wall meets the standard requirement}$$

$$17.4^\circ\text{C} \geq 9.2^\circ\text{C} \rightarrow \text{The wall meets the standard requirement}$$

**Figure 2.** Thermogram of insulated wall from inside.

After insulation of the examined wall with thermal insulation foam the inside her surface temperature increased to  $17.4^{\circ}\text{C}$  (Figure 2), at nearly the same indoor air temperature. Subsequently, the wall was assessed from a hygienic point of view, and it was found that after wall insulation it meets the hygienic criterion as its surface temperature was higher than the critical surface temperature for mold formation  $\theta_{si,80} = 12^{\circ}\text{C}$  and dew point temperature  $\theta_{dp} = 9^{\circ}\text{C}$ .

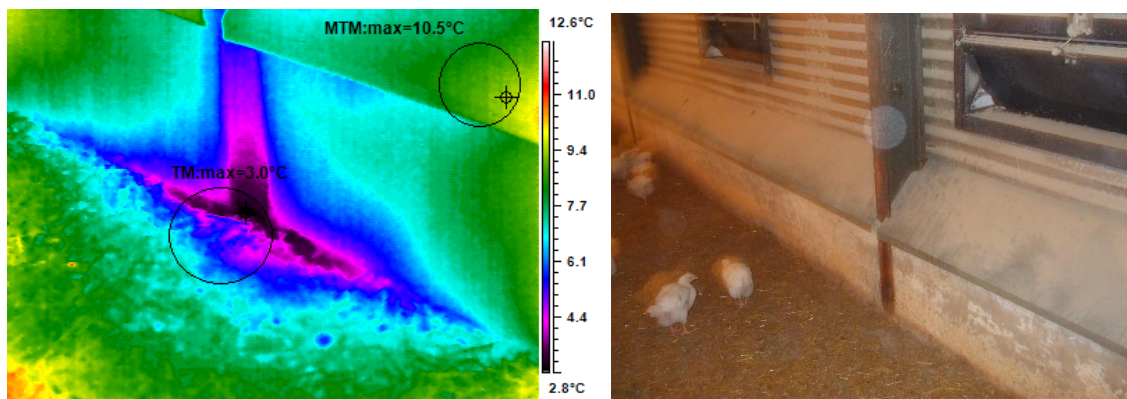
$\theta_i = 17^{\circ}\text{C}$ ,  $\theta_e = -3.5^{\circ}\text{C}$ ,  $\Delta\theta_{ie} = 20.5^{\circ}\text{C}$ ,  $\varphi_i = 50\%$ ,  $\varphi_e = 38.5\%$ ,  $\theta_{si,80} = 9.79^{\circ}\text{C}$ ,  $\theta_{dp} = 6.51^{\circ}\text{C}$ ,  $\theta_{dp} = 0.2\text{ K}$  (for thermal bridges  $\Delta\theta_{dp} = 0\text{ K}$ ),  $\Delta\theta_{si} = 0.5\text{ K}$ , the surface temperature of the wall at the thermal bridge TM (Figure 3)  $\theta_{si,TM} = 3^{\circ}\text{C}$ , the surface temperature of the wall outside of the thermal bridge MTM (Figure 3)  $\theta_{si,MTM} = 10.5^{\circ}\text{C}$ .

TM:  $3^{\circ}\text{C} < 9.79^{\circ}\text{C} \rightarrow$  The wall doesn't meet the standard requirement

MTM:  $10.5^{\circ}\text{C} \geq 10.29^{\circ}\text{C} \rightarrow$  The wall meets the standard requirement

TM:  $3^{\circ}\text{C} < 6.51^{\circ}\text{C} \rightarrow$  The wall doesn't meet the standard requirement

MTM:  $10.5^{\circ}\text{C} \geq 6.71^{\circ}\text{C} \rightarrow$  The wall meets the standard requirement

**Figure 3.** Detail of a thermal bridge of non-insulated plinth.

TM – measurement made at the point of thermal bridge, MTM – measurement taken outside the thermal bridge

A thermal bridge was detected by thermovision in the plinth part of the wall construction in contact wall with bedding, which was subsequently assessed from a hygienic point of view. The results show that the wall in question at the location of the thermal bridge doesn't meet the hygiene criterion. At this place there was a significant leakage of heat resulting in a low surface temperature  $\theta_{si,TM} = 3^{\circ}\text{C}$ , which was lower than the critical surface temperature for mold formation  $\theta_{si,80} = 9.79^{\circ}\text{C}$  and also as dew point temperature  $\theta_{dp} = 6.51^{\circ}\text{C}$ . Condensation of water vapor and the formation of molds is a prerequisite in the given location. Outside the thermal bridge, the wall met the hygiene criterion as its surface temperature was higher than the norm value of  $\theta_{si,MTM} = 10.5^{\circ}\text{C}$ .

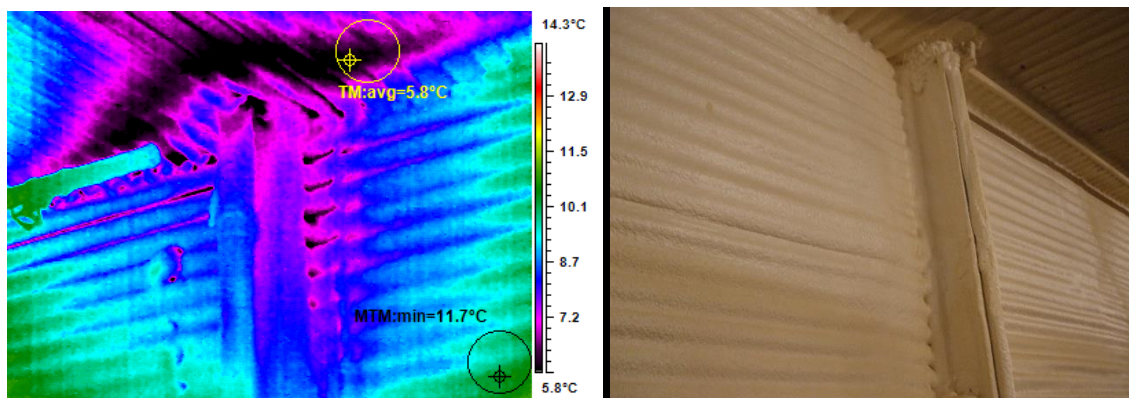
$\theta_i = 16.7^{\circ}\text{C}$ ,  $\theta_e = -3.5^{\circ}\text{C}$ ,  $\Delta\theta_{ie} = 20.2^{\circ}\text{C}$ ,  $\varphi_i = 54\%$ ,  $\varphi_e = 39\%$ ,  $\theta_{si,80} = 10.7^{\circ}\text{C}$ ,  $\theta_{dp} = 7.4^{\circ}\text{C}$ ,  $\theta_{si} = 0.5\text{ K}$ ,  $\Delta\theta_{dp} = 0.2\text{ K}$ , surface temperature of the ceiling at the place of the thermal bridge TM (Figure 4)

$\theta_{si, TM} = 5.8\text{ }^{\circ}\text{C}$ , surface temperature of insulated wall outside of the thermal bridge MTM (Figure 4),  
 $\theta_{si, MTM} = 11.7\text{ }^{\circ}\text{C}$ .

TM:  $5.8\text{ }^{\circ}\text{C} < 11.2\text{ }^{\circ}\text{C} \rightarrow$  The wall doesn't meet the standard requirement

MTM:  $11.7\text{ }^{\circ}\text{C} \geq 11.2\text{ }^{\circ}\text{C} \rightarrow$  The wall meets the standard requirement

TM:  $5.8\text{ }^{\circ}\text{C} < 7.4\text{ }^{\circ}\text{C} \rightarrow$  The wall doesn't meet the standard requirement

MTM:  $11.7\text{ }^{\circ}\text{C} \geq 7.6\text{ }^{\circ}\text{C} \rightarrow$  The wall meets the standard requirement

**Figure 4.** The contact of the uninsulated ceiling and insulated internal wall.

TM – measurement made at the point of thermal bridge, MTM – measurement taken outside the thermal bridge

Wall construction made from corrugated sheet was insulated with sprayed PUR foam, while the ceiling wasn't insulated. There was heat leakage at the point of contact between the ceiling and the wall (Figure 4). Place of the thermal bridge was considered hygienic, while from the point of view of mold formation it didn't meet the standard requirements, because the surface temperature at this critical point was only  $\theta_{si, TM} = 5.8\text{ }^{\circ}\text{C}$ . In terms of dew point temperature  $\theta_{dp} = 7.4\text{ }^{\circ}\text{C}$  and critical surface temperature for mold formation  $\theta_{si, 80} = 10.7\text{ }^{\circ}\text{C}$ , the wall construction didn't fit. Insulated wall construction outside the thermal bridge meet hygienic criteria. Almost double value of the surface temperature of the thermally insulated part of wall  $\theta_{si, MTM} = 11.7\text{ }^{\circ}\text{C}$  above the surface temperature at the site of thermal bridge indicates a need for additional thermal insulation of the ceiling construction. For agricultural buildings with relative humidity over 75 % is recommended to double-shell roof construction system with ventilated air gap [7], to reduce the heat loss through the roof construction during the winter season, thereby reducing the cost of heating the building with gas [8].

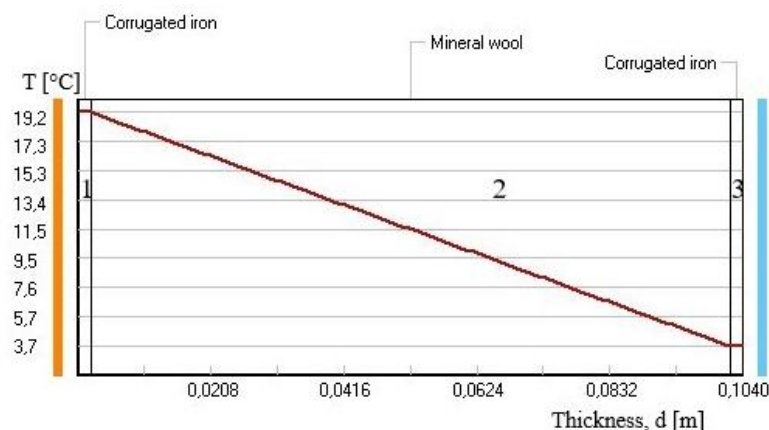
**Figure 5.** Temperatures in a typical structure site under steady-state design conditions before thermal insulation.

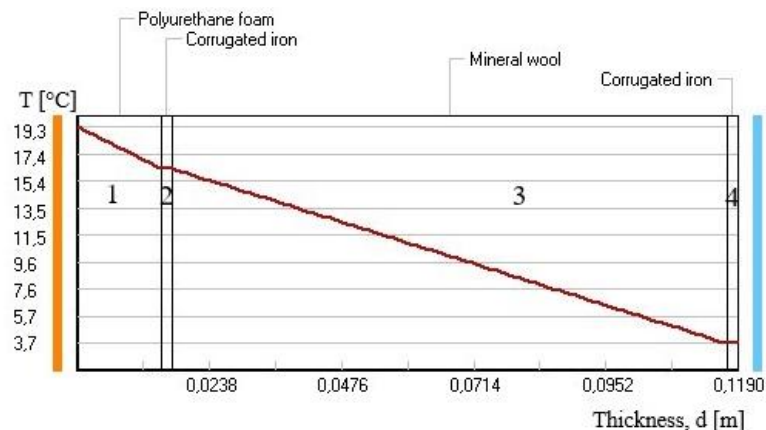
**Figure 6.** Temperatures in a typical structure site under steady-state design conditions after thermal insulation.

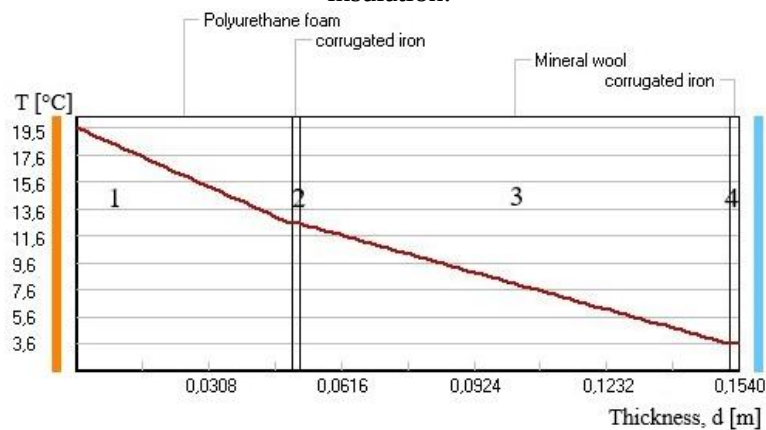
**Figure 7.** Temperatures in a typical structure site under steady-state design conditions after thermal insulation with greater thickness.

At present, according to valid criteria, this thickness of insulation is not sufficient. After designing a larger insulation thickness of PUR foam to 50 mm, this thickness already suited. The recommended heat transfer coefficient of the external wall structure ( $U_{r1}$ ) according to [11] is  $0.22 \text{ W} \cdot \text{m}^{-2} \cdot \text{K}^{-1}$ . This value is valid from 2016 to 2020. In order for the condition to be met,  $U \leq U_{r1}$  must apply. In the event that this condition cannot be met, at least the condition that the maximum value of the heat transfer coefficient  $U_{\max} = 0.46 \text{ W} \cdot \text{m}^{-2} \cdot \text{K}^{-1}$  must be met. The recommended value of the thermal resistance of the external wall structure ( $R_{r1}$ ) according to [11] is  $4.4 \text{ m}^2 \cdot \text{K} \cdot \text{W}^{-1}$  (valid from 2016 to 2020) where the condition  $R \geq R_{r1}$  must be met. The minimum thermal resistance value of  $R_{\min}$  shall be at least  $2.0 \text{ m}^2 \cdot \text{K} \cdot \text{W}^{-1}$ . The calculated and recommended heat transfer coefficient and thermal resistance values of the structure are shown in Table 3.
